NYC Department of Education
Building Condition Assessment Survey 2023 - 2024

Architectural Inspection

Asset: P.S. 209 - QUEENS, 16-10 UTOPIA PKWY, New York, 11357

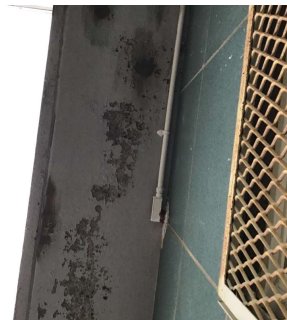
Facade D
No violations recorded.

CONCRETE: DETERIORATED

REPLACE

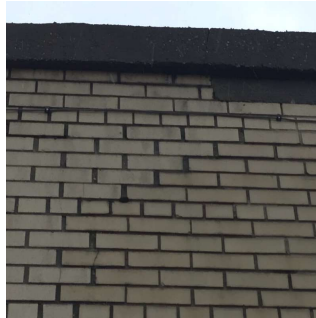
CH

BRICK: DETERIORATED CAP

REPLACE

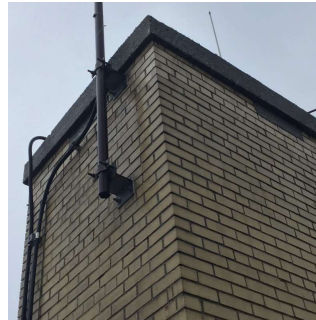
CH

BRICK: DETERIORATED JOINTS

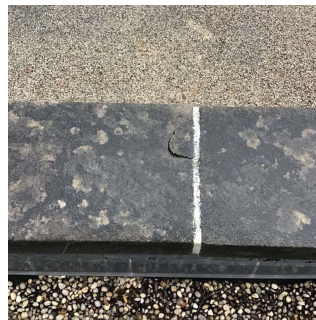
Roof 2

CAST STONE: CRACKED/BROKEN PIECES

REPLACE-IN-KIND

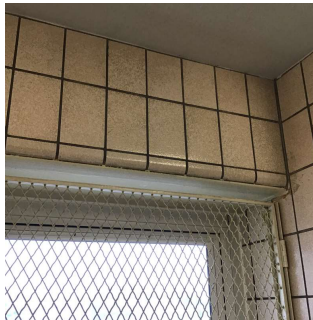
Facade G - Stair EF/2,3

BRICK: WATER INFILTRATION IN INSTRUCTIONAL SPACE

REPAIR

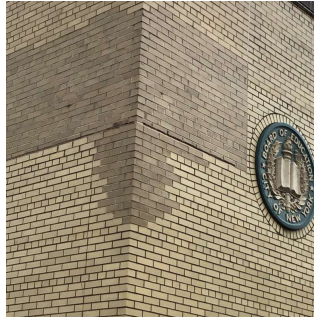
Facade A

BRICK: CRACKS/DISPLACED/SPALLED BRICK AT BUILDING CORNERS

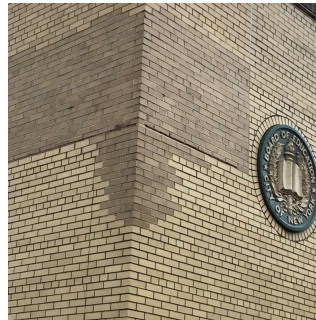
Facade A

BRICK: MAJOR / THRU CRACKS

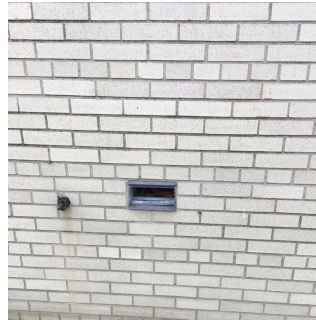
All Facades
No violations recorded.

Deficiency	MISSING/DAMAGED SCREEN
Roof Plan reference

Deficiency Quantity	10
Quantity Uom	S.F.
Potential Action	REPLACE
Urgency of Action	PRIORITY 4
Purpose of Action	LEVEL 2

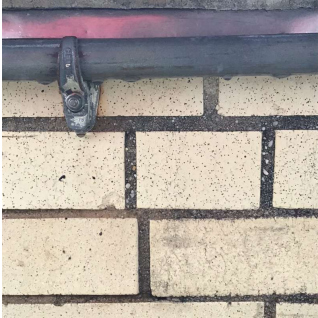
BRICK: DETERIORATED JOINTS

Question	Response
EXTERIOR	
PARAPETS	
Deficiency Quantity	200
Quantity Uom	S.F.
Potential Action	REPOINT
Urgency of Action	PRIORITY 3
Purpose of Action	LEVEL 2
Deficiency Photo1

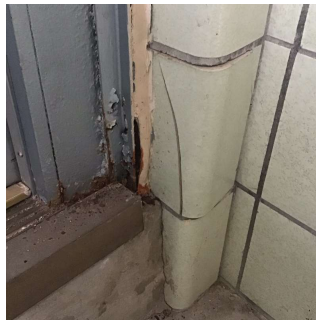
Question	Response
EXTERIOR	
ROOF	
Roofing	
ROOFING	
Deficiency Photo1	 
	Roof 1
Violations	No violations recorded.
ROOFING DRAINS	Inspected
Condition	2 - Between Good and Fair
Deficiency	No deficiencies recorded
Specialties	Inspected
BULKHEAD/PENTHOUSE	Inspected
Condition	3 - Fair
Deficiency	BULKHEAD/PENTHOUSE DOORS: DETERIORATED DOOR AND FRAME
Roof Plan reference	<p>Q209</p>  
Deficiency Quantity	1
Quantity Uom	EACH
Potential Action	REPLACE DOOR AND FRAME
Urgency of Action	PRIORITY 4
Purpose of Action	LEVEL 2
Deficiency Photo1	 
	BH3
Violations	No violations recorded.
Deficiency	BULKHEAD/PENTHOUSE WALLS/INTERIOR: GLAZED BLOCK CRACKS/SPALLING

100
S.F.
REPLACE
PRIORITY 3
LEVEL 2

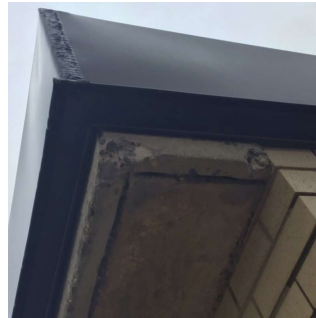
BH2

BULKHEAD/PENTHOUSE ROOF: DETERIORATED

10
S.F.
REPAIR
PRIORITY 3
LEVEL 2

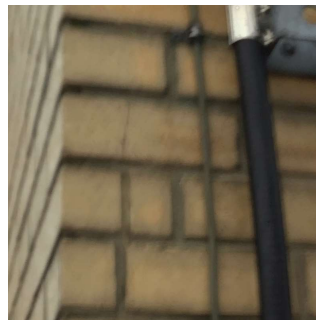
BH1

**BULKHEAD/PENTHOUSE WALLS/EXTERIOR:
CRACKS/SPALLING - MINOR**

40

REPAIR

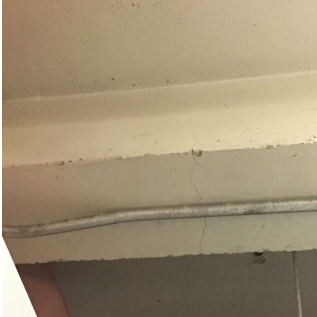
Question	Response
INTERIOR	
POOLS	Does not Exist
STRUCTURAL	Inspected
COLUMNS/BEAMS/BEARING WALLS	Inspected
Condition	3 - Fair
Deficiency	STEEL COLUMNS/BEAMS: DETERIORATED CONCRETE FIREPROOFING
Deficiency Location/Instance	Basement - Electrical Room
Deficiency Quantity	50
Quantity Uom	S.F.
Potential Action	REPLACE
Urgency of Action	PRIORITY 3
Purpose of Action	LEVEL 5
Deficiency Photo1

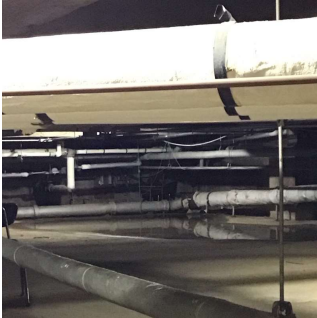
Violations	Basement - Room B7 No violations recorded.

Violations	Basement - Electrical Room No violations recorded.
FLOOR STRUCTURE	Inspected
Condition	2 - Between Good and Fair
Deficiency	No deficiencies recorded
FOUNDATION WALLS	Inspected
Material Type(s)	Concrete, Masonry
Condition	4 - Between Fair and Poor
Deficiency	CONCRETE: WATER INFILTRATION IN NON- INSTRUCTIONAL SPACE
Deficiency Location/Instance	Basement - Room B7
Deficiency Quantity	100
Quantity Uom	S.F.
Potential Action	INSTALL WATERPROOFING
Urgency of Action	PRIORITY 5
Purpose of Action	LEVEL 5
Deficiency Photo1

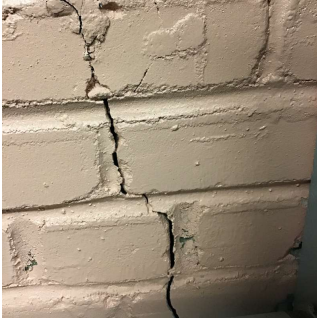
Deficiency	BRICK: CRACKED/SPALLED

Question	Response
INTERIOR	
STRUCTURAL	
FOUNDATION WALLS	
Deficiency Location/Instance	Basement - Electrical Room
Deficiency Quantity	60
Quantity Uom	S.F.
Potential Action	RESTITCH
Urgency of Action	PRIORITY 3
Purpose of Action	LEVEL 5
Deficiency Photo1

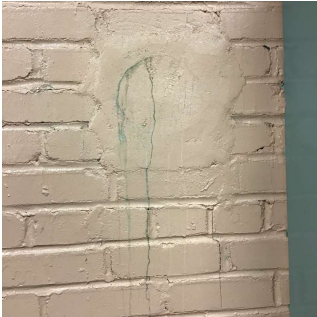
Violations	Basement - Electrical Room No violations recorded.
Deficiency	BRICK: WATER INFILTRATION IN ELECTRICAL PANEL ROOM
Deficiency Location/Instance	Basement - Electrical Room
Deficiency Quantity	100
Quantity Uom	S.F.
Potential Action	INSTALL WATERPROOFING
Urgency of Action	PRIORITY 5
Purpose of Action	LEVEL 6
Deficiency Photo1

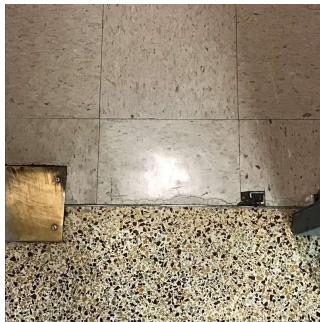
Question	Response
INTERIOR	
AUDITORIUM	
Fixed Seating	
Deficiency Photo1	 
Violations	Seat Q/1 No violations recorded.
Floor Finish	
Instance on 1st Floor (404 Seats)	Inspected
Condition	2 - Between Good and Fair
Deficiency	VINYL TILES: BROKEN/DETERIORATED/MISSING TILES
Deficiency Location/Instance	Near the entrance
Deficiency Quantity	10
Quantity Uom	S.F.
Potential Action	REPLACE
Urgency of Action	PRIORITY 3
Purpose of Action	LEVEL 2
Deficiency Photo1

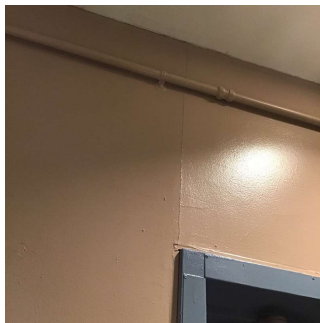
Question	Response
INTERIOR	
AUDITORIUM	
Walls	
Deficiency Photo1

Violations	Near the entrance No violations recorded.
Window Curtains/Shades/Blinds	
Instance on 1st Floor (404 Seats)	Inspected
Condition	2 - Between Good and Fair
Deficiency	No deficiencies recorded
CAFETERIA	
Instance on 1st Floor	Inspected
Ceiling	
Instance on 1st Floor	Inspected
Condition	2 - Between Good and Fair
Deficiency	ACOUSTIC TILES ON PLASTER: DAMAGED/MISSING
Deficiency Location/Instance	Near the Kitchen, by the Window, Rear
Deficiency Quantity	20
Quantity Uom	S.F.
Potential Action	REPLACE
Urgency of Action	PRIORITY 3
Purpose of Action	LEVEL 2
Deficiency Photo1	 
Violations	Near the Center No violations recorded.
Deficiency	PLASTER: CRACKS/SPALLING
Deficiency Location/Instance	Near the Vending Machine
Deficiency Quantity	10
Quantity Uom	S.F.
Potential Action	REPLACE
Urgency of Action	PRIORITY 3
Purpose of Action	LEVEL 2

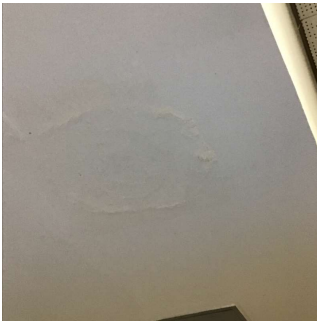
Question	Response
INTERIOR	
CAFETERIA	
Ceiling	
Deficiency Photo1

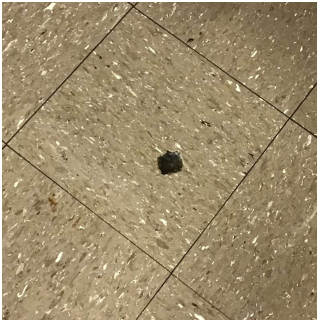
Violations	Near the Vending Machine No violations recorded.
Door(s)	
Instance on 1st Floor	Inspected
Condition	2 - Between Good and Fair
Deficiency	No deficiencies recorded
Fixed Equipment	
Instance on 1st Floor	Does not Exist
Floor Finish	
Instance on 1st Floor	Inspected
Condition	2 - Between Good and Fair
Deficiency	VINYL TILES: BROKEN/DETERIORATED/MISSING TILES
Deficiency Location/Instance	Near the Vending Machine, by Kitchen, side
Deficiency Quantity	15
Quantity Uom	S.F.
Potential Action	REPLACE
Urgency of Action	PRIORITY 3
Purpose of Action	LEVEL 2
Deficiency Photo1

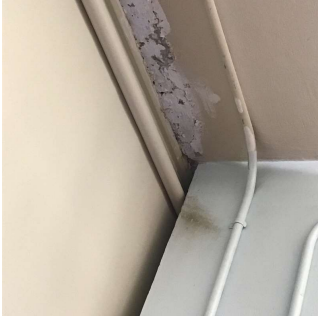
Question	Response
INTERIOR	
CAFETERIA	Inspected
Window Curtains/Shades/Blinds	
Instance on 1st Floor	Does not Exist
CLASSROOMS/CORRIDORS/ADMIN SPACES	
Ceiling	Inspected
Condition	2 - Between Good and Fair
Deficiency	PLASTER: CRACKS/SPALLING
Deficiency Location/Instance	Room 306B
Deficiency Quantity	10
Quantity Uom	S.F.
Potential Action	REPLACE
Urgency of Action	PRIORITY 3
Purpose of Action	LEVEL 2
Deficiency Photo1

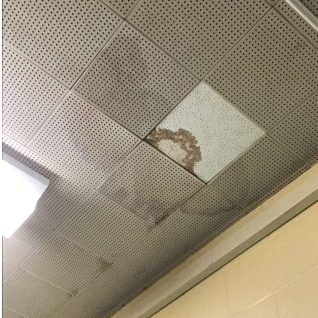
Violations	Room 306B No violations recorded.
Deficiency	ACOUSTIC TILES ON PLASTER: DAMAGED/MISSING
Deficiency Location/Instance	Corridor near Rooms 202, 215, 308B, 309, 313, and others
Deficiency Quantity	180
Quantity Uom	S.F.
Potential Action	REPLACE
Urgency of Action	PRIORITY 3
Purpose of Action	LEVEL 2
Deficiency Photo1

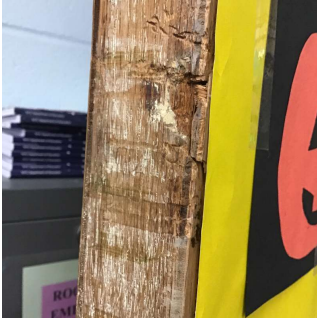
Violations	Corridor near Room 309 No violations recorded.
Door(s)	Inspected
Condition	5 - Poor
Deficiency	WOOD: DETERIORATED DOOR
Deficiency Location/Instance	Rooms 108, 200, 201, 221

Deficiency Quantity	4
Quantity Uom	EACH
Potential Action	MAINTENANCE

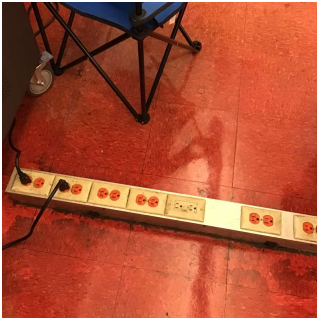
Room 201
Violations	No violations recorded.
Floor Finish	Inspected
Condition	3 - Fair
Deficiency	VINYL TILES: TRIPPING HAZARD - ELECTRICAL OUTLET
Deficiency Location/Instance	Room 306B
Deficiency Quantity	10
Quantity Uom	S.F.
Potential Action	REMOVE
Urgency of Action	PRIORITY 5
Purpose of Action	LEVEL 6
Deficiency Photo1

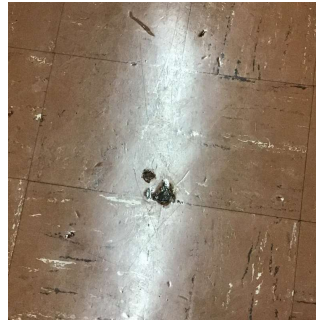
Room 308A

Room 306B
Violations	No violations recorded.
Deficiency	VINYL TILES: BROKEN/DETERIORATED/MISSING TILES
Deficiency Location/Instance	Rooms 106, 303, 305B, 308A, Corridor near Room 101, and others
Deficiency Quantity	900
Quantity Uom	S.F.
Potential Action	REPLACE
Urgency of Action	PRIORITY 3
Purpose of Action	LEVEL 2

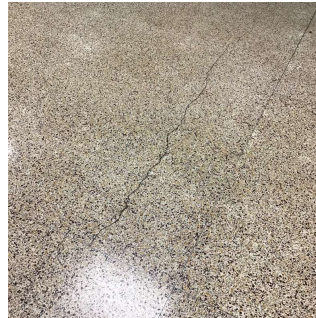
In the Lobby

TERRAZZO: CRACKS

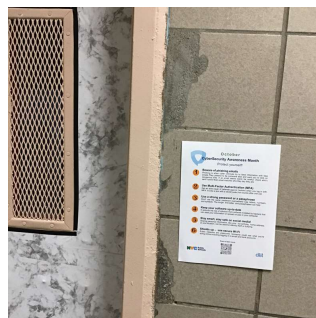
GLAZED BLOCK: CRACKS/SPALLING

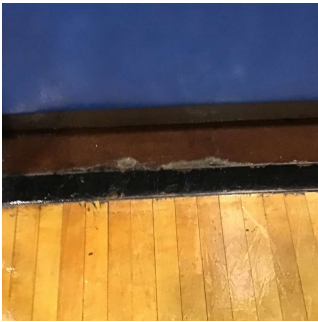
Violations	Office No violations recorded.

Question	Response
INTERIOR	
CLASSROOMS/CORRIDORS/ADMIN SPACES	Inspected
Walls	Inspected
Violations	Corridor near Room 306B No violations recorded.
Specialties	Does not Exist
GYMNASIUM	Inspected
Instance on 1st Floor	Inspected
Ceiling	
Instance on 1st Floor	Inspected
Condition	2 - Between Good and Fair
Deficiency	No deficiencies recorded
Door(s)	
Instance on 1st Floor	Inspected
Condition	2 - Between Good and Fair
Deficiency	No deficiencies recorded
Fixed Equipment	
Instance on 1st Floor	Inspected
Condition	2 - Between Good and Fair
Deficiency	No deficiencies recorded
Floor Finish	
Instance on 1st Floor	Inspected
Condition	2 - Between Good and Fair
Deficiency	VINYL TILES: BROKEN/DETERIORATED/MISSING TILES
Deficiency Location/Instance	Office
Deficiency Quantity	10
Quantity Uom	S.F.
Potential Action	REPLACE
Urgency of Action	PRIORITY 3
Purpose of Action	LEVEL 2
Deficiency Photo1

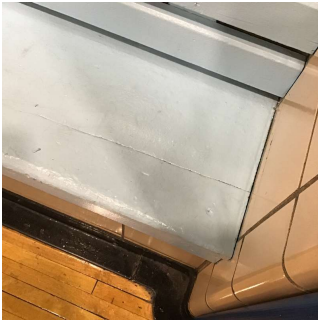
Violations	Near the Drinking Fountain (minor warping) No violations recorded.
Seating	
Instance on 1st Floor	Inspected
Condition	3 - Fair
Deficiency	DAMAGED FIXED SEATING
Deficiency Location/Instance	Near the window
Deficiency Quantity	1
Quantity Uom	EACH
Potential Action	REPLACE
Urgency of Action	PRIORITY 3
Purpose of Action	LEVEL 2
Deficiency Photo1

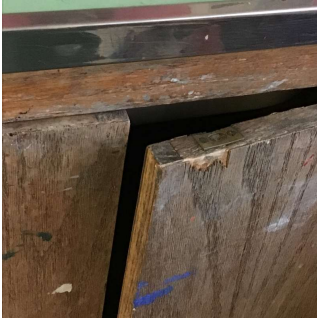
Near the window
Violations	No violations recorded.
LIBRARY	
Instance on Room 226	Inspected
Built-in Furnishing	
Instance on Room 226	Inspected
Condition	3 - Fair
Deficiency	SINK/STORAGE CABINET - DAMAGED/DETERIORATED

Question	Response
INTERIOR	
LIBRARY	
Built-in Furnishing	
Deficiency Location/Instance	Near the window side
Deficiency Quantity	10
Quantity Uom	L.F.
Potential Action	REPLACE
Urgency of Action	PRIORITY 3
Purpose of Action	LEVEL 2
Deficiency Photo1

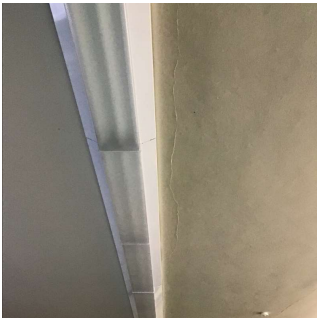
Violations	Near the window side No violations recorded.
Ceiling	
Instance on Room 226	Inspected
Condition	2 - Between Good and Fair
Deficiency	PLASTER: CRACKS/SPALLING
Deficiency Location/Instance	Near the center
Deficiency Quantity	30
Quantity Uom	S.F.
Potential Action	REPLACE
Urgency of Action	PRIORITY 3
Purpose of Action	LEVEL 2
Deficiency Photo1

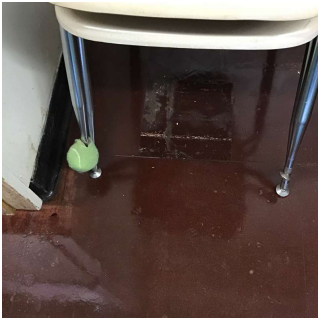
Violations	Near the center No violations recorded.
Door(s)	
Instance on Room 226	Inspected
Condition	2 - Between Good and Fair
Deficiency	No deficiencies recorded
Floor Finish	
Instance on Room 226	Inspected
Condition	2 - Between Good and Fair
Deficiency	VINYL TILES: BROKEN/DETERIORATED/MISSING TILES
Deficiency Location/Instance	Near the window, by the side

Question	Response
INTERIOR	
LIBRARY	
Floor Finish	
Deficiency Quantity	10
Quantity Uom	S.F.
Potential Action	REPLACE
Urgency of Action	PRIORITY 3
Purpose of Action	LEVEL 2
Deficiency Photo1

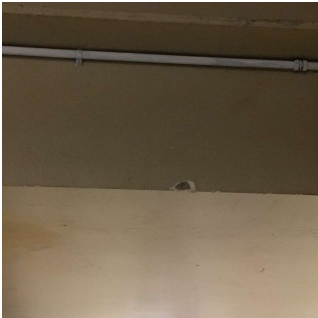
Violations	Along the side No violations recorded.
Walls	
Instance on Room 226	Inspected
Condition	2 - Between Good and Fair
Deficiency	No deficiencies recorded
LOCKER ROOM	
Instance on 1st Floor (500 SF)	Inspected
Alternative use	Yes
Instance on 2nd Floor (500 SF)	Inaccessible
Ceiling	
Instance on 1st Floor (500 SF)	Inspected
Condition	2 - Between Good and Fair
Deficiency	PLASTER: CRACKS/SPALLING
Deficiency Location/Instance	Near the Center
Deficiency Quantity	10
Quantity Uom	S.F.
Potential Action	REPLACE
Urgency of Action	PRIORITY 3
Purpose of Action	LEVEL 2
Deficiency Photo1

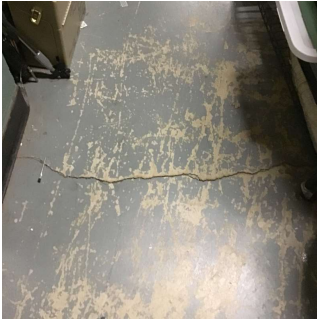
Question	Response
INTERIOR	
LOCKER ROOM	
Door(s)	
Condition	2 - Between Good and Fair
Deficiency	No deficiencies recorded
Floor Finish	
Instance on 1st Floor (500 SF)	Inspected
Condition	2 - Between Good and Fair
Deficiency	CONCRETE: CRACKS
Deficiency Location/Instance	Near the Center
Deficiency Quantity	20
Quantity Uom	S.F.
Potential Action	REPLACE
Urgency of Action	PRIORITY 3
Purpose of Action	LEVEL 2
Deficiency Photo1

Near the Center
Violations	No violations recorded.
Locker Room Lockers	
Instance on 1st Floor (500 SF)	Does not Exist
Walls	
Instance on 1st Floor (500 SF)	Inspected
Condition	2 - Between Good and Fair
Deficiency	No deficiencies recorded
MULTI-PURPOSE ROOM	Does not Exist
SCIENCE DEMO ROOM	Does not Exist
SCIENCE LAB	Does not Exist
SCIENCE PREP ROOM	Does not Exist
SHOWER ROOM	Inspected
Instance on 1st Floor	Inaccessible
Instance on 2nd Floor	Inaccessible
STAIRS/RAMPS: INTERIOR	Inspected
Do Letter Stair Signs Exist?	Yes

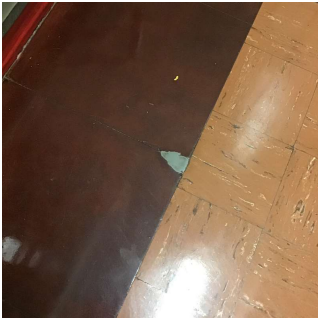
Question	Response
INTERIOR	
STAIRS/RAMPS: INTERIOR	
Railings	Inspected
Deficiency	No deficiencies recorded
Stairs and Landings	Inspected
Condition	3 - Fair
Deficiency	VINYL TILES: BROKEN/DETERIORATED/MISSING TILES
Deficiency Location/Instance	Stair EF/1, HG/1
Deficiency Quantity	30
Quantity Uom	S.F.
Potential Action	REPLACE
Urgency of Action	PRIORITY 3
Purpose of Action	LEVEL 2
Deficiency Photo1

Stair HG/1
Violations	No violations recorded.
Deficiency	STONE: BROKEN/MISSING
Deficiency Location/Instance	Stairs EF/1,2, HG/1,2
Deficiency Quantity	100
Quantity Uom	S.F.
Potential Action	REPLACE
Urgency of Action	PRIORITY 3
Purpose of Action	LEVEL 2
Deficiency Photo1

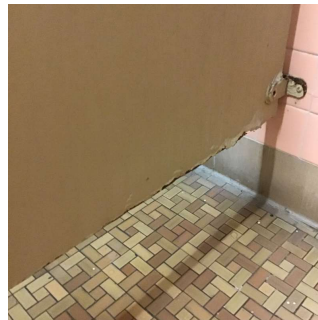
Room 120

RUST - MAJOR

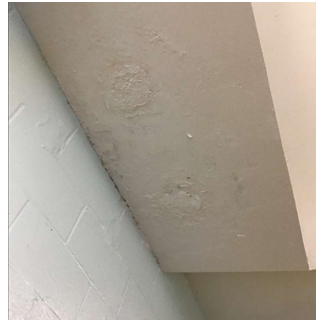
Room 113

PLASTER: CRACKS/SPALLING - ACTIVE LEAK

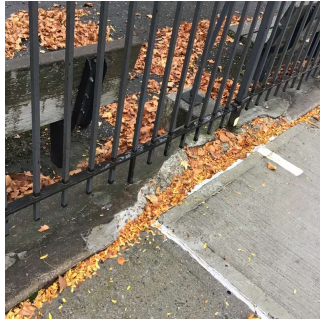
Question	Response
INTERIOR	
TOILET ROOMS - STUDENTS	
Walls	
Deficiency Quantity	10
Quantity Uom	S.F.
Potential Action	REPLACE
Urgency of Action	PRIORITY 3
Purpose of Action	LEVEL 2
Deficiency Photo1	 
Violations	Inside Room 300 No violations recorded.
LIFE SAFETY	Inspected
F.D. HOLDING AREA	Does not Exist
STEEL STAIRS	Does not Exist
SITE	Inspected
CONTAINERIZATION	Does not Exist
Drainage System for Asphalt	Inspected
Catch Basins/Manhole - Surrounded by asphalt	Inspected
Condition	2 - Between Good and Fair
Deficiency	No deficiencies recorded
Culverts - Asphalt Covering	Does not Exist
Drainage System for Concrete	Inspected
Catch Basins/Manhole - Surrounded by concrete	Inspected
Condition	2 - Between Good and Fair
Deficiency	No deficiencies recorded
Culverts - Concrete Covering	Does not Exist
Drainage System for Soil	Does not Exist
DRINKING FOUNTAINS	Does not Exist
FENCES	Inspected
Condition	3 - Fair
Deficiency	CONCRETE CURB: DAMAGED/DETERIORATED

Deficiency Location/Instance	16th Road
Deficiency Quantity	40
Quantity Uom	S.F.
Potential Action	REPLACE
Urgency of Action	PRIORITY 3
Purpose of Action	LEVEL 2

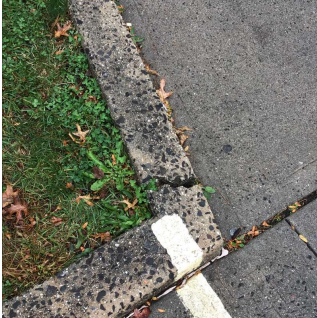
Violations	16th Avenue No violations recorded.
IRRIGATION SYSTEM	Does not Exist
PAVING	Inspected
Student Non-Use	Inspected
Gravel Exists?	No
Asphalt	Does not Exist
Concrete	Inspected
Condition	2 - Between Good and Fair
Deficiency	No deficiencies recorded
Pavers	Does not Exist
Student Use	Does not Exist
Site Sidewalks & Walkways	Inspected
Asphalt	Does not Exist
Concrete	Inspected
Condition	4 - Between Fair and Poor
Deficiency	DAMAGED CURBS
Deficiency Location/Instance	Utopia Parkway
Deficiency Quantity	15
Quantity Uom	L.F.

Question	Response
SITE	
PAVING	
Site Sidewalks & Walkways	
Concrete	
Potential Action	REPLACE
Urgency of Action	PRIORITY 3
Purpose of Action	LEVEL 2
Deficiency Photo1

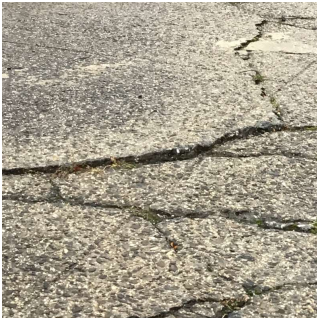
Utopia Parkway
Violations	No violations recorded.
Deficiency	HEAVING
Deficiency Location/Instance	Walkway between the School and NYC Park
Deficiency Quantity	125
Quantity Uom	S.F.
Potential Action	REPLACE
Urgency of Action	PRIORITY 3
Purpose of Action	LEVEL 2
Deficiency Photo1

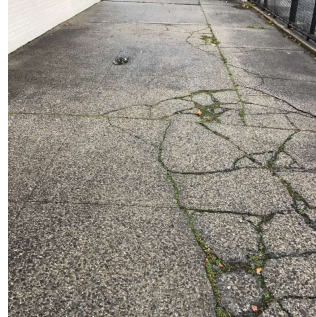
Walkway between the School and NYC Park
Violations	No violations recorded.
Deficiency	DAMAGED/DETERIORATED/MISSING SECTIONS
Deficiency Location/Instance	16th Road, Walkway between the School and NYC Park
Deficiency Quantity	1,350
Quantity Uom	S.F.
Potential Action	REPLACE
Urgency of Action	PRIORITY 3
Purpose of Action	LEVEL 2

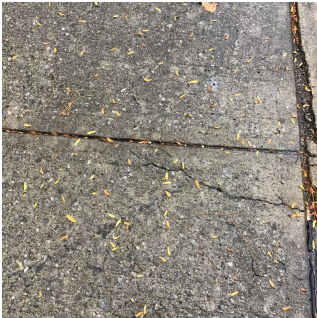
Question	Response
SITE	
PAVING	
DOT Sidewalk	
Concrete	
Deficiency Photo1	 
Violations	16th Avenue No violations recorded.
Deficiency	DAMAGED/DETERIORATED/MISSING SECTIONS
Deficiency Location/Instance	16th Road, 16th Avenue, Utopia Parkway
Deficiency Quantity	125
Quantity Uom	S.F.
Potential Action	REPLACE
Urgency of Action	PRIORITY 3
Purpose of Action	LEVEL 2
Deficiency Photo1

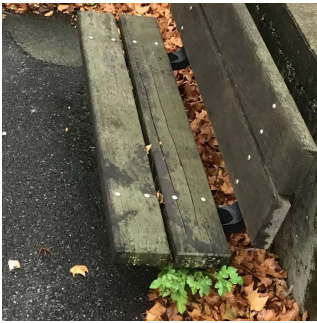
Violations	16th Avenue No violations recorded.
Pavers	Does not Exist
PLAYGROUNDS	Inspected
Instance on 16th Road	Inspected
Benches	
Instance on 16th Road	Inspected
Condition	3 - Fair
Deficiency	DAMAGED/DETERIORATED
Deficiency Location/Instance	16th Road
Deficiency Quantity	1
Quantity Uom	EACH
Potential Action	REPLACE
Urgency of Action	PRIORITY 3
Purpose of Action	LEVEL 2
