NYC Department of Education
Building Condition Assessment Survey 2023 - 2024

Architectural Inspection

Asset: P.S. 212 - QUEENS, 34-25 82ND STREET, New York, 11372

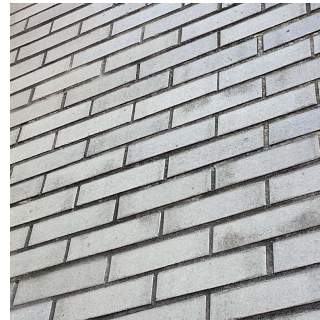
CH

CHIMNEY

CAST STONE: DETERIORATED BED JOINT

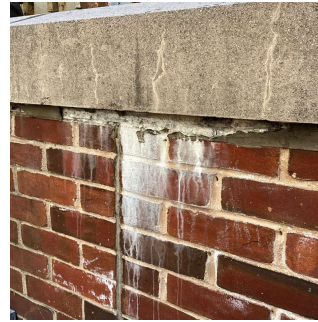
Roof 1

COPING

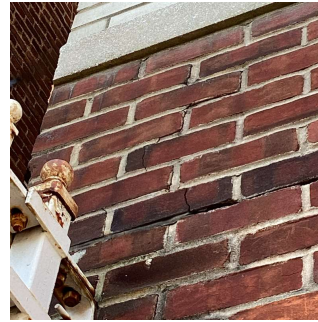
Facade F

Violations	Facade A No violations recorded.
EXTERIOR WALLS	Inspected
Material Type(s)	Masonry, Concrete
Replacement Quantity	36,700
Replacement Uom	S.F.
Instance on All Facades	Inspected
Instance Condition	3 - Fair
Instance Quantity	36,700
Instance Quantity Uom	S.F.
Deficiency	BRICK: CRACKS/DISPLACED/SPALLED BRICK AT BUILDING CORNERS
Roof Plan reference	Q212

Deficiency Quantity	20
Quantity Uom	S.F.
Potential Action	REMOVE AND REBUILD
Urgency of Action	PRIORITY 4
Purpose of Action	LEVEL 2

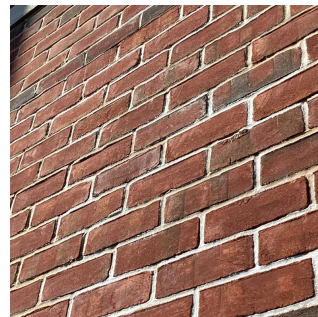
Facade F

BRICK: DETERIORATED JOINTS

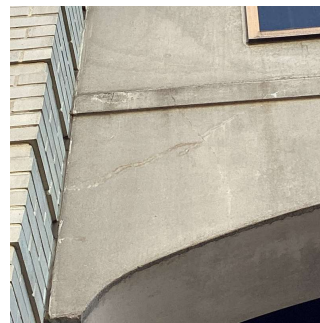
Facade A

CAST IN PLACE / PRE-CAST CONCRETE: MINOR
CRACKS/SPALLING

REPAIR

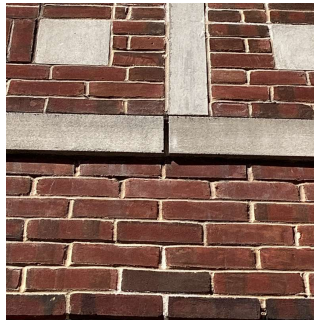
Facade F

CAST IN PLACE / PRE-CAST CONCRETE: DETERIORATED
JOINTS

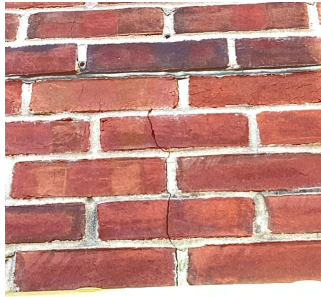
BRICK: MINOR CRACKS AND SPALLING

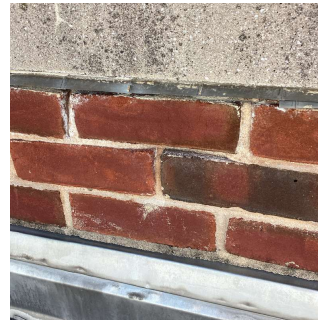
Roof 2

Deficiency Quantity	40
Quantity Uom	S.F.
Potential Action	MAINTENANCE
Urgency of Action	PRIORITY 1
Purpose of Action	LEVEL 1
Deficiency Photo1	No photo recorded
Violations	No violations recorded.
Deficiency	BRICK: DETERIORATED JOINTS

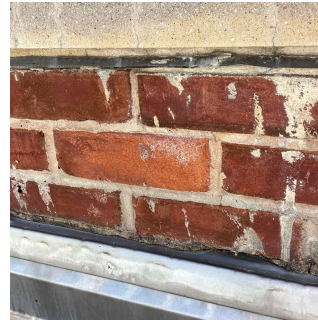
Roof 2

BRICK: MINOR CRACKS, SPALLING

REPAIR

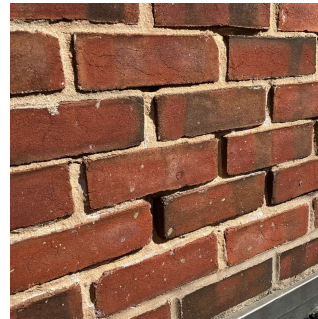
Roof 1

BRICK: DETERIORATED JOINTS

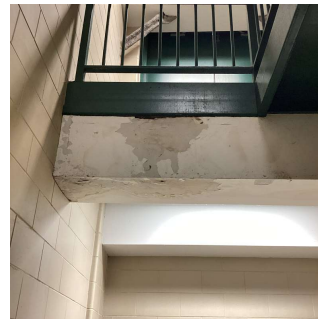
Roof 1 - Stair B/5

Roof 2
Violations	No violations recorded.
Deficiency	BUILT-UP: ROOFING: MAJOR ACTIVE ROOF LEAKS IN NON-INSTRUCTIONAL SPACE

REPLACE ROOFING WITHOUT MAJOR EQUIPMENT REMOVAL

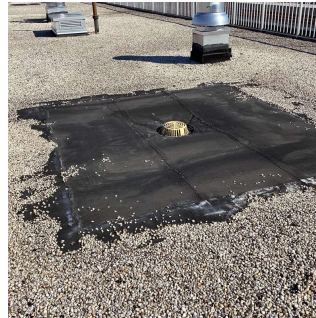
Roof 2

BUILT-UP: ROOFING: OPEN SEAMS

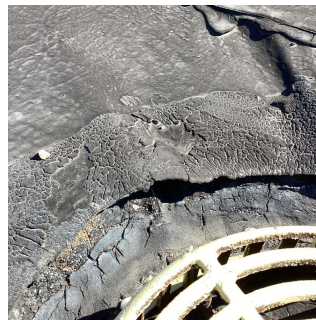
Roof 2

BUILT-UP: FLASHING: PITCH POCKET DETERIORATED - MAJOR

1
EACH
REPLACE
PRIORITY 4
LEVEL 2

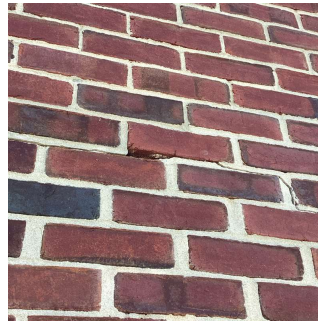
BH1
No violations recorded.

BULKHEAD/PENTHOUSE WALLS/EXTERIOR: DETERIORATED JOINTS

10
S.F.
REPOINT

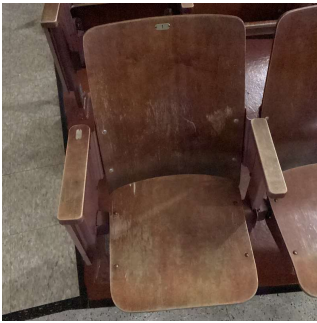
Main Entrance
Violations	No violations recorded.
Fixed H/C Lift	
Instance on 1st Floor (300 Seats)	Does not Exist
Fixed Seating	
Instance on 1st Floor (300 Seats)	Inspected
Condition	2 - Between Good and Fair
Deficiency	DAMAGED/BROKEN/INOPERABLE
Deficiency Location/Instance	Seats J/1, K/2, L/106, N/5, O/102 and others
Deficiency Quantity	8
Quantity Uom	EACH
Potential Action	REPLACE
Urgency of Action	PRIORITY 3
Purpose of Action	LEVEL 2

Seat J/1
Violations	No violations recorded.
Floor Finish	
Instance on 1st Floor (300 Seats)	Inspected
Condition	2 - Between Good and Fair
Deficiency	VINYL TILES: DETERIORATED SUBSTRATE
Deficiency Location/Instance	Room 133, Near Entrance
Deficiency Quantity	40
Quantity Uom	S.F.
Potential Action	REPLACE
Urgency of Action	PRIORITY 3
Purpose of Action	LEVEL 2
Deficiency Photo1

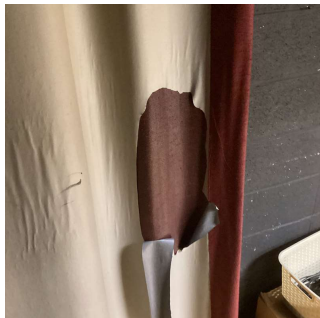
Question	Response
INTERIOR	
AUDITORIUM	
Stage	
Stage Curtains	
Instance on 1st Floor (300 Seats)	Inspected
Condition	3 - Fair
Deficiency	WORN/DETERIORATED
Deficiency Location/Instance	Right Side
Deficiency Quantity	100
Quantity Uom	S.F.
Potential Action	REPLACE
Urgency of Action	PRIORITY 3
Purpose of Action	LEVEL 2
Deficiency Photo1

Right Side
Violations	No violations recorded.
Walls	
Instance on 1st Floor (300 Seats)	Inspected
Condition	2 - Between Good and Fair
Deficiency	No deficiencies recorded
Window Curtains/Shades/Blinds	
Instance on 1st Floor (300 Seats)	Does not Exist
CAFETERIA	
Instance on 1st Floor	Inspected
Ceiling	
Instance on 1st Floor	Inspected
Condition	2 - Between Good and Fair
Deficiency	ACOUSTIC TILES: DAMAGED/MISSING
Deficiency Location/Instance	Center
Deficiency Quantity	10
Quantity Uom	S.F.
Potential Action	REPLACE
Urgency of Action	PRIORITY 3
Purpose of Action	LEVEL 2

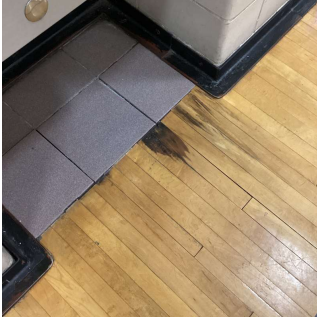
Instance on Sub-Basement	Inspected
Condition	2 - Between Good and Fair
Deficiency	WOOD: DAMAGED/DETERIORATED
Deficiency Location/Instance	Rear, Near Drinking Fountain
Deficiency Quantity	20

Question	Response
INTERIOR	
GYMNASIUM	
Floor Finish	
Quantity Uom	S.F.
Potential Action	REPLACE
Urgency of Action	PRIORITY 3
Purpose of Action	LEVEL 2
Deficiency Photo1

Near Drinking Fountain
Violations	No violations recorded.
Deficiency	CONCRETE: CRACKS
Deficiency Location/Instance	Storage Room
Deficiency Quantity	25
Quantity Uom	S.F.
Potential Action	REPLACE
Urgency of Action	PRIORITY 3
Purpose of Action	LEVEL 2
Deficiency Photo1

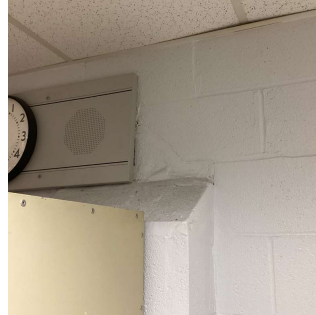
Office
No violations recorded.

Storage Room
Violations	No violations recorded.
Seating	
Instance on Sub-Basement	Does not Exist
Sliding-folding Partition	
Instance on Sub-Basement	Does not Exist
Stage	
Instance on Sub-Basement	Does not Exist
Walls	
Instance on Sub-Basement	Inspected
Condition	2 - Between Good and Fair
Deficiency	MASONRY: CRACKS/SPALLING
Deficiency Location/Instance	Office
Deficiency Quantity	10
Quantity Uom	S.F.
Potential Action	REPLACE

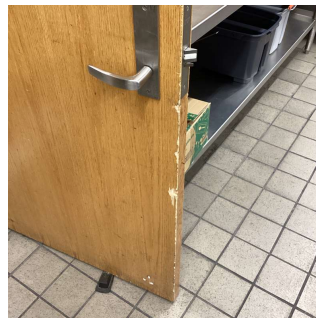
Entrance from Serving area

WOOD: DETERIORATED DOOR

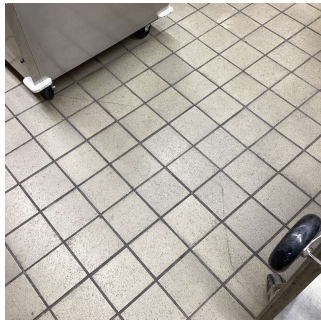
Question	Response
INTERIOR	
KITCHEN	
Door(s)	
Violations	No violations recorded.
Floor Finish	
Instance on 1st Floor	Inspected
Condition	2 - Between Good and Fair
Deficiency	QUARRY TILE: BROKEN/MISSING TILES
Deficiency Location/Instance	Serving area
Deficiency Quantity	10
Quantity Uom	S.F.
Potential Action	REPLACE
Urgency of Action	PRIORITY 3
Purpose of Action	LEVEL 2
Deficiency Photo1

Violations	Serving area No violations recorded.
Walls	
Instance on 1st Floor	Inspected
Condition	2 - Between Good and Fair
Deficiency	No deficiencies recorded
LIBRARY	Inspected
Instance on Basement	Inspected
Built-in Furnishing	
Instance on Basement	Inspected
Condition	2 - Between Good and Fair
Deficiency	No deficiencies recorded
Ceiling	
Instance on Basement	Inspected
Condition	2 - Between Good and Fair
Deficiency	ACOUSTIC TILES: DAMAGED/MISSING
Deficiency Location/Instance	Left Side near Desk, Near Windows
Deficiency Quantity	20
Quantity Uom	S.F.

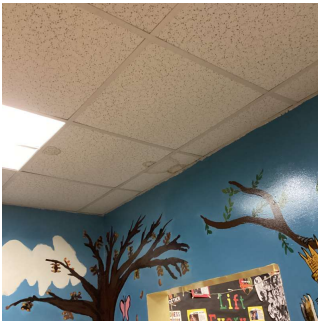
Question	Response
INTERIOR	
LIBRARY	
Ceiling	
Deficiency Photo1

Violations	Left Side near Desk No violations recorded.
Door(s)	
Instance on Basement	Inspected
Condition	2 - Between Good and Fair
Deficiency	No deficiencies recorded
Floor Finish	
Instance on Basement	Inspected
Condition	2 - Between Good and Fair
Deficiency	No deficiencies recorded
Walls	
Instance on Basement	Inspected
Condition	2 - Between Good and Fair
Deficiency	No deficiencies recorded
LOCKER ROOM	Does not Exist
MULTI-PURPOSE ROOM	Does not Exist
SCIENCE DEMO ROOM	Inspected
Instance on Room 405	Inspected
Alternative use	No
Fixed Equipment	
Instance on Room 405	Inspected
Condition	2 - Between Good and Fair
Deficiency	No deficiencies recorded
SCIENCE LAB	Does not Exist
SCIENCE PREP ROOM	Inspected
Instance on Room 407	Inspected
Alternative use	No
Fixed Equipment	
Instance on Room 407	Inspected
Condition	2 - Between Good and Fair
Deficiency	No deficiencies recorded

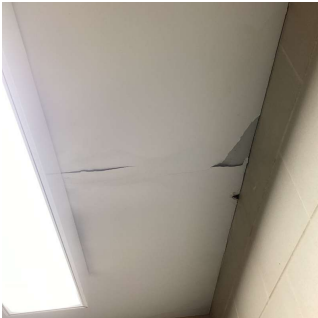
SHOWER ROOM	Does not Exist
STAIRS/RAMPS: INTERIOR	
Do Letter Stair Signs Exist?	Inspected Yes
Ceiling	
Condition	Inspected 2 - Between Good and Fair
Deficiency	GYPSUM BOARD: DAMAGED/DETERIORATED
Deficiency Location/Instance	Stairs A/2, B/Sub-Basement, 1

Question	Response
INTERIOR	
STAIRS/RAMPS: INTERIOR	
Ceiling	
Deficiency Quantity	60
Quantity Uom	S.F.
Potential Action	REPLACE
Urgency of Action	PRIORITY 3
Purpose of Action	LEVEL 2
Deficiency Photo1

Stair B/Sub-Basement
Violations	No violations recorded.
Door(s)	Inspected
Condition	5 - Poor
Deficiency	WOOD: DETERIORATED DOOR
Deficiency Location/Instance	Stairs A/1, B/1, C/1
Deficiency Quantity	4
Quantity Uom	EACH
Potential Action	MAINTENANCE
Urgency of Action	PRIORITY 3
Purpose of Action	LEVEL 2
Deficiency Photo1

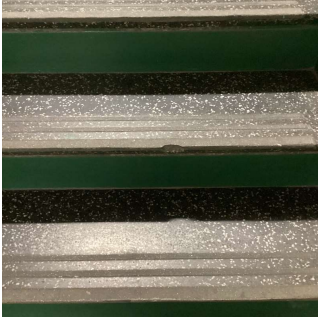
Question	Response
INTERIOR	
STAIRS/RAMPS: INTERIOR	
Stairs and Landings	
Urgency of Action	PRIORITY 3
Purpose of Action	LEVEL 2
Deficiency Photo1

Stair B/Sub-Basement
Violations	No violations recorded.
Deficiency	VINYL TILES: DETERIORATED SUBSTRATE
Deficiency Location/Instance	Stairs A/1, 2, B/2, 4, C/1 and others
Deficiency Quantity	50
Quantity Uom	S.F.
Potential Action	REPLACE
Urgency of Action	PRIORITY 3
Purpose of Action	LEVEL 2
Deficiency Photo1

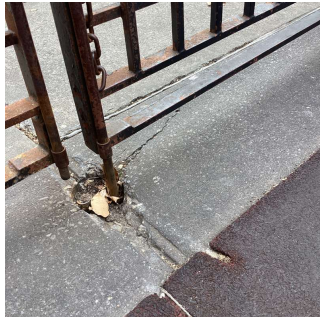
Question	Response
SITE	
PAVING	
Site Sidewalks & Walkways	
Concrete	
Deficiency Photo1

83rd Street
Violations	No violations recorded.
Pavers	Does not Exist
DOT Sidewalk	Inspected
Asphalt	Does not Exist
Concrete	Inspected
Condition	4 - Between Fair and Poor
Deficiency	HEAVING
Deficiency Location/Instance	82nd Street
Deficiency Quantity	175
Quantity Uom	S.F.
Potential Action	REPLACE
Urgency of Action	PRIORITY 3
Purpose of Action	LEVEL 2
Deficiency Photo1

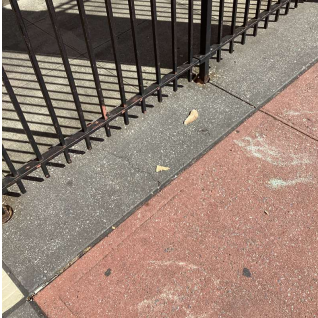
Question	Response
SITE	
PLAYGROUNDS	
Pavement	
Deficiency Location/Instance	Near Exit 3
Deficiency Quantity	25
Quantity Uom	S.F.
Potential Action	REPLACE
Urgency of Action	PRIORITY 3
Purpose of Action	LEVEL 2
Deficiency Photo1

Violations	Near Exit 3 No violations recorded.
Play Equipment	
Instance on 2nd Floor Plaza Deck	Inspected
Condition	5 - Poor
Deficiency	BROKEN/DETERIORATED/MISSING
Deficiency Location/Instance	North Side
Deficiency Quantity	1
Quantity Uom	EACH
Potential Action	REPLACE
Urgency of Action	PRIORITY 3
Purpose of Action	LEVEL 2
Deficiency Photo1

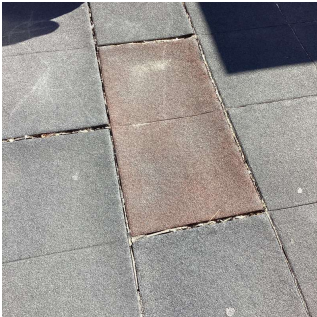
Question	Response
SITE	
PLAYGROUNDS	
Safety Surfacing	
Purpose of Action	LEVEL 2
Deficiency Photo1

Near Entrance
Violations	No violations recorded.
Instance on 2nd Floor Plaza Deck	Inspected
Condition	3 - Fair
Deficiency	DETERIORATED/MISSING
Deficiency Location/Instance	Near Entrance, Center, Rear
Deficiency Quantity	50
Quantity Uom	S.F.
Potential Action	REPLACE
Urgency of Action	PRIORITY 3
Purpose of Action	LEVEL 2
Deficiency Photo1

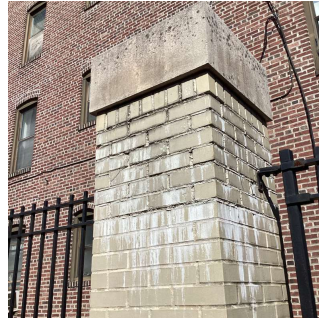
Question	Response
SITE	
SITE WALLS (NOT RETAINING WALLS)	
Quantity Uom	S.F.
Potential Action	REPOINT
Urgency of Action	PRIORITY 3
Purpose of Action	LEVEL 2
Deficiency Photo1

Violations	Playground No violations recorded.
STAIRS/RAMPS: EXTERIOR	
	Does not Exist
ARTWORK	
Instance	Inspected
Instance Photo	Interior - Corridors - 21645
