NYC Department of Education
Building Condition Assessment Survey 2023 - 2024

Architectural Inspection

Asset: P.S. 214 - QUEENS, 31-15 140 STREET, New York, 11354

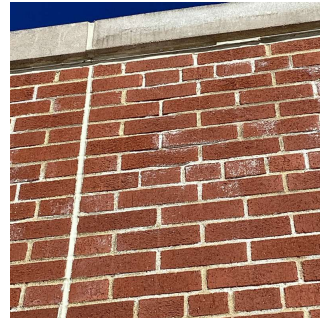
PH

BULKHEAD/PENTHOUSE WALLS/EXTERIOR: DETERIORATED JOINTS

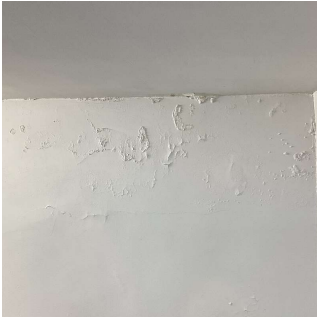
| Question | Response |
|---|--|
| Violations | BH1 No violations recorded. |

**BULKHEAD/PENTHOUSE WALLS/INTERIOR: PLASTER
CRACKS/SPALLING**

REPLACE

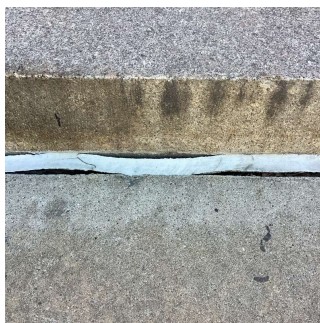
| Question | Response |
|---|---|
| Violations | Facade A No violations recorded. |

| Question | Response |
|---|---|
| Deficiency | STONE: DETERIORATED JOINTS |

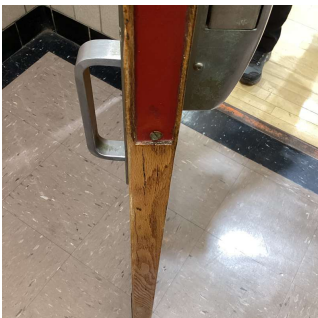
| Question | Response |
|---|--|
| | Left Side Exit |

| Question | Response |
|---|--|
| Condition | 3 - Fair |
| Deficiency | WOOD: DETERIORATED DOOR |
| Deficiency Location/Instance | Left Side Exit |

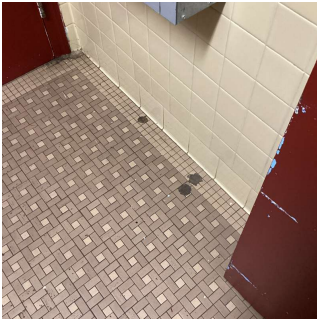
| Question | Response |
|---|--|
| | Near Entrance |

| Question | Response |
|---|--|
| Condition | 2 - Between Good and Fair |
| Deficiency | CERAMIC TILE: BROKEN/MISSING TILES |
| Deficiency Location/Instance | Near Entrance, near Office |

| Question | Response |
|---|--|
| Potential Action | REPLACE |

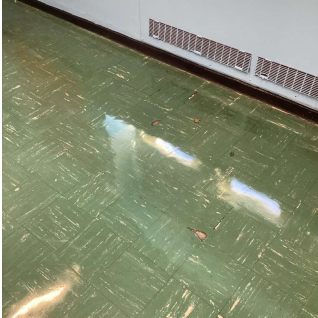
| Question | Response |
|---|--|
| Condition | 2 - Between Good and Fair |
| Deficiency | VINYL TILES: BROKEN/DETERIORATED/MISSING TILES |
| Deficiency Location/Instance | Near Windows |

| Question | Response |
|---|--|
| Potential Action | REPLACE |

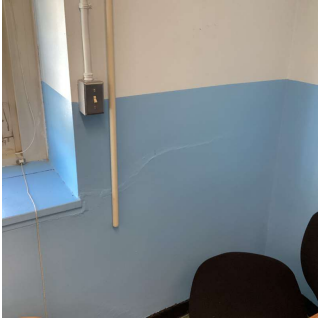
| Question | Response |
|---|--|
| Condition | 2 - Between Good and Fair |
| Deficiency | PLASTER: CRACKS/SPALLING |
| Deficiency Location/Instance | Near Windows |

| Question | Response |
|---|--|
| Potential Action | REPLACE |

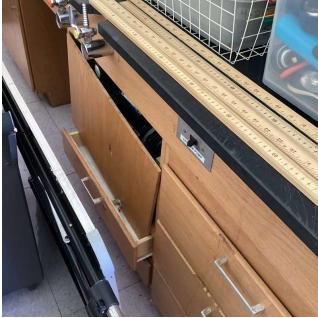
| Question | Response |
|---|--|
| Condition | 3 - Fair |
| Deficiency | CABINETS: MISSING/DAMAGED |
| Deficiency Location/Instance | Room 304 |

| Question | Response |
|---|--|
| Potential Action | REPLACE |

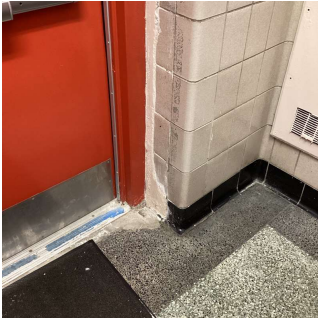
| Question | Response |
|---|--|
| Deficiency | GLAZED BLOCK: CRACKS/SPALLING |

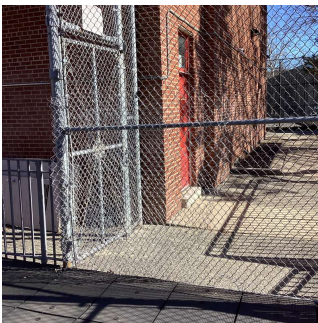
| Question | Response |
|---|--|
| Deficiency | CHAIN LINK: DAMAGED/DETERIORATED |
