**NYC Department of Education**  
**Building Condition Assessment Survey 2023 - 2024**

Architectural Inspection

**Asset:** J.H.S. 216 - QUEENS, 64-20 175 STREET, New York, 11365

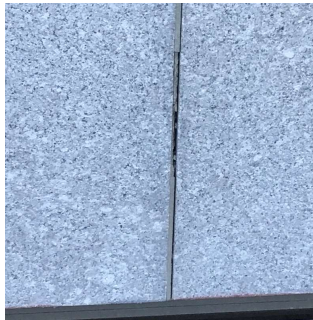
Facade G

STONE: CHIPPED/SPALLED/BROKEN PIECES - MINOR

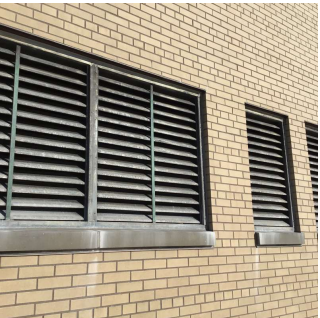
Question	Response
<b>EXTERIOR</b>	
<b>EXTERIOR WALLS</b>	Inspected
Violations	No violations recorded.
<b>EXTERIOR SOFFITS</b>	Inspected
Condition	2 - Between Good and Fair
Deficiency	No deficiencies recorded
<b>LOADING DOCK</b>	Does not Exist
<b>LOUVER</b>	Inspected
Condition	3 - Fair
Deficiency	MISSING/DAMAGED SCREEN
Roof Plan reference

Deficiency Quantity	100
Quantity Uom	S.F.
Potential Action	REPLACE
Urgency of Action	PRIORITY 4
Purpose of Action	LEVEL 2
Deficiency Photo1

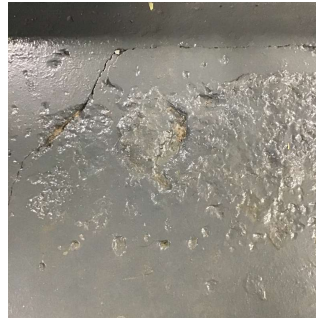
Basement - Boiler Room

CONCRETE SLAB ON GRADE: THRU CRACKS

REPAIR

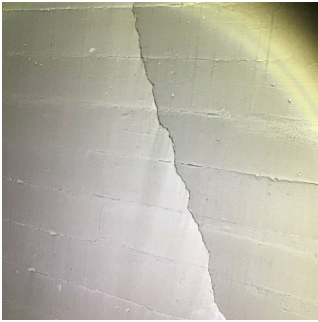
Question	Response
<b>INTERIOR</b>	
<b>STRUCTURAL</b>	
<b>FOUNDATION WALLS</b>	
Deficiency Photo1	 
Violations	Basement - Crawl Space No violations recorded.
Deficiency	CONCRETE: CRACKED/SPALLED/REINFORCEMENT EXPOSED
Deficiency Location/Instance	Basement - Crawl Space
Deficiency Quantity	20
Quantity Uom	S.F.
Potential Action	REPAIR
Urgency of Action	PRIORITY 3
Purpose of Action	LEVEL 5
Deficiency Photo1

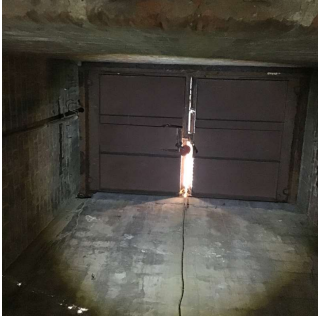
Question	Response
<b>INTERIOR</b>	
<b>STRUCTURAL</b>	
<b>VAULTS-BUNKERS</b>	
<b>Foundation Walls</b>	Inspected
Violations	No violations recorded.
<b>Slab Structure</b>	Inspected
Condition	2 - Between Good and Fair
Deficiency	No deficiencies recorded
<b>Vault/Ash Hoist Doors and Framing</b>	Inspected
Condition	5 - Poor
Deficiency	<b>WATER INFILTRATION</b>
Deficiency Location/Instance	Basement - Ash Hoist Vault
Deficiency Quantity	10
Quantity Uom	S.F.
Potential Action	REPAIR
Urgency of Action	PRIORITY 5
Purpose of Action	LEVEL 2
Deficiency Photo1

Violations	Basement - Ash Hoist Vault No violations recorded.
<b>AUDITORIUM</b>	Inspected
Instance on 1st Floor (500 Seats )	Inspected
<b>Ceiling</b>	Inspected
Instance on 1st Floor (500 Seats )	Inspected
Condition	2 - Between Good and Fair
Deficiency	<b>PLASTER: CRACKS/SPALLING</b>
Deficiency Location/Instance	Near Entrance
Deficiency Quantity	20
Quantity Uom	S.F.
Potential Action	REPLACE

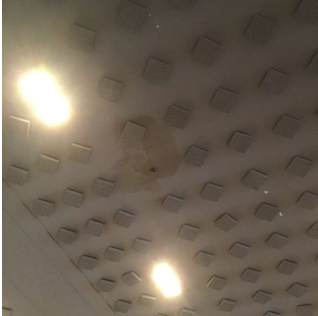
Violations	Near Entrance

Urgency of Action	PRIORITY 3
Purpose of Action	LEVEL 2
Deficiency Photo1

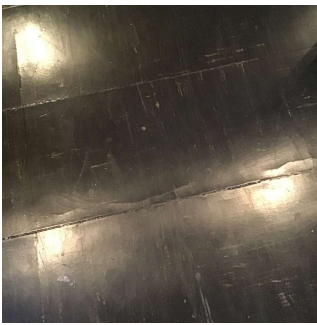
Question	Response
<b>INTERIOR</b>	
<b>AUDITORIUM</b>	
<b>Floor Finish</b>	
Deficiency Photo1

Near Seat M/2
Violations	No violations recorded.
<b>Sliding-folding Partition</b>	
Instance on 1st Floor (500 Seats )	Does not Exist
<b>Stage</b>	
Instance on 1st Floor (500 Seats )	Inspected
<b>Stage</b>	
Instance on 1st Floor (500 Seats )	Inspected
Condition	3 - Fair
Deficiency	DAMAGED STEPS
Deficiency Location/Instance	Right and Left Side
Deficiency Quantity	40
Quantity Uom	S.F.
Potential Action	REPLACE
Urgency of Action	PRIORITY 3
Purpose of Action	LEVEL 2
Deficiency Photo1	 
	Right Side
Violations	No violations recorded.
Deficiency	DAMAGED FLOOR
Deficiency Location/Instance	Left Side, Near center
Deficiency Quantity	30
Quantity Uom	S.F.
Potential Action	REPLACE
Urgency of Action	PRIORITY 3
Purpose of Action	LEVEL 2

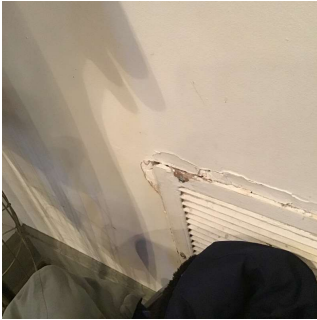
Stage Area
Violations	No violations recorded.
Deficiency	PLASTER: CRACKS/SPALLING
Deficiency Location/Instance	Near Entrance, Stage Left Side
Deficiency Quantity	20
Quantity Uom	S.F.
Potential Action	REPLACE
Urgency of Action	PRIORITY 3
Purpose of Action	LEVEL 2
Deficiency Photo1

Near Entrance
Violations	No violations recorded.
<b>Window Curtains/Shades/Blinds</b>	
Instance on 1st Floor (500 Seats )	Inspected
Condition	2 - Between Good and Fair
Deficiency	No deficiencies recorded
<b>CAFETERIA</b>	
Instance on Basement	Inspected
<b>Ceiling</b>	
Instance on Basement	Inspected
Condition	2 - Between Good and Fair
Deficiency	No deficiencies recorded
<b>Door(s)</b>	
Instance on Basement	Inspected
Condition	5 - Poor
Deficiency	METAL: DETERIORATED DOOR
Deficiency Location/Instance	Entrances, Storage - Cage Area
Deficiency Quantity	5

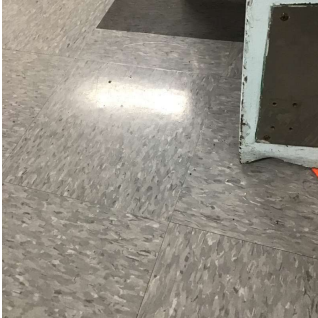
Question	Response
<b>INTERIOR</b>	
<b>CAFETERIA</b>	
<b>Door(s)</b>	
Urgency of Action	PRIORITY 3
Purpose of Action	LEVEL 2
Deficiency Photo1

Entrance
Violations	No violations recorded.
<b>Fixed Equipment</b>	
Instance on Basement	Does not Exist
<b>Floor Finish</b>	
Instance on Basement	Inspected
Condition	2 - Between Good and Fair
Deficiency	VINYL TILES: BROKEN/DETERIORATED/MISSING TILES
Deficiency Location/Instance	Cage Area
Deficiency Quantity	10
Quantity Uom	S.F.
Potential Action	REPLACE
Urgency of Action	PRIORITY 3
Purpose of Action	LEVEL 2
Deficiency Photo1

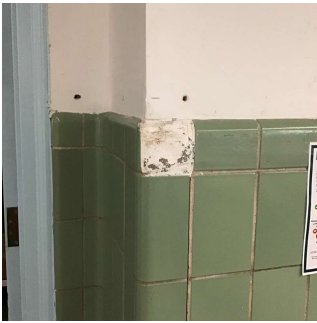
Question	Response
<b>INTERIOR</b>	
<b>CAFETERIA</b>	
<b>Walls</b>	
Deficiency Photo1

Violations	Near Storage Room No violations recorded.
<b>Window Curtains/Shades/Blinds</b>	
Instance on Basement	Does not Exist
<b>CLASSROOMS/CORRIDORS/ADMIN SPACES</b>	
<b>Ceiling</b>	Inspected
Condition	2 - Between Good and Fair
Deficiency	PLASTER: CRACKS/SPALLING
Deficiency Location/Instance	Room 202
Deficiency Quantity	10
Quantity Uom	S.F.
Potential Action	REPLACE
Urgency of Action	PRIORITY 3
Purpose of Action	LEVEL 2
Deficiency Photo1

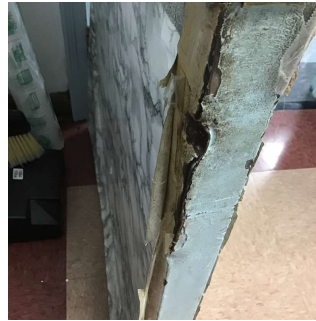
Room 303

Violations	Room 202 No violations recorded.
<b>Door(s)</b>	
Condition	Inspected
Condition	5 - Poor
Deficiency	METAL: DETERIORATED DOOR
Deficiency Location/Instance	Rooms 201, 202, 303, 332
Deficiency Quantity	5
Quantity Uom	EACH
Potential Action	MAINTENANCE
Urgency of Action	PRIORITY 3
Purpose of Action	LEVEL 2

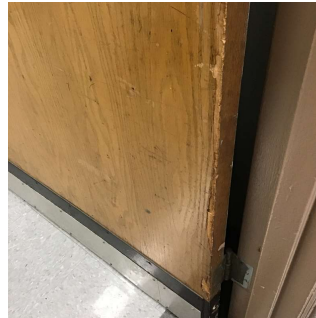
Room 119

WOOD: DETERIORATED DOOR

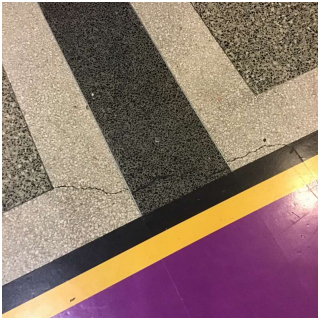
Question	Response
<b>INTERIOR</b>	
<b>CLASSROOMS/CORRIDORS/ADMIN SPACES</b>	
<b>Floor Finish</b>	
Violations	Room 230 No violations recorded.
Deficiency	TERRAZZO: CRACKS
Deficiency Location/Instance	Main Entrance
Deficiency Quantity	30
Quantity Uom	S.F.
Potential Action	REPLACE
Urgency of Action	PRIORITY 3
Purpose of Action	LEVEL 2
Deficiency Photo1

Violations	Main Entrance No violations recorded.
Deficiency	VINYL TILES: BROKEN/DETERIORATED/MISSING TILES
Deficiency Location/Instance	Rooms 301, 320, 330, 343, Corridor near Room 313,and others.
Deficiency Quantity	200
Quantity Uom	S.F.
Potential Action	REPLACE
Urgency of Action	PRIORITY 3
Purpose of Action	LEVEL 2
Deficiency Photo1

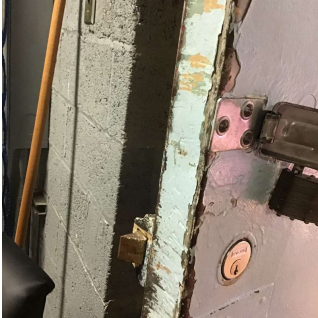
Question	Response
<b>INTERIOR</b>	
<b>GYMNASIUM</b>	
<b>Door(s)</b>	
Instance on 1st Floor	Inspected
Condition	3 - Fair
Deficiency	METAL: DETERIORATED DOOR
Deficiency Location/Instance	Storage Room
Deficiency Quantity	1
Quantity Uom	EACH
Potential Action	MAINTENANCE
Urgency of Action	PRIORITY 3
Purpose of Action	LEVEL 2
Deficiency Photo1

Storage Room
Violations	No violations recorded.
<b>Fixed Equipment</b>	
Instance on 1st Floor	Inspected
Condition	2 - Between Good and Fair
Deficiency	No deficiencies recorded
<b>Floor Finish</b>	
Instance on 1st Floor	Inspected
Condition	2 - Between Good and Fair
Deficiency	VINYL TILES: BROKEN/DETERIORATED/MISSING TILES
Deficiency Location/Instance	Office
Deficiency Quantity	10
Quantity Uom	S.F.
Potential Action	REPLACE
Urgency of Action	PRIORITY 3
Purpose of Action	LEVEL 2
Deficiency Photo1

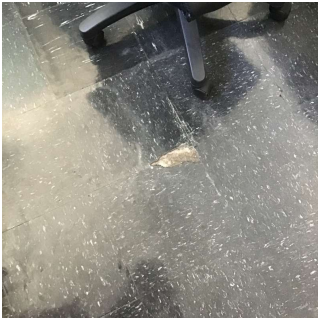
Office
Violations	No violations recorded.
<b>Seating</b>	
Instance on 1st Floor	Inspected

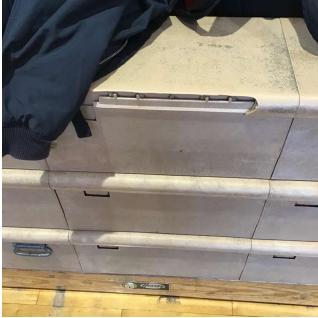
Question	Response
<b>INTERIOR</b>	
<b>GYMNASIUM</b>	
<b>Seating</b>	
Condition	2 - Between Good and Fair
Deficiency	DAMAGED BLEACHERS
Deficiency Location/Instance	Right and Left Side
Deficiency Quantity	30
Quantity Uom	S.F.
Potential Action	REPLACE
Urgency of Action	PRIORITY 3
Purpose of Action	LEVEL 2
Deficiency Photo1

Right Side
Violations	No violations recorded.
<b>Sliding-folding Partition</b>	
Instance on 1st Floor	Inspected
Condition	5 - Poor
Deficiency	MECHANISM/TRACKS: DAMAGED/INOPERABLE
Deficiency Location/Instance	Center
Deficiency Quantity	80
Quantity Uom	L.F.
Potential Action	REPLACE
Urgency of Action	PRIORITY 3
Purpose of Action	LEVEL 2
Deficiency Photo1	No photo recorded
Violations	No violations recorded.
<b>Stage</b>	
Instance on 1st Floor	Does not Exist
<b>Walls</b>	
Instance on 1st Floor	Inspected
Condition	2 - Between Good and Fair
Deficiency	PLASTER: CRACKS/SPALLING
Deficiency Location/Instance	Office

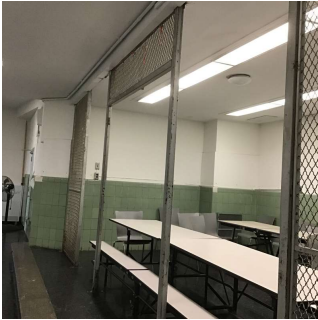
Question	Response
<b>INTERIOR</b>	
<b>GYMNASIUM</b>	Inspected
<b>Window Curtains/Shades/Blinds</b>	
Instance on 1st Floor	Does not Exist
<b>INTERIOR DOOR HARDWARE</b>	Inspected
Condition	3 - Fair
Deficiency	No deficiencies recorded
<b>INTERIOR GUARDS</b>	Inspected
Condition	3 - Fair
Deficiency	DETERIORATED/TORN-OUT/MISSING
Deficiency Location/Instance	Cafeteria - Near Exit 7
Deficiency Quantity	200
Quantity Uom	S.F.
Potential Action	REPLACE
Urgency of Action	PRIORITY 3
Purpose of Action	LEVEL 2
Deficiency Photo1

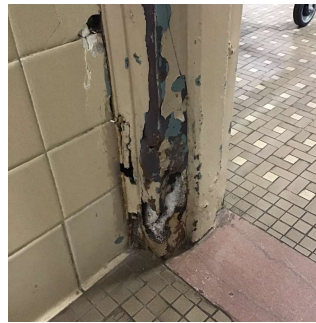
Fridge Area

METAL: DETERIORATED DOOR

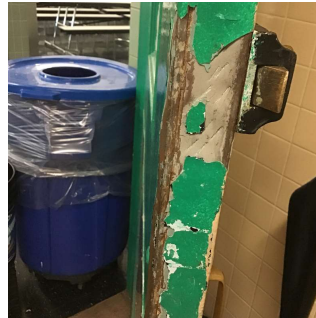
Entrance

Violations	No violations recorded.
<b>KITCHEN</b>	Inspected
Instance on Basement	Inspected
<b>Ceiling</b>	
Instance on Basement	Inspected
Condition	2 - Between Good and Fair
Deficiency	No deficiencies recorded
<b>Door(s)</b>	
Instance on Basement	Inspected
Condition	5 - Poor
Deficiency	METAL: DETERIORATED DOOR AND FRAME
Deficiency Location/Instance	Fridge Area, Entrance, Storage Room, Mop room.
Deficiency Quantity	4

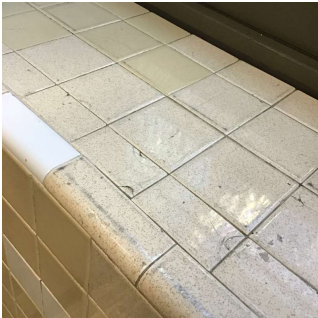
Question	Response
<b>INTERIOR</b>	
<b>KITCHEN</b>	
<b>Walls</b>	
Instance on Basement	Inspected
Condition	2 - Between Good and Fair
Deficiency	CERAMIC TILE: BROKEN/ MISSING
Deficiency Location/Instance	Near Windows, Serving Area.
Deficiency Quantity	20
Quantity Uom	S.F.
Potential Action	REPLACE
Urgency of Action	PRIORITY 3
Purpose of Action	LEVEL 2
Deficiency Photo1

Violations	Near Windows No violations recorded.
Deficiency	PLASTER: CRACKS/SPALLING
Deficiency Location/Instance	Office, Storage Room
Deficiency Quantity	20
Quantity Uom	S.F.
Potential Action	REPLACE
Urgency of Action	PRIORITY 3
Purpose of Action	LEVEL 2
Deficiency Photo1

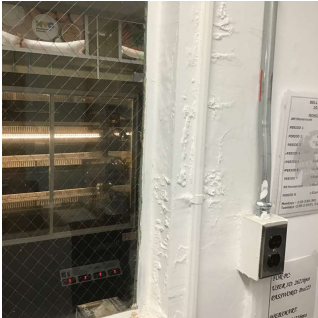
Violations	Office No violations recorded.
<b>LIBRARY</b>	
Instance on Room 248	Inspected
Instance on Room 248	Inspected
<b>Built-in Furnishing</b>	
Instance on Room 248	Inspected
Condition	2 - Between Good and Fair
Deficiency	No deficiencies recorded
<b>Ceiling</b>	
Instance on Room 248	Inspected

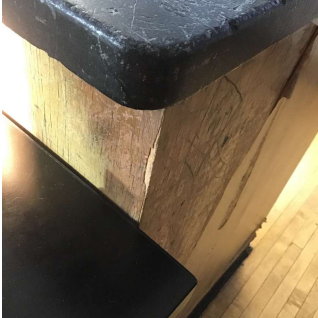
Question	Response
<b>INTERIOR</b>	
<b>SCIENCE DEMO ROOM</b>	
<b>Fixed Equipment</b>	
Instance on Rooms 203, 220	Inspected
Condition	3 - Fair
Deficiency	CABINETS: MISSING/DAMAGED
Deficiency Location/Instance	Rooms 203, 220
Deficiency Quantity	10
Quantity Uom	L.F.
Potential Action	REPLACE
Urgency of Action	PRIORITY 3
Purpose of Action	LEVEL 2
Deficiency Photo1

Violations	Room 220 No violations recorded.
Instance on Rooms 216, 217, 219, 320	Inspected
Condition	3 - Fair
Deficiency	CABINETS: MISSING/DAMAGED
Deficiency Location/Instance	Rooms 216, 217, 219, 320
Deficiency Quantity	16
Quantity Uom	L.F.
Potential Action	REPLACE
Urgency of Action	PRIORITY 3
Purpose of Action	LEVEL 2
Deficiency Photo1

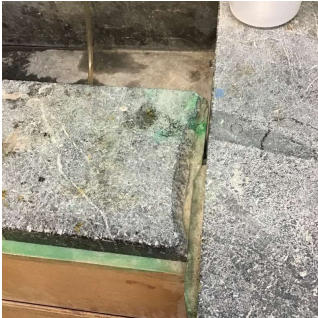
Question	Response
<b>INTERIOR</b>	
<b>SCIENCE PREP ROOM</b>	
	Inspected
Instance on Rooms 218, 318	Inspected
Alternative use	No
<b>Fixed Equipment</b>	
Instance on Rooms 218, 318	Inspected
Condition	5 - Poor
Deficiency	DEMO TABLE: DAMAGED/DETERIORATED
Deficiency Location/Instance	Rooms 218, 318
Deficiency Quantity	2
Quantity Uom	EACH
Potential Action	REPLACE
Urgency of Action	PRIORITY 3
Purpose of Action	LEVEL 2
Deficiency Photo1

Room 318
Violations	No violations recorded.
<b>SHOWER ROOM</b>	
	Inspected
Instance on Basement - Boys	Inaccessible
<b>STAIRS/RAMPS: INTERIOR</b>	
	Inspected
Do Letter Stair Signs Exist?	Partially
<b>Ceiling</b>	
	Inspected
Condition	2 - Between Good and Fair
Deficiency	PLASTER: CRACKS/SPALLING
Deficiency Location/Instance	Stair D/1 - Vestibule
Deficiency Quantity	10
Quantity Uom	S.F.
Potential Action	REPLACE
Urgency of Action	PRIORITY 3
Purpose of Action	LEVEL 2
Deficiency Photo1

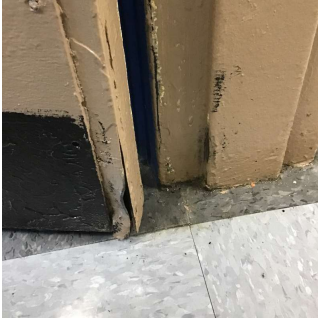
Question	Response
<b>INTERIOR</b>	
<b>STAIRS/RAMPS: INTERIOR</b>	
<b>Door(s)</b>	
Condition	2 - Between Good and Fair
Deficiency	METAL: DETERIORATED DOOR
Deficiency Location/Instance	Stair D/1
Deficiency Quantity	1
Quantity Uom	EACH
Potential Action	MAINTENANCE
Urgency of Action	PRIORITY 3
Purpose of Action	LEVEL 2
Deficiency Photo1

Violations	Stair D/1 No violations recorded.
<b>Partition</b>	Does not Exist
<b>Railings</b>	Inspected
Condition	2 - Between Good and Fair
Deficiency	No deficiencies recorded
<b>Stairs and Landings</b>	Inspected
Condition	2 - Between Good and Fair
Deficiency	VINYL TILES: BROKEN/DETERIORATED/MISSING TILES
Deficiency Location/Instance	Stair B/1
Deficiency Quantity	10
Quantity Uom	S.F.
Potential Action	REPLACE
Urgency of Action	PRIORITY 3
Purpose of Action	LEVEL 2
Deficiency Photo1

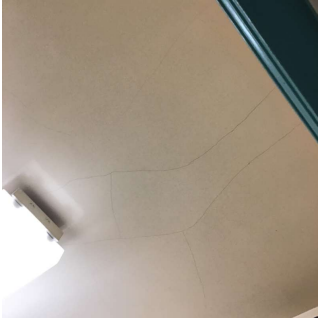
Question	Response
<b>INTERIOR</b>	
<b>TOILET ROOMS - STAFF</b>	Inspected
<b>Ceiling</b>	Inspected
Condition	3 - Fair
Deficiency	PLASTER: CRACKS/SPALLING
Deficiency Location/Instance	Rooms 116, 341
Deficiency Quantity	30
Quantity Uom	S.F.
Potential Action	REPLACE
Urgency of Action	PRIORITY 3
Purpose of Action	LEVEL 2
Deficiency Photo1

Violations	Room 116 No violations recorded.
<b>Door(s)</b>	Inspected
Condition	5 - Poor
Deficiency	WOOD: DETERIORATED DOOR
Deficiency Location/Instance	Rooms 110, 112, 116, 119C, 214, 341, Kitchen, Inside Principal Office.
Deficiency Quantity	9
Quantity Uom	EACH
Potential Action	MAINTENANCE
Urgency of Action	PRIORITY 3
Purpose of Action	LEVEL 2
Deficiency Photo1

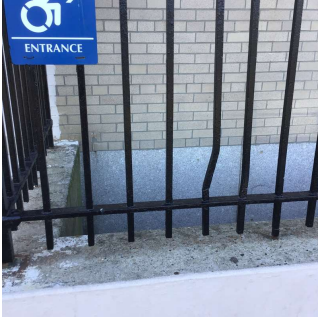
Question	Response
<b>SITE</b>	
<b>Drainage System for Soil</b>	Inspected
<b>Catch Basins/Manhole - Surrounded by Soil</b>	Inspected
Condition	2 - Between Good and Fair
Deficiency	No deficiencies recorded
<b>Culverts - Soil Covering</b>	Does not Exist
<b>DRINKING FOUNTAINS</b>	Inspected
Condition	2 - Between Good and Fair
Deficiency	No deficiencies recorded
<b>FENCES</b>	Inspected
Condition	3 - Fair
Deficiency	WROUGHT IRON: DAMAGED/DETERIORATED
Deficiency Location/Instance	174th Street, 175th Street
Deficiency Quantity	120
Quantity Uom	S.F.
Potential Action	REPLACE
Urgency of Action	PRIORITY 3
Purpose of Action	LEVEL 2
Deficiency Photo1

Violations	175th Street No violations recorded.
Deficiency	CONCRETE CURB: DAMAGED/DETERIORATED
Deficiency Location/Instance	65th Avenue, 174th Street, 175 Street, Schoolyard Area.
Deficiency Quantity	130
Quantity Uom	S.F.
Potential Action	REPLACE
Urgency of Action	PRIORITY 3
Purpose of Action	LEVEL 2

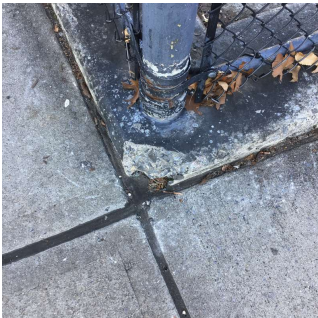
Violations	175 Street No violations recorded.
<b>IRRIGATION SYSTEM</b>	Does not Exist
<b>PAVING</b>	Inspected
<b>Student Non-Use</b>	Inspected

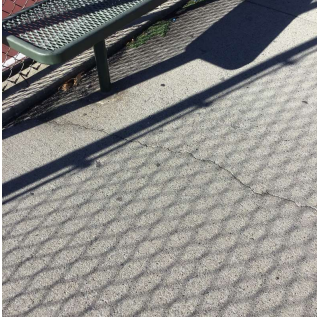
Question	Response
<b>SITE</b>	
<b>PAVING</b>	
<b>Student Use</b>	
<b>Concrete</b>	
Condition	3 - Fair
Deficiency	DAMAGED/DETERIORATED/MISSING SECTIONS
Deficiency Location/Instance	Baseball Area, Near Seats Area, Exits 3, 8.
Deficiency Quantity	100
Quantity Uom	S.F.
Potential Action	REPLACE
Urgency of Action	PRIORITY 3
Purpose of Action	LEVEL 2
Deficiency Photo1

Baseball Area
Violations	No violations recorded.
<b>Pavers</b>	Inspected
Condition	2 - Between Good and Fair
Deficiency	HEAVING
Deficiency Location/Instance	Near Handball wall, Baseball Area
Deficiency Quantity	20
Quantity Uom	S.F.
Potential Action	REPLACE
Urgency of Action	PRIORITY 3
Purpose of Action	LEVEL 2
Deficiency Photo1

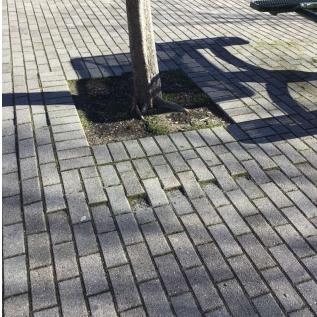
Near Handball wall
Violations	No violations recorded.
<b>Site Sidewalks &amp; Walkways</b>	Inspected
<b>Asphalt</b>	Does not Exist
<b>Concrete</b>	Inspected
Condition	3 - Fair
Deficiency	DAMAGED/DETERIORATED/MISSING SECTIONS
Deficiency Location/Instance	Near Exits 3, 4

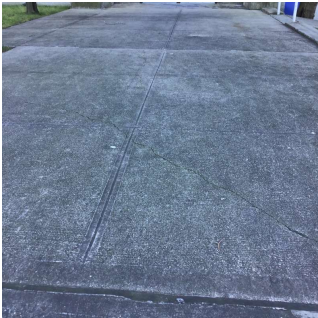
Deficiency Quantity	175

Question	Response
<b>SITE</b>	
<b>PAVING</b>	
<b>Site Sidewalks &amp; Walkways</b>	
<b>Concrete</b>	
Quantity Uom	S.F.
Potential Action	REPLACE
Urgency of Action	PRIORITY 3
Purpose of Action	LEVEL 2
Deficiency Photo1

Near Exit 4
Violations	No violations recorded.
<b>Pavers</b>	Does not Exist
<b>DOT Sidewalk</b>	Inspected
<b>Asphalt</b>	Does not Exist
<b>Concrete</b>	Inspected
Condition	4 - Between Fair and Poor
Deficiency	DAMAGED/DETERIORATED/MISSING SECTIONS
Deficiency Location/Instance	64th Avenue, 65th Avenue, 174th Street, 175 Street
Deficiency Quantity	1,175
Quantity Uom	S.F.
Potential Action	REPLACE
Urgency of Action	PRIORITY 3
Purpose of Action	LEVEL 2
Deficiency Photo1

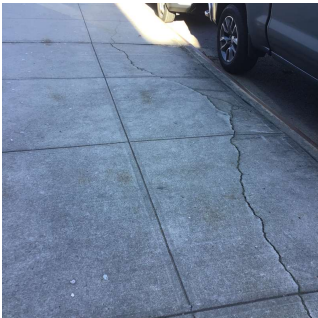
175th Street
Violations	No violations recorded.
Deficiency	DAMAGED CURBS
Deficiency Location/Instance	64th Avenue, 65th Avenue, 174th street, 175 Street
Deficiency Quantity	185
Quantity Uom	L.F.
Potential Action	REPLACE
Urgency of Action	PRIORITY 3

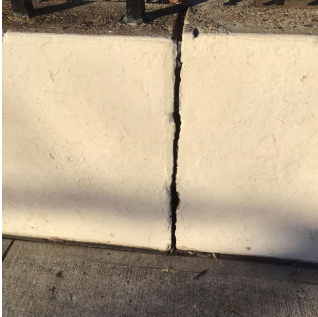
Question	Response
<b>SITE</b>	
<b>PAVING</b>	
<b>DOT Sidewalk</b>	
<b>Concrete</b>	
Deficiency Photo1	 
Violations	174th street No violations recorded.
<b>Pavers</b>	Does not Exist
<b>PLAYGROUNDS</b>	Does not Exist
<b>PLAYING SURFACE</b>	Inspected
<b>Playing Field</b>	Inspected
Instance on Schoolyard	Inspected
Instance Condition	2 - Between Good and Fair
Deficiency	ARTIFICIAL TURF: DAMAGED/WORN OUT
Deficiency Location/Instance	Near Basketball Area, Baseball Cage
Deficiency Quantity	20
Quantity Uom	S.F.
Potential Action	REPLACE
Urgency of Action	PRIORITY 3
Purpose of Action	LEVEL 2
Deficiency Photo1	 
Violations	Baseball Cage No violations recorded.
<b>Running Track</b>	Does not Exist
<b>RETAINING WALLS</b>	Inspected
Are there any Retaining Walls 6' OR higher facing public street/sidewalk?	No
Condition	3 - Fair
Deficiency	CAST IN PLACE CONCRETE: DETERIORATED CONTROL/EXPANSION JOINT
Deficiency Location/Instance	175 Street, 64th Avenue

Deficiency Quantity	30
Quantity Uom	L.F.
Potential Action	REPLACE

Question	Response
<b>SITE</b>	
<b>RETAINING WALLS</b>	
Urgency of Action	PRIORITY 3
Purpose of Action	LEVEL 2
Deficiency Photo1

175 Street
Violations	No violations recorded.
Deficiency	CAST IN PLACE CONCRETE: CRACKS/SPALLING - MAJOR
Deficiency Location/Instance	175th Street, 64th Avenue
Deficiency Quantity	50
Quantity Uom	S.F.
Potential Action	REPLACE
Urgency of Action	PRIORITY 3
Purpose of Action	LEVEL 2
Deficiency Photo1

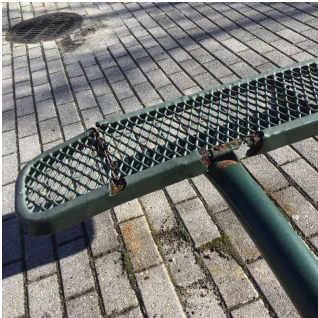
64th Avenue
Violations	No violations recorded.
<b>SEATING</b>	
	Inspected
<b>Benches</b>	Inspected
<b>Concrete</b>	Does not Exist
<b>Metal/Wood/Plastic</b>	Inspected
Condition	5 - Poor
Deficiency	DAMAGED/DETERIORATED
Deficiency Location/Instance	Near Handball wall
Deficiency Quantity	5
Quantity Uom	EACH
Potential Action	REPLACE
Urgency of Action	PRIORITY 3
Purpose of Action	LEVEL 2

Question	Response
<b>SITE</b>	
<b>SEATING</b>	
<b>Benches</b>	
<b>Metal/Wood/Plastic</b>	
Deficiency Photo1

Violations	Near 175th Street No violations recorded.
<b>Bleachers</b>	Does not Exist
<b>SITE WALLS (NOT RETAINING WALLS)</b>	Inspected
Condition	3 - Fair
Deficiency	CAST IN PLACE CONCRETE: CRACKS/SPALLING - MAJOR
Deficiency Location/Instance	Handball wall
Deficiency Quantity	70
Quantity Uom	S.F.
Potential Action	REPLACE
Urgency of Action	PRIORITY 3
Purpose of Action	LEVEL 2
Deficiency Photo1

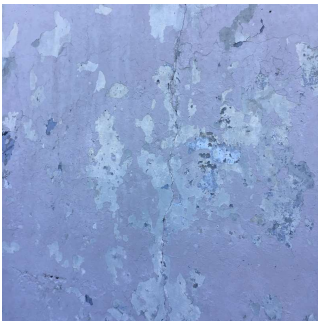
Violations	Handball wall No violations recorded.
<b>STAIRS/RAMPS: EXTERIOR</b>	Inspected
<b>Railings</b>	Inspected
Condition	2 - Between Good and Fair
Deficiency	No deficiencies recorded
<b>Site Cheek/flank Walls</b>	Inspected
Condition	3 - Fair
Deficiency	CAST IN PLACE CONCRETE: CRACKS/SPALLING - MAJOR
Deficiency Location/Instance	Near 174th Street, Entrance to Schoolyard.
Deficiency Quantity	50
Quantity Uom	S.F.

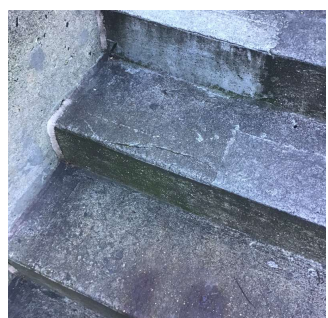
Violations	Near 174th Street No violations recorded.
<b>Stairs/ramps</b>	Inspected
Condition	2 - Between Good and Fair
Deficiency	CAST IN PLACE CONCRETE: CRACKS/SPALLING - MAJOR
Deficiency Location/Instance	Near Exit 4
Deficiency Quantity	10
Quantity Uom	S.F.
Potential Action	REPLACE
Urgency of Action	PRIORITY 3
Purpose of Action	LEVEL 2
Deficiency Photo1

Violations	Near Exit 4 No violations recorded.
<b>ARTWORK</b>	Does not Exist
