NYC Department of Education
Building Condition Assessment Survey 2023 - 2024

Architectural Inspection

Asset: P.S. 219 - QUEENS, 144-39 GRAVETT ROAD, New York, 11367

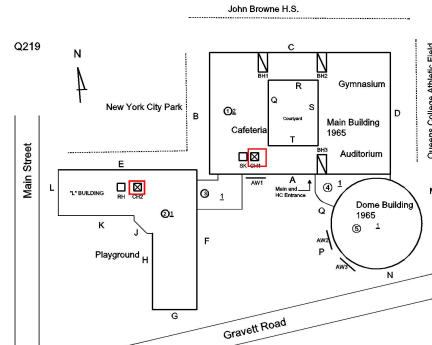
Roof Plan reference

BRICK: DETERIORATED CAP

REPLACE

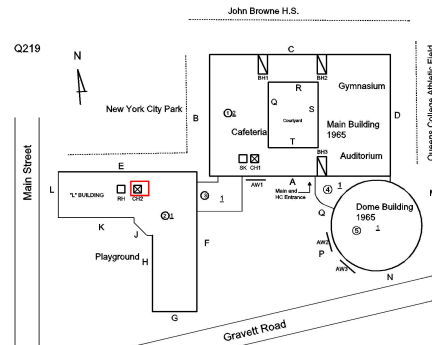
Roof Plan reference

BRICK: MINOR CRACKS AND SPALLING

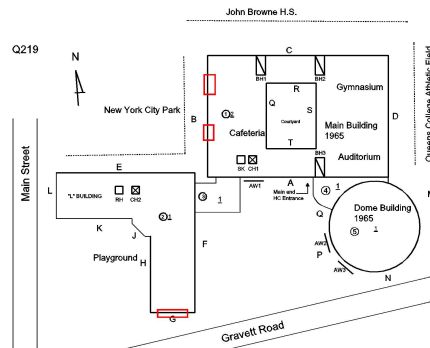
Roof Plan reference

METAL: DETERIORATED DOOR AND FRAME - MINOR DETERIORATION

6
EACH
MAINTENANCE
PRIORITY 3
LEVEL 2
No photo recorded
No violations recorded.

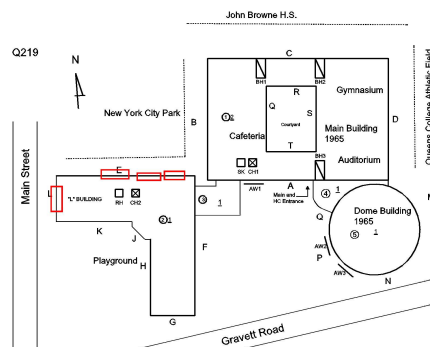
METAL: DETERIORATED DOOR AND FRAME - MAJOR DETERIORATION

Question	Response
EXTERIOR	
DOORS	
DOORS AND FRAMES	
Deficiency Quantity	6
Quantity Uom	EACH
Potential Action	REPLACE
Urgency of Action	PRIORITY 4
Purpose of Action	LEVEL 2
Deficiency Photo1	 
Violations	Facade L - Exit 19 No violations recorded.
DOOR HARDWARE	Inspected
Condition	3 - Fair
Deficiency	No deficiencies recorded
LINTELS	Inspected
Condition	2 - Between Good and Fair
Deficiency	No deficiencies recorded
TRANSOM/SIDE LIGHT	Inspected
Condition	3 - Fair
Deficiency	METAL: BROKEN GLASS
Roof Plan reference

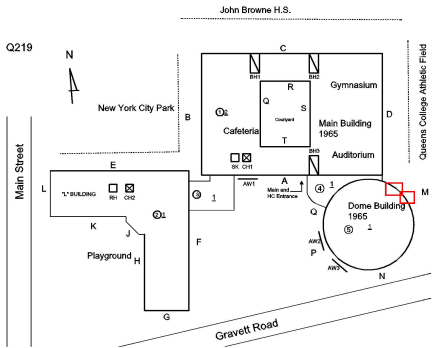
Deficiency Quantity	60
Quantity Uom	S.F.
Potential Action	MAINTENANCE
Urgency of Action	PRIORITY 3
Purpose of Action	LEVEL 2
Deficiency Photo1	No photo recorded
Violations	No violations recorded.
Deficiency	METAL: DENTED, MAJOR RUSTING

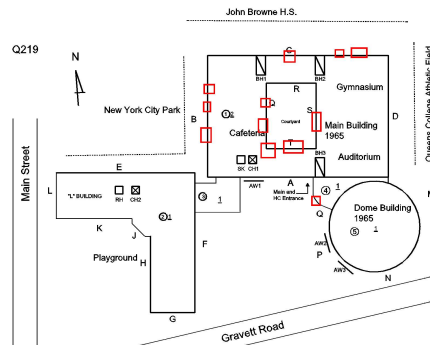
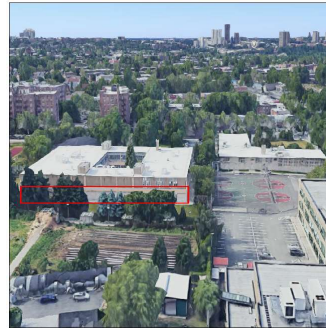
Roof Plan reference

CAST IN PLACE / PRE-CAST CONCRETE: MAJOR CRACKS/SPALLING

REPLACE

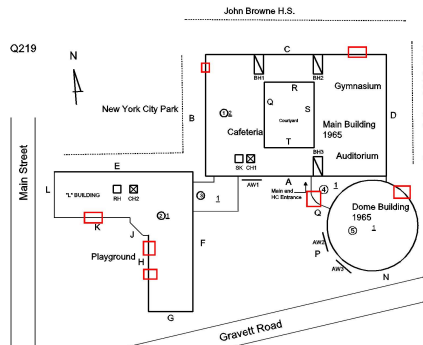
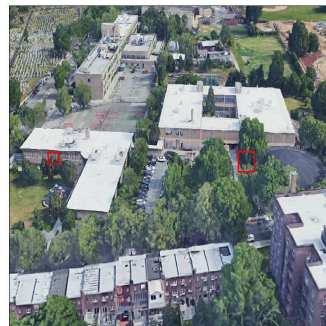
Roof Plan reference

CAST IN PLACE / PRE-CAST CONCRETE: MINOR CRACKS/SPALLING

REPAIR
PRIORITY 3
LEVEL 2

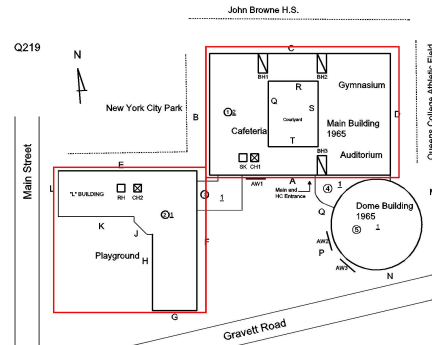
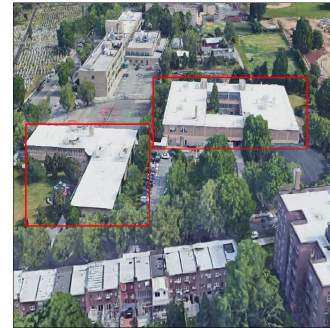
Roof Plan reference

BRICK: DETERIORATED JOINTS

4,000
S.F.
REPOINT
PRIORITY 3
LEVEL 2

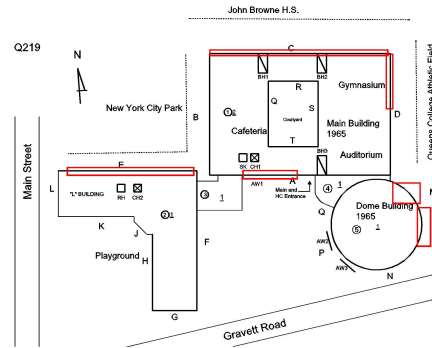
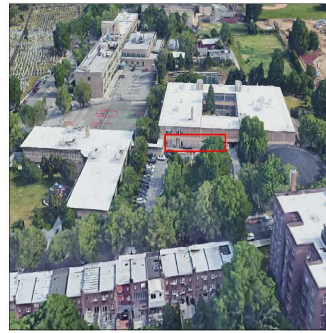
Roof Plan reference

BRICK: EFFLORESCENCE

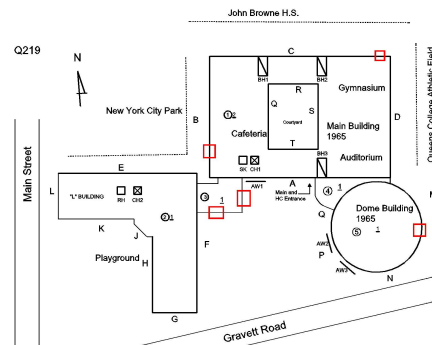
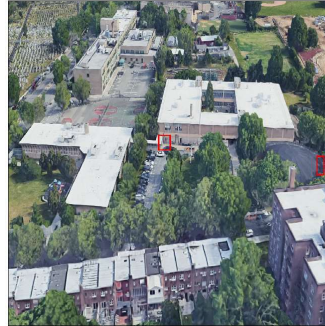
Roof Plan reference

BRICK: DETERIORATED JOINTS

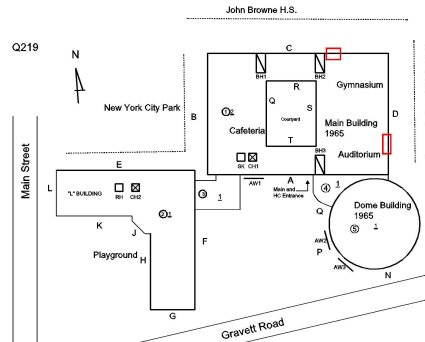
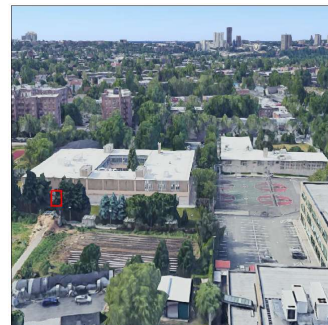
Roof Plan reference

BRICK: MAJOR / THRU CRACKS

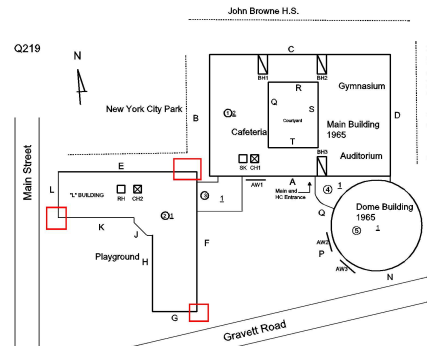
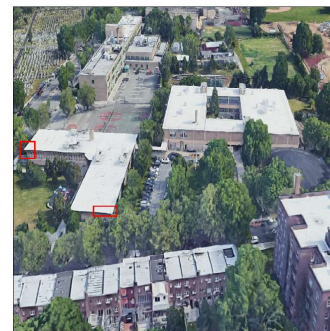
Roof Plan reference

CONCRETE: MINOR CRACKS/SPALLING

40
S.F.
REPAIR
PRIORITY 3
LEVEL 2

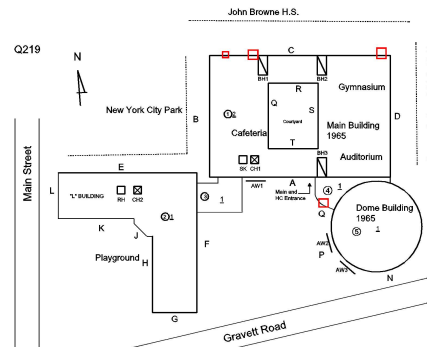
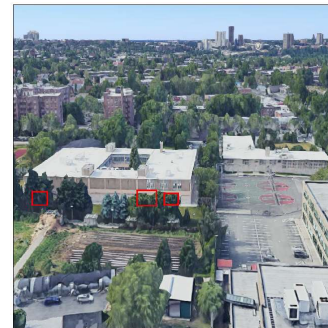
Roof Plan reference

BROKEN/ DENTED BLADES

REPLACE

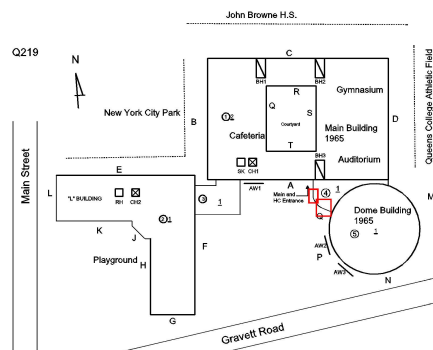
Question	Response
EXTERIOR	
LOUVER	Inspected
	Facade Q
Violations	No violations recorded.
PARAPETS	Does not Exist
PLAZA DECK	Does not Exist
ROOF	Inspected
Roofing	Inspected
Replacement Quantity	72,000
Replacement Uom	S.F.
ROOF HATCH/SMOKE HATCH	Inspected
Condition	1 - Good
Deficiency	No deficiencies recorded
LEADERS, GUTTERS, DOWNSPOUTS, SCUPPERS	Inspected
Condition	1 - Good
Deficiency	No deficiencies recorded
ROOF BARRIER/FENCE	Inspected
Condition	3 - Fair
Deficiency	BEAR CLAW/METAL BAR: DETERIORATED, MAJOR RUSTING
Roof Plan reference

Deficiency Quantity	20
Quantity Uom	S.F.
Potential Action	REPLACE
Urgency of Action	PRIORITY 4
Purpose of Action	LEVEL 2
Deficiency Photo1

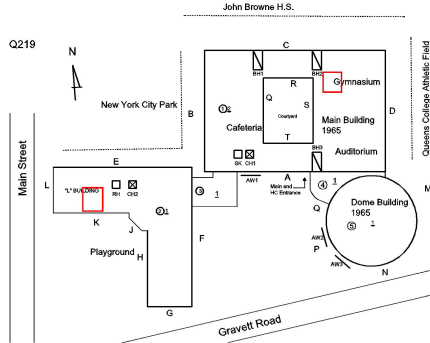
Roof 1
Instance Quantity	62,000
Instance Quantity Uom	S.F.
Does the roof have major mechanical equipment sitting on Dunnage Steel less than 18" above the Roofing?	No
Does this roof instance have a Sustainable Roof System?	Yes
Sustainable Roof Type	White Roof
Sustainable Roof Location (Roof Number)	Roofs 1-3
Do solar panels exist on these roofs?	No
Is/Are the roof(s) suitable for Solar Panel installation?	Yes
Installation Year	2019
Source of Installation	Custodial Staff
Deficiency	MODIFIED BITUMEN: ROOFING: MAJOR ACTIVE ROOF LEAKS IN INSTRUCTIONAL SPACE
Roof Plan reference

Deficiency Quantity	200
Quantity Uom	S.F.
Potential Action	REPLACE ROOFING WITHOUT MAJOR EQUIPMENT REMOVAL
Urgency of Action	PRIORITY 5
Purpose of Action	LEVEL 2
Deficiency Photo1

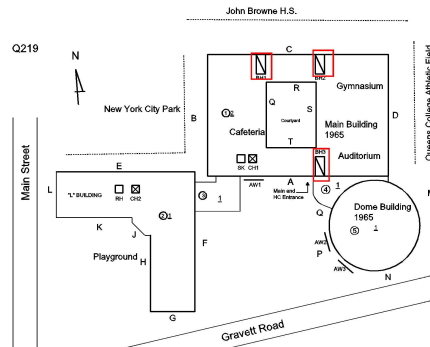
Roof Plan reference

Deficiency
BULKHEAD/PENTHOUSE WALLS/EXTERIOR: EFFLORESCENCE

Deficiency Quantity 300
Quantity Uom S.F.
Potential Action MAINTENANCE
Urgency of Action PRIORITY 1
Purpose of Action LEVEL 1
Deficiency Photo1 No photo recorded
Violations No violations recorded.

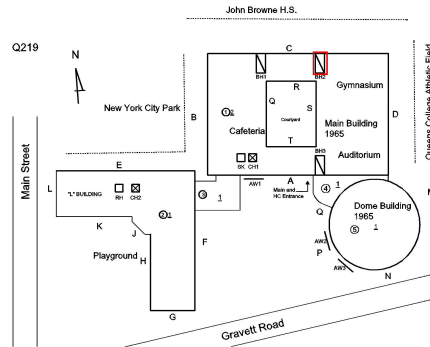
Roof Plan reference

Deficiency
BULKHEAD/PENTHOUSE WALLS/EXTERIOR: DETERIORATED JOINTS

Deficiency Quantity 20
Quantity Uom S.F.
Potential Action REPOINT
Urgency of Action PRIORITY 3
Purpose of Action LEVEL 2

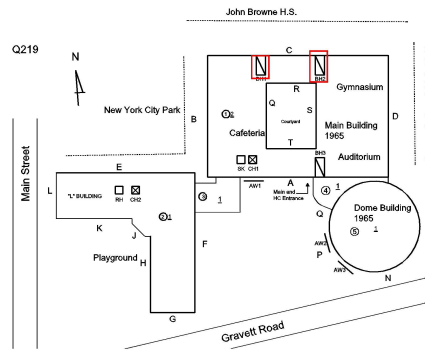
Roof Plan reference

BULKHEAD/PENTHOUSE WALLS/INTERIOR: GLAZED BLOCK DETERIORATED JOINTS

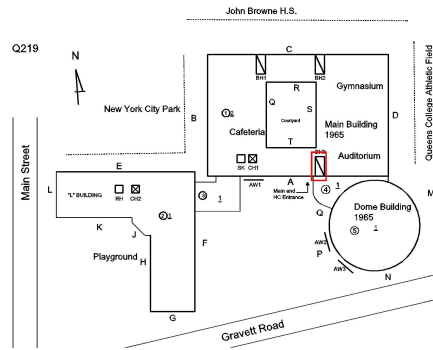
Roof Plan reference

BULKHEAD/PENTHOUSE WALLS/EXTERIOR: DETERIORATED JOINTS

20
S.F.
REPOINT
PRIORITY 4
LEVEL 2

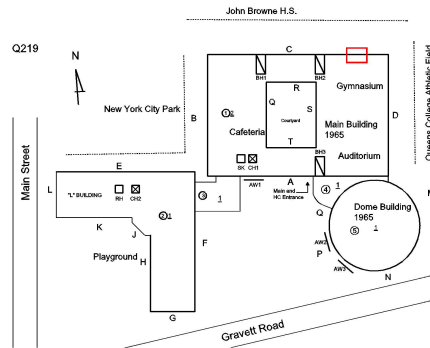
Roof Plan reference

CUPOLA/ SPIRES/ TOWERS	Does not Exist
DORMER	Does not Exist
DUNNAGE STEEL	Inspected
Condition	2 - Between Good and Fair
Deficiency	No deficiencies recorded
SKYLIGHT/ROOF VENT	Inspected
Material Type(s)	Glass
Condition	1 - Good
Deficiency	No deficiencies recorded
ROOF/GRAVITY TANK	Does not Exist
STAIRS/RAMPS: EXTERIOR	Inspected
BUILDING CHEEK/FLANK WALLS	Inspected
Condition	3 - Fair
Deficiency	CAST IN PLACE CONCRETE: CRACKS/SPALLING - MAJOR

10
 S.F.
 REPLACE
 PRIORITY 4
 LEVEL 2

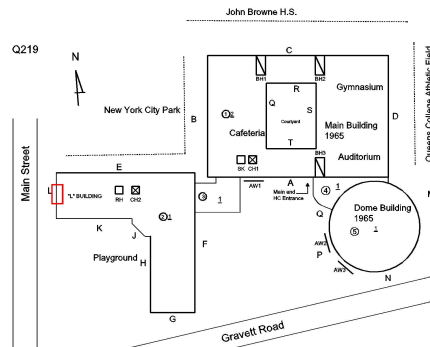
Roof Plan reference

RUST - MAJOR

10
 L.F.
 REPLACE
 PRIORITY 4
 LEVEL 2

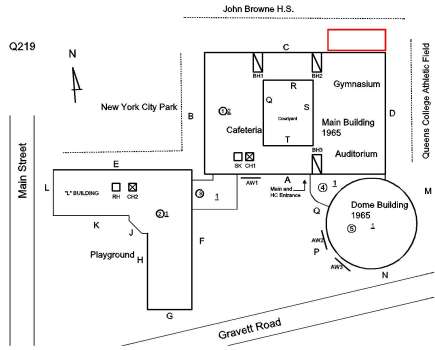
Violations	Facade L No violations recorded.
STAIRS/RAMPS	
Condition	Inspected 5 - Poor
Deficiency	CONCRETE: DETERIORATED SUBSTRATE
Roof Plan reference

Deficiency Quantity	200
Quantity Uom	S.F.
Potential Action	REPLACE SUBSTRATE AND RESET
Urgency of Action	PRIORITY 4
Purpose of Action	LEVEL 2
Deficiency Photo1

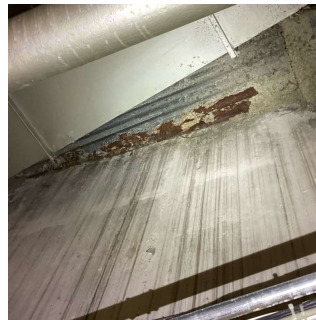
Dome Building - Basement

METAL DECK AND CONCRETE: DETERIORATED

REPAIR

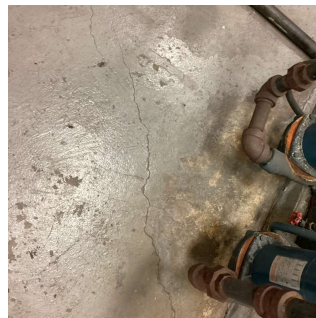
CONCRETE SLAB ON GRADE: THRU CRACKS

REPAIR

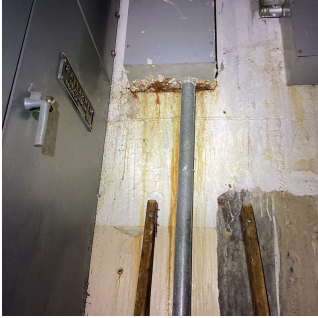
Question	Response
INTERIOR	
STRUCTURAL	
FLOOR STRUCTURE	Inspected
Violations	L-Building - Boiler Room No violations recorded.
FOUNDATION WALLS	Inspected
Material Type(s)	Concrete
Condition	4 - Between Fair and Poor
Deficiency	CONCRETE: WATER INFILTRATION IN ELECTRICAL PANEL ROOM
Deficiency Location/Instance	Main Building - Electrical Panel Room
Deficiency Quantity	100
Quantity Uom	S.F.
Potential Action	INSTALL WATERPROOFING
Urgency of Action	PRIORITY 5
Purpose of Action	LEVEL 6
Deficiency Photo1

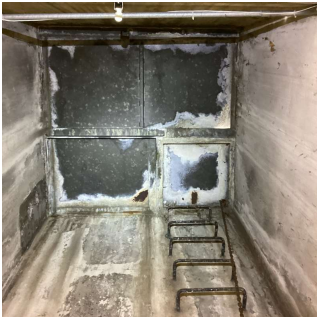
Condition	5 - Poor
Deficiency	WATER INFILTRATION
Deficiency Location/Instance	Main Building - Vault
Deficiency Quantity	10
Quantity Uom	S.F.
Potential Action	REPAIR
Urgency of Action	PRIORITY 5
Purpose of Action	LEVEL 2

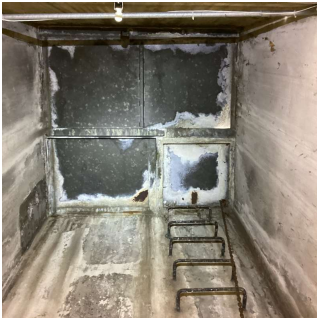
Violations	Main Building - Vault No violations recorded.
Deficiency	DETERIORATED/DAMAGED VAULT/ASH HOIST DOORS AND FRAMING
Deficiency Location/Instance	Main Building - Vault
Deficiency Quantity	1
Quantity Uom	EACH
Potential Action	REPLACE
Urgency of Action	PRIORITY 4
Purpose of Action	LEVEL 2
Deficiency Photo1

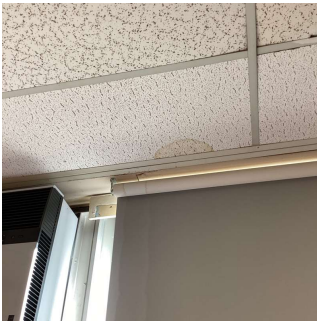
Condition	2 - Between Good and Fair
Deficiency	ACOUSTIC TILES: DAMAGED/MISSING - ACTIVE LEAK
Deficiency Location/Instance	Near Windows
Deficiency Quantity	10
Quantity Uom	S.F.
Potential Action	REPLACE
Urgency of Action	PRIORITY 5
Purpose of Action	LEVEL 2

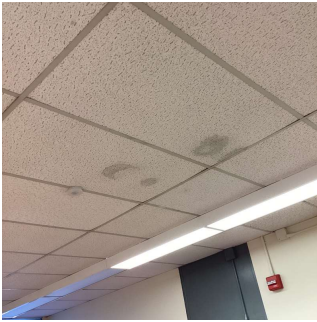
Violations	Near Windows No violations recorded.
Instance on 1st Floor - Staff (600 SF)	Inspected
Condition	3 - Fair
Deficiency	ACOUSTIC TILES: DAMAGED/MISSING
Deficiency Location/Instance	Near Entrance, Left Side
Deficiency Quantity	20
Quantity Uom	S.F.
Potential Action	REPLACE
Urgency of Action	PRIORITY 3
Purpose of Action	LEVEL 2
Deficiency Photo1

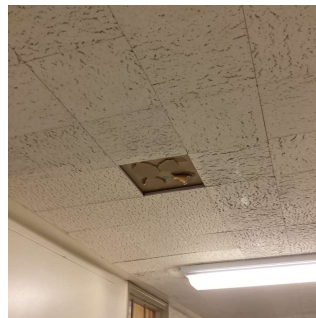
Corridor near Room 101

ACOUSTIC TILES ON PLASTER: DAMAGED/MISSING

REPLACE

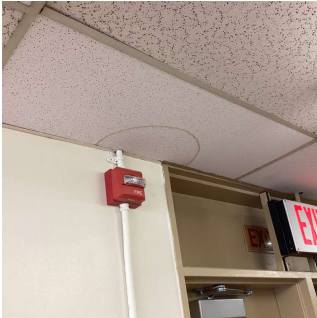
Question	Response
INTERIOR	
CLASSROOMS/CORRIDORS/ADMIN SPACES	
Ceiling	
Violations	No violations recorded.
Deficiency	ACOUSTIC TILES: DAMAGED/MISSING - ACTIVE LEAK
Deficiency Location/Instance	Corridor near Stair C/2, Corridor Near Room 198, Main Entrance Lobby, Room 127
Deficiency Quantity	40
Quantity Uom	S.F.
Potential Action	REPLACE
Urgency of Action	PRIORITY 5
Purpose of Action	LEVEL 2
Deficiency Photo1

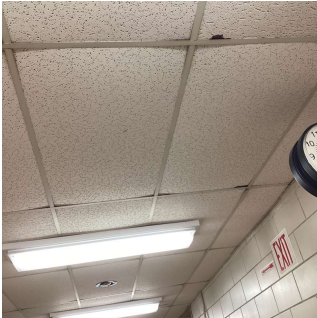
Violations	No violations recorded.
Deficiency	ACOUSTIC TILES: DAMAGED/MISSING
Deficiency Location/Instance	Corridor near Room 160, Rooms 236A, 236B, 234, Corridor Near Stair B/2 and others
Deficiency Quantity	300
Quantity Uom	S.F.
Potential Action	REPLACE
Urgency of Action	PRIORITY 3
Purpose of Action	LEVEL 2
Deficiency Photo1

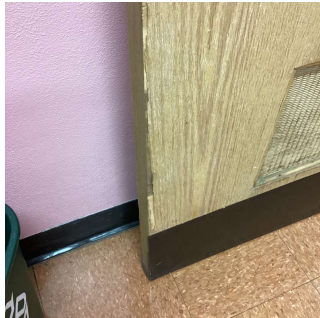
Violations	No violations recorded.
Door(s)	Inspected
Condition	5 - Poor
Deficiency	WOOD: DETERIORATED DOOR
Deficiency Location/Instance	Rooms 264, 260, 259, 172, 156 and others
Deficiency Quantity	16

Quantity Uom	EACH
Potential Action	MAINTENANCE
Urgency of Action	PRIORITY 3

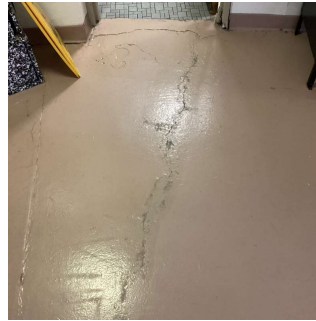
Corridor near Room 303

Violations	Corridor near Exit 17&18 No violations recorded.
Deficiency	CONCRETE: CRACKS
Deficiency Location/Instance	Corridor near Rooms 310, 305, 303, Corridor near Exit 10
Deficiency Quantity	400
Quantity Uom	S.F.
Potential Action	REPLACE
Urgency of Action	PRIORITY 3
Purpose of Action	LEVEL 2

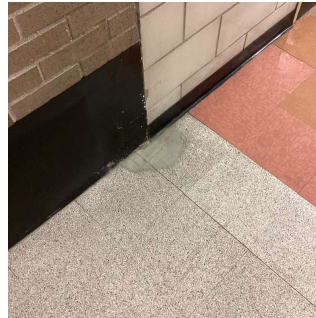
Corridor near Room 199

VINYL TILES: BROKEN/DETERIORATED/MISSING TILES

REPLACE

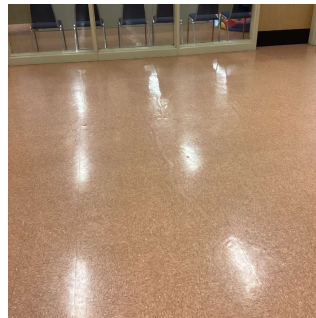
Corridor near Room 185

VINYL TILES: DETERIORATED SUBSTRATE

REPLACE

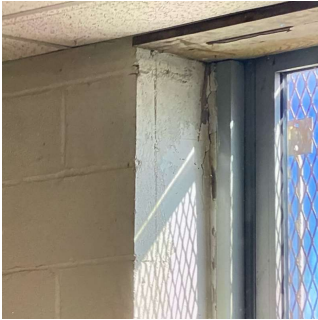
Question	Response
INTERIOR	
CLASSROOMS/CORRIDORS/ADMIN SPACES	
Floor Finish	Inspected
Violations	No violations recorded.
Walls	Inspected
Condition	2 - Between Good and Fair
Deficiency	MASONRY: CRACKS/SPALLING - ACTIVE LEAK
Deficiency Location/Instance	Room 289
Deficiency Quantity	10
Quantity Uom	S.F.
Potential Action	REPLACE
Urgency of Action	PRIORITY 5
Purpose of Action	LEVEL 2
Deficiency Photo1

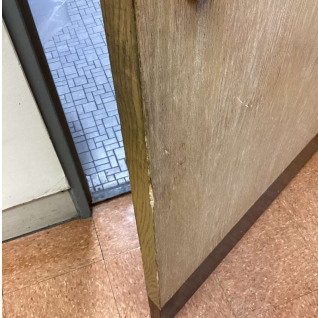
Question	Response
INTERIOR	
KITCHEN	
Door(s)	
Deficiency Location/Instance	Exit to Staff Cafeteria, Room 151-1
Deficiency Quantity	2
Quantity Uom	EACH
Potential Action	MAINTENANCE
Urgency of Action	PRIORITY 3
Purpose of Action	LEVEL 2
Deficiency Photo1

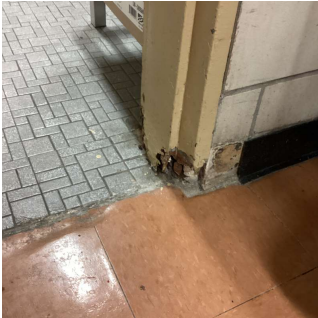
Violations	Exit to Staff Cafeteria No violations recorded.
Deficiency	METAL: DETERIORATED DOOR AND FRAME
Deficiency Location/Instance	Room 151-3
Deficiency Quantity	1
Quantity Uom	EACH
Potential Action	MAINTENANCE
Urgency of Action	PRIORITY 3
Purpose of Action	LEVEL 2
Deficiency Photo1

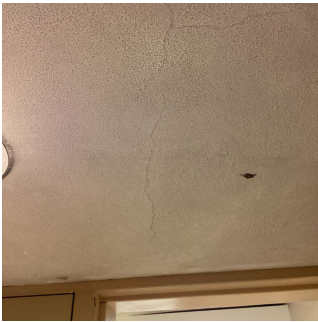
Violations	Stair B/1 Vestibule No violations recorded.

Question	Response
INTERIOR	
LIBRARY	
Floor Finish	
Deficiency	No deficiencies recorded
Walls	
Instance on 2nd Floor	Inspected
Condition	2 - Between Good and Fair
Deficiency	No deficiencies recorded
LOCKER ROOM	Does not Exist
MULTI-PURPOSE ROOM	Does not Exist
SCIENCE DEMO ROOM	Does not Exist
SCIENCE LAB	Inspected
Instance on Room 258A	Inspected
Alternative use	No
Fixed Equipment	
Instance on Room 258A	Inspected
Condition	2 - Between Good and Fair
Deficiency	No deficiencies recorded
SCIENCE PREP ROOM	Does not Exist
SHOWER ROOM	Does not Exist
STAIRS/RAMPS: INTERIOR	Inspected
Do Letter Stair Signs Exist?	Yes
Ceiling	Inspected
Condition	2 - Between Good and Fair
Deficiency	PLASTER: CRACKS/SPALLING
Deficiency Location/Instance	Stair B/1 Vestibule
Deficiency Quantity	20
Quantity Uom	S.F.
Potential Action	REPLACE
Urgency of Action	PRIORITY 3
Purpose of Action	LEVEL 2
Deficiency Photo1

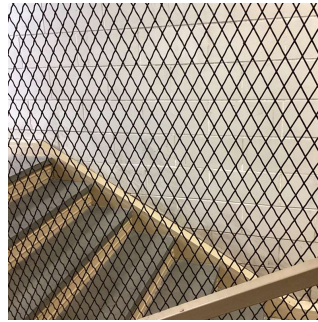
Door(s)	Inspected
Condition	2 - Between Good and Fair
Deficiency	No deficiencies recorded
Partition	Does not Exist
Railings	Inspected
Condition	3 - Fair
Deficiency	METAL: MISSING
Deficiency Location/Instance	Stair D/Bulkhead

Deficiency Quantity	10
Quantity Uom	L.F.
Potential Action	REPLACE
Urgency of Action	PRIORITY 5
Purpose of Action	LEVEL 6
Deficiency Photo1

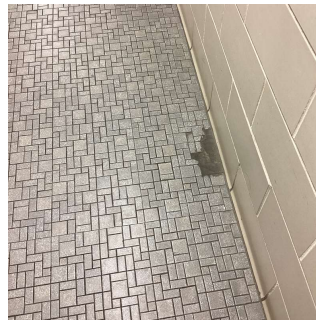
Room 184

CERAMIC TILE: BROKEN/MISSING TILES

REPLACE

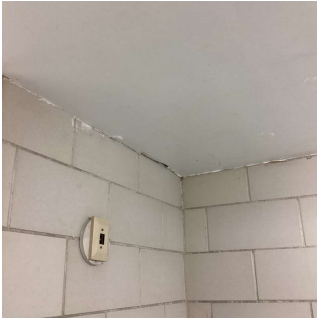
Question	Response
INTERIOR	
TOILET ROOMS - STAFF	
Stalls	
Deficiency Photo1	 
Violations	Room 246 No violations recorded.
Walls	Inspected
Condition	2 - Between Good and Fair
Deficiency	No deficiencies recorded
TOILET ROOMS - STUDENTS	
Ceiling	Inspected
Condition	2 - Between Good and Fair
Deficiency	GYPSON BOARD: DAMAGED/DETERIORATED
Deficiency Location/Instance	Rooms 242, 310
Deficiency Quantity	20
Quantity Uom	S.F.
Potential Action	REPLACE
Urgency of Action	PRIORITY 3
Purpose of Action	LEVEL 2
Deficiency Photo1

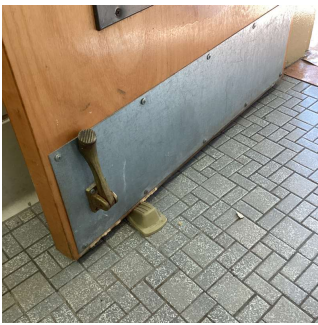
Violations	Room 242 No violations recorded.
Door(s)	Inspected
Condition	5 - Poor
Deficiency	WOOD: DETERIORATED DOOR
Deficiency Location/Instance	Rooms 304, 284, 280, 170, 168 and others
Deficiency Quantity	8
Quantity Uom	EACH
Potential Action	MAINTENANCE
Urgency of Action	PRIORITY 3
Purpose of Action	LEVEL 2

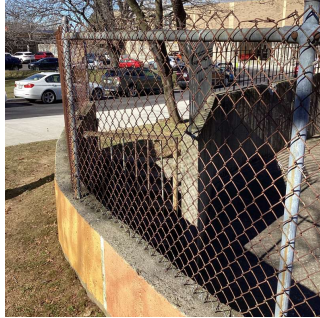
Gravett Road
Violations	No violations recorded.
Deficiency	CHAIN LINK: DAMAGED/DETERIORATED
Deficiency Location/Instance	Main Street, Gravett Road
Deficiency Quantity	100
Quantity Uom	S.F.
Potential Action	REPLACE
Urgency of Action	PRIORITY 3
Purpose of Action	LEVEL 2
Deficiency Photo1

Condition	2 - Between Good and Fair
Deficiency	No deficiencies recorded
Culverts - Soil Covering	Does not Exist
DRINKING FOUNTAINS	
FENCES	
Condition	Inspected
Condition	4 - Between Fair and Poor
Deficiency	CHAIN LINK: RUST - MAJOR
Deficiency Location/Instance	Gravett Road
Deficiency Quantity	400
Quantity Uom	S.F.

Question	Response
SITE	
FENCES	
Potential Action	REPLACE
Urgency of Action	PRIORITY 3
Purpose of Action	LEVEL 2
Deficiency Photo1

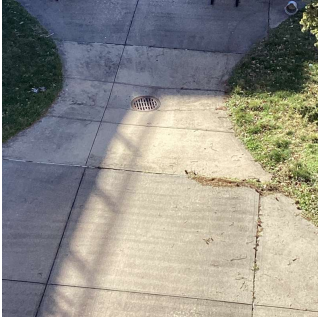
Question	Response
SITE	
PAVING	
Student Use	
Concrete	
Deficiency	CRACKS - MAJOR
Deficiency Location/Instance	Courtyard
Deficiency Quantity	75
Quantity Uom	S.F.
Potential Action	REPLACE
Urgency of Action	PRIORITY 3
Purpose of Action	LEVEL 2
Deficiency Photo1

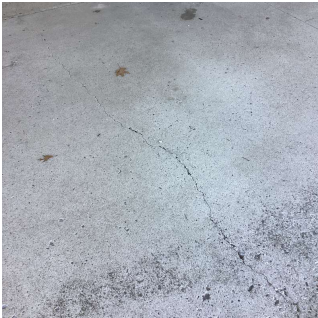
Violations	Exit 13 No violations recorded.
Pavers	Does not Exist
DOT Sidewalk	Inspected
Asphalt	Does not Exist
Concrete	Inspected

Violations	Courtyard No violations recorded.
Pavers	Does not Exist
Site Sidewalks & Walkways	Inspected
Asphalt	Does not Exist
Concrete	Inspected
Condition	4 - Between Fair and Poor
Deficiency	CRACKS - MAJOR
Deficiency Location/Instance	Exits 13, 11, 10, 4, 3 and others
Deficiency Quantity	725
Quantity Uom	S.F.
Potential Action	REPLACE
Urgency of Action	PRIORITY 3
Purpose of Action	LEVEL 2
Deficiency Photo1

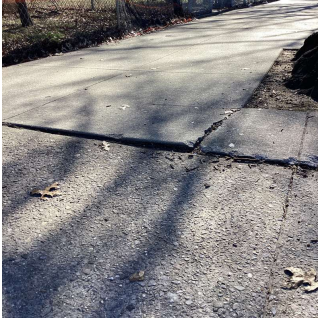
Violations	Main Street No violations recorded.
Deficiency	DAMAGED CURBS
Deficiency Location/Instance	Main Street, Gravett Road
Deficiency Quantity	80
Quantity Uom	L.F.
Potential Action	REPLACE
Urgency of Action	PRIORITY 3
Purpose of Action	LEVEL 2
Deficiency Photo1

Question	Response
SITE	
PAVING	
DOT Sidewalk	
Concrete	
Condition	4 - Between Fair and Poor
Deficiency	HEAVING
Deficiency Location/Instance	Main Street, Gravett Road
Deficiency Quantity	200
Quantity Uom	S.F.
Potential Action	REPLACE
Urgency of Action	PRIORITY 3
Purpose of Action	LEVEL 2
Deficiency Photo1

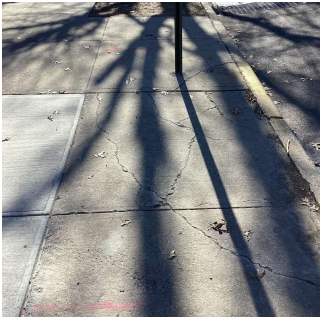
Violations	Main Street No violations recorded.
Deficiency	DAMAGED/DETERIORATED/MISSING SECTIONS
Deficiency Location/Instance	Main Street, Gravett Road
Deficiency Quantity	600
Quantity Uom	S.F.
Potential Action	REPLACE
Urgency of Action	PRIORITY 3
Purpose of Action	LEVEL 2

Question	Response
SITE	
PAVING	
DOT Sidewalk	
Concrete	
Deficiency Photo1

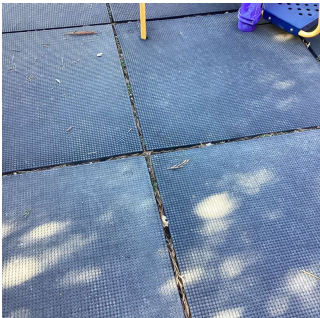
Near Steps

Main Street
Violations	No violations recorded.
Pavers	Does not Exist
PLAYGROUNDS	Inspected
Instance on South Side of L Building	Inspected
Benches	
Instance on South Side of L Building	Inspected
Condition	2 - Between Good and Fair
Deficiency	No deficiencies recorded
Fence	
Instance on South Side of L Building	Does not Exist
Pavement	
Instance on South Side of L Building	Does not Exist
Play Equipment	
Instance on South Side of L Building	Inspected
Condition	2 - Between Good and Fair
Deficiency	No deficiencies recorded
Safety Surfacing	
Instance on South Side of L Building	Inspected
Condition	2 - Between Good and Fair
Deficiency	DETERIORATED/MISSING
Deficiency Location/Instance	Near Steps, Near concrete Benches
Deficiency Quantity	40
Quantity Uom	S.F.
Potential Action	REPLACE
Urgency of Action	PRIORITY 3
Purpose of Action	LEVEL 2
Deficiency Photo1

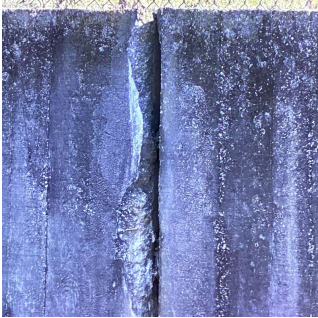
Question	Response
SITE	
PLAYGROUNDS	Inspected
Safety Surfacing	
Violations	No violations recorded.
Unpaved Area	
Instance on South Side of L Building	Does not Exist
PLAYING SURFACE	Does not Exist
RETAINING WALLS	Inspected
Are there any Retaining Walls 6' OR higher facing public street/sidewalk?	No
Condition	3 - Fair
Deficiency	CAST IN PLACE CONCRETE: CRACKS/SPALLING - MAJOR
Deficiency Location/Instance	Near Exit 14, Rear of Dome
Deficiency Quantity	40
Quantity Uom	S.F.
Potential Action	REPLACE
Urgency of Action	PRIORITY 3
Purpose of Action	LEVEL 2
Deficiency Photo1

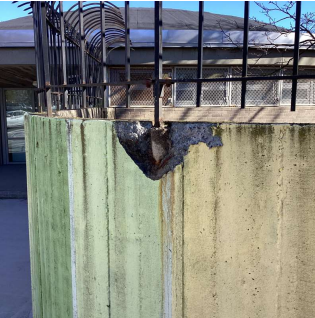
Deficiency	CAST IN PLACE CONCRETE: CRACKS/SPALLING - MAJOR
Deficiency Location/Instance	Near Exits 10, 11
Deficiency Quantity	40
Quantity Uom	S.F.
Potential Action	REPLACE
Urgency of Action	PRIORITY 3
Purpose of Action	LEVEL 2

Question	Response
SITE	
SITE WALLS (NOT RETAINING WALLS)	
Deficiency Photo1 Violations
