NYC Department of Education
Building Condition Assessment Survey 2023 - 2024

Architectural Inspection

Q223

Asset: P.S. 223 - QUEENS, 125-20 SUTPHIN BLVD, New York, 11436

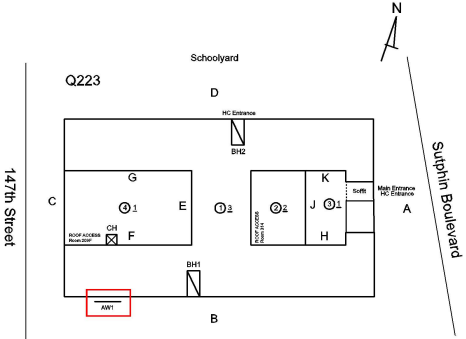
Question	Response
Architectural	
EXTERIOR	Inspected
AREAWAY	Inspected
Instance on AW1	Inspected
Instance Condition	3 - Fair
Instance Quantity	1
Instance Quantity Uom	EACH
Deficiency	AREAWAY WALLS: CRACKS AND SPALLING
Roof Plan reference

Deficiency Quantity	10
Quantity Uom	S.F.
Potential Action	REPLACE

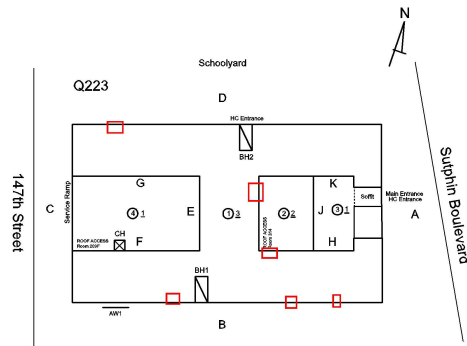
CAST STONE: CRACKED/BROKEN PIECES

30
 L.F.
 REPLACE-IN-KIND
 PRIORITY 4
 LEVEL 2

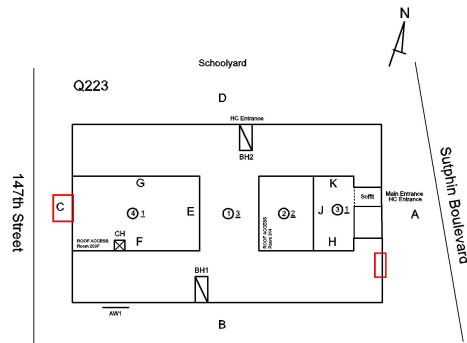
METAL CLAD: DETERIORATED DOOR AND FRAME - MAJOR DETERIORATION

3
 EACH
 REPLACE
 PRIORITY 4
 LEVEL 2

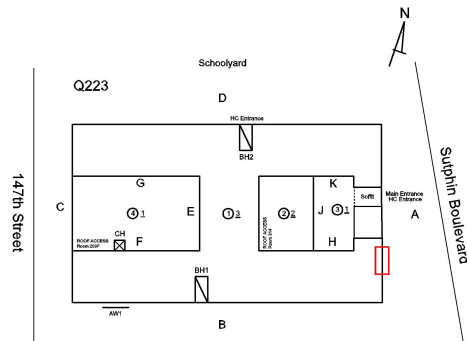
METAL: DENTED, MAJOR RUSTING

REPLACE

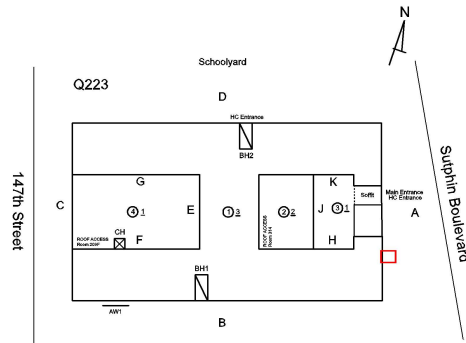
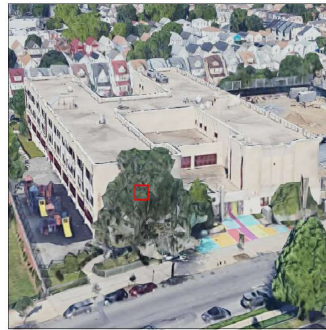
Material Type(s)	Concrete, Masonry
Replacement Quantity	24,000
Replacement Uom	S.F.
Instance on All Facades	Inspected
Instance Condition	3 - Fair
Instance Quantity	24,000
Instance Quantity Uom	S.F.
Deficiency	BRICK: MINOR CRACKS AND SPALLING
Roof Plan reference

Deficiency Quantity	10
Quantity Uom	S.F.
Potential Action	RESTITCH
Urgency of Action	PRIORITY 3
Purpose of Action	LEVEL 2
Deficiency Photo1

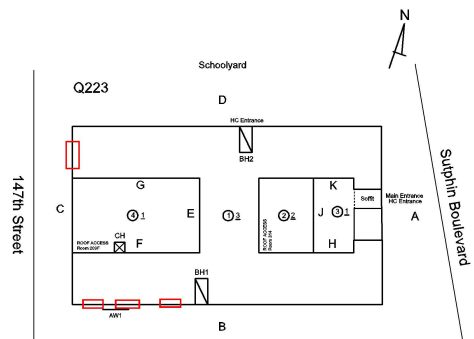
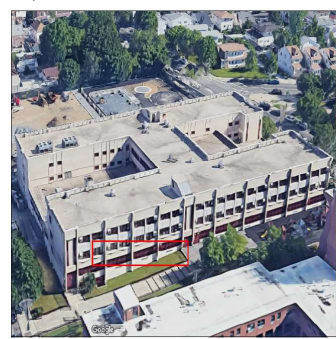
Question	Response
EXTERIOR	
LOUVER	
Condition	3 - Fair
Deficiency	BROKEN/ DENTED BLADES
Roof Plan reference

Deficiency Quantity	30
Quantity Uom	S.F.
Potential Action	REPLACE
Urgency of Action	PRIORITY 4
Purpose of Action	LEVEL 2
Deficiency Photo1

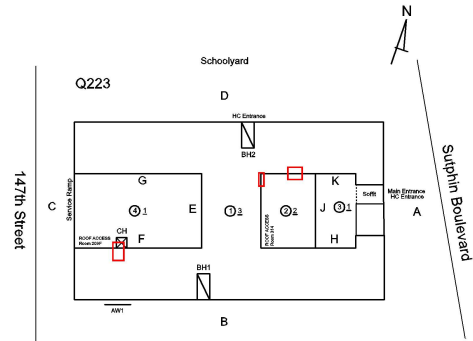
Violations	Facade B No violations recorded.
PARAPETS	
Material Type(s)	Inspected Masonry
Replacement Quantity	7,000
Replacement Uom	C.F.
Instance on All Facades	Inspected
Instance Condition	3 - Fair
Instance Quantity	7,000
Instance Quantity Uom	C.F.
Deficiency	BRICK: MAJOR DETERIORATION/CRACKS

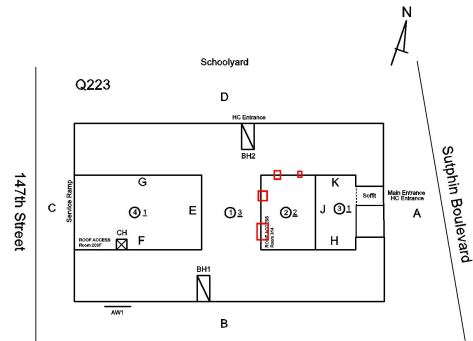
BRICK: MINOR CRACKS, SPALLING

REPAIR

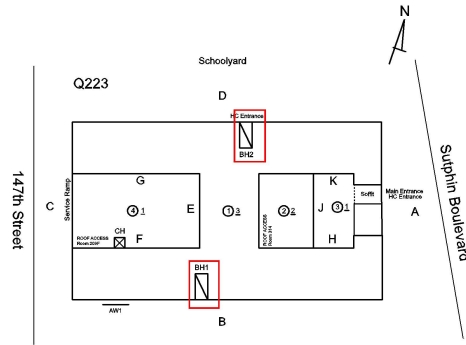
BULKHEAD/PENTHOUSE WALLS/EXTERIOR: DETERIORATED JOINTS

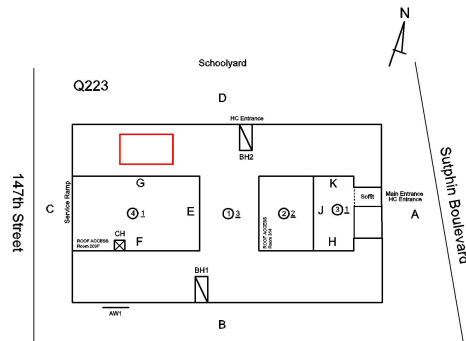
HEIGHT LESS THAN 18"

REPLACE

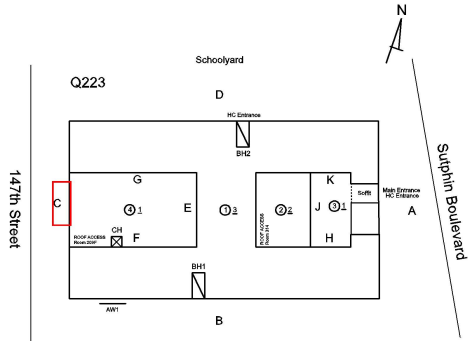
Roof 1
Violations	No violations recorded.
SKYLIGHT/ROOF VENT	Does not Exist
ROOF/GRAVITY TANK	Does not Exist
STAIRS/RAMPS: EXTERIOR	Inspected
BUILDING CHEEK/FLANK WALLS	Inspected
Condition	3 - Fair
Deficiency	CAST IN PLACE CONCRETE: CRACKS/SPALLING - MAJOR
Roof Plan reference

Deficiency Quantity	10
Quantity Uom	S.F.
Potential Action	REPLACE
Urgency of Action	PRIORITY 4
Purpose of Action	LEVEL 2
Deficiency Photo1

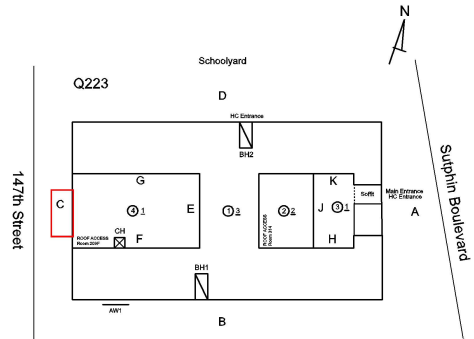
Question	Response
EXTERIOR	
STAIRS/RAMPS: EXTERIOR	
RAILINGS	Inspected
Condition	2 - Between Good and Fair
Deficiency	No deficiencies recorded
STAIRS/RAMPS	Inspected
Condition	3 - Fair
Deficiency	CONCRETE: CRACKS/SPALLING - MINOR
Roof Plan reference

Deficiency Quantity	20
Quantity Uom	S.F.
Potential Action	REPAIR
Urgency of Action	PRIORITY 3
Purpose of Action	LEVEL 2
Deficiency Photo1

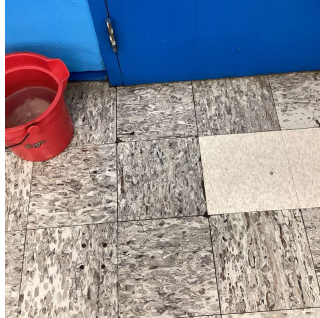
Question	Response
INTERIOR	
CAFETERIA	
Floor Finish	
Urgency of Action	PRIORITY 3
Purpose of Action	LEVEL 2
Deficiency Photo1

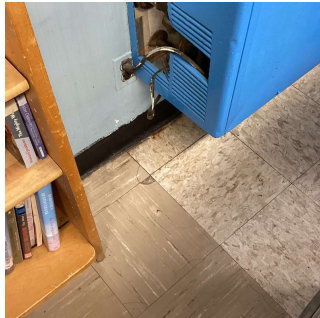
Near Kitchen
Violations	No violations recorded.
Instance on 1st Floor - Staff (750 SF)	Inspected
Condition	2 - Between Good and Fair
Deficiency	VINYL TILES: BROKEN/DETERIORATED/MISSING TILES
Deficiency Location/Instance	Near Drinking Fountain, Near Windows
Deficiency Quantity	15
Quantity Uom	S.F.
Potential Action	REPLACE
Urgency of Action	PRIORITY 3
Purpose of Action	LEVEL 2
Deficiency Photo1

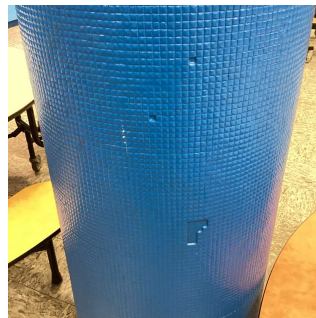
CERAMIC TILE: BROKEN/ MISSING
Columns at Center
10
S.F.
REPLACE
PRIORITY 3
LEVEL 2

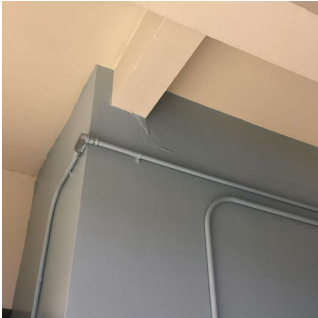
Question	Response
INTERIOR	
CAFETERIA	
Walls	
Violations	Columns at Center No violations recorded.
Instance on 1st Floor - Staff (750 SF)	Inspected
Condition	2 - Between Good and Fair
Deficiency	PLASTER: CRACKS/SPALLING
Deficiency Location/Instance	Near Entrance from Kitchen, Near Windows
Deficiency Quantity	20
Quantity Uom	S.F.
Potential Action	REPLACE
Urgency of Action	PRIORITY 3
Purpose of Action	LEVEL 2
Deficiency Photo1

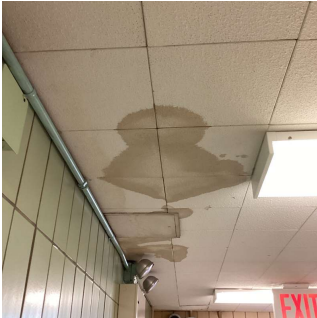
Question	Response
INTERIOR	
CLASSROOMS/CORRIDORS/ADMIN SPACES	
Ceiling	
Deficiency	ACOUSTIC TILES ON PLASTER: DAMAGED/MISSING
Deficiency Location/Instance	Corridor near Rooms 115, 130, 207, 312, 318, and others
Deficiency Quantity	180
Quantity Uom	S.F.
Potential Action	REPLACE
Urgency of Action	PRIORITY 3
Purpose of Action	LEVEL 2
Deficiency Photo1

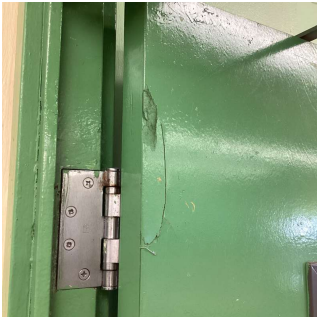
Violations	Corridor near Room 115 No violations recorded.
Door(s)	Inspected
Condition	5 - Poor
Deficiency	WOOD: DETERIORATED DOOR
Deficiency Location/Instance	Rooms 115, 123, 300A, 300D, 304, 313A
Deficiency Quantity	6
Quantity Uom	EACH
Potential Action	MAINTENANCE
Urgency of Action	PRIORITY 3
Purpose of Action	LEVEL 2
Deficiency Photo1

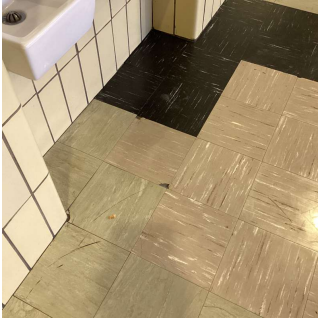
Question	Response
INTERIOR	
GYMNASIUM	
Floor Finish	
Instance on 1st Floor	Inspected
Condition	2 - Between Good and Fair
Deficiency	VINYL TILES: BROKEN/DETERIORATED/MISSING TILES
Deficiency Location/Instance	Near Drinking Fountain, Left Side
Deficiency Quantity	20
Quantity Uom	S.F.
Potential Action	REPLACE
Urgency of Action	PRIORITY 3
Purpose of Action	LEVEL 2
Deficiency Photo1

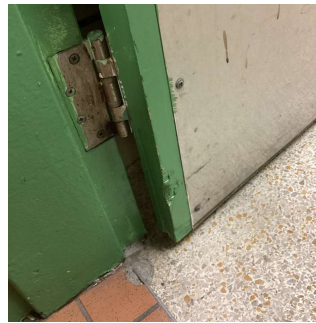
Violations	Near Entrance from Student Cafeteria No violations recorded.
Door(s)	
Instance on 1st Floor	Inspected
Condition	3 - Fair
Deficiency	WOOD: DETERIORATED DOOR
Deficiency Location/Instance	Exit 7 Vestibule
Deficiency Quantity	1

Quantity Uom	EACH
Potential Action	MAINTENANCE
Urgency of Action	PRIORITY 3
Purpose of Action	LEVEL 2

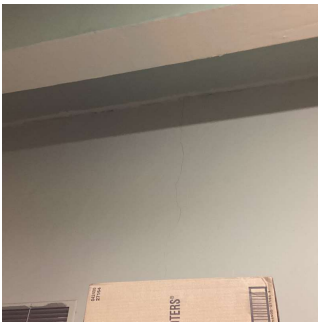
Question	Response
INTERIOR	
KITCHEN	
Walls	
Instance on 1st Floor	Inspected
Condition	2 - Between Good and Fair
Deficiency	PLASTER: CRACKS/SPALLING
Deficiency Location/Instance	Storage Room
Deficiency Quantity	10
Quantity Uom	S.F.
Potential Action	REPLACE
Urgency of Action	PRIORITY 3
Purpose of Action	LEVEL 2
Deficiency Photo1

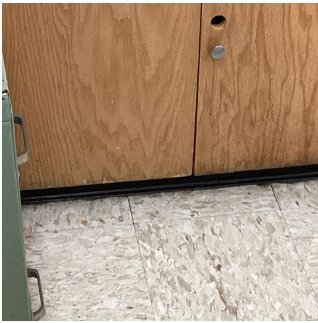
Violations	Storage Room No violations recorded.
LIBRARY	
Instance on Room 207	Inspected
Condition	2 - Between Good and Fair
Deficiency	SINK/STORAGE CABINET - DAMAGED/DETERIORATED
Deficiency Location/Instance	Near Entrance
Deficiency Quantity	10
Quantity Uom	L.F.
Potential Action	REPLACE
Urgency of Action	PRIORITY 3
Purpose of Action	LEVEL 2
Deficiency Photo1

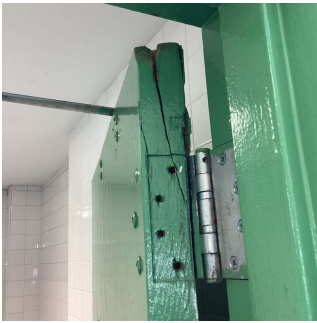
Question	Response
INTERIOR	
TOILET ROOMS - STAFF	Inspected
Walls	Inspected
Violations	Kitchen Office No violations recorded.
TOILET ROOMS - STUDENTS	Inspected
Ceiling	Inspected
Condition	2 - Between Good and Fair
Deficiency	No deficiencies recorded
Door(s)	Inspected
Condition	5 - Poor
Deficiency	METAL: DETERIORATED DOOR AND FRAME
Deficiency Location/Instance	In Room 129/130
Deficiency Quantity	1
Quantity Uom	EACH
Potential Action	MAINTENANCE
Urgency of Action	PRIORITY 3
Purpose of Action	LEVEL 2
Deficiency Photo1	No photo recorded
Violations	No violations recorded.
Deficiency	WOOD: DETERIORATED DOOR
Deficiency Location/Instance	Rooms 200 Boys, 203 Girls, 213 Boys, 303 Boys, 316, and others
Deficiency Quantity	14
Quantity Uom	EACH
Potential Action	MAINTENANCE
Urgency of Action	PRIORITY 3
Purpose of Action	LEVEL 2
Deficiency Photo1

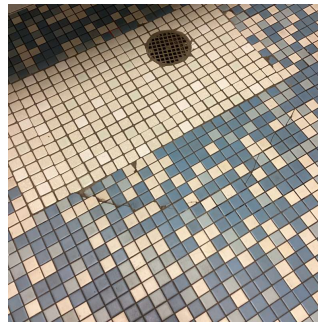
Deficiency	CERAMIC TILE: DETERIORATED SUBSTRATE
Deficiency Location/Instance	Room 309 Boys
Deficiency Quantity	10
Quantity Uom	S.F.
Potential Action	REPLACE
Urgency of Action	PRIORITY 3
Purpose of Action	LEVEL 2

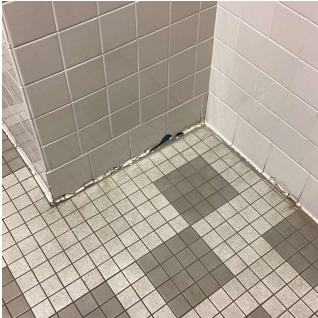
Question	Response
INTERIOR	
TOILET ROOMS - STUDENTS	
Stalls	Inspected
	Room 200 Girls
Violations	No violations recorded.
Walls	Inspected
Condition	2 - Between Good and Fair
Deficiency	CERAMIC TILE: BROKEN/ MISSING
Deficiency Location/Instance	Rooms 200 Boys, 203 Girls, 209 Boys, 313 Girls, 318, and others
Deficiency Quantity	120
Quantity Uom	S.F.
Potential Action	REPLACE
Urgency of Action	PRIORITY 3
Purpose of Action	LEVEL 2
Deficiency Photo1

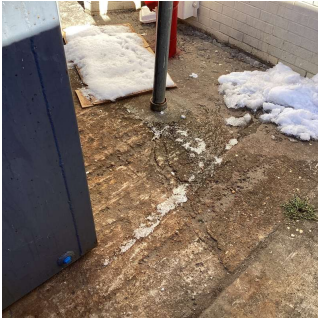
Room 318
Violations	No violations recorded.
LIFE SAFETY	
F.D. HOLDING AREA	Inspected
Condition	2 - Between Good and Fair
Deficiency	No deficiencies recorded
STEEL STAIRS	
	Does not Exist
SITE	
CONTAINERIZATION	Inspected
Condition	4 - Between Fair and Poor
Deficiency	CONCRETE PAD DAMAGED
Deficiency Location/Instance	147th Street
Deficiency Quantity	100
Quantity Uom	S.F.
Potential Action	REPAIR
Urgency of Action	PRIORITY 3
Purpose of Action	LEVEL 2
Deficiency Photo1

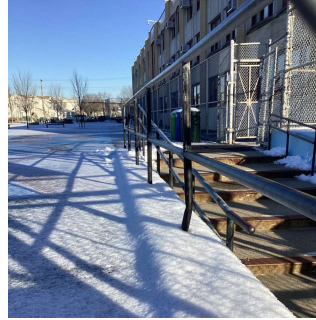
Schoolyard Near 147th Street
No violations recorded.

FENCES	Inspected
Condition	4 - Between Fair and Poor
Deficiency	ALUMINUM: DAMAGED/DETERIORATED
Deficiency Location/Instance	Schoolyard near 147th Street
Deficiency Quantity	40
Quantity Uom	S.F.
Potential Action	REPLACE
Urgency of Action	PRIORITY 3
Purpose of Action	LEVEL 2

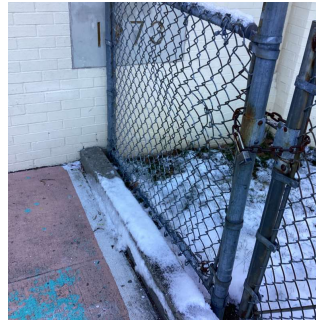
Sutphin Boulevard
No violations recorded.

CHAIN LINK: DAMAGED/DETERIORATED

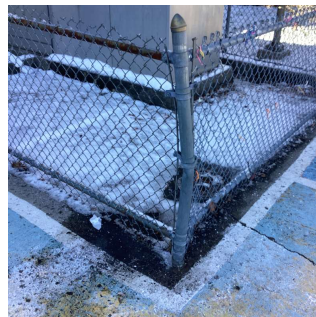
Sutphin Boulevard
No violations recorded.

CHAIN LINK: DAMAGED POST/RAIL

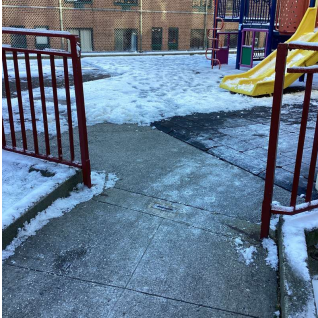
Question	Response
SITE	
PLAYGROUNDS	
Fence	
Instance on South Side of Building	Inspected
Condition	2 - Between Good and Fair
Deficiency	WROUGHT IRON: MISSING SECTIONS
Deficiency Location/Instance	Entrance from Sutphin Boulevard
Deficiency Quantity	40
Quantity Uom	S.F.
Potential Action	REPLACE
Urgency of Action	PRIORITY 3
Purpose of Action	LEVEL 2
Deficiency Photo1

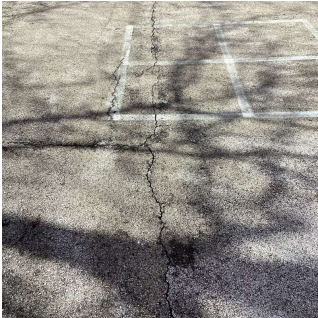
Violations	Entrance from Sutphin Boulevard No violations recorded.
Pavement	
Instance on South Side of Building	Inspected
Condition	3 - Fair
Deficiency	ASPHALT: CRACKS - MAJOR
Deficiency Location/Instance	Near Exit 5
Deficiency Quantity	200
Quantity Uom	S.F.
Potential Action	REPLACE
Urgency of Action	PRIORITY 3
Purpose of Action	LEVEL 2
Deficiency Photo1

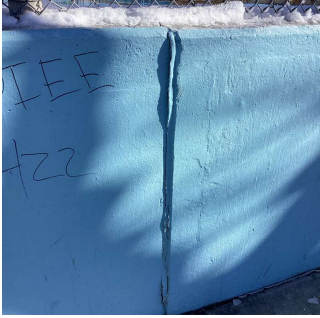
Question	Response
SITE	
PLAYGROUNDS	
Play Equipment	
Deficiency	No deficiencies recorded
Safety Surfacing	
Instance on Schoolyard	Inaccessible
Instance on South Side of Building	Inaccessible
Unpaved Area	
Instance on Schoolyard	Does not Exist
Instance on South Side of Building	Does not Exist
PLAYING SURFACE	
Playing Field	Inspected
Instance on Schoolyard	Inaccessible
Running Track	
	Does not Exist
RETAINING WALLS	
Are there any Retaining Walls 6' OR higher facing public street/sidewalk?	Inspected
	No
Condition	3 - Fair
Deficiency	CAST IN PLACE CONCRETE: DETERIORATED CONTROL/EXPANSION JOINT
Deficiency Location/Instance	147th Street, Sutphin Boulevard
Deficiency Quantity	20
Quantity Uom	L.F.
Potential Action	REPLACE
Urgency of Action	PRIORITY 3
Purpose of Action	LEVEL 2
Deficiency Photo1

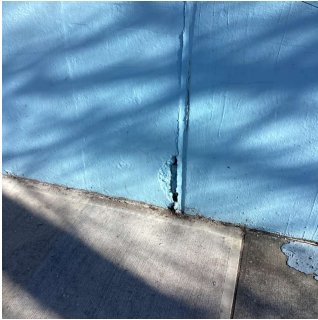
147th Street
Violations	No violations recorded.
Deficiency	CAST IN PLACE CONCRETE: CRACKS/SPALLING - MAJOR
Deficiency Location/Instance	147th Street, Sutphin Boulevard

Deficiency Quantity	30
Quantity Uom	S.F.
Potential Action	REPLACE
Urgency of Action	PRIORITY 3
Purpose of Action	LEVEL 2

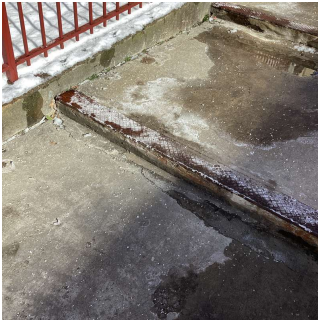
Violations	South side of Building No violations recorded.
Stairs/ramps	Inspected
Condition	3 - Fair
Deficiency	CAST IN PLACE CONCRETE: CRACKS/SPALLING - MAJOR
Deficiency Location/Instance	South side of Building
Deficiency Quantity	50
Quantity Uom	S.F.
Potential Action	REPLACE
Urgency of Action	PRIORITY 3
Purpose of Action	LEVEL 2
Deficiency Photo1
