**NYC Department of Education**  
**Building Condition Assessment Survey 2023 - 2024**

Architectural Inspection

**Asset:** P.S. 225 - QUEENS, 1-90 BEACH 110 STREET, New York, 11694

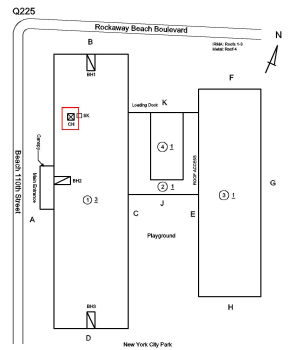
Roof Plan reference

**BRICK: DETERIORATED LADDER**

Deficiency Quantity

1

REPLACE

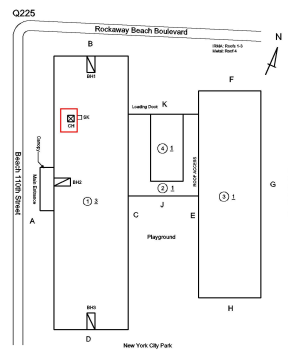
Roof Plan reference

**BRICK: DETERIORATED JOINTS**

Deficiency Quantity

30

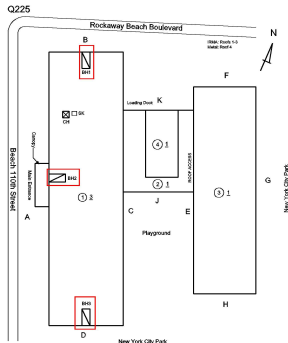
Violations	Roof 1 No violations recorded.
<b>COPING</b>	
Condition	Inspected 3 - Fair
Deficiency	CAST STONE: DETERIORATED TRANSVERSE JOINTS
Roof Plan reference

Deficiency Quantity	50
Quantity Uom	L.F.
Potential Action	MAINTENANCE
Urgency of Action	PRIORITY 3
Purpose of Action	LEVEL 2
Deficiency Photo1

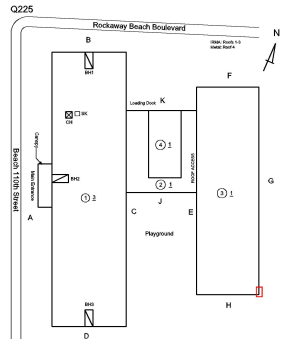
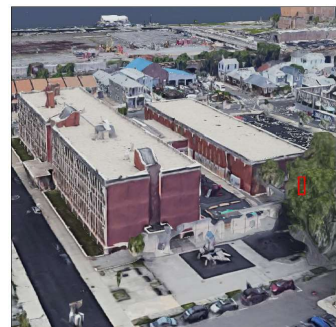
Question	Response
<b>EXTERIOR</b>	
<b>DOORS</b>	
<b>LINTELS</b>	Inspected
Condition	2 - Between Good and Fair
Deficiency	No deficiencies recorded
<b>TRANSOM/SIDE LIGHT</b>	Inspected
Condition	2 - Between Good and Fair
Deficiency	No deficiencies recorded
<b>EXTERIOR WALLS</b>	Inspected
Material Type(s)	Masonry, Concrete
Replacement Quantity	23,000
Replacement Uom	S.F.
Instance on All Facades	Inspected
Instance Condition	5 - Poor
Instance Quantity	23,000
Instance Quantity Uom	S.F.
Deficiency	<b>BRICK: CRACKS/DISPLACED/SPALLED BRICK AT BUILDING CORNERS</b>
Roof Plan reference

Deficiency Quantity	10
Quantity Uom	S.F.
Potential Action	REMOVE AND REBUILD
Urgency of Action	PRIORITY 4
Purpose of Action	LEVEL 2

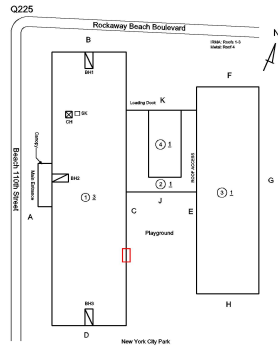
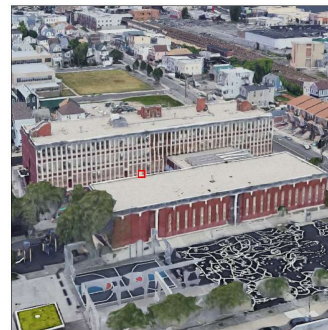
Roof Plan reference

**BRICK: DETERIORATED JOINTS**

Deficiency Quantity

10

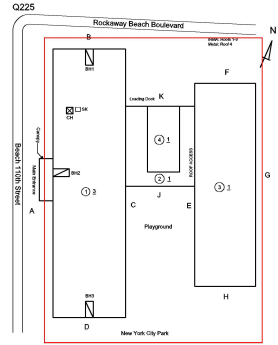
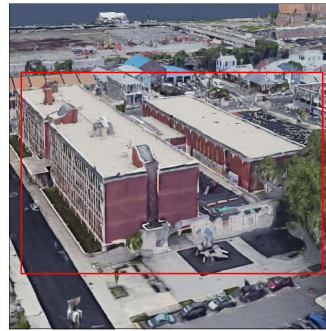
Roof Plan reference

**BRICK: DETERIORATED JOINTS**

Deficiency Quantity

5,000

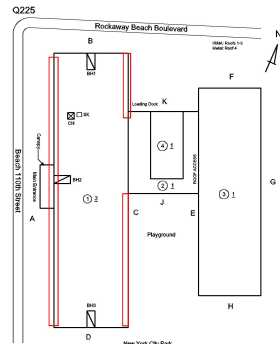
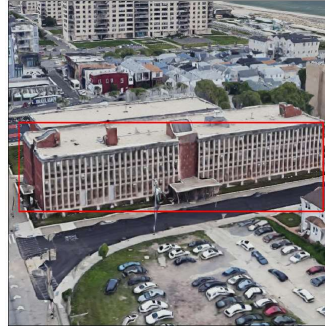
Roof Plan reference

**BRICK: WATER INFILTRATION IN INSTRUCTIONAL SPACE**

Deficiency Quantity

3,600

REPAIR

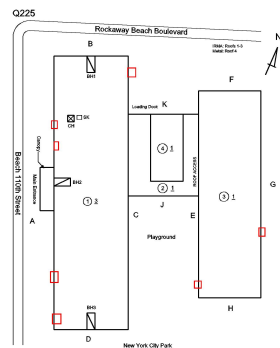
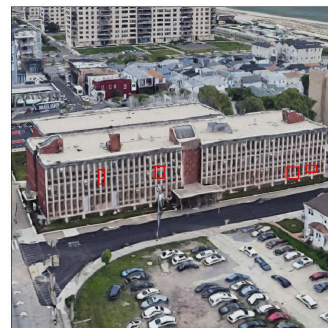
Roof Plan reference

**CAST IN PLACE / PRE-CAST CONCRETE: MINOR  
CRACKS/SPALLING**

Deficiency Quantity

30

S.F.  
REPAIR  
PRIORITY 3  
LEVEL 2

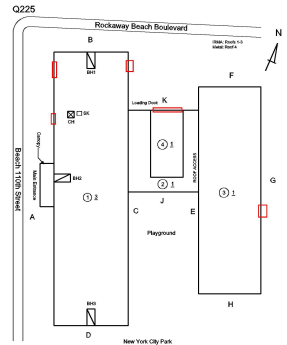
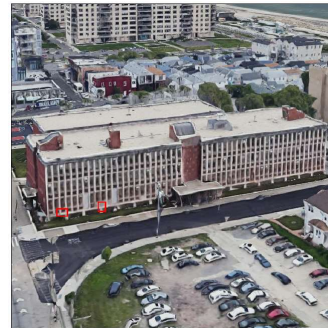
Roof Plan reference

**CAST IN PLACE / PRE-CAST CONCRETE: MAJOR  
CRACKS/SPALLING**

50  
S.F.  
REPLACE  
PRIORITY 4  
LEVEL 2

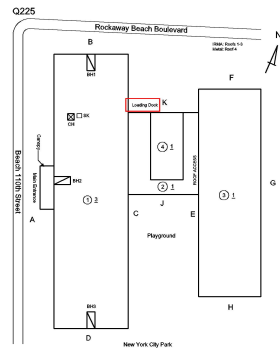
Roof Plan reference

**DETERIORATED CONCRETE PLATFORM WITH CRACKED, SPALLED CONCRETE OR EXPOSED REINFORCING**

Deficiency Quantity

30

REPAIR

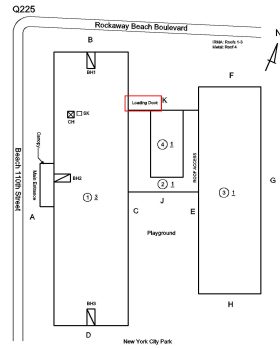
Roof Plan reference

**LOADING DOCK**

5  
 EACH  
 REPLACE  
 PRIORITY 4  
 LEVEL 2

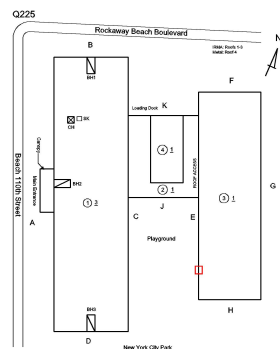
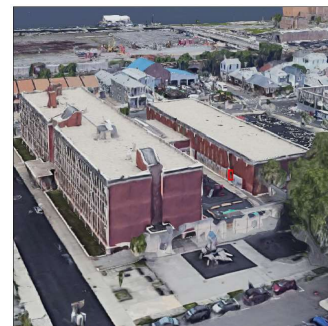
Roof Plan reference

BROKEN/ DENTED BLADES

Question	Response
<b>EXTERIOR</b>	
<b>LOUVER</b>	
Deficiency Quantity	10
Quantity Uom	S.F.
Potential Action	REPLACE
Urgency of Action	PRIORITY 4
Purpose of Action	LEVEL 2
Deficiency Photo1

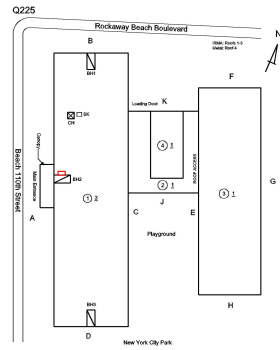
Roof Plan reference

DAMAGED/MISSING

Deficiency Quantity

10

REPLACE

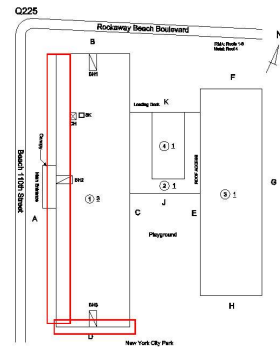
Roof Plan reference

RAILINGS/PANELS: DETERIORATED, MAJOR RUSTING

Deficiency Quantity

120

REPLACE

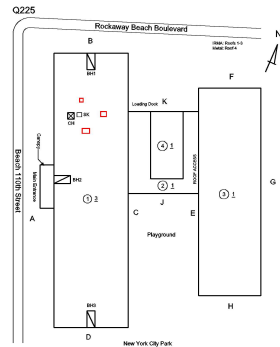
Roof Plan reference

IRMA: ROOFING: DAMAGED INSULATION

Deficiency Quantity

20

REPLACE

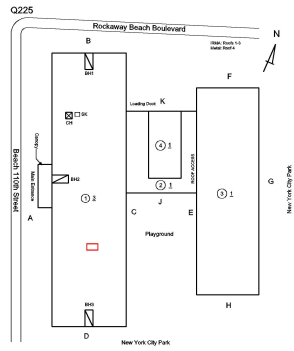
Question	Response
<b>EXTERIOR</b>	
<b>ROOF</b>	
<b>Roofing</b>	
<b>ROOFING</b>	Inspected
	Roof 1
Violations	No violations recorded.
Deficiency	IRMA: ROOFING: MAJOR ACTIVE ROOF LEAKS IN INSTRUCTIONAL SPACE
Roof Plan reference

Deficiency Quantity	100
Quantity Uom	S.F.
Potential Action	REPLACE ROOFING WITHOUT MAJOR EQUIPMENT REMOVAL
Urgency of Action	PRIORITY 5
Purpose of Action	LEVEL 2
Deficiency Photo1

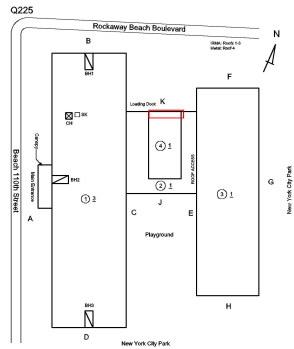
Question	Response
<b>EXTERIOR</b>	
<b>ROOF</b>	
<b>Roofing</b>	
<b>ROOFING</b>	
Installation Year	2006
Source of Installation	Custodial Staff
Deficiency	METAL: ROOFING: MAJOR ACTIVE ROOF LEAKS IN INSTRUCTIONAL SPACE
Roof Plan reference

Deficiency Quantity	100
Quantity Uom	S.F.
Potential Action	REPLACE
Urgency of Action	PRIORITY 5
Purpose of Action	LEVEL 2
Deficiency Photo1

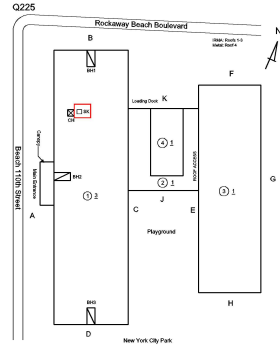
Roof Plan reference

**SHAFT VENTS DAMAGED**

Deficiency Quantity

1

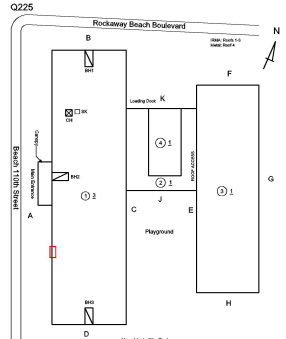
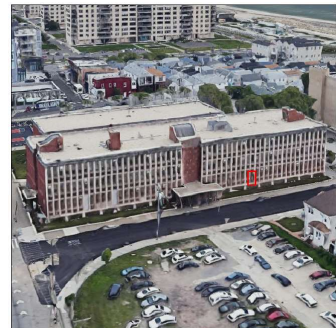
Question	Response
<b>EXTERIOR</b>	
<b>WINDOWS</b>	
Replacement Uom	S.F.
<b>EXTERIOR GUARDS</b>	
Condition	3 - Fair
Deficiency	RUST - MAJOR
Roof Plan reference

Deficiency Quantity	30
Quantity Uom	S.F.
Potential Action	REPLACE
Urgency of Action	PRIORITY 4
Purpose of Action	LEVEL 2
Deficiency Photo1

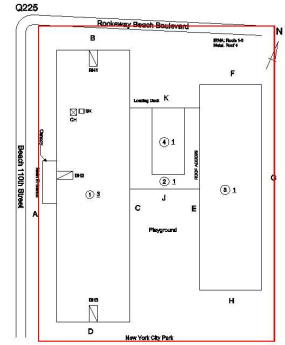
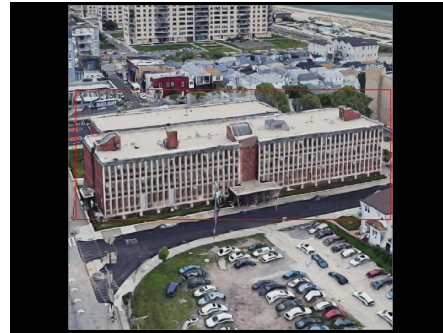
Are these windows insulated	No
Installation Year	1996
Source of Installation	Custodial Staff
Deficiency	ALUMINUM - DOUBLE HUNG: AIR/WATER INFILTRATION
Roof Plan reference

Deficiency Quantity	1,500
Quantity Uom	L.F.
Potential Action	REPLACE TRIM, SILLS OR WEATHERSTRIPPING
Urgency of Action	PRIORITY 5
Purpose of Action	LEVEL 2
Deficiency Photo1	No photo recorded
Violations	No violations recorded.

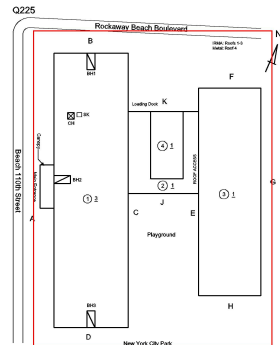
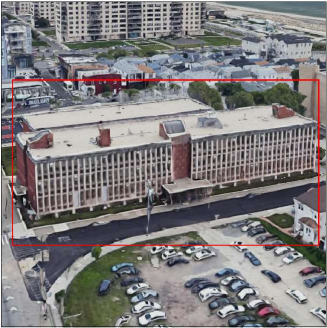
Roof Plan reference

Deficiency	ALUMINUM - DOUBLE HUNG: INOPERABLE BALANCE
------------	--

Deficiency Quantity	30
Quantity Uom	EACH
Potential Action	REPLACE BALANCES
Urgency of Action	PRIORITY 3
Purpose of Action	LEVEL 2
Deficiency Photo1	No photo recorded
Violations	No violations recorded.
<b>INTERIOR</b>	Inspected
<b>POOLS</b>	Does not Exist
<b>STRUCTURAL</b>	Inspected
<b>COLUMNS/BEAMS/BEARING WALLS</b>	Inspected
Condition	2 - Between Good and Fair
Deficiency	No deficiencies recorded
<b>FLOOR STRUCTURE</b>	Inspected
Condition	2 - Between Good and Fair
Deficiency	No deficiencies recorded
<b>FOUNDATION WALLS</b>	Inspected
Material Type(s)	Concrete
Condition	4 - Between Fair and Poor
Deficiency	CONCRETE: CRACKED/SPALLED/REINFORCEMENT EXPOSED
Deficiency Location/Instance	Basement - Gas Meter Room, Paint Storage Room
Deficiency Quantity	20
Quantity Uom	S.F.
Potential Action	REPAIR
Urgency of Action	PRIORITY 3
Purpose of Action	LEVEL 5

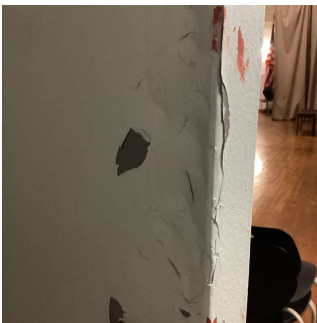
Stage Room Left side
Violations	No violations recorded.
<b>Door(s)</b>	
Instance on 1st Floor (411 Seats)	Inspected
Condition	3 - Fair
Deficiency	METAL: DETERIORATED DOOR
Deficiency Location/Instance	Stage Room Left side
Deficiency Quantity	1
Quantity Uom	EACH
Potential Action	MAINTENANCE
Urgency of Action	PRIORITY 3
Purpose of Action	LEVEL 2
Deficiency Photo1

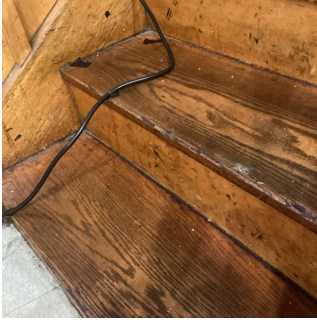
Near Seat R/6
Violations	No violations recorded.
<b>Sliding-folding Partition</b>	
Instance on 1st Floor (411 Seats)	Does not Exist
<b>Stage</b>	
Instance on 1st Floor (411 Seats)	Inspected
<b>Stage</b>	Inspected
Instance on 1st Floor (411 Seats)	Inspected
Condition	3 - Fair
Deficiency	DAMAGED STEPS
Deficiency Location/Instance	Right and Left Side
Deficiency Quantity	30
Quantity Uom	S.F.
Potential Action	REPLACE
Urgency of Action	PRIORITY 3
Purpose of Action	LEVEL 2
Deficiency Photo1

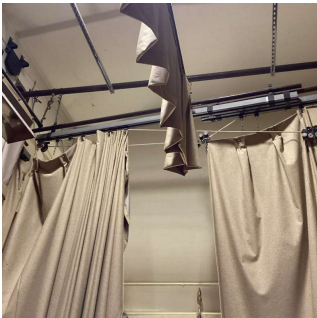
Question	Response
<b>INTERIOR</b>	
<b>AUDITORIUM</b>	
<b>Stage</b>	
<b>Stage Curtain Rigging</b>	Inspected
Violations	No violations recorded.
<b>Stage Curtains</b>	Inspected
Instance on 1st Floor (411 Seats)	Inspected
Condition	4 - Between Fair and Poor
Deficiency	WORN/DETERIORATED
Deficiency Location/Instance	Lateral Right Side
Deficiency Quantity	300
Quantity Uom	S.F.
Potential Action	REPLACE
Urgency of Action	PRIORITY 3
Purpose of Action	LEVEL 2
Deficiency Photo1

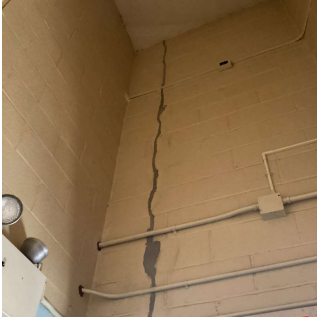
Violations	Lateral Right Side No violations recorded.
<b>Walls</b>	
Instance on 1st Floor (411 Seats)	Inspected
Condition	2 - Between Good and Fair
Deficiency	MASONRY: CRACKS/SPALLING
Deficiency Location/Instance	Near Exit 6
Deficiency Quantity	20
Quantity Uom	S.F.
Potential Action	REPLACE
Urgency of Action	PRIORITY 3
Purpose of Action	LEVEL 2
Deficiency Photo1

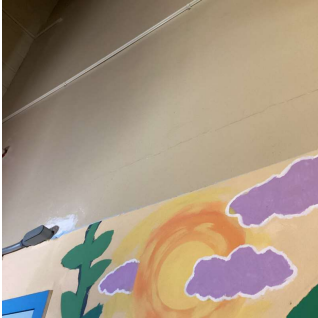
Violations	Near Exit 6 No violations recorded.
Deficiency	PLASTER: CRACKS/SPALLING
Deficiency Location/Instance	Near Entrance, Exit 6, Windows

Question	Response
<b>INTERIOR</b>	
<b>AUDITORIUM</b>	
<b>Walls</b>	
Quantity Uom	S.F.
Potential Action	REPLACE
Urgency of Action	PRIORITY 3
Purpose of Action	LEVEL 2
Deficiency Photo1

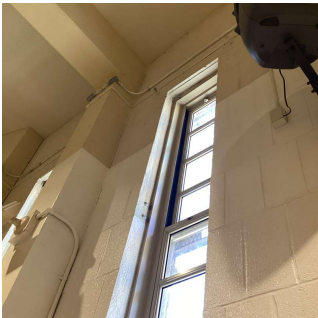
Near Exit 6
Violations	No violations recorded.
<b>Window Curtains/Shades/Blinds</b>	
Instance on 1st Floor (411 Seats)	Inspected
Condition	5 - Poor
Deficiency	WORN/DAMAGED CURTAINS
Deficiency Location/Instance	Near Seats E/1, G/1
Deficiency Quantity	40
Quantity Uom	S.F.
Potential Action	MAINTENANCE
Urgency of Action	PRIORITY 3
Purpose of Action	LEVEL 2
Deficiency Photo1

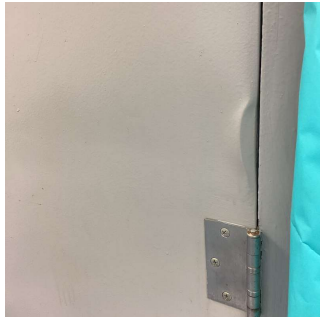
Violations	Near center No violations recorded.
<b>Door(s)</b>	
Instance on 1st Floor	Inspected
Condition	3 - Fair
Deficiency	METAL: DETERIORATED DOOR
Deficiency Location/Instance	Entrance Gymnasium
Deficiency Quantity	1
Quantity Uom	EACH

Question	Response
<b>INTERIOR</b>	
<b>CAFETERIA</b>	
<b>Door(s)</b>	
Purpose of Action	LEVEL 2
Deficiency Photo1

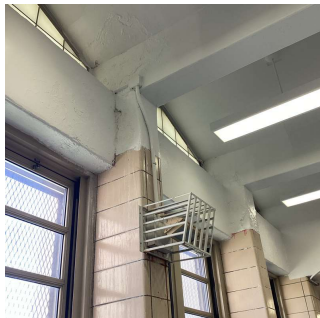
Violations	Entrance Gymnasium No violations recorded.
<b>Fixed Equipment</b>	
Instance on 1st Floor	Does not Exist
<b>Floor Finish</b>	
Instance on 1st Floor	Inspected
Condition	2 - Between Good and Fair
Deficiency	No deficiencies recorded
<b>Sliding-folding Partition</b>	
Instance on 1st Floor	Does not Exist
<b>Stage</b>	
Instance on 1st Floor	Does not Exist
<b>Walls</b>	
Instance on 1st Floor	Inspected
Condition	2 - Between Good and Fair
Deficiency	PLASTER: CRACKS/SPALLING - ACTIVE LEAK
Deficiency Location/Instance	Near Windows
Deficiency Quantity	50
Quantity Uom	S.F.
Potential Action	REPLACE
Urgency of Action	PRIORITY 5
Purpose of Action	LEVEL 2
Deficiency Photo1

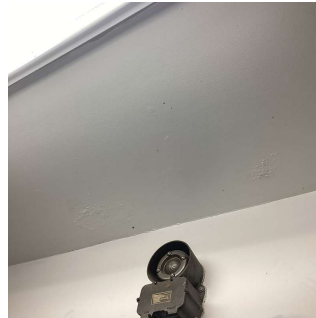
Corridor near Room 187

PLASTER: CRACKS/SPALLING

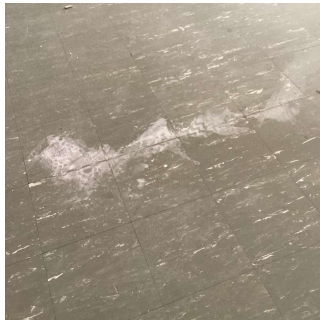
Question	Response
<b>INTERIOR</b>	
<b>CLASSROOMS/CORRIDORS/ADMIN SPACES</b>	
<b>Door(s)</b>	Inspected
	Room 234
Violations	No violations recorded.
<b>Floor Finish</b>	Inspected
Condition	2 - Between Good and Fair
Deficiency	VINYL TILES: BROKEN/DETERIORATED/MISSING TILES
Deficiency Location/Instance	Rooms 131, 212, 222, Corridor near Rooms 138, 161, 170
Deficiency Quantity	1,200
Quantity Uom	S.F.
Potential Action	REPLACE
Urgency of Action	PRIORITY 3
Purpose of Action	LEVEL 2
Deficiency Photo1

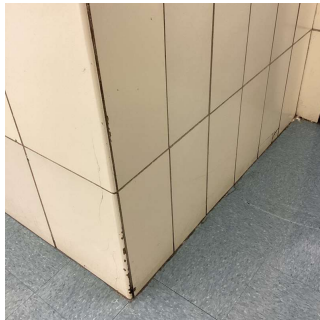
Corridor near Auditorium

Room 222
Violations	No violations recorded.
<b>Walls</b>	Inspected
Condition	2 - Between Good and Fair
Deficiency	GLAZED BLOCK: CRACKS/SPALLING
Deficiency Location/Instance	Corridor near Rooms 187, 210, 305, Corridor near Auditorium, Main Entrance, and others
Deficiency Quantity	50
Quantity Uom	S.F.
Potential Action	REPLACE
Urgency of Action	PRIORITY 3
Purpose of Action	LEVEL 2
Deficiency Photo1

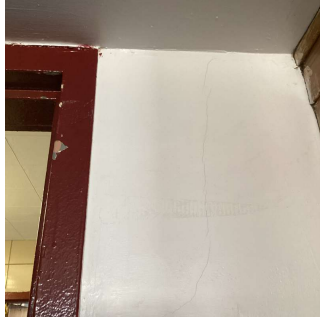
Violations	No violations recorded.
Deficiency	PLASTER: CRACKS/SPALLING
Deficiency Location/Instance	Rooms 210, 212, Corridor near Room 187
Deficiency Quantity	20
Quantity Uom	S.F.

Question	Response
<b>INTERIOR</b>	
<b>CLASSROOMS/CORRIDORS/ADMIN SPACES</b>	
<b>Walls</b>	
Potential Action	REPLACE
Urgency of Action	PRIORITY 3
Purpose of Action	LEVEL 2
Deficiency Photo1

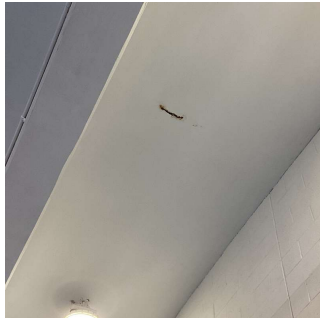
Room 212
Violations	No violations recorded.
<b>Specialties</b>	Does not Exist
<b>GYMNASIUM</b>	Inspected
Instance on 1st Floor	Inspected
<b>Ceiling</b>	
Instance on 1st Floor	Inspected
Condition	2 - Between Good and Fair
Deficiency	PLASTER: CRACKS/SPALLING - ACTIVE LEAK
Deficiency Location/Instance	Near Back wall
Deficiency Quantity	10
Quantity Uom	S.F.
Potential Action	REPLACE
Urgency of Action	PRIORITY 5
Purpose of Action	LEVEL 2
Deficiency Photo1

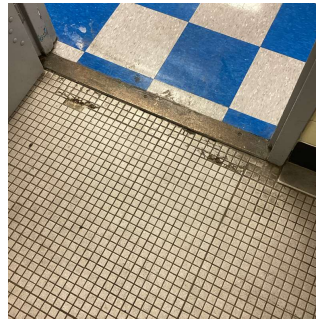
Instance on 1st Floor	Inspected
Condition	2 - Between Good and Fair
Deficiency	CERAMIC TILE: BROKEN/MISSING TILES
Deficiency Location/Instance	Storage Room / Mop Room, Serving Area, Near Center, Sink Area
Deficiency Quantity	30
Quantity Uom	S.F.
Potential Action	REPLACE
Urgency of Action	PRIORITY 3
Purpose of Action	LEVEL 2
Deficiency Photo1

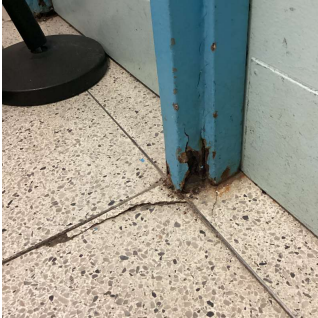
Question	Response
<b>INTERIOR</b>	
<b>STAIRS/RAMPS: INTERIOR</b>	
<b>Door(s)</b>	
Quantity Uom	EACH
Potential Action	MAINTENANCE
Urgency of Action	PRIORITY 3
Purpose of Action	LEVEL 2
Deficiency Photo1

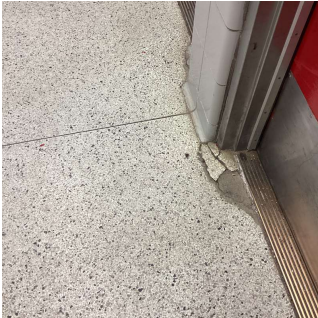
Violations	Stair C/Vestibule No violations recorded.
<b>Partition</b>	Does not Exist
<b>Railings</b>	Inspected
Condition	2 - Between Good and Fair
Deficiency	No deficiencies recorded
<b>Stairs and Landings</b>	Inspected
Condition	5 - Poor
Deficiency	TERRAZZO: CRACKS
Deficiency Location/Instance	Stair B/Vestibule, 1, 2, C/1, 2, and others
Deficiency Quantity	80
Quantity Uom	S.F.
Potential Action	REPLACE
Urgency of Action	PRIORITY 3
Purpose of Action	LEVEL 2
Deficiency Photo1

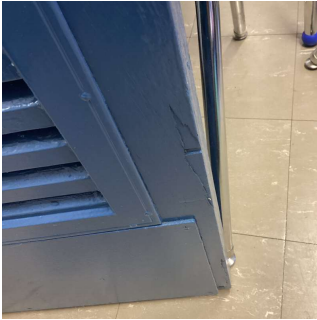
Question	Response
<b>INTERIOR</b>	
<b>TOILET ROOMS - STAFF</b>	
<b>Door(s)</b>	
Deficiency Photo1	 
Violations	Room 125 No violations recorded.
Deficiency	WOOD: DETERIORATED DOOR
Deficiency Location/Instance	Rooms 107, 125, inside Principal office
Deficiency Quantity	3
Quantity Uom	EACH
Potential Action	MAINTENANCE
Urgency of Action	PRIORITY 3
Purpose of Action	LEVEL 2
Deficiency Photo1

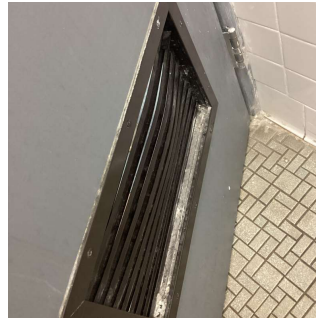
Room 160

METAL: DAMAGED LOUVER

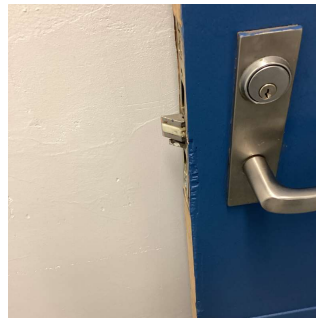
Room 160

WOOD: DETERIORATED DOOR

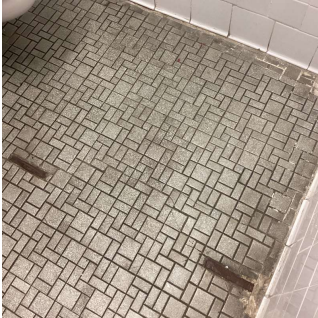
Question	Response
<b>INTERIOR</b>	
<b>TOILET ROOMS - STUDENTS</b>	
<b>Floor Finish</b>	Inspected
Condition	2 - Between Good and Fair
Deficiency	CERAMIC TILE: BROKEN/MISSING TILES
Deficiency Location/Instance	Rooms 158, 160
Deficiency Quantity	20
Quantity Uom	S.F.
Potential Action	REPLACE
Urgency of Action	PRIORITY 3
Purpose of Action	LEVEL 2
Deficiency Photo1

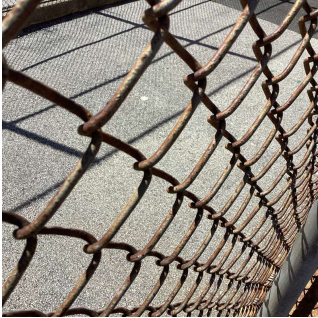
Question	Response
<b>SITE</b>	
<b>FENCES</b>	
Violations	No violations recorded.
Deficiency	CHAIN LINK: RUST - MAJOR
Deficiency Location/Instance	Near NYC Park
Deficiency Quantity	500
Quantity Uom	S.F.
Potential Action	REPLACE
Urgency of Action	PRIORITY 3
Purpose of Action	LEVEL 2
Deficiency Photo1

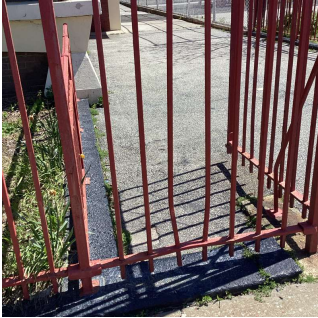
Violations	Near NYC Park No violations recorded.
Deficiency	WROUGHT IRON: DAMAGED/DETERIORATED
Deficiency Location/Instance	Beach 110 Street
Deficiency Quantity	160
Quantity Uom	S.F.
Potential Action	REPLACE
Urgency of Action	PRIORITY 3
Purpose of Action	LEVEL 2
Deficiency Photo1

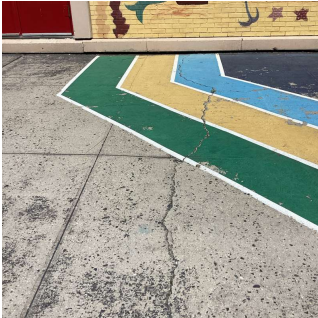
Question	Response
<b>SITE</b>	
<b>PAVING</b>	
<b>Student Use</b>	
<b>Asphalt</b>	
Purpose of Action	LEVEL 2
Deficiency Photo1	 
Violations	Near Play Equipment No violations recorded.
<b>Concrete</b>	Inspected
Condition	3 - Fair
Deficiency	DAMAGED/DETERIORATED/MISSING SECTIONS
Deficiency Location/Instance	Near Exit 4
Deficiency Quantity	200
Quantity Uom	S.F.
Potential Action	REPLACE
Urgency of Action	PRIORITY 3
Purpose of Action	LEVEL 2
Deficiency Photo1

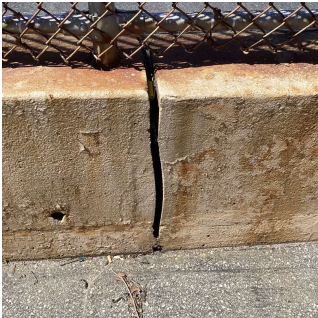
Question	Response
<b>SITE</b>	
<b>PLAYGROUNDS</b>	Inspected
<b>Unpaved Area</b>	
Instance on Schoolyard	Does not Exist
<b>PLAYING SURFACE</b>	Does not Exist
<b>RETAINING WALLS</b>	Inspected
Are there any Retaining Walls 6' OR higher facing public street/sidewalk?	No
Condition	3 - Fair
Deficiency	CAST IN PLACE CONCRETE: DETERIORATED CONTROL/EXPANSION JOINT
Deficiency Location/Instance	Near NYC Park
Deficiency Quantity	20
Quantity Uom	L.F.
Potential Action	REPLACE
Urgency of Action	PRIORITY 3
Purpose of Action	LEVEL 2
Deficiency Photo1

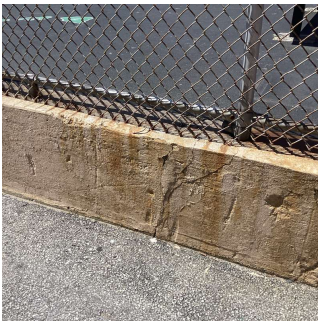
Near NYC Park
Violations	No violations recorded.
Deficiency	CAST IN PLACE CONCRETE: CRACKS/SPALLING - MAJOR
Deficiency Location/Instance	Near NYC Park
Deficiency Quantity	50
Quantity Uom	S.F.
Potential Action	REPLACE
Urgency of Action	PRIORITY 3
Purpose of Action	LEVEL 2
Deficiency Photo1

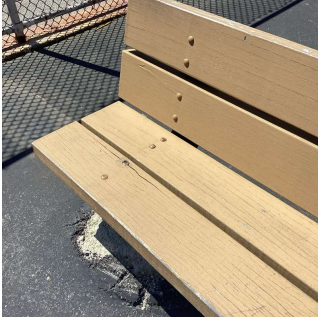
Question	Response
<b>SITE</b>	
<b>SEATING</b>	
<b>Benches</b>	
<b>Metal/Wood/Plastic</b>	
Condition	4 - Between Fair and Poor
Deficiency	DAMAGED/DETERIORATED
Deficiency Location/Instance	Near NYC Park
Deficiency Quantity	2
Quantity Uom	EACH
Potential Action	REPLACE
Urgency of Action	PRIORITY 3
Purpose of Action	LEVEL 2
Deficiency Photo1
