NYC Department of Education
Building Condition Assessment Survey 2023 - 2024

Architectural Inspection

Asset: I.S. 226 - QUEENS, 121-10 ROCKAWAY BLVD, New York, 11420

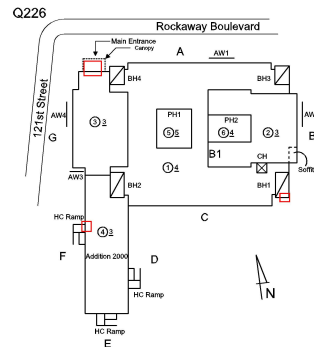
METAL: DETERIORATED DOOR AND FRAME - MAJOR DETERIORATION

8
EACH
REPLACE
PRIORITY 4
LEVEL 2

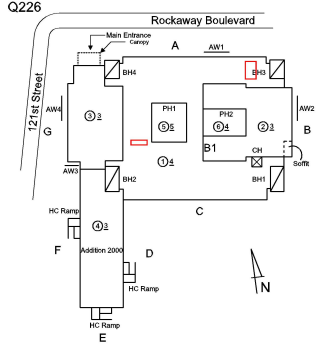
Installation Year	2012
Source of Installation	Custodial Staff
Deficiency	MODIFIED BITUMEN: ROOFING: DELAMINATION
Roof Plan reference	Q226

Deficiency Quantity	30
Quantity Uom	S.F.
Potential Action	REPLACE ROOFING WITHOUT MAJOR EQUIPMENT REMOVAL
Urgency of Action	PRIORITY 4

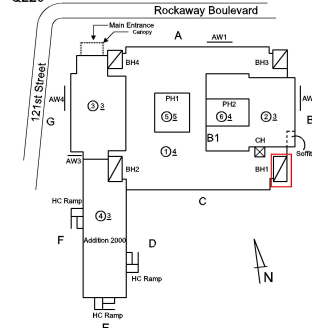
BULKHEAD/PENTHOUSE WALLS/EXTERIOR: DETERIORATED JOINTS

30

Question	Response
EXTERIOR	
ROOF	
Specialties	
BULKHEAD/PENTHOUSE	
Quantity Uom	S.F.
Potential Action	REPOINT
Urgency of Action	PRIORITY 3
Purpose of Action	LEVEL 2
Deficiency Photo1

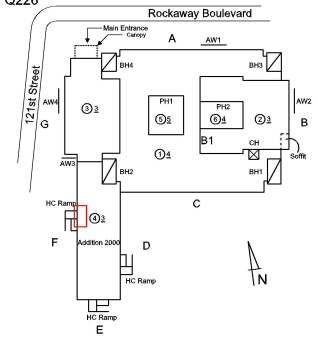
Violations	Roof 1 - Bulkhead 1 No violations recorded.
CUPOLA/ SPIRES/ TOWERS	Does not Exist
DORMER	Does not Exist
DUNNAGE STEEL	Inspected
Condition	2 - Between Good and Fair
Deficiency	No deficiencies recorded
SKYLIGHT/ROOF VENT	Does not Exist
ROOF/GRAVITY TANK	Does not Exist
STAIRS/RAMPS: EXTERIOR	Inspected
BUILDING CHEEK/FLANK WALLS	Inspected
Condition	2 - Between Good and Fair
Deficiency	No deficiencies recorded
RAILINGS	Inspected
Condition	2 - Between Good and Fair
Deficiency	No deficiencies recorded
STAIRS/RAMPS	Inspected
Condition	3 - Fair
Deficiency	CONCRETE: CRACKS/SPALLING - MINOR
Roof Plan reference	Q226

Deficiency Quantity	20
Quantity Uom	S.F.
Potential Action	REPAIR
Urgency of Action	PRIORITY 3

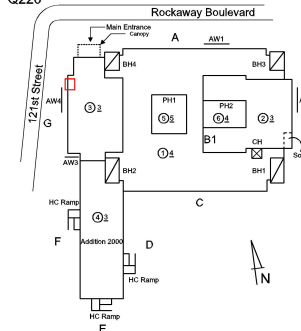
ALUMINUM - OTHER: BROKEN PANE

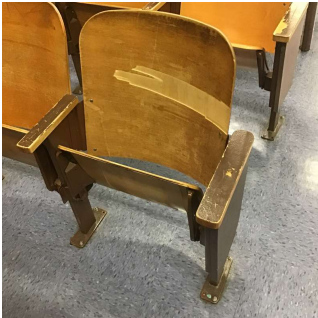
Question	Response
INTERIOR	
AUDITORIUM	
Fixed Seating	
Violations	No violations recorded.
Deficiency	DAMAGED/BROKEN/INOPERABLE
Deficiency Location/Instance	Seats A/12,108, B/2, 109, 110 and others
Deficiency Quantity	138
Quantity Uom	EACH
Potential Action	REPLACE
Urgency of Action	PRIORITY 3
Purpose of Action	LEVEL 2
Deficiency Photo1

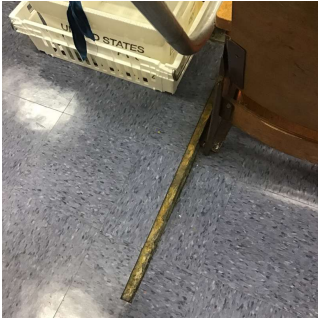
Violations	No violations recorded.
Floor Finish	
Instance on 1st Floor (634 Seats)	Inspected
Condition	2 - Between Good and Fair
Deficiency	VINYL TILES: BROKEN/DETERIORATED/MISSING TILES
Deficiency Location/Instance	Rear
Deficiency Quantity	20
Quantity Uom	S.F.
Potential Action	REPLACE
Urgency of Action	PRIORITY 3
Purpose of Action	LEVEL 2
Deficiency Photo1

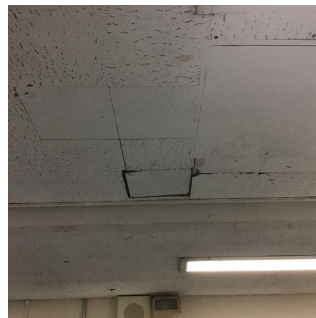
ACOUSTIC TILES ON PLASTER: DAMAGED/MISSING

REPLACE

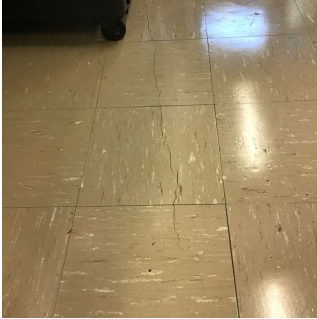
Question	Response
INTERIOR	
CAFETERIA	
Floor Finish	
Violations	No violations recorded.
Instance on 1st Floor- Staff	Inspected
Condition	2 - Between Good and Fair
Deficiency	VINYL TILES: DETERIORATED SUBSTRATE
Deficiency Location/Instance	Center
Deficiency Quantity	15
Quantity Uom	S.F.
Potential Action	REPLACE
Urgency of Action	PRIORITY 3
Purpose of Action	LEVEL 2
Deficiency Photo1

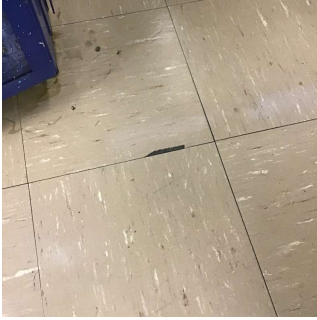
Violations	No violations recorded.
Deficiency	VINYL TILES: BROKEN/DETERIORATED/MISSING TILES
Deficiency Location/Instance	Near Window
Deficiency Quantity	10
Quantity Uom	S.F.
Potential Action	REPLACE
Urgency of Action	PRIORITY 3
Purpose of Action	LEVEL 2
Deficiency Photo1

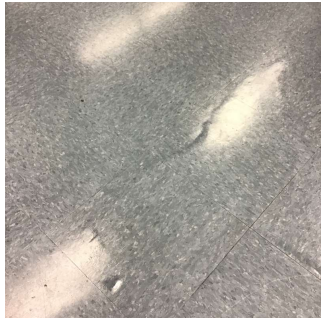
Violations	No violations recorded.
Instance on 1st Floor- Original Building - Student s	Inspected
Condition	2 - Between Good and Fair
Deficiency	VINYL TILES: DETERIORATED SUBSTRATE
Deficiency Location/Instance	Center, Near Serving Area, Right Side
Deficiency Quantity	80

Quantity Uom	S.F.
Potential Action	REPLACE
Urgency of Action	PRIORITY 3

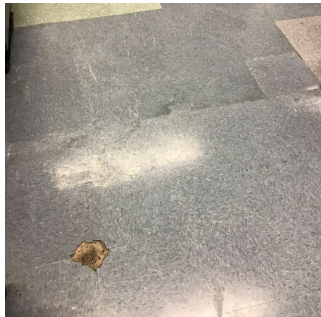
Center
Violations	No violations recorded.
Deficiency	VINYL TILES: BROKEN/DETERIORATED/MISSING TILES
Deficiency Location/Instance	Rear Right Side
Deficiency Quantity	20
Quantity Uom	S.F.
Potential Action	REPLACE
Urgency of Action	PRIORITY 3
Purpose of Action	LEVEL 2
Deficiency Photo1

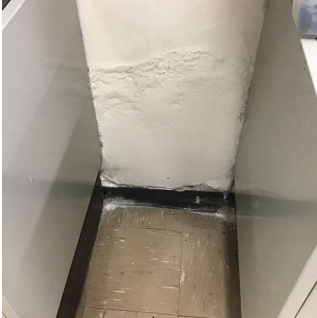
Condition	2 - Between Good and Fair
Deficiency	PLASTER: CRACKS/SPALLING
Deficiency Location/Instance	Along Windows
Deficiency Quantity	10

Question	Response
INTERIOR	
CAFETERIA	
Walls	
Quantity Uom	S.F.
Potential Action	REPLACE
Urgency of Action	PRIORITY 3
Purpose of Action	LEVEL 2
Deficiency Photo1

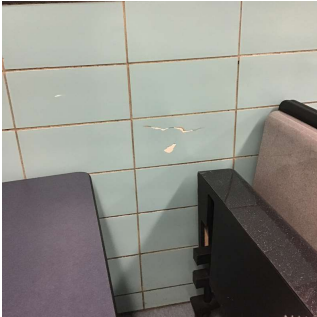
Violations	Along Windows No violations recorded.
Instance on 1st Floor- Original Building - Student s	Inspected
Condition	2 - Between Good and Fair
Deficiency	GLAZED BLOCK: CRACKS/SPALLING
Deficiency Location/Instance	Left Side, rear wall
Deficiency Quantity	20
Quantity Uom	S.F.
Potential Action	REPLACE
Urgency of Action	PRIORITY 3
Purpose of Action	LEVEL 2
Deficiency Photo1

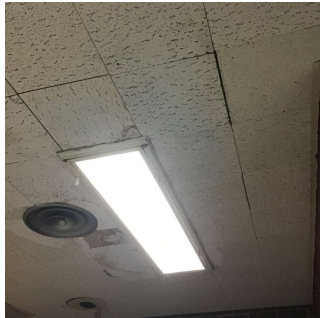
Question	Response
INTERIOR	
CLASSROOMS/CORRIDORS/ADMIN SPACES	
Ceiling	
Urgency of Action	PRIORITY 3
Purpose of Action	LEVEL 2
Deficiency Photo1	 
	Room 377
Violations	No violations recorded.
Deficiency	ACOUSTIC TILES ON PLASTER: DAMAGED/MISSING
Deficiency Location/Instance	Near Main Entrance, Corridor near Rooms 439, 449F, 215, 145 and others
Deficiency Quantity	1,300
Quantity Uom	S.F.
Potential Action	REPLACE
Urgency of Action	PRIORITY 3
Purpose of Action	LEVEL 2
Deficiency Photo1

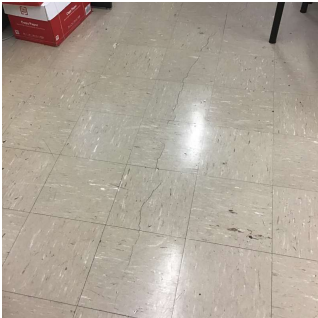
Question	Response
INTERIOR	
CLASSROOMS/CORRIDORS/ADMIN SPACES	
Floor Finish	
Violations	Main Entrance No violations recorded.
Deficiency	VINYL TILES: DETERIORATED SUBSTRATE
Deficiency Location/Instance	Room 449F, corridor near Rooms 304E, 443 445,437 and others
Deficiency Quantity	400
Quantity Uom	S.F.
Potential Action	REPLACE
Urgency of Action	PRIORITY 3
Purpose of Action	LEVEL 2
Deficiency Photo1

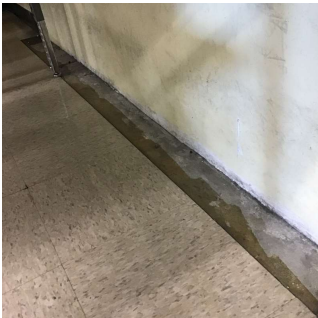
Violations	Room 449F No violations recorded.
Deficiency	VINYL TILES: BROKEN/DETERIORATED/MISSING TILES
Deficiency Location/Instance	Rooms 439, 449B, Corridor near 449J, 419, Exit A/4 and others
Deficiency Quantity	900
Quantity Uom	S.F.
Potential Action	REPLACE
Urgency of Action	PRIORITY 3
Purpose of Action	LEVEL 2
Deficiency Photo1

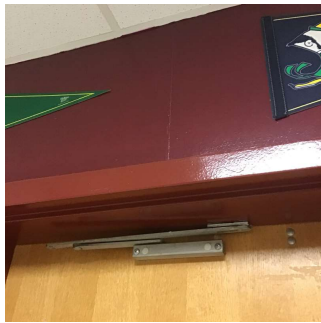
Violations	Room 439 No violations recorded.
Walls	Inspected
Condition	2 - Between Good and Fair
Deficiency	GYPSON BOARD: DETERIORATED
Deficiency Location/Instance	Corridor near Rooms 271,273, 278,

Deficiency Quantity	30
Quantity Uom	S.F.
Potential Action	REPLACE
Urgency of Action	PRIORITY 3
Purpose of Action	LEVEL 2

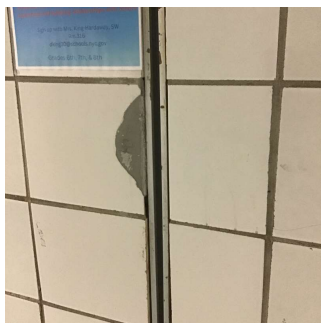
Violations	Corridor near Room 271 No violations recorded.
Deficiency	GLAZED BLOCK: CRACKS/SPALLING
Deficiency Location/Instance	Corridor near rooms 358, 316,215, 203, 141 and others
Deficiency Quantity	120
Quantity Uom	S.F.
Potential Action	REPLACE
Urgency of Action	PRIORITY 3
Purpose of Action	LEVEL 2
Deficiency Photo1

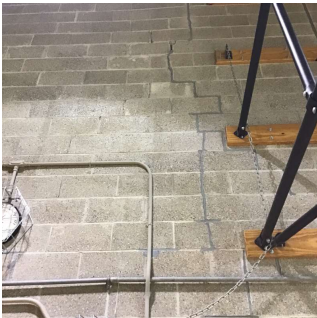
Question	Response
INTERIOR	
GYMNASIUM	
Walls	
Deficiency	GLAZED BLOCK: CRACKS/SPALLING
Deficiency Location/Instance	Front Wall
Deficiency Quantity	20
Quantity Uom	S.F.
Potential Action	REPLACE
Urgency of Action	PRIORITY 3
Purpose of Action	LEVEL 2
Deficiency Photo1	 
Violations	Front Wall No violations recorded.
Deficiency	MASONRY: CRACKS/SPALLING
Deficiency Location/Instance	200
Deficiency Quantity	200
Quantity Uom	S.F.
Potential Action	REPLACE
Urgency of Action	PRIORITY 3
Purpose of Action	LEVEL 2
Deficiency Photo1

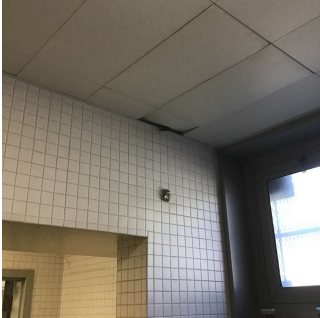
Question	Response
INTERIOR	
KITCHEN	
Ceiling	
Instance on 1st Floor Addition	Inspected
Condition	2 - Between Good and Fair
Deficiency	METAL PAN: DAMAGED/MISSING
Deficiency Location/Instance	Near serving area
Deficiency Quantity	10
Quantity Uom	S.F.
Potential Action	REPLACE
Urgency of Action	PRIORITY 3
Purpose of Action	LEVEL 2
Deficiency Photo1

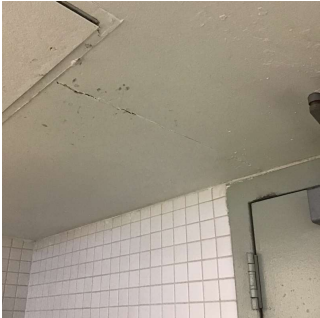
Violations	Near serving area No violations recorded.
Deficiency	GYPSUM BOARD: DAMAGED/DETERIORATED
Deficiency Location/Instance	Near Exit
Deficiency Quantity	20
Quantity Uom	S.F.
Potential Action	REPLACE
Urgency of Action	PRIORITY 3
Purpose of Action	LEVEL 2
Deficiency Photo1

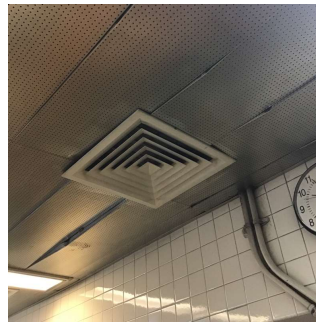
Near Entrance

Violations	Near Exit No violations recorded.
Instance on 1st Floor Original Building	Inspected
Condition	3 - Fair
Deficiency	METAL PAN: DAMAGED/MISSING
Deficiency Location/Instance	Near Entrance, Center, Corridor, near Windows
Deficiency Quantity	60
Quantity Uom	S.F.
Potential Action	REPLACE
Urgency of Action	PRIORITY 3

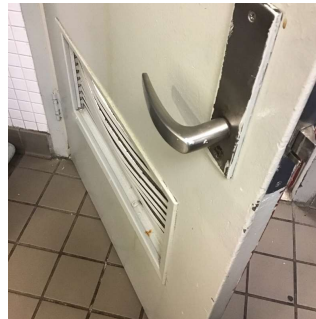
Instance on 1st Floor Addition	Inspected
Condition	3 - Fair
Deficiency	METAL: DAMAGED LOUVER
Deficiency Location/Instance	Exit
Deficiency Quantity	1
Quantity Uom	EACH
Potential Action	MAINTENANCE
Urgency of Action	PRIORITY 3
Purpose of Action	LEVEL 2
Deficiency Photo1

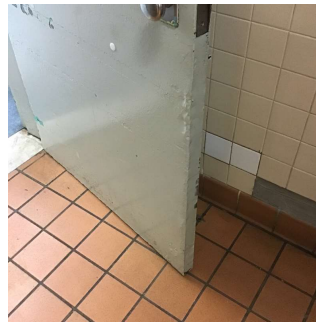
Instance on 1st Floor Original Building	Inspected
Condition	3 - Fair
Deficiency	METAL: DETERIORATED DOOR
Deficiency Location/Instance	Main Entrance
Deficiency Quantity	1
Quantity Uom	EACH
Potential Action	MAINTENANCE
Urgency of Action	PRIORITY 3
Purpose of Action	LEVEL 2

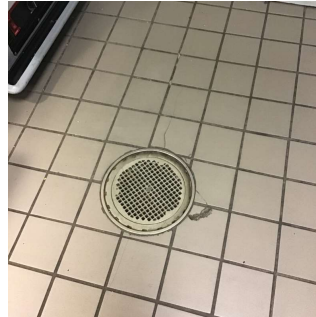
Instance on 1st Floor Addition	Inspected
Condition	2 - Between Good and Fair
Deficiency	QUARRY TILE: BROKEN/MISSING TILES
Deficiency Location/Instance	Near Exit
Deficiency Quantity	20
Quantity Uom	S.F.
Potential Action	REPLACE
Urgency of Action	PRIORITY 3
Purpose of Action	LEVEL 2
Deficiency Photo1

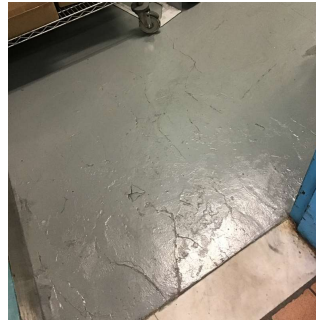
Instance on 1st Floor Original Building	Inspected
Condition	3 - Fair
Deficiency	CONCRETE: CRACKS
Deficiency Location/Instance	Storage room
Deficiency Quantity	10
Quantity Uom	S.F.
Potential Action	REPLACE
Urgency of Action	PRIORITY 3
Purpose of Action	LEVEL 2

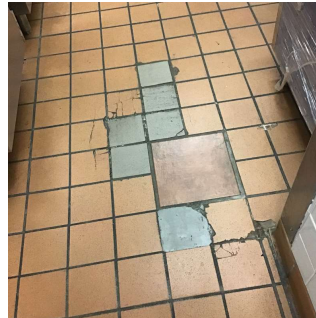
Near Corridor

QUARRY TILE: BROKEN/MISSING TILES

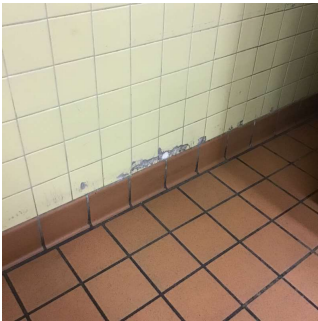
Instance on 1st Floor Original Building	Inspected
Condition	2 - Between Good and Fair
Deficiency	CERAMIC TILE: BROKEN/ MISSING
Deficiency Location/Instance	Near serving area, Exit
Deficiency Quantity	40
Quantity Uom	S.F.
Potential Action	REPLACE
Urgency of Action	PRIORITY 3
Purpose of Action	LEVEL 2

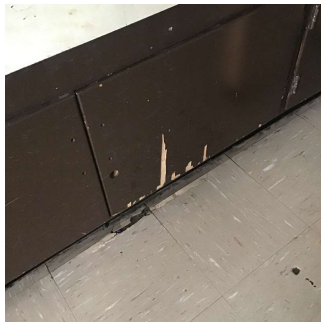
Question	Response
INTERIOR	
SCIENCE DEMO ROOM	
Alternative use	Yes
Fixed Equipment	
Instance on Room 341	Inspected
Condition	2 - Between Good and Fair
Deficiency	No deficiencies recorded
SCIENCE LAB	
Instance on Rooms 404A, 405, 407	Under Construction
Instance on Rooms 205, 305	Inspected
Alternative use	No
Instance on Rooms 207, 307	Inspected
Alternative use	No
Instance on Room 305	Inspected
Instance Quantity Uom	EACH
Alternative use	No
Fixed Equipment	
Instance on Room 305	Inspected
Condition	4 - Between Fair and Poor
Deficiency	CABINETS: MISSING/DAMAGED
Deficiency Location/Instance	Room 305
Deficiency Quantity	20
Quantity Uom	L.F.
Potential Action	REPLACE
Urgency of Action	PRIORITY 3
Purpose of Action	LEVEL 2
Deficiency Photo1

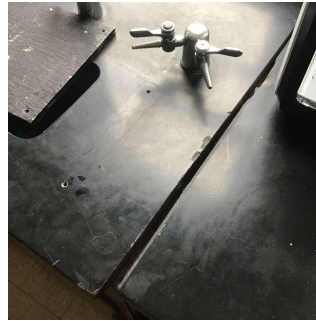
Room 305
Violations	No violations recorded.
Instance on Rooms 205, 305	Inspected
Condition	5 - Poor
Deficiency	TRI-FACIAL TABLE: DAMAGED
Deficiency Location/Instance	Rooms 205, 305
Deficiency Quantity	6

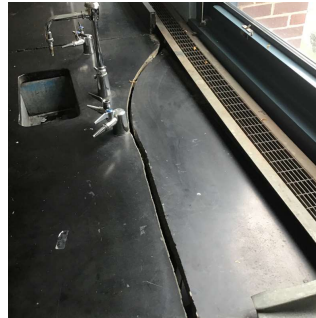
Along Windows

TRI-FACIAL TABLE: DAMAGED

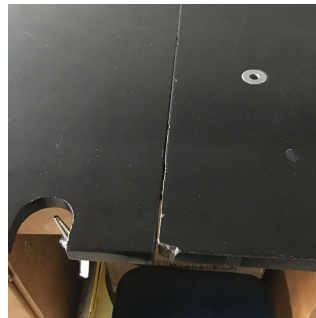
Room 305

DEMO TABLE: DAMAGED/DETERIORATED

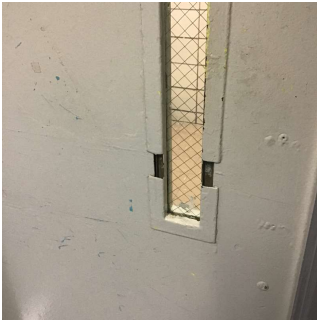
Door(s)	Inspected
Condition	2 - Between Good and Fair
Deficiency	METAL: DETERIORATED DOOR
Deficiency Location/Instance	Stair D/1
Deficiency Quantity	2
Quantity Uom	EACH
Potential Action	MAINTENANCE
Urgency of Action	PRIORITY 3
Purpose of Action	LEVEL 2

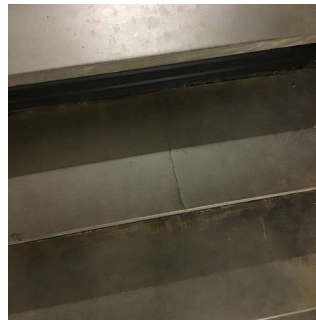
Stair D/2

STONE: BROKEN/MISSING

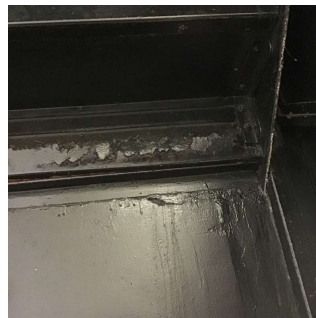
METAL: RUST - MAJOR

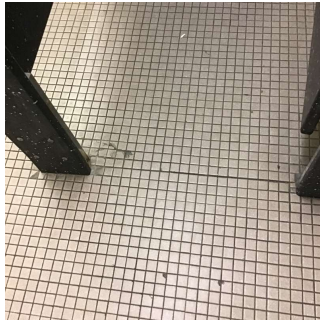
Violations	Kitchen Male Staff No violations recorded.
Floor Finish	Inspected
Condition	2 - Between Good and Fair
Deficiency	CERAMIC TILE: BROKEN/MISSING TILES
Deficiency Location/Instance	Room 157
Deficiency Quantity	10
Quantity Uom	S.F.
Potential Action	REPLACE
Urgency of Action	PRIORITY 3
Purpose of Action	LEVEL 2
Deficiency Photo1

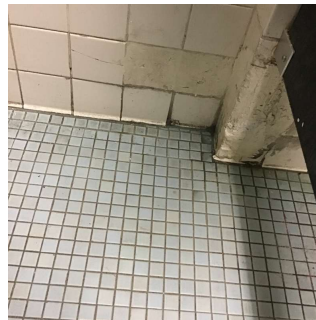
Room 315

CERAMIC TILE: BROKEN/ MISSING

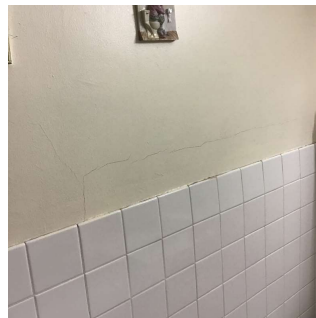
PLASTER: CRACKS/SPALLING

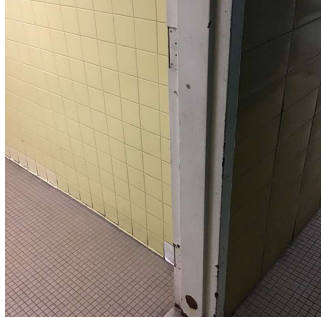
Violations	Room 132 No violations recorded.
Deficiency	WOOD: MISSING DOOR
Deficiency Location/Instance	Boys Locker Room, Boys restroom near room 171
Deficiency Quantity	2
Quantity Uom	EACH
Potential Action	MAINTENANCE
Urgency of Action	PRIORITY 3
Purpose of Action	LEVEL 2
Deficiency Photo1

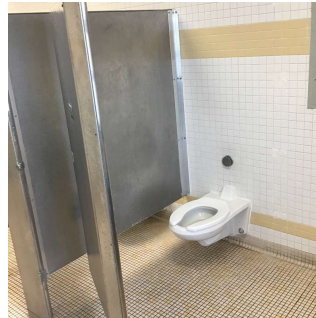
Room 380

BROKEN/MISSING

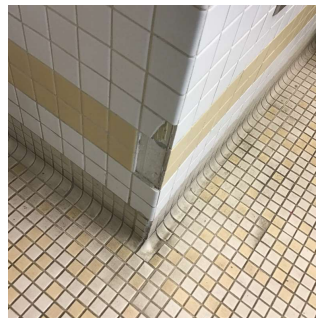
CERAMIC TILE: BROKEN/ MISSING

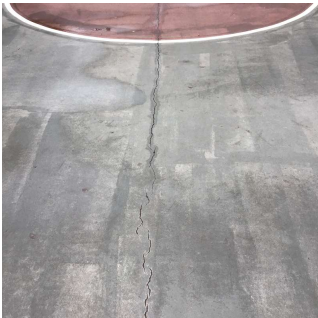
Parking Lot
Violations	No violations recorded.
Pavers	
	Inspected
Condition	2 - Between Good and Fair
Deficiency	No deficiencies recorded
Student Use	
	Inspected
Gravel Exists?	No
Asphalt	
	Inspected
Condition	3 - Fair
Deficiency	CRACKS - MAJOR
Deficiency Location/Instance	Schoolyard
Deficiency Quantity	450
Quantity Uom	S.F.
Potential Action	REPLACE
Urgency of Action	PRIORITY 3
Purpose of Action	LEVEL 2
Deficiency Photo1

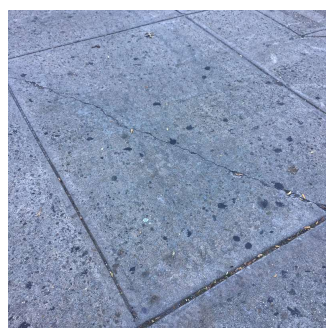
Violations	121st Street No violations recorded.
Deficiency	DAMAGED/DETERIORATED/MISSING SECTIONS
Deficiency Location/Instance	Rockaway Boulevard, 121st Street, 122nd Street
Deficiency Quantity	925
Quantity Uom	S.F.
Potential Action	REPLACE
Urgency of Action	PRIORITY 3
Purpose of Action	LEVEL 2
Deficiency Photo1

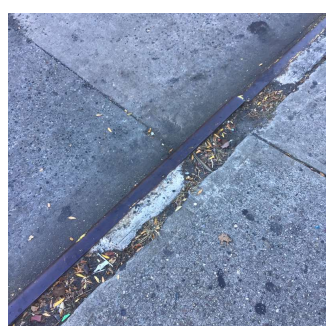
Violations	Rockaway Boulevard No violations recorded.
Deficiency	DAMAGED CURBS
Deficiency Location/Instance	Rockaway Boulevard
Deficiency Quantity	725
Quantity Uom	L.F.
Potential Action	REPLACE
Urgency of Action	PRIORITY 3
Purpose of Action	LEVEL 2
Deficiency Photo1

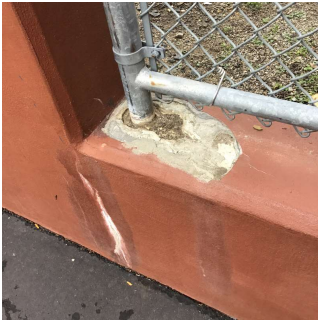
Question	Response
SITE	
PAVING	Inspected
DOT Sidewalk	
Concrete	Inspected
Violations	Rockaway Boulevard No violations recorded.
Pavers	Does not Exist
PLAYGROUNDS	Inspected
Instance on Rear School Yard	Inspected
Benches	
Instance on Rear School Yard	Does not Exist
Fence	
Instance on Rear School Yard	Does not Exist
Pavement	
Instance on Rear School Yard	Does not Exist
Play Equipment	
Instance on Rear School Yard	Inspected
Condition	2 - Between Good and Fair
Deficiency	No deficiencies recorded
Safety Surfacing	
Instance on Rear School Yard	Inspected
Condition	2 - Between Good and Fair
Deficiency	No deficiencies recorded
Unpaved Area	
Instance on Rear School Yard	Does not Exist
PLAYING SURFACE	Does not Exist
RETAINING WALLS	Inspected
Are there any Retaining Walls 6' OR higher facing public street/sidewalk?	No
Condition	2 - Between Good and Fair
Deficiency	CAST IN PLACE CONCRETE: CRACKS/SPALLING - MAJOR
Deficiency Location/Instance	Schoolyard, Along 121st Street

Deficiency Quantity	20
Quantity Uom	S.F.
Potential Action	REPLACE
Urgency of Action	PRIORITY 3
Purpose of Action	LEVEL 2
Deficiency Photo1

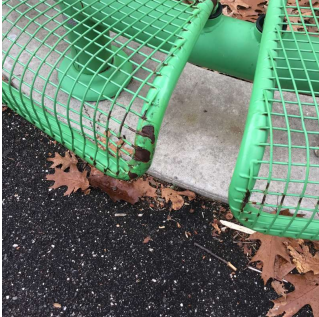
Question	Response
SITE	
SEATING	
Benches	
Concrete	Does not Exist
Metal/Wood/Plastic	Inspected
Condition	5 - Poor
Deficiency	DAMAGED/DETERIORATED
Deficiency Location/Instance	Near Playground
Deficiency Quantity	5
Quantity Uom	EACH
Potential Action	REPLACE
Urgency of Action	PRIORITY 3
Purpose of Action	LEVEL 2
Deficiency Photo1

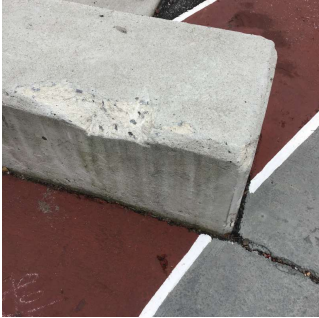
Near Playground
Violations	No violations recorded.
Bleachers	Does not Exist
SITE WALLS (NOT RETAINING WALLS)	Inspected
Condition	2 - Between Good and Fair
Deficiency	CAST IN PLACE CONCRETE: CRACKS/SPALLING - MAJOR
Deficiency Location/Instance	Near Playground
Deficiency Quantity	20
Quantity Uom	S.F.
Potential Action	REPLACE
Urgency of Action	PRIORITY 3
Purpose of Action	LEVEL 2
Deficiency Photo1
