**NYC Department of Education**  
**Building Condition Assessment Survey 2023 - 2024**

Architectural Inspection

**Asset:** I.S. 227 - QUEENS, 32-02 JUNCTION BLVD, New York, 11369

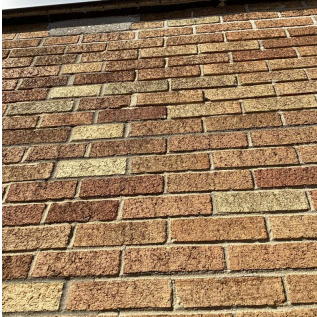
Violations	AW1 No violations recorded.
<b>AWNINGS AND CANOPIES</b>	Does not Exist
<b>CHIMNEY</b>	Inspected
Material Type(s)	Masonry
Condition	3 - Fair
Deficiency	<b>BRICK: DETERIORATED JOINTS</b>
Roof Plan reference

Deficiency Quantity	10
Quantity Uom	S.F.
Potential Action	REPOINT
Urgency of Action	PRIORITY 4
Purpose of Action	LEVEL 2
Deficiency Photo1

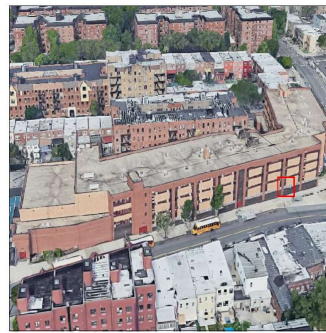
**BRICK: DETERIORATED CONTROL/EXPANSION JOINTS**

10

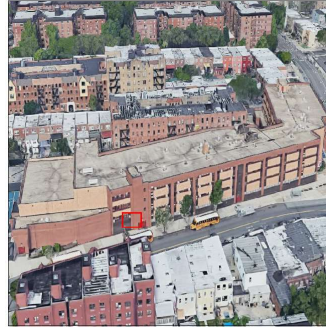
**BRICK: MAJOR / THRU CRACKS**

30

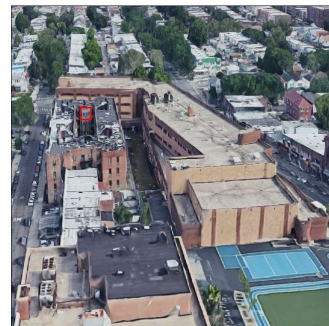
CAST IN PLACE / PRE-CAST CONCRETE: MAJOR  
CRACKS/SPALLING

10

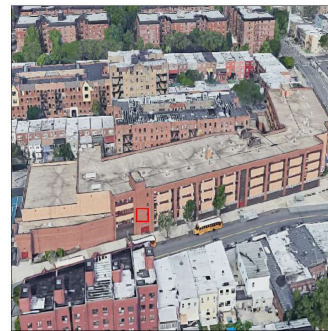
**BRICK: DETERIORATED JOINTS**

10  
S.F.  
REPOINT  
PRIORITY 3  
LEVEL 2

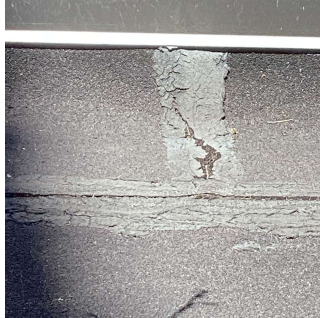
Question	Response
<b>EXTERIOR</b>	
<b>ROOF</b>	
<b>Roofing</b>	
<b>ROOFING</b>	
Potential Action	MAINTENANCE
Urgency of Action	PRIORITY 3
Purpose of Action	LEVEL 2
Deficiency Photo1

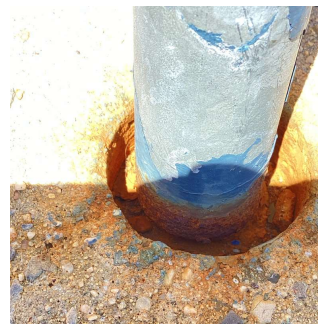
Facade C  
No violations recorded.

Violations	Facade A No violations recorded.
<b>RAILINGS</b>	
Condition	Inspected 5 - Poor
Deficiency	RUST - MAJOR

15  
L.F.  
REPLACE  
PRIORITY 4  
LEVEL 2

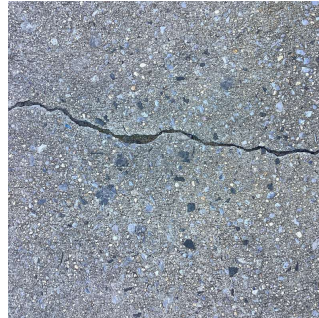
Violations	Facade B No violations recorded.
Deficiency	<b>CONCRETE: CRACKS/SPALLING - MAJOR</b>

Deficiency Quantity	10
Quantity Uom	S.F.
Potential Action	REPLACE
Urgency of Action	PRIORITY 4
Purpose of Action	LEVEL 2
Deficiency Photo1

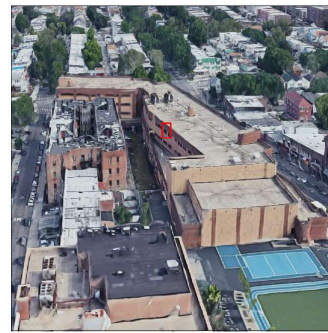
Violations	Facade A No violations recorded.
<b>WINDOWS</b>	Inspected
Replacement Quantity	7,400
Replacement Uom	S.F.
<b>EXTERIOR GUARDS</b>	Inspected
Condition	2 - Between Good and Fair
Deficiency	No deficiencies recorded
<b>LINTELS</b>	Inspected
Condition	2 - Between Good and Fair
Deficiency	No deficiencies recorded
<b>WINDOWS</b>	Inspected
Material Type(s)	Aluminum
Instance on Aluminum - Other: All Facades	Inspected
Instance Condition	2 - Between Good and Fair
Instance Quantity	5,400
Instance Quantity Uom	S.F.
Are these windows insulated	Yes
Installation Year	2009
Source of Installation	Custodial Staff
Deficiency	ALUMINUM - OTHER: BROKEN PANE

30

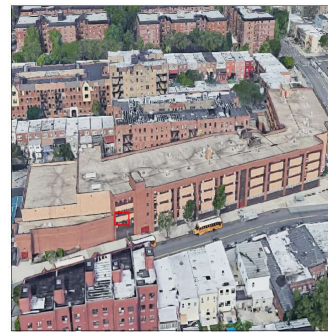
Facade B - Room 213A  
No violations recorded.

ALUMINUM - DOUBLE HUNG: BROKEN PANE

30  
S.F.  
MAINTENANCE  
PRIORITY 3  
LEVEL 2

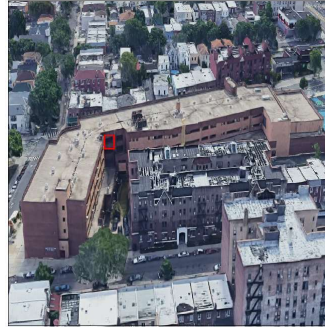
Facade D - Corridor near Elevator Bank A  
No violations recorded.

**ALUMINUM - DOUBLE HUNG: DETERIORATED**

30  
S.F.  
REPLACE WINDOW  
PRIORITY 4  
LEVEL 2

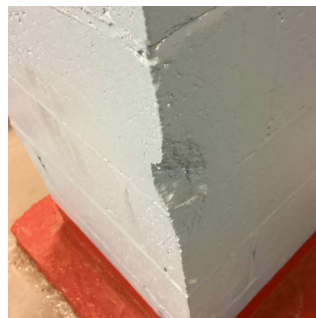
STEEL COLUMNS/BEAMS: DETERIORATED MASONRY  
FIREPROOFING

REPLACE

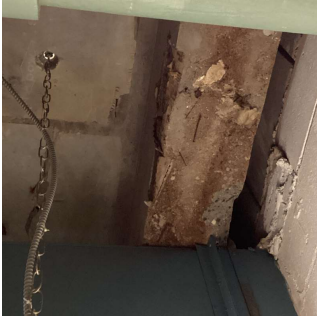
Question	Response
<b>INTERIOR</b>	
<b>STRUCTURAL</b>	
<b>COLUMNS/BEAMS/BEARING WALLS</b>	
Violations	Basement - Boiler Room Pit No violations recorded.
Deficiency	<b>STEEL COLUMNS/BEAMS: DETERIORATED CONCRETE FIREPROOFING</b>
Deficiency Location/Instance	Basement - Room 26
Deficiency Quantity	10
Quantity Uom	S.F.
Potential Action	REPLACE
Urgency of Action	PRIORITY 4
Purpose of Action	LEVEL 5
Deficiency Photo1

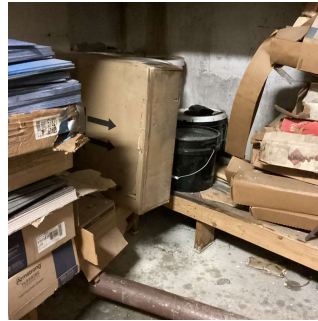
Room B26

**FOUNDATION WALLS**

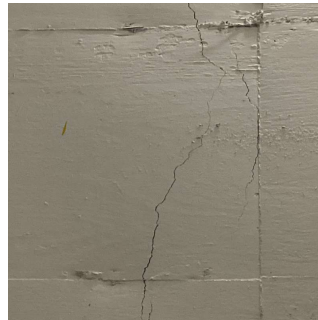
Basement - Storage near Boiler Room Pit

**CONCRETE: CRACKED/SPALLED/REINFORCEMENT EXPOSED**

REPAIR

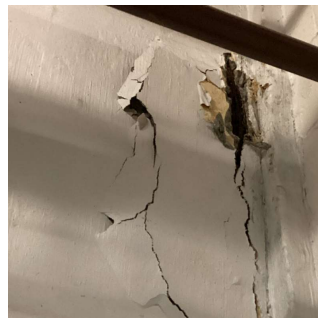
**CONCRETE: CRACKED/SPALLED/REINFORCEMENT EXPOSED**

REPAIR

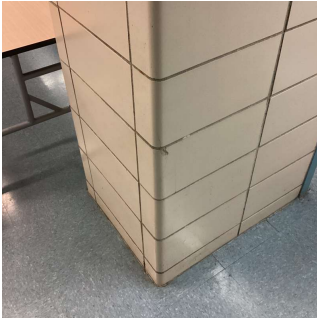
Question	Response
<b>INTERIOR</b>	
<b>CAFETERIA</b>	
<b>Stage</b>	
Instance on 1st Floor - Students	Does not Exist
<b>Walls</b>	
Instance on 1st Floor - Students	Inspected
Condition	2 - Between Good and Fair
Deficiency	GLAZED BLOCK: CRACKS/SPALLING
Deficiency Location/Instance	Near Entrance
Deficiency Quantity	10
Quantity Uom	S.F.
Potential Action	REPLACE
Urgency of Action	PRIORITY 3
Purpose of Action	LEVEL 2
Deficiency Photo1

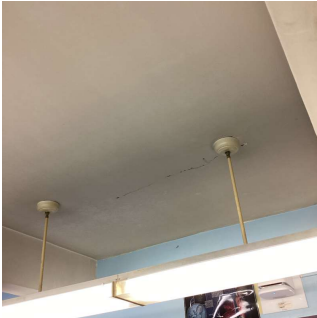
Near Entrance
Violations	No violations recorded.
<b>Window Curtains/Shades/Blinds</b>	
Instance on 1st Floor - Staff (1,000 SF)	Does not Exist
Instance on 1st Floor - Students	Does not Exist
<b>CLASSROOMS/CORRIDORS/ADMIN SPACES</b>	
<b>Ceiling</b>	Inspected
Condition	2 - Between Good and Fair
Deficiency	PLASTER: CRACKS/SPALLING
Deficiency Location/Instance	Rooms 446, 437, 435, 415
Deficiency Quantity	80
Quantity Uom	S.F.
Potential Action	REPLACE
Urgency of Action	PRIORITY 3
Purpose of Action	LEVEL 2

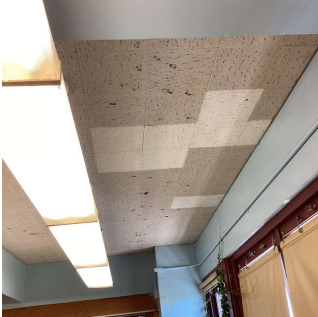
Question	Response
<b>INTERIOR</b>	
<b>CLASSROOMS/CORRIDORS/ADMIN SPACES</b>	
<b>Ceiling</b>	
Deficiency Location/Instance	Room 449, 416, 317, Corridor near Rooms 447, 439A and others
Deficiency Quantity	700
Quantity Uom	S.F.
Potential Action	REPLACE
Urgency of Action	PRIORITY 3
Purpose of Action	LEVEL 2
Deficiency Photo1

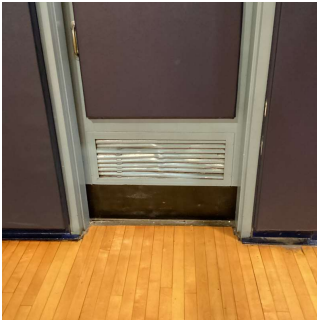
Right Side
Violations	No violations recorded.
<b>Door(s)</b>	
Instance on 2nd Floor	Inspected
Condition	5 - Poor
Deficiency	METAL: DAMAGED LOUVER
Deficiency Location/Instance	Storage Room 1, Storage 2
Deficiency Quantity	3
Quantity Uom	EACH
Potential Action	MAINTENANCE
Urgency of Action	PRIORITY 3
Purpose of Action	LEVEL 2
Deficiency Photo1

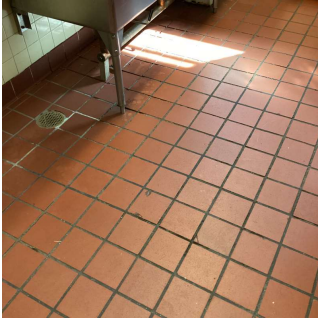
Question	Response
<b>INTERIOR</b>	
<b>KITCHEN</b>	
<b>Floor Finish</b>	
Instance on 1st Floor	Inspected
Condition	2 - Between Good and Fair
Deficiency	QUARRY TILE: BROKEN/MISSING TILES
Deficiency Location/Instance	Near Sinks, Near Coolers
Deficiency Quantity	20
Quantity Uom	S.F.
Potential Action	REPLACE
Urgency of Action	PRIORITY 3
Purpose of Action	LEVEL 2
Deficiency Photo1

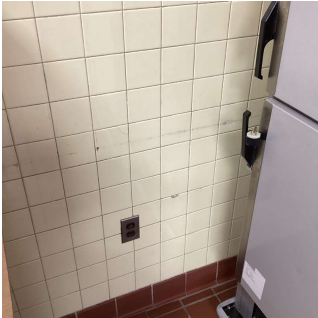
Violations	Near Sinks No violations recorded.
<b>Walls</b>	
Instance on 1st Floor	Inspected
Condition	3 - Fair
Deficiency	CERAMIC TILE: BROKEN/ MISSING
Deficiency Location/Instance	Near Ovens, Serving Area
Deficiency Quantity	20
Quantity Uom	S.F.
Potential Action	REPLACE
Urgency of Action	PRIORITY 3
Purpose of Action	LEVEL 2
Deficiency Photo1

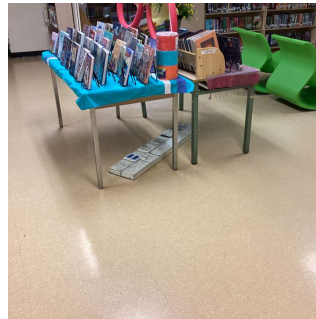
Instance on Room 220	Inspected
Condition	2 - Between Good and Fair
Deficiency	VINYL TILES: TRIPPING HAZARD - ELECTRICAL OUTLET
Deficiency Location/Instance	Center
Deficiency Quantity	10
Quantity Uom	S.F.
Potential Action	REMOVE
Urgency of Action	PRIORITY 5
Purpose of Action	LEVEL 6
Deficiency Photo1

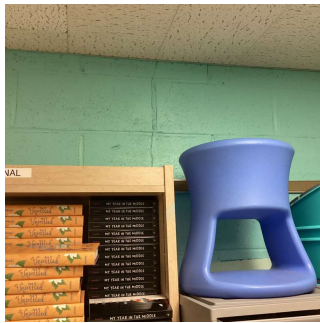
Instance on Room 220	Inspected
Condition	2 - Between Good and Fair
Deficiency	MASONRY: CRACKS/SPALLING
Deficiency Location/Instance	Office
Deficiency Quantity	10
Quantity Uom	S.F.
Potential Action	REPLACE
Urgency of Action	PRIORITY 3
Purpose of Action	LEVEL 2

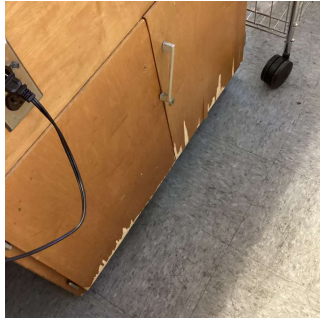
Room 346
Violations	No violations recorded.
Instance on Rooms 446, 346, 246	Inspected
Condition	5 - Poor
Deficiency	CABINETRY: MISSING/DAMAGED
Deficiency Location/Instance	Rooms 446, 346, 246
Deficiency Quantity	45
Quantity Uom	L.F.
Potential Action	REPLACE
Urgency of Action	PRIORITY 3
Purpose of Action	LEVEL 2
Deficiency Photo1

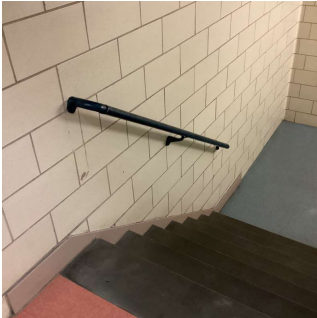
Question	Response
<b>INTERIOR</b>	
<b>SHOWER ROOM</b>	
<b>Door(s)</b>	Inspected
Instance on 2nd Floor - Girls	Inspected
Condition	2 - Between Good and Fair
Deficiency	No deficiencies recorded
<b>Floor Finish</b>	
Instance on 2nd Floor - Girls	Inspected
Condition	2 - Between Good and Fair
Deficiency	No deficiencies recorded
<b>Walls</b>	
Instance on 2nd Floor - Girls	Inspected
Condition	2 - Between Good and Fair
Deficiency	No deficiencies recorded
<b>STAIRS/RAMPS: INTERIOR</b>	Inspected
Do Letter Stair Signs Exist?	Yes
<b>Ceiling</b>	Inspected
Condition	2 - Between Good and Fair
Deficiency	No deficiencies recorded
<b>Door(s)</b>	Inspected
Condition	2 - Between Good and Fair
Deficiency	No deficiencies recorded
<b>Partition</b>	Does not Exist
<b>Railings</b>	Inspected
Condition	3 - Fair
Deficiency	METAL: MISSING
Deficiency Location/Instance	Stair A/2
Deficiency Quantity	10
Quantity Uom	L.F.
Potential Action	REPLACE
Urgency of Action	PRIORITY 5

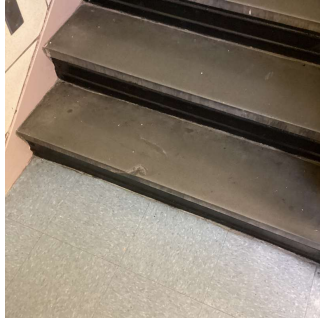
Violations	Stair A/2 No violations recorded.
<b>Stairs and Landings</b>	Inspected
Condition	2 - Between Good and Fair
Deficiency	STONE: BROKEN/MISSING
Deficiency Location/Instance	Stairs A/3, BC/2, EF/1, Corridor near Cafeteria
Deficiency Quantity	50
Quantity Uom	S.F.
Potential Action	REPLACE

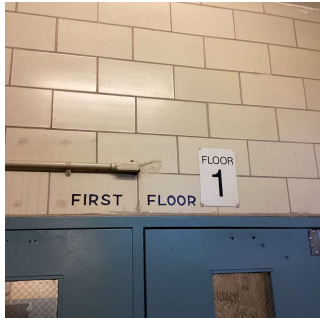
Violations	Stair BC/2 No violations recorded.
<b>Walls</b>	
Condition	Inspected 2 - Between Good and Fair
Deficiency	GLAZED BLOCK: CRACKS/SPALLING
Deficiency Location/Instance	Stair D/1
Deficiency Quantity	10
Quantity Uom	S.F.
Potential Action	REPLACE
Urgency of Action	PRIORITY 3
Purpose of Action	LEVEL 2
Deficiency Photo1

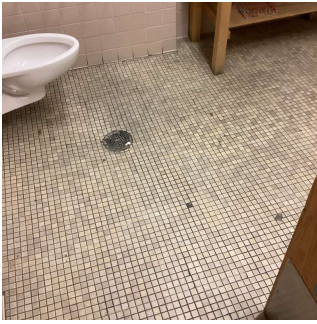
Violations	Kitchen Womens No violations recorded.
<b>Floor Finish</b>	Inspected
Condition	4 - Between Fair and Poor
Deficiency	CERAMIC TILE: BROKEN/MISSING TILES
Deficiency Location/Instance	Rooms 431F, 331, 231, 229, 211 and others
Deficiency Quantity	60
Quantity Uom	S.F.
Potential Action	REPLACE
Urgency of Action	PRIORITY 3
Purpose of Action	LEVEL 2
Deficiency Photo1

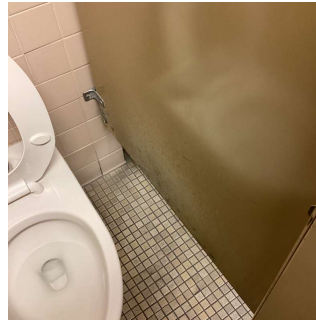
Room 331

Violations	Room 431F No violations recorded.
<b>Stalls</b>	Inspected
Condition	5 - Poor
Deficiency	RUST - MAJOR
Deficiency Location/Instance	Rooms 331, 140, 136
Deficiency Quantity	3
Quantity Uom	EACH
Potential Action	REPLACE
Urgency of Action	PRIORITY 3
Purpose of Action	LEVEL 2

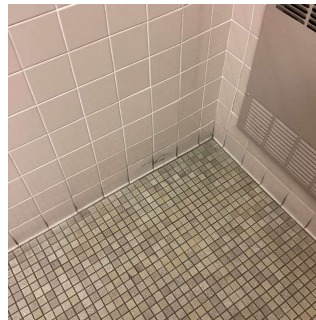
Room 331

CERAMIC TILE: BROKEN/ MISSING

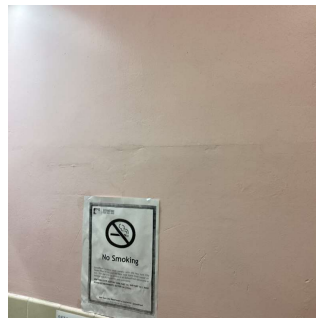
PLASTER: CRACKS/SPALLING

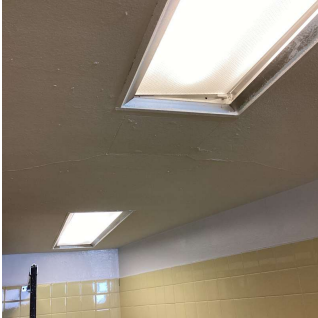
Question	Response
<b>INTERIOR</b>	
<b>TOILET ROOMS - STAFF</b>	Inspected
<b>Walls</b>	Inspected
Violations	Kitchen Womens No violations recorded.
<b>TOILET ROOMS - STUDENTS</b>	Inspected
<b>Ceiling</b>	Inspected
Condition	2 - Between Good and Fair
Deficiency	PLASTER: CRACKS/SPALLING
Deficiency Location/Instance	Rooms 445, 443, 436
Deficiency Quantity	60
Quantity Uom	S.F.
Potential Action	REPLACE
Urgency of Action	PRIORITY 3
Purpose of Action	LEVEL 2
Deficiency Photo1

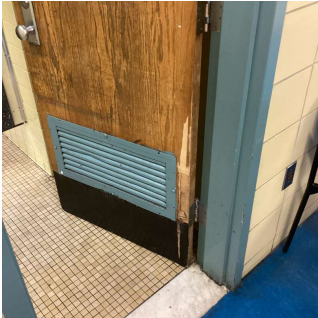
Violations	Room 443 No violations recorded.
<b>Door(s)</b>	Inspected
Condition	5 - Poor
Deficiency	WOOD: DETERIORATED DOOR
Deficiency Location/Instance	Rooms 443, 438, 431M, 338, 336 and others
Deficiency Quantity	15
Quantity Uom	EACH
Potential Action	MAINTENANCE
Urgency of Action	PRIORITY 3
Purpose of Action	LEVEL 2
Deficiency Photo1

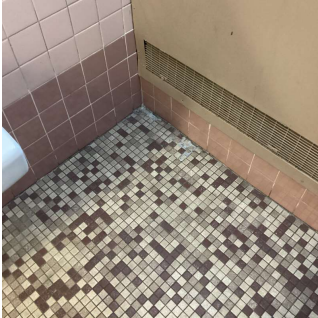
Violations	Room 443 No violations recorded.
<b>Floor Finish</b>	Inspected
Condition	2 - Between Good and Fair
Deficiency	CERAMIC TILE: BROKEN/MISSING TILES

Question	Response
<b>INTERIOR</b>	
<b>TOILET ROOMS - STUDENTS</b>	Inspected
<b>Floor Finish</b>	
Deficiency Location/Instance	Rooms 445, 431M, 438, 436, 338 and others
Deficiency Quantity	60
Quantity Uom	S.F.
Potential Action	REPLACE
Urgency of Action	PRIORITY 3
Purpose of Action	LEVEL 2
Deficiency Photo1

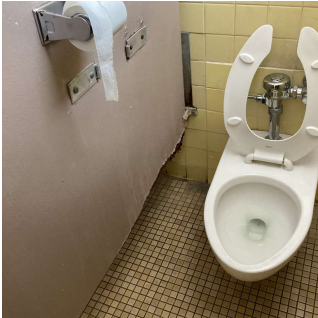
Room 445
Violations	No violations recorded.
<b>Stalls</b>	Inspected
Condition	5 - Poor
Deficiency	RUST - MAJOR
Deficiency Location/Instance	Room 343
Deficiency Quantity	4
Quantity Uom	EACH
Potential Action	REPLACE
Urgency of Action	PRIORITY 3
Purpose of Action	LEVEL 2
Deficiency Photo1

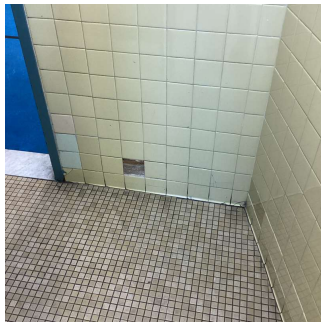
Room 343
Violations	No violations recorded.
<b>Walls</b>	Inspected
Condition	2 - Between Good and Fair
Deficiency	CERAMIC TILE: BROKEN/ MISSING
Deficiency Location/Instance	Rooms 445, 443, 438, 436, 336 and others
Deficiency Quantity	110
Quantity Uom	S.F.
Potential Action	REPLACE
Urgency of Action	PRIORITY 3
Purpose of Action	LEVEL 2

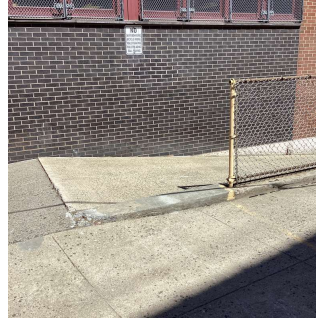
<b>Culverts - Soil Covering</b>	Does not Exist
<b>DRINKING FOUNTAINS</b>	Inspected
Condition	2 - Between Good and Fair
Deficiency	No deficiencies recorded
<b>FENCES</b>	Inspected
Condition	4 - Between Fair and Poor
Deficiency	CHAIN LINK: MISSING SECTIONS
Deficiency Location/Instance	Parking Lot
Deficiency Quantity	50
Quantity Uom	S.F.
Potential Action	REPLACE
Urgency of Action	PRIORITY 3
Purpose of Action	LEVEL 2

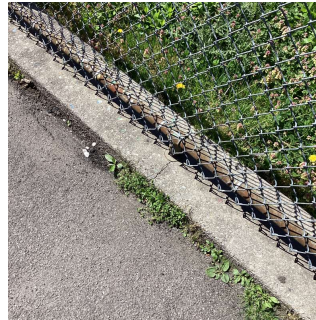
Near Exit 10

CONCRETE CURB: DAMAGED/DETERIORATED

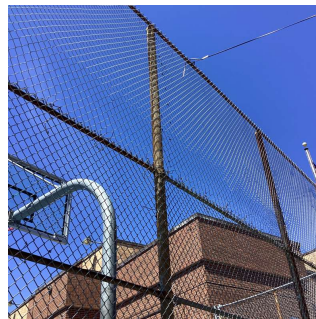
Junction Boulevard

CHAIN LINK: DAMAGED/DETERIORATED

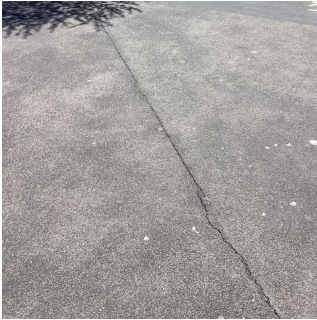
Question	Response
<b>SITE</b>	
<b>PAVING</b>	
<b>Student Use</b>	
<b>Asphalt</b>	
Deficiency	CRACKS - MAJOR
Deficiency Location/Instance	Schoolyard
Deficiency Quantity	200
Quantity Uom	S.F.
Potential Action	REPLACE
Urgency of Action	PRIORITY 3
Purpose of Action	LEVEL 2
Deficiency Photo1

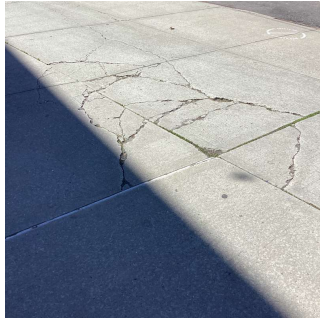
Violations	Junction Boulevard No violations recorded.
Deficiency	<b>DAMAGED/DETERIORATED/MISSING SECTIONS</b>
Deficiency Location/Instance	Junction Boulevard, Northern Boulevard, 93rd Street, 32nd Avenue
Deficiency Quantity	1,950
Quantity Uom	S.F.
Potential Action	REPLACE
Urgency of Action	PRIORITY 3
Purpose of Action	LEVEL 2
Deficiency Photo1
