NYC Department of Education
Building Condition Assessment Survey 2023 - 2024

Architectural Inspection

Asset: P.S. 232 - QUEENS, 153-23 83 STREET, New York, 11414

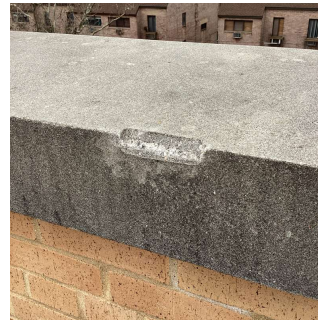
Roof 1

Deficiency Quantity	400
Quantity Uom	L.F.
Potential Action	MAINTENANCE
Urgency of Action	PRIORITY 3
Purpose of Action	LEVEL 2
Deficiency Photo1	No photo recorded
Violations	No violations recorded.
Deficiency	CAST STONE: CRACKED/BROKEN PIECES

REPLACE-IN-KIND

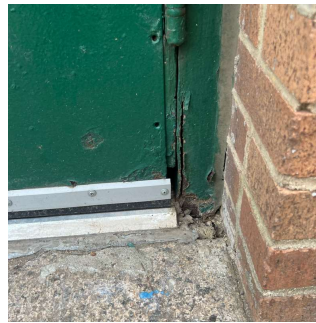
Facade A

METAL CLAD: DETERIORATED DOOR AND FRAME - MAJOR DETERIORATION

REPLACE

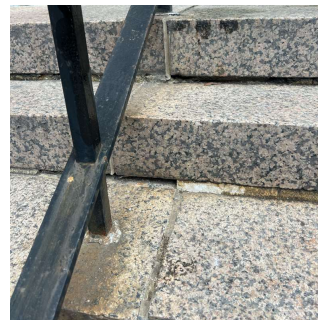
Facade B

STONE: DETERIORATED JOINTS

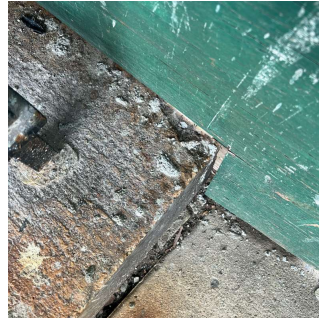
STONE: CRACKS/SPALLING - MAJOR

Deficiency Quantity	10
Quantity Uom	S.F.
Potential Action	REPLACE
Urgency of Action	PRIORITY 4
Purpose of Action	LEVEL 2
Deficiency Photo1

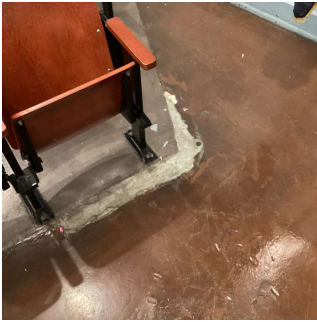
Seat O/101
Violations	No violations recorded.
Floor Finish	
Instance on 1st Floor (416 Seats)	Inspected
Condition	2 - Between Good and Fair
Deficiency	SHEET VINYL: BROKEN/DETERIORATED
Deficiency Location/Instance	Near Seat A/7, Near Entrance Left and Right Side Aisle, Near Stage
Deficiency Quantity	80
Quantity Uom	S.F.
Potential Action	REPLACE
Urgency of Action	PRIORITY 3
Purpose of Action	LEVEL 2
Deficiency Photo1

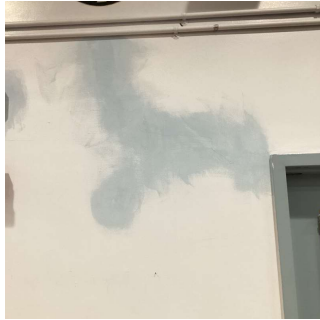
Near Entrance
Violations	No violations recorded.
Deficiency	MASONRY: CRACKS/SPALLING
Deficiency Location/Instance	Left Side of Stage
Deficiency Quantity	40
Quantity Uom	S.F.
Potential Action	REPLACE
Urgency of Action	PRIORITY 3
Purpose of Action	LEVEL 2
Deficiency Photo1

Question	Response
INTERIOR	
AUDITORIUM	
Stage	
Stage Curtains	
Deficiency	No deficiencies recorded
Walls	
Instance on 1st Floor (416 Seats)	Inspected
Condition	2 - Between Good and Fair
Deficiency	PLASTER: CRACKS/SPALLING
Deficiency Location/Instance	Near Entrance, Left and Right Side
Deficiency Quantity	40
Quantity Uom	S.F.
Potential Action	REPLACE
Urgency of Action	PRIORITY 3
Purpose of Action	LEVEL 2
Deficiency Photo1

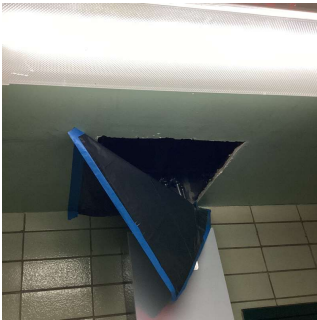
Question	Response
INTERIOR	
CAFETERIA	
Ceiling	
Instance on 1st Floor	Inspected
Condition	2 - Between Good and Fair
Deficiency	ACOUSTIC TILES ON PLASTER: DAMAGED/MISSING
Deficiency Location/Instance	Near Entrance, Center
Deficiency Quantity	20
Quantity Uom	S.F.
Potential Action	REPLACE
Urgency of Action	PRIORITY 3
Purpose of Action	LEVEL 2
Deficiency Photo1	 
Violations	Near Entrance No violations recorded.
Deficiency	PLASTER: CRACKS/SPALLING
Deficiency Location/Instance	Exit 4 Vestibule
Deficiency Quantity	10
Quantity Uom	S.F.
Potential Action	REPLACE
Urgency of Action	PRIORITY 3
Purpose of Action	LEVEL 2
Deficiency Photo1

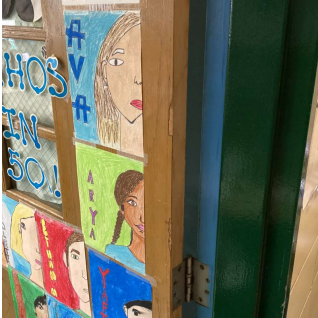
Question	Response
INTERIOR	
CLASSROOMS/CORRIDORS/ADMIN SPACES	
Ceiling	
Condition	2 - Between Good and Fair
Deficiency	ACOUSTIC TILES ON PLASTER: DAMAGED/MISSING
Deficiency Location/Instance	Corridor near Room 320, Main Entrance Vestibule
Deficiency Quantity	40
Quantity Uom	S.F.
Potential Action	REPLACE
Urgency of Action	PRIORITY 3
Purpose of Action	LEVEL 2
Deficiency Photo1	 
Violations	Main Entrance Vestibule No violations recorded.
Door(s)	
Condition	Inspected
Condition	5 - Poor
Deficiency	WOOD: DETERIORATED DOOR
Deficiency Location/Instance	Rooms 324, 321, 315, 311, 305 and others
Deficiency Quantity	17
Quantity Uom	EACH
Potential Action	MAINTENANCE
Urgency of Action	PRIORITY 3
Purpose of Action	LEVEL 2
Deficiency Photo1

Violations	Room 315 No violations recorded.
Floor Finish	
Condition	Inspected
Condition	2 - Between Good and Fair
Deficiency	VINYL TILES: BROKEN/DETERIORATED/MISSING TILES
Deficiency Location/Instance	Corridor near Room 315, Rooms 322, 320, 206, 202 and others

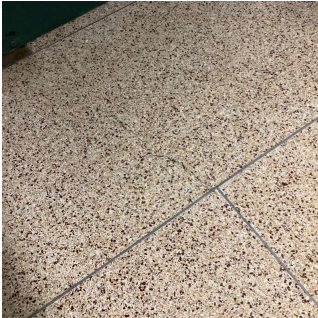
Violations	Corridor near Room 315 No violations recorded.
Deficiency	TERRAZZO: CRACKS
Deficiency Location/Instance	Main Entrance Lobby, Exit 5 Vestibule
Deficiency Quantity	20
Quantity Uom	S.F.
Potential Action	REPLACE
Urgency of Action	PRIORITY 3
Purpose of Action	LEVEL 2
Deficiency Photo1

Violations	Main Entrance Lobby No violations recorded.
Walls	Inspected
Condition	2 - Between Good and Fair
Deficiency	GLAZED BLOCK: CRACKS/SPALLING
Deficiency Location/Instance	Corridor near Stair A/3, 2, Corridor near Room 133, Main Entrance Lobby
Deficiency Quantity	40
Quantity Uom	S.F.
Potential Action	REPLACE
Urgency of Action	PRIORITY 3
Purpose of Action	LEVEL 2

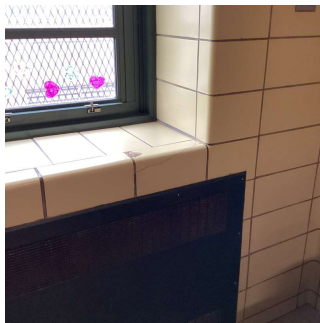
Corridor near Stair A/3
Violations	No violations recorded.
Deficiency	PLASTER: CRACKS/SPALLING
Deficiency Location/Instance	Exits 5, 9 Vestibules, Corridor near cafeteria, Corridor near stair A/3, 2 and others
Deficiency Quantity	120
Quantity Uom	S.F.
Potential Action	REPLACE
Urgency of Action	PRIORITY 3
Purpose of Action	LEVEL 2
Deficiency Photo1

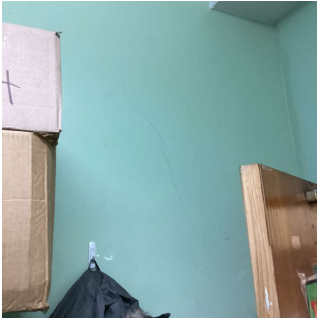
Question	Response
INTERIOR	
GYMNASIUM	
Stage	
Instance on 1st Floor	Does not Exist
Walls	
Instance on 1st Floor	Inspected
Condition	2 - Between Good and Fair
Deficiency	PLASTER: CRACKS/SPALLING
Deficiency Location/Instance	Office, Near Windows
Deficiency Quantity	40
Quantity Uom	S.F.
Potential Action	REPLACE
Urgency of Action	PRIORITY 3
Purpose of Action	LEVEL 2
Deficiency Photo1

Violations	Office No violations recorded.
Window Curtains/Shades/Blinds	
Instance on 1st Floor	Does not Exist
INTERIOR DOOR HARDWARE	
Condition	Inspected
Deficiency	3 - Fair
Deficiency	No deficiencies recorded
INTERIOR GUARDS	
Condition	Inspected
Deficiency	2 - Between Good and Fair
Deficiency	No deficiencies recorded
KITCHEN	
Instance on 1st Floor	Inspected
Instance on 1st Floor	Inspected
Ceiling	
Instance on 1st Floor	Inspected
Condition	2 - Between Good and Fair
Deficiency	METAL PAN: DAMAGED/MISSING
Deficiency Location/Instance	Center, Near Freezers

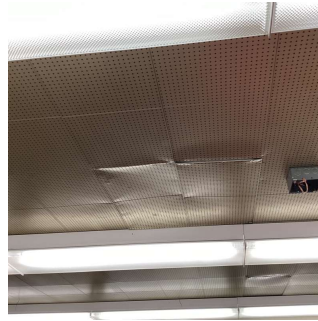
Center

Deficiency Quantity	20
Quantity Uom	S.F.
Potential Action	REPLACE
Urgency of Action	PRIORITY 3
Purpose of Action	LEVEL 2

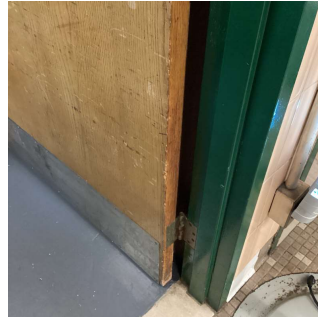
Storage Room

Instance on 1st Floor	Inspected
Condition	4 - Between Fair and Poor
Deficiency	WOOD: DETERIORATED DOOR
Deficiency Location/Instance	Storage Room, Women Locker Room
Deficiency Quantity	2
Quantity Uom	EACH
Potential Action	MAINTENANCE
Urgency of Action	PRIORITY 3
Purpose of Action	LEVEL 2
Deficiency Photo1

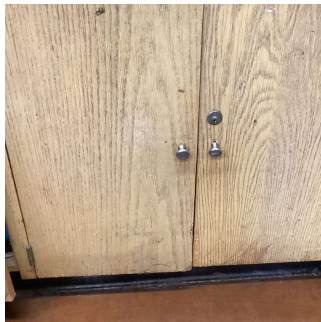
Violations	Near Windows No violations recorded.
LIBRARY	Inspected
Instance on Room 225	Inspected
Built-in Furnishing	
Instance on Room 225	Inspected
Condition	3 - Fair
Deficiency	SINK/STORAGE CABINET - DAMAGED/DETERIORATED
Deficiency Location/Instance	Left Side Near Entrance
Deficiency Quantity	10
Quantity Uom	L.F.
Potential Action	REPLACE
Urgency of Action	PRIORITY 3
Purpose of Action	LEVEL 2
Deficiency Photo1

Violations	Left Side Near Entrance No violations recorded.
Ceiling	
Instance on Room 225	Inspected
Condition	2 - Between Good and Fair
Deficiency	No deficiencies recorded
Door(s)	
Instance on Room 225	Inspected
Condition	3 - Fair
Deficiency	WOOD: DETERIORATED DOOR
Deficiency Location/Instance	Main Entrance
Deficiency Quantity	1
Quantity Uom	EACH
Potential Action	MAINTENANCE
Urgency of Action	PRIORITY 3

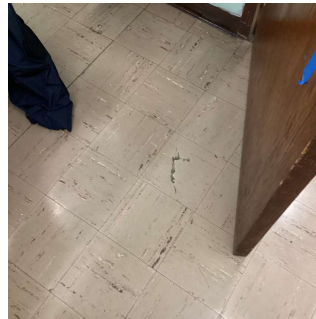
Instance on Room 141 (300 SF)	Inspected
Condition	2 - Between Good and Fair
Deficiency	VINYL TILES: BROKEN/DETERIORATED/MISSING TILES
Deficiency Location/Instance	Near Shower Room
Deficiency Quantity	10
Quantity Uom	S.F.
Potential Action	REPLACE
Urgency of Action	PRIORITY 3
Purpose of Action	LEVEL 2
Deficiency Photo1

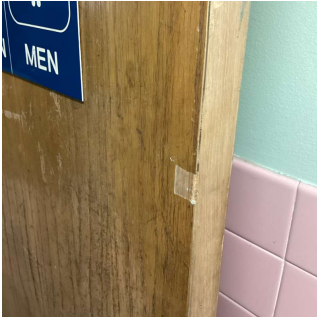
Violations	Stair C/3 No violations recorded.
TOILET ROOMS - STAFF	
Ceiling	Inspected
Condition	2 - Between Good and Fair
Deficiency	No deficiencies recorded
Door(s)	Inspected
Condition	5 - Poor
Deficiency	WOOD: DETERIORATED DOOR
Deficiency Location/Instance	Rooms 307, 130, inside Kitchen
Deficiency Quantity	3
Quantity Uom	EACH
Potential Action	MAINTENANCE
Urgency of Action	PRIORITY 3
Purpose of Action	LEVEL 2
Deficiency Photo1

Violations	Room 307 No violations recorded.
Floor Finish	Inspected
Condition	2 - Between Good and Fair
Deficiency	No deficiencies recorded

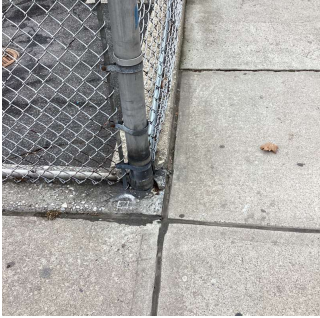
Question	Response
SITE	
FENCES	
Quantity Uom	S.F.
Potential Action	REPLACE
Urgency of Action	PRIORITY 3
Purpose of Action	LEVEL 2
Deficiency Photo1

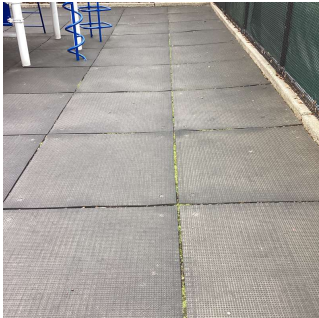
Violations	Near NYC Park

Question	Response
SITE	
PLAYGROUNDS	Inspected
Fence	Near Entrance
Violations	No violations recorded.
Pavement	
Instance on South Side Of Building	Inspected
Condition	4 - Between Fair and Poor
Deficiency	ASPHALT: CRACKS - MAJOR
Deficiency Location/Instance	Near Entrance, Center, Near NYCPark
Deficiency Quantity	300
Quantity Uom	S.F.
Potential Action	REPLACE
Urgency of Action	PRIORITY 3
Purpose of Action	LEVEL 2
Deficiency Photo1	 
Violations	Near Entrance No violations recorded.
Play Equipment	
Instance on South Side Of Building	Inspected
Condition	2 - Between Good and Fair
Deficiency	No deficiencies recorded
Safety Surfacing	
Instance on South Side Of Building	Inspected
Condition	3 - Fair
Deficiency	DETERIORATED/MISSING
Deficiency Location/Instance	Near NYC Park, Near Entrance, Center
Deficiency Quantity	70
Quantity Uom	S.F.
Potential Action	REPLACE
Urgency of Action	PRIORITY 3
Purpose of Action	LEVEL 2
Deficiency Photo1
