NYC Department of Education
Building Condition Assessment Survey 2023 - 2024

Architectural Inspection

Asset: P.S. 234 - QUEENS, 30-15 29TH STREET, New York, 11102

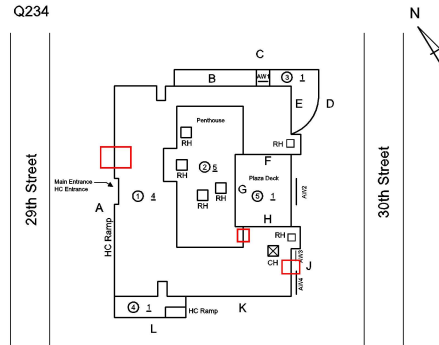
Roof Plan reference

Question	Response
Architectural	
EXTERIOR	Inspected
AREAWAY	Inspected
Instance on AW1 - AW4	Inaccessible
Instance Quantity	4
Instance Quantity Uom	EACH
AWNINGS AND CANOPIES	Does not Exist
CHIMNEY	Inspected
Material Type(s)	Masonry
Condition	2 - Between Good and Fair
Deficiency	No deficiencies recorded
COPING	Inspected
Condition	3 - Fair
Deficiency	CAST STONE: CRACKED/BROKEN PIECES

COPING

REPLACE-IN-KIND

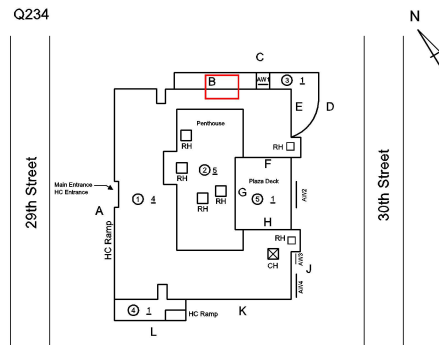
Roof Plan reference

METAL: DETERIORATED DOOR AND FRAME - MAJOR DETERIORATION

REPLACE

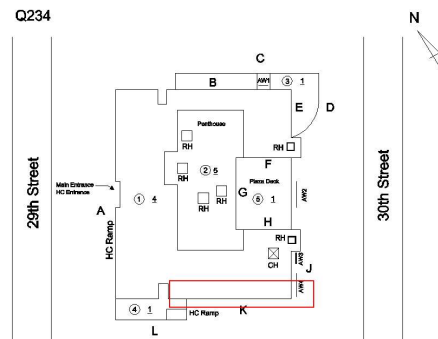
Roof Plan reference

BRICK: EFFLORESCENCE

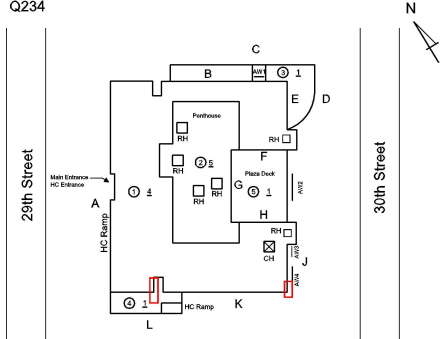
Deficiency Quantity	500
Quantity Uom	S.F.
Potential Action	MAINTENANCE
Urgency of Action	PRIORITY 1
Purpose of Action	LEVEL 1
Deficiency Photo	No photo recorded
Violations	No violations recorded.
EXTERIOR SOFFITS	Inspected
Condition	2 - Between Good and Fair
Deficiency	No deficiencies recorded
LOADING DOCK	Does not Exist
LOUVER	Inspected
Condition	2 - Between Good and Fair
Deficiency	No deficiencies recorded
PARAPETS	Inspected
Material Type(s)	Masonry
Replacement Quantity	7,000
Replacement Uom	C.F.
Instance on All Roofs	Inspected
Instance Condition	3 - Fair
Instance Quantity	7,000
Instance Quantity Uom	C.F.
Deficiency	BRICK: DETERIORATED CONTROL/EXPANSION JOINT
Roof Plan reference	Q234

Deficiency Quantity	20
Quantity Uom	L.F.
Potential Action	MAINTENANCE
Urgency of Action	PRIORITY 3
Purpose of Action	LEVEL 2

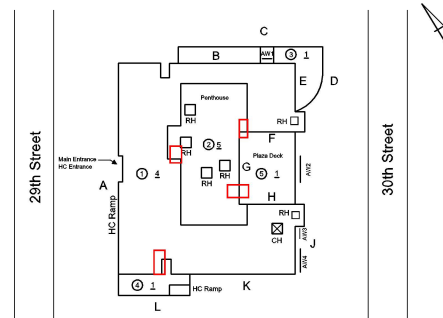
Roof Plan reference

BRICK: MINOR CRACKS, SPALLING

REPAIR

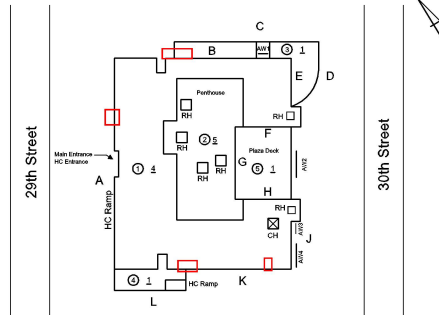
Roof Plan reference

Is/Are the roof(s) suitable for Solar Panel installation?	Yes
Installation Year	2003
Source of Installation	Custodial Staff
Deficiency	BUILT-UP: FLASHING: DETERIORATED JOINTS

30
L.F.
MAINTENANCE
PRIORITY 3
LEVEL 2

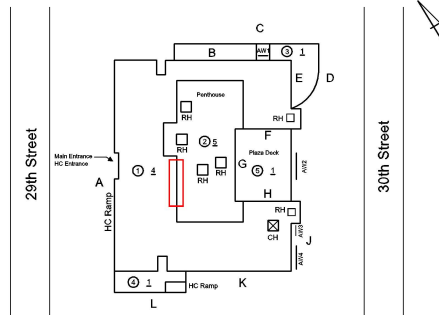
Roof Plan reference

BULKHEAD/PENTHOUSE WALLS/INTERIOR: CMU
CRACKS/SPALLING

15
S.F.
REPLACE

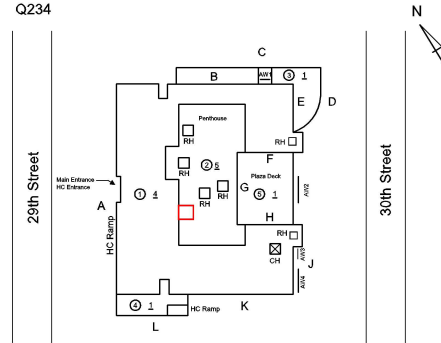
Roof Plan reference

BULKHEAD/PENTHOUSE CEILING: GYPSUM BOARD DAMAGED/DETERIORATED

10
S.F.
REPLACE
PRIORITY 4
LEVEL 2

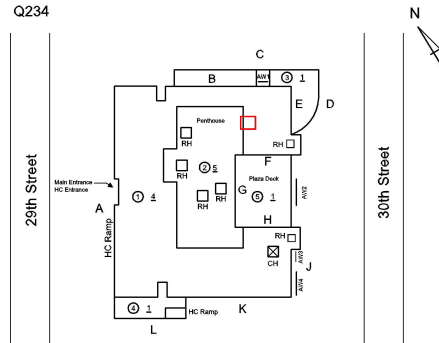
Roof Plan reference

BULKHEAD/PENTHOUSE WALLS/EXTERIOR: MAJOR THRU CRACKS

20
 S.F.
 REMOVE AND REBUILD
 PRIORITY 4
 LEVEL 2

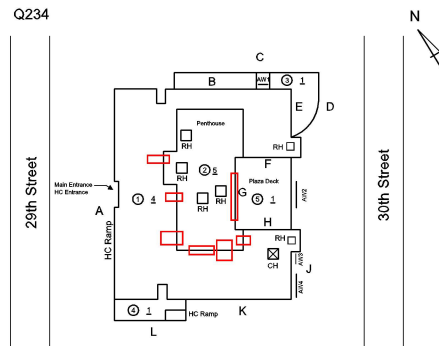
Roof Plan reference

Deficiency **BULKHEAD/PENTHOUSE WALLS/EXTERIOR: DETERIORATED JOINTS**

120
 S.F.
 REPOINT
 PRIORITY 4
 LEVEL 2

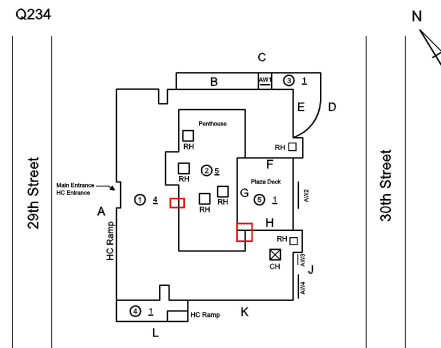
Roof Plan reference

**BULKHEAD/PENTHOUSE WALLS/EXTERIOR:
CRACKS/SPALLING - MAJOR**

REPLACE

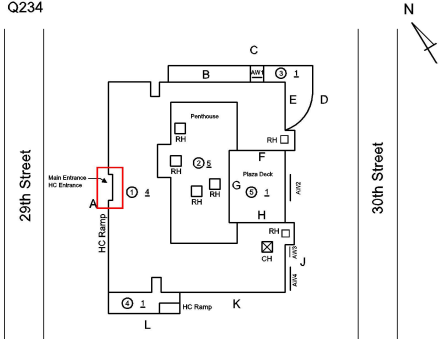
Question	Response
EXTERIOR	
STAIRS/RAMPS: EXTERIOR	Inspected
BUILDING CHEEK/FLANK WALLS	Inspected
Condition	2 - Between Good and Fair
Deficiency	BRICK: CRACKS/SPALLING - MINOR
Roof Plan reference	Q234

Deficiency Quantity	10
Quantity Uom	S.F.
Potential Action	REPAIR
Urgency of Action	PRIORITY 3
Purpose of Action	LEVEL 2
Deficiency Photo1

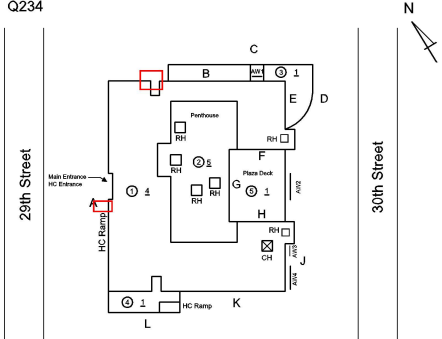
Violations	Facade A No violations recorded.
RAILINGS	Inspected
Condition	2 - Between Good and Fair
Deficiency	No deficiencies recorded
STAIRS/RAMPS	Inspected
Condition	4 - Between Fair and Poor
Deficiency	CONCRETE: CRACKS/SPALLING - MAJOR
Roof Plan reference	Q234

Deficiency Quantity	20
Quantity Uom	S.F.
Potential Action	REPLACE
Urgency of Action	PRIORITY 4

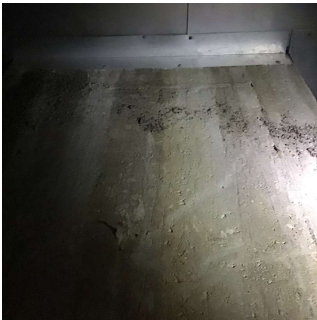
<p>Basement - Electrical Room</p> <p>No violations recorded.</p>
Violations	
FOUNDATION WALLS	
Material Type(s)	Inspected Concrete
Condition	4 - Between Fair and Poor
Deficiency	CONCRETE: WATER INFILTRATION IN NON- INSTRUCTIONAL SPACE
Deficiency Location/Instance	Basement - C04A
Deficiency Quantity	300
Quantity Uom	S.F.
Potential Action	INSTALL WATERPROOFING
Urgency of Action	PRIORITY 5
Purpose of Action	LEVEL 5
Deficiency Photo1

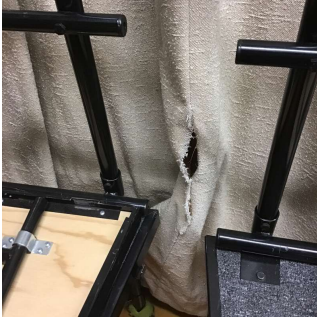
Question	Response
INTERIOR	
AUDITORIUM	
Floor Finish	
Deficiency Photo1	 
	Near Seat H/1
Violations	No violations recorded.
Sliding-folding Partition	
Instance on 1st Floor (325 Seats)	Does not Exist
Stage	
Instance on 1st Floor (325 Seats)	Inspected
Stage	Inspected
Instance on 1st Floor (325 Seats)	Inspected
Condition	2 - Between Good and Fair
Deficiency	DAMAGED STEPS
Deficiency Location/Instance	Left Side
Deficiency Quantity	10
Quantity Uom	S.F.
Potential Action	REPLACE
Urgency of Action	PRIORITY 3
Purpose of Action	LEVEL 2
Deficiency Photo1	 
	Left Side
Violations	No violations recorded.
Stage Curtain Rigging	
Instance on 1st Floor (325 Seats)	Inspected
Condition	2 - Between Good and Fair
Deficiency	No deficiencies recorded
Stage Curtains	
Instance on 1st Floor (325 Seats)	Inspected
Condition	3 - Fair
Deficiency	WORN/DETERIORATED
Deficiency Location/Instance	Back Curtains
Deficiency Quantity	100
Quantity Uom	S.F.

Question	Response
INTERIOR	
AUDITORIUM	
Stage	
Stage Curtains	
Potential Action	REPLACE
Urgency of Action	PRIORITY 3
Purpose of Action	LEVEL 2
Deficiency Photo1

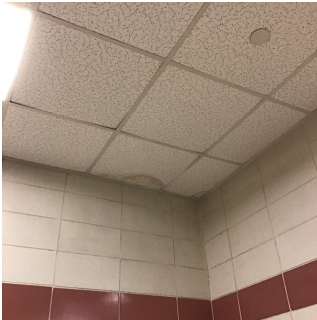
Question	Response
INTERIOR	
CAFETERIA	
Ceiling	
Deficiency Photo1	 
	Near center
Violations	No violations recorded.
Instance on 1st Floor - Students	Inspected
Condition	2 - Between Good and Fair
Deficiency	ACOUSTIC TILES: DAMAGED/MISSING
Deficiency Location/Instance	Near center, Windows
Deficiency Quantity	40
Quantity Uom	S.F.
Potential Action	REPLACE
Urgency of Action	PRIORITY 3
Purpose of Action	LEVEL 2
Deficiency Photo1

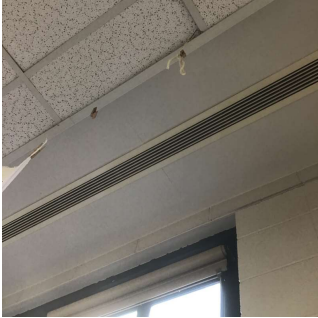
Back wall
Violations	No violations recorded.
Window Curtains/Shades/Blinds	
Instance on 1st Floor - Staff (600 SF)	Does not Exist
Instance on 1st Floor - Students	Does not Exist
CLASSROOMS/CORRIDORS/ADMIN SPACES	
Ceiling	Inspected
Condition	2 - Between Good and Fair
Deficiency	GYPSUM BOARD: DAMAGED/DETERIORATED
Deficiency Location/Instance	Rooms 247, 232, 300, 338, 339, and others.
Deficiency Quantity	100
Quantity Uom	S.F.
Potential Action	REPLACE
Urgency of Action	PRIORITY 3
Purpose of Action	LEVEL 2
Deficiency Photo1

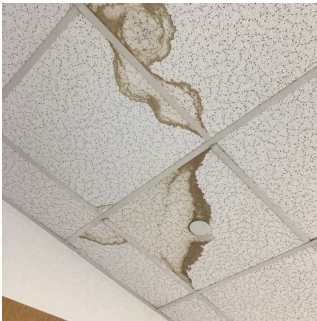
Room 300
Violations	No violations recorded.
Deficiency	ACOUSTIC TILES: DAMAGED/MISSING
Deficiency Location/Instance	Rooms 218, 308, 413, 146D, Corridor near Room 111, and others.
Deficiency Quantity	250
Quantity Uom	S.F.
Potential Action	REPLACE

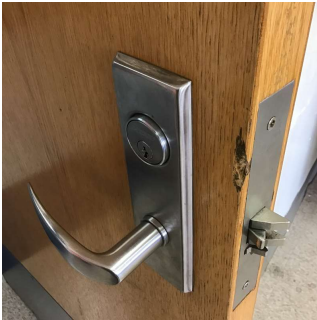
Room 413
Violations	No violations recorded.
Door(s)	Inspected
Condition	5 - Poor
Deficiency	WOOD: DETERIORATED DOOR
Deficiency Location/Instance	Rooms 308, 332, 413, 438, 446, and others.
Deficiency Quantity	9
Quantity Uom	EACH
Potential Action	MAINTENANCE
Urgency of Action	PRIORITY 3
Purpose of Action	LEVEL 2
Deficiency Photo1

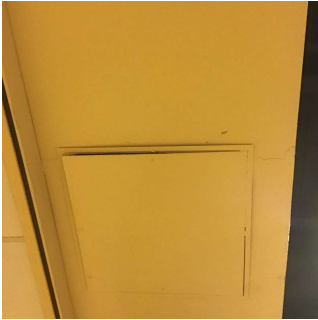
Violations	Room C46 - Gymnasium Office No violations recorded.
Deficiency	GYPSUM BOARD: DAMAGED/DETERIORATED
Deficiency Location/Instance	Near Sliding Partition
Deficiency Quantity	10
Quantity Uom	S.F.
Potential Action	REPLACE
Urgency of Action	PRIORITY 3
Purpose of Action	LEVEL 2
Deficiency Photo1

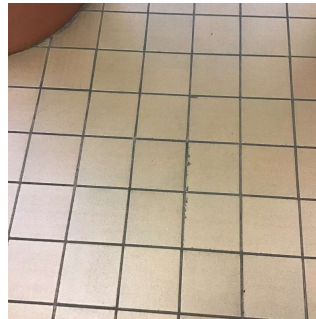
Instance on 1st Floor	Inspected
Condition	2 - Between Good and Fair
Deficiency	QUARRY TILE: BROKEN/MISSING TILES
Deficiency Location/Instance	Serving Area
Deficiency Quantity	10
Quantity Uom	S.F.
Potential Action	REPLACE
Urgency of Action	PRIORITY 3
Purpose of Action	LEVEL 2
Deficiency Photo1

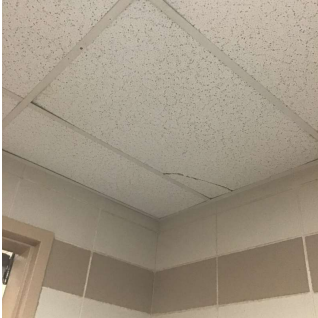
Question	Response
INTERIOR	
STAIRS/RAMPS: INTERIOR	
Ceiling	
Condition	2 - Between Good and Fair
Deficiency	ACOUSTIC TILES: DAMAGED/MISSING
Deficiency Location/Instance	Stair C/Basement
Deficiency Quantity	10
Quantity Uom	S.F.
Potential Action	REPLACE
Urgency of Action	PRIORITY 3
Purpose of Action	LEVEL 2
Deficiency Photo1

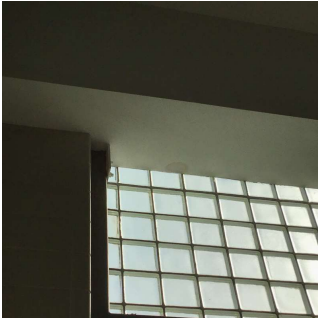
Violations	Stair C/Basement No violations recorded.
Deficiency	GYPSUM BOARD: DAMAGED/DETERIORATED
Deficiency Location/Instance	Stair B/2, 4
Deficiency Quantity	20
Quantity Uom	S.F.
Potential Action	REPLACE
Urgency of Action	PRIORITY 3
Purpose of Action	LEVEL 2
Deficiency Photo1

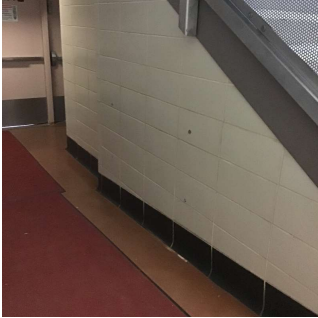
Violations	Stair B/4 No violations recorded.
Door(s)	Inspected
Condition	2 - Between Good and Fair
Deficiency	No deficiencies recorded
Partition	Does not Exist
Railings	Inspected
Condition	3 - Fair
Deficiency	METAL: MISSING
Deficiency Location/Instance	Stair B/1
Deficiency Quantity	10
Quantity Uom	L.F.

Question	Response
INTERIOR	
STAIRS/RAMPS: INTERIOR	
Railings	
Potential Action	REPLACE
Urgency of Action	PRIORITY 5
Purpose of Action	LEVEL 6
Deficiency Photo1

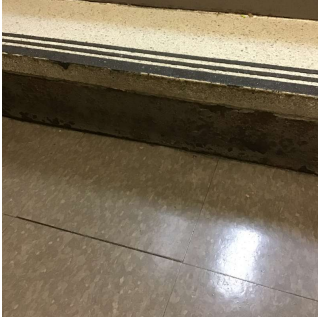
Stair B/1
Violations	No violations recorded.
Stairs and Landings	Inspected
Condition	2 - Between Good and Fair
Deficiency	METAL: RUST - MAJOR
Deficiency Location/Instance	Stairs B/Basement, C/Basement
Deficiency Quantity	20
Quantity Uom	S.F.
Potential Action	REPLACE
Urgency of Action	PRIORITY 3
Purpose of Action	LEVEL 2
Deficiency Photo1

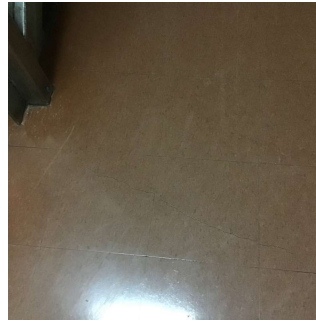
Stair C/1

Stair C/Basement
Violations	No violations recorded.
Deficiency	VINYL TILES: BROKEN/DETERIORATED/MISSING TILES
Deficiency Location/Instance	Stairs B/1, C/1
Deficiency Quantity	20
Quantity Uom	S.F.
Potential Action	REPLACE
Urgency of Action	PRIORITY 3
Purpose of Action	LEVEL 2

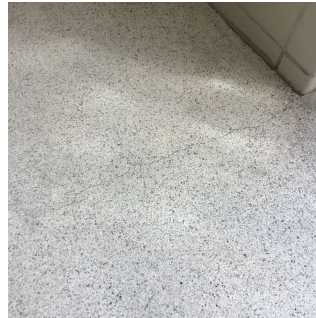
Stair B/1

TERRAZZO: CRACKS

REPLACE

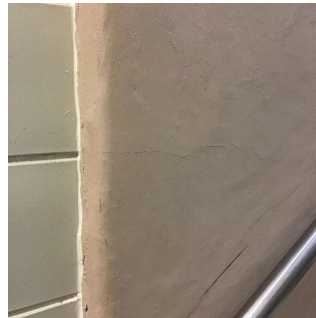
PLASTER: CRACKS/SPALLING

REPLACE

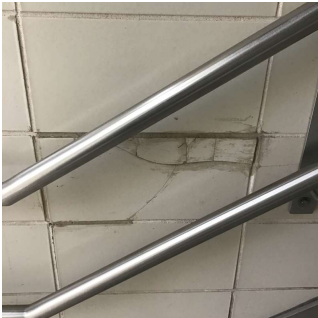
Question	Response
INTERIOR	
STAIRS/RAMPS: INTERIOR	
Walls	
Violations	Stair C/Basement No violations recorded.
Deficiency	GLAZED BLOCK: CRACKS/SPALLING
Deficiency Location/Instance	Stairs B/3, C/1, 3
Deficiency Quantity	20
Quantity Uom	S.F.
Potential Action	REPLACE
Urgency of Action	PRIORITY 3
Purpose of Action	LEVEL 2
Deficiency Photo1

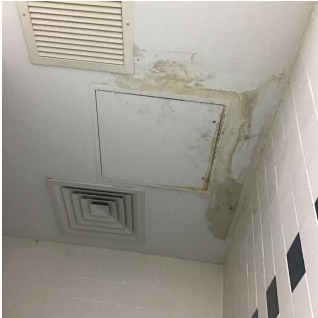
Violations	Stair C/1 No violations recorded.
TOILET ROOMS - STAFF	Inspected
Ceiling	Inspected
Condition	3 - Fair
Deficiency	GYPSUM BOARD: DAMAGED/DETERIORATED
Deficiency Location/Instance	Rooms C36, 109, Inside Room C46 - Gymnasium Office.
Deficiency Quantity	30
Quantity Uom	S.F.
Potential Action	REPLACE
Urgency of Action	PRIORITY 3
Purpose of Action	LEVEL 2
Deficiency Photo1

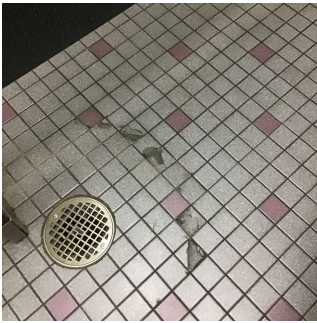
Room 327
Violations	No violations recorded.
Door(s)	Inspected
Condition	5 - Poor
Deficiency	METAL: DAMAGED LOUVER
Deficiency Location/Instance	Rooms C05A, C05B, 327, 427, Cafeteria-Boys
Deficiency Quantity	5
Quantity Uom	EACH
Potential Action	MAINTENANCE
Urgency of Action	PRIORITY 3
Purpose of Action	LEVEL 2
Deficiency Photo1	 
	Cafeteria - Boys
Violations	No violations recorded.
Floor Finish	Inspected
Condition	2 - Between Good and Fair
Deficiency	CERAMIC TILE: BROKEN/MISSING TILES
Deficiency Location/Instance	Rooms 100, 102/104, Cafeteria - Boys, Cafeteria - Girls
Deficiency Quantity	20
Quantity Uom	S.F.
Potential Action	REPLACE
Urgency of Action	PRIORITY 3
Purpose of Action	LEVEL 2

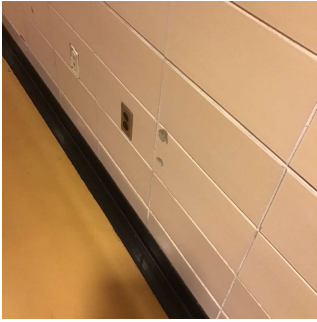
Violations	Cafeteria - Boys No violations recorded.
Stalls	Inspected
Condition	2 - Between Good and Fair
Deficiency	No deficiencies recorded
Walls	Inspected
Condition	2 - Between Good and Fair
Deficiency	GLAZED BLOCK: CRACKS/SPALLING
Deficiency Location/Instance	Near Drinking Fountain
Deficiency Quantity	10
Quantity Uom	S.F.
Potential Action	REPLACE
Urgency of Action	PRIORITY 3
Purpose of Action	LEVEL 2
Deficiency Photo1

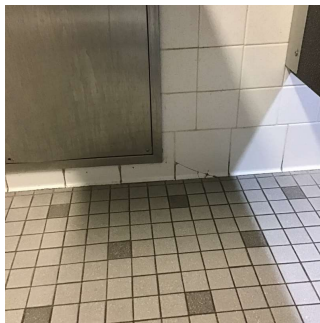
Violations	Near Drinking Fountain No violations recorded.
Deficiency	CERAMIC TILE: BROKEN/ MISSING
Deficiency Location/Instance	Rooms C05B, 327, 423, 427
Deficiency Quantity	20
Quantity Uom	S.F.
Potential Action	REPLACE
Urgency of Action	PRIORITY 3
Purpose of Action	LEVEL 2

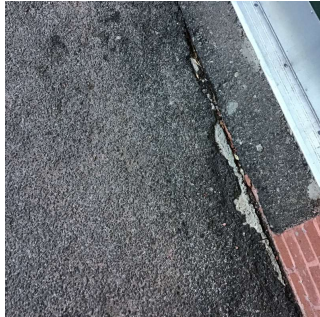
Violations	Room C05B No violations recorded.
LIFE SAFETY	Inspected
F.D. HOLDING AREA	Does not Exist
STEEL STAIRS	Does not Exist
SITE	Inspected
CONTAINERIZATION	Does not Exist
Drainage System for Asphalt	Inspected
Catch Basins/Manhole - Surrounded by asphalt	Inspected
Condition	2 - Between Good and Fair
Deficiency	No deficiencies recorded
Culverts - Asphalt Covering	Does not Exist
Drainage System for Concrete	Inspected
Catch Basins/Manhole - Surrounded by concrete	Inspected
Condition	2 - Between Good and Fair
Deficiency	No deficiencies recorded
Culverts - Concrete Covering	Does not Exist
Drainage System for Soil	Does not Exist
DRINKING FOUNTAINS	Does not Exist
FENCES	Inaccessible
IRRIGATION SYSTEM	Does not Exist
PAVING	Inspected
Student Non-Use	Inspected
Gravel Exists?	No
Asphalt	Inspected
Condition	2 - Between Good and Fair
Deficiency	CRACKS - MAJOR

Deficiency Location/Instance	Near Exit 5
Deficiency Quantity	30
Quantity Uom	S.F.
Potential Action	REPLACE
Urgency of Action	PRIORITY 3
Purpose of Action	LEVEL 2

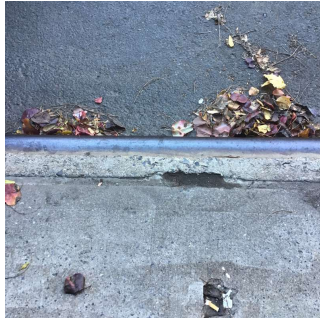
29th Street
Violations	No violations recorded.
Deficiency	DAMAGED/DETERIORATED/MISSING SECTIONS

Question	Response
SITE	
PAVING	
DOT Sidewalk	
Concrete	
Deficiency Location/Instance	29th Street, 30th Street
Deficiency Quantity	250
Quantity Uom	S.F.
Potential Action	REPLACE
Urgency of Action	PRIORITY 3
Purpose of Action	LEVEL 2
Deficiency Photo1	 
Violations	29th Street No violations recorded.
Pavers	Does not Exist
PLAYGROUNDS	Inspected
Instance on 2nd Floor - Plaza Deck	Inaccessible
PLAYING SURFACE	Does not Exist
RETAINING WALLS	Inspected
Are there any Retaining Walls 6' OR higher facing public street/sidewalk?	No
Condition	3 - Fair
Deficiency	CAST IN PLACE CONCRETE: CRACKS/SPALLING - MAJOR
Deficiency Location/Instance	30th Street, Near Exit 5
Deficiency Quantity	40
Quantity Uom	S.F.
Potential Action	REPLACE
Urgency of Action	PRIORITY 3
Purpose of Action	LEVEL 2
Deficiency Photo1	 
Violations	30th Street No violations recorded.
SEATING	Inspected
Benches	Inspected
Concrete	Does not Exist
