NYC Department of Education
Building Condition Assessment Survey 2023 - 2024

Architectural Inspection

Asset: I.S. 238 - QUEENS, 88-15 182 STREET, New York, 11423

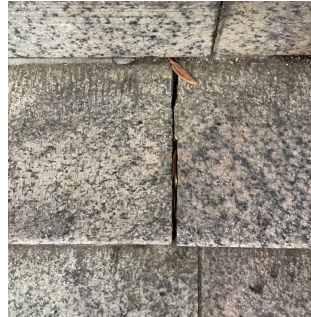
STONE: DETERIORATED JOINTS

Deficiency Quantity	70
Quantity Uom	L.F.
Potential Action	REPOINT
Urgency of Action	PRIORITY 4
Purpose of Action	LEVEL 2
Deficiency Photo1

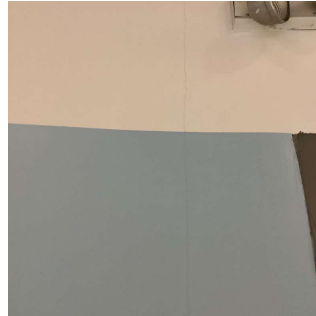
Near Entrance

PLASTER: CRACKS/SPALLING

REPLACE

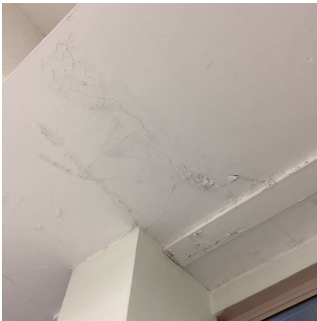
Question	Response
INTERIOR	
CAFETERIA	
Ceiling	
Instance on Ground Floor - Students	Inspected
Condition	2 - Between Good and Fair
Deficiency	ACOUSTIC TILES ON PLASTER: DAMAGED/MISSING
Deficiency Location/Instance	Near center
Deficiency Quantity	20
Quantity Uom	S.F.
Potential Action	REPLACE
Urgency of Action	PRIORITY 3
Purpose of Action	LEVEL 2
Deficiency Photo1	 
Violations	Near center No violations recorded.
Deficiency	PLASTER: CRACKS/SPALLING
Deficiency Location/Instance	Near Windows
Deficiency Quantity	10
Quantity Uom	S.F.
Potential Action	REPLACE
Urgency of Action	PRIORITY 3
Purpose of Action	LEVEL 2
Deficiency Photo1	 
Violations	Near Windows No violations recorded.
Instance on Ground Floor - Staff	Inspected
Condition	2 - Between Good and Fair
Deficiency	PLASTER: CRACKS/SPALLING
Deficiency Location/Instance	Near Windows
Deficiency Quantity	20
Quantity Uom	S.F.
Potential Action	REPLACE
Urgency of Action	PRIORITY 3
Purpose of Action	LEVEL 2

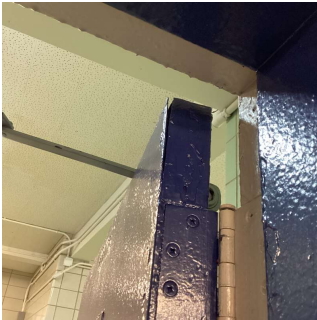
Near Windows
Violations	No violations recorded.
Door(s)	
Instance on Ground Floor - Students	Inspected
Condition	3 - Fair
Deficiency	METAL: DETERIORATED DOOR
Deficiency Location/Instance	Entrance
Deficiency Quantity	1
Quantity Uom	EACH
Potential Action	MAINTENANCE
Urgency of Action	PRIORITY 3
Purpose of Action	LEVEL 2
Deficiency Photo1

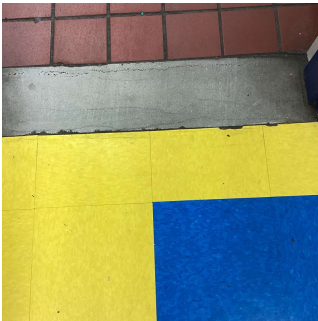
Entrance
Violations	No violations recorded.
Fixed Equipment	
Instance on Ground Floor - Staff	Does not Exist
Instance on Ground Floor - Students	Does not Exist
Floor Finish	
Instance on Ground Floor - Students	Inspected
Condition	2 - Between Good and Fair
Deficiency	VINYL TILES: BROKEN/DETERIORATED/MISSING TILES
Deficiency Location/Instance	Near Serving Area
Deficiency Quantity	10
Quantity Uom	S.F.
Potential Action	REPLACE
Urgency of Action	PRIORITY 3
Purpose of Action	LEVEL 2

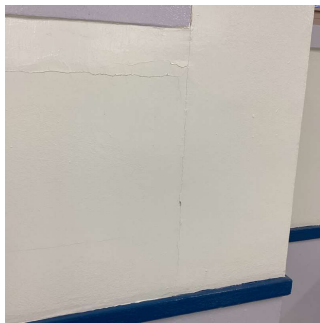
Violations	Near Windows No violations recorded.
Instance on Ground Floor - Staff	Inspected
Condition	2 - Between Good and Fair
Deficiency	PLASTER: CRACKS/SPALLING
Deficiency Location/Instance	Near Windows, Serving Area, Entrance
Deficiency Quantity	30

Quantity Uom	S.F.
Potential Action	REPLACE
Urgency of Action	PRIORITY 3
Purpose of Action	LEVEL 2

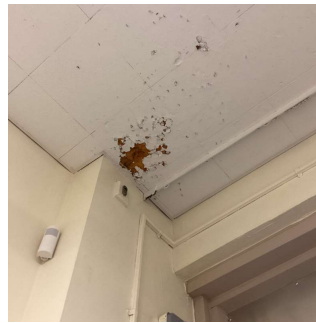
Room 327

Violations	Room 253 No violations recorded.
Deficiency	ACOUSTIC TILES ON PLASTER: DAMAGED/MISSING
Deficiency Location/Instance	Rooms 125, 243, 305, 327, Corridor near Room 355, and others.
Deficiency Quantity	1,300
Quantity Uom	S.F.
Potential Action	REPLACE
Urgency of Action	PRIORITY 3
Purpose of Action	LEVEL 2

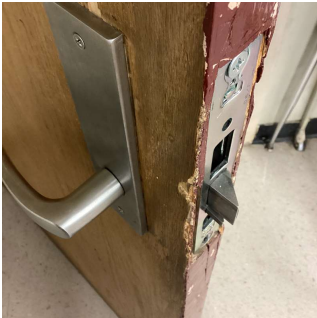
Question	Response
INTERIOR	
CLASSROOMS/CORRIDORS/ADMIN SPACES	
Door(s)	
	Room 307
Violations	No violations recorded.
Deficiency	WOOD: DETERIORATED DOOR
Deficiency Location/Instance	Rooms 127, 129, 243, 306, 339, and others.
Deficiency Quantity	25
Quantity Uom	EACH
Potential Action	MAINTENANCE
Urgency of Action	PRIORITY 3
Purpose of Action	LEVEL 2
Deficiency Photo1

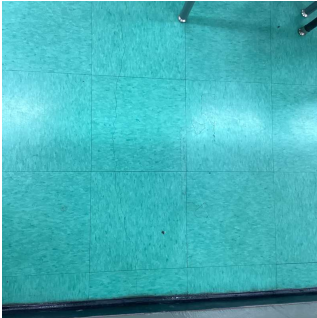
Room 339
Violations	No violations recorded.
Floor Finish	Inspected
Condition	2 - Between Good and Fair
Deficiency	VINYL TILES: DETERIORATED SUBSTRATE
Deficiency Location/Instance	Room 155
Deficiency Quantity	10
Quantity Uom	S.F.
Potential Action	REPLACE
Urgency of Action	PRIORITY 3
Purpose of Action	LEVEL 2
Deficiency Photo1

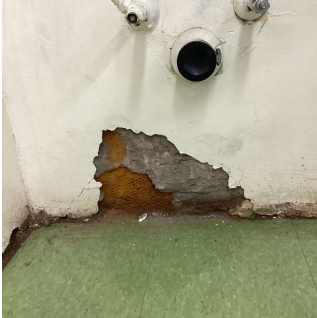
Question	Response
INTERIOR	
CLASSROOMS/CORRIDORS/ADMIN SPACES	
Walls	Inspected
Condition	2 - Between Good and Fair
Deficiency	PLASTER: CRACKS/SPALLING
Deficiency Location/Instance	Rooms 116, 153, 329, 353, Corridor near Room 308, and others.
Deficiency Quantity	400
Quantity Uom	S.F.
Potential Action	REPLACE
Urgency of Action	PRIORITY 3
Purpose of Action	LEVEL 2
Deficiency Photo1

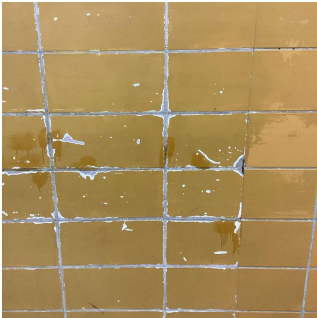
Room 329
Violations	No violations recorded.
Deficiency	GLAZED BLOCK: CRACKS/SPALLING
Deficiency Location/Instance	Corridor near Rooms G62, 260, 353, 358, Corridor near Stair A/3, and others.
Deficiency Quantity	100
Quantity Uom	S.F.
Potential Action	REPLACE
Urgency of Action	PRIORITY 3
Purpose of Action	LEVEL 2
Deficiency Photo1

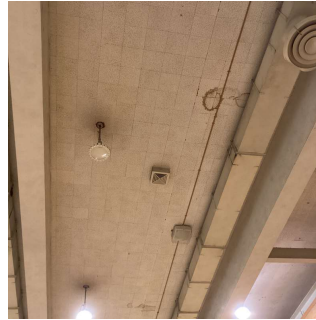
Near center

Condition	2 - Between Good and Fair
Deficiency	ACOUSTIC TILES ON PLASTER: DAMAGED/MISSING
Deficiency Location/Instance	Near center, Entrances
Deficiency Quantity	30
Quantity Uom	S.F.
Potential Action	REPLACE
Urgency of Action	PRIORITY 3
Purpose of Action	LEVEL 2
Deficiency Photo1

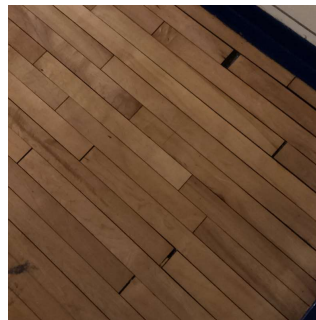
Instance on Ground Floor	Inspected
Condition	2 - Between Good and Fair
Deficiency	WOOD: DAMAGED/DETERIORATED
Deficiency Location/Instance	Near Entrance
Deficiency Quantity	20
Quantity Uom	S.F.
Potential Action	REPLACE
Urgency of Action	PRIORITY 3
Purpose of Action	LEVEL 2
Deficiency Photo1

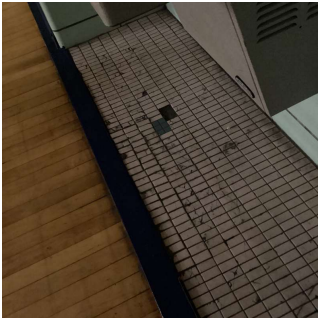
Question	Response
INTERIOR	
GYMNASIUM	
Floor Finish	
Violations	No violations recorded.
Deficiency	CERAMIC TILE: BROKEN/MISSING TILES
Deficiency Location/Instance	Drinking Fountain Area
Deficiency Quantity	20
Quantity Uom	S.F.
Potential Action	REPLACE
Urgency of Action	PRIORITY 3
Purpose of Action	LEVEL 2
Deficiency Photo1

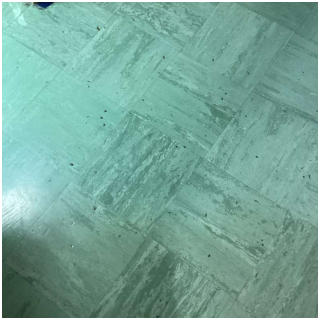
Violations	Drinking Fountain Area No violations recorded.
Deficiency	VINYL TILES: BROKEN/DETERIORATED/MISSING TILES
Deficiency Location/Instance	Near Entrance
Deficiency Quantity	20
Quantity Uom	S.F.
Potential Action	REPLACE
Urgency of Action	PRIORITY 3
Purpose of Action	LEVEL 2
Deficiency Photo1

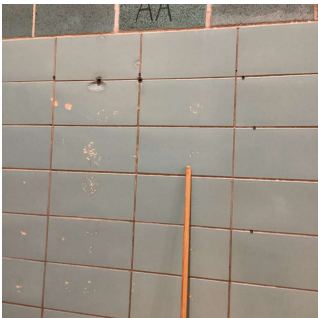
Violations	Near Drinking Fountain No violations recorded.
Deficiency	GLAZED BLOCK: CRACKS/SPALLING
Deficiency Location/Instance	Near Entrance, Girls Locker Room, Drinking Fountain Area.
Deficiency Quantity	20
Quantity Uom	S.F.
Potential Action	REPLACE
Urgency of Action	PRIORITY 3
Purpose of Action	LEVEL 2
Deficiency Photo1

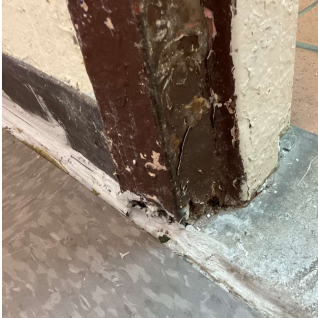
Question	Response
INTERIOR	
KITCHEN	
Door(s)	
Instance on Ground Floor	Inspected
Condition	3 - Fair
Deficiency	METAL: DETERIORATED DOOR AND FRAME
Deficiency Location/Instance	Room G77
Deficiency Quantity	1
Quantity Uom	EACH
Potential Action	MAINTENANCE
Urgency of Action	PRIORITY 3
Purpose of Action	LEVEL 2
Deficiency Photo1

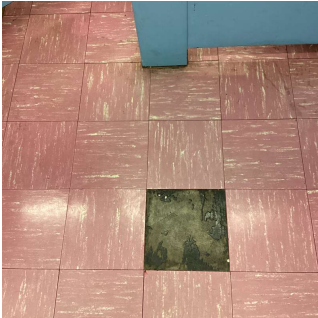
Violations	Room G77 No violations recorded.
Floor Finish	
Instance on Ground Floor	Inspected
Condition	3 - Fair
Deficiency	VINYL TILES: BROKEN/DETERIORATED/MISSING TILES
Deficiency Location/Instance	Women locker Room / Inside Kitchen
Deficiency Quantity	10
Quantity Uom	S.F.
Potential Action	REPLACE
Urgency of Action	PRIORITY 3
Purpose of Action	LEVEL 2
Deficiency Photo1

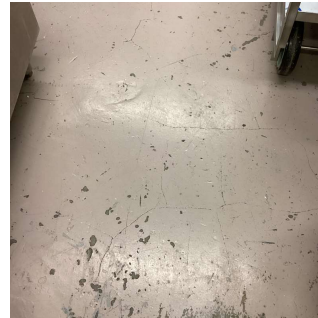
Violations	Women locker Room / Inside Kitchen No violations recorded.
Deficiency	CONCRETE: CRACKS
Deficiency Location/Instance	Storage/ Serving Area
Deficiency Quantity	20
Quantity Uom	S.F.
Potential Action	REPLACE
Urgency of Action	PRIORITY 3

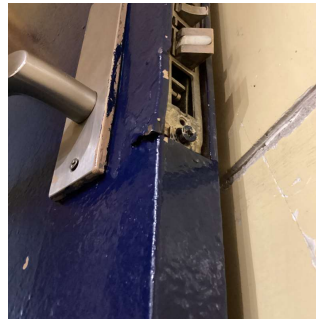
Instance on Ground Floor - Girls (118 Lockers)	Inspected
Condition	3 - Fair
Deficiency	METAL: DETERIORATED DOOR
Deficiency Location/Instance	Entrance
Deficiency Quantity	1
Quantity Uom	EACH
Potential Action	MAINTENANCE
Urgency of Action	PRIORITY 3
Purpose of Action	LEVEL 2
Deficiency Photo1

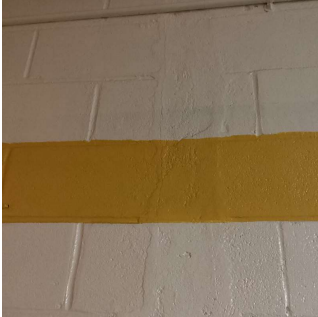
Question	Response
INTERIOR	
LOCKER ROOM	
Walls	
Deficiency Location/Instance	Near Entrance
Deficiency Quantity	10
Quantity Uom	S.F.
Potential Action	REPLACE
Urgency of Action	PRIORITY 3
Purpose of Action	LEVEL 2
Deficiency Photo1

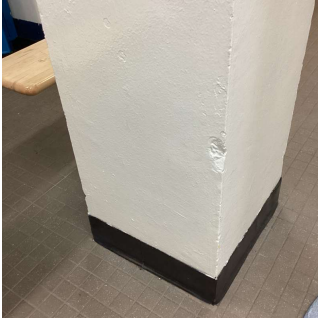
Near Entrance
Violations	No violations recorded.
Instance on Ground Floor - Boys (124 Lockers)	Inspected
Condition	2 - Between Good and Fair
Deficiency	PLASTER: CRACKS/SPALLING
Deficiency Location/Instance	Columns
Deficiency Quantity	10
Quantity Uom	S.F.
Potential Action	REPLACE
Urgency of Action	PRIORITY 3
Purpose of Action	LEVEL 2
Deficiency Photo1

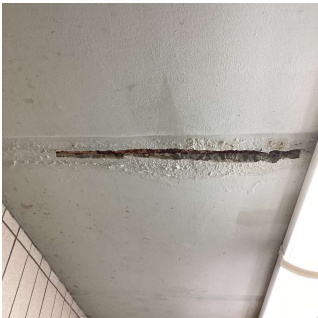
Question	Response
INTERIOR	
SCIENCE PREP ROOM	Inspected
Fixed Equipment	
Instance on Rooms 333, 353A	Inspected
Condition	2 - Between Good and Fair
Deficiency	No deficiencies recorded
SHOWER ROOM	Inspected
Instance on Ground Floor - Boys	Inaccessible
Instance on Ground Floor - Girls	Inaccessible
STAIRS/RAMPS: INTERIOR	Inspected
Do Letter Stair Signs Exist?	Yes
Ceiling	
Condition	2 - Between Good and Fair
Deficiency	PLASTER: CRACKS/SPALLING
Deficiency Location/Instance	Stair A/3, B/Ground Floor, D/1, Ground Floor.
Deficiency Quantity	50
Quantity Uom	S.F.
Potential Action	REPLACE
Urgency of Action	PRIORITY 3
Purpose of Action	LEVEL 2
Deficiency Photo1

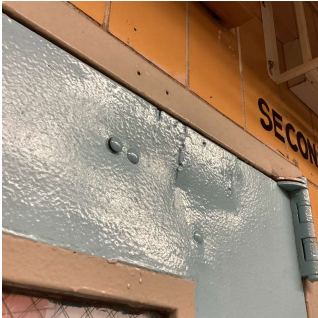
Stair A/2

Stair D/1
Violations	No violations recorded.
Door(s)	Inspected
Condition	5 - Poor
Deficiency	METAL: DETERIORATED DOOR
Deficiency Location/Instance	Stair A/2, E/1
Deficiency Quantity	2
Quantity Uom	EACH
Potential Action	MAINTENANCE
Urgency of Action	PRIORITY 3
Purpose of Action	LEVEL 2

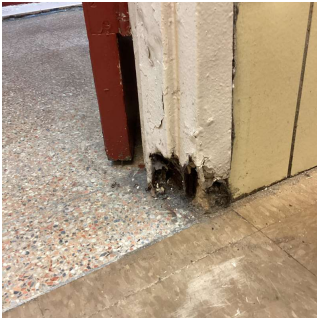
Question	Response
INTERIOR	
STAIRS/RAMPS: INTERIOR	
Door(s)	
Violations	No violations recorded.
Deficiency	METAL: DETERIORATED DOOR AND FRAME
Deficiency Location/Instance	Stair C/Ground Floor - Vestibule, D/1, F/Ground Floor - Vestibule,
Deficiency Quantity	8
Quantity Uom	EACH
Potential Action	MAINTENANCE
Urgency of Action	PRIORITY 3
Purpose of Action	LEVEL 2
Deficiency Photo1

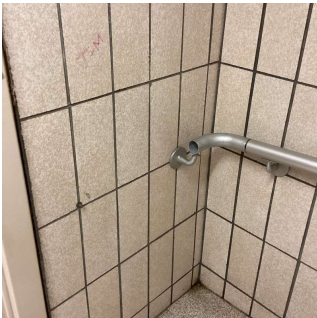
Violations	No violations recorded.
Partition	Does not Exist
Railings	Inspected
Condition	4 - Between Fair and Poor
Deficiency	METAL: DAMAGED
Deficiency Location/Instance	Stair E/Ground Floor - Vestibule
Deficiency Quantity	10
Quantity Uom	L.F.
Potential Action	REPLACE
Urgency of Action	PRIORITY 3
Purpose of Action	LEVEL 2
Deficiency Photo1

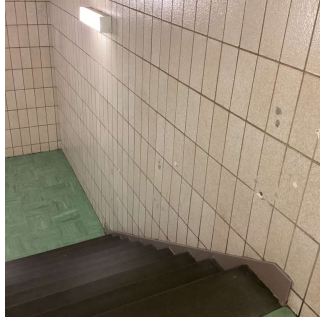
Violations	No violations recorded.
Deficiency	METAL: MISSING
Deficiency Location/Instance	Stair F/3
Deficiency Quantity	10
Quantity Uom	L.F.
Potential Action	REPLACE
Urgency of Action	PRIORITY 5

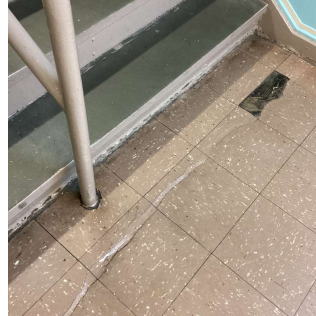
Stair C/Ground Floor

VINYL TILES: DETERIORATED SUBSTRATE

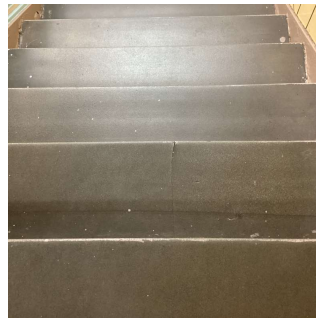
Stair C/Ground Floor

STONE: BROKEN/MISSING

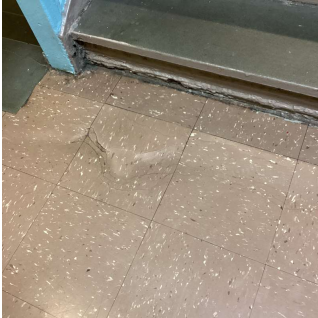
Question	Response
INTERIOR	
STAIRS/RAMPS: INTERIOR	
Stairs and Landings	
Deficiency	TERRAZZO: CRACKS
Deficiency Location/Instance	Near Auditorium, Stair A/Ground Floor - Vestibule, F/Ground Floor - Vestibule, E/Ground Floor - Vestibule.
Deficiency Quantity	40
Quantity Uom	S.F.
Potential Action	REPLACE
Urgency of Action	PRIORITY 3
Purpose of Action	LEVEL 2
Deficiency Photo1	 
Violations	Near Auditorium No violations recorded.
Deficiency	VINYL TILES: BROKEN/DETERIORATED/MISSING TILES
Deficiency Location/Instance	Stairs A/Ground Floor, C/Ground Floor, 1, 2, 3, and others.
Deficiency Quantity	100
Quantity Uom	S.F.
Potential Action	REPLACE
Urgency of Action	PRIORITY 3
Purpose of Action	LEVEL 2
Deficiency Photo1

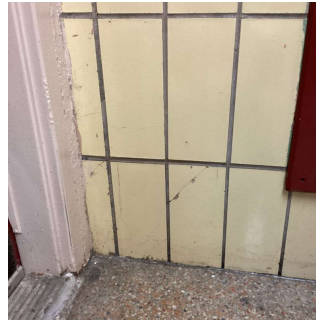
Stair C/Ground Floor - Vestibule

Violations	Stair C/1 No violations recorded.
Walls	Inspected
Condition	2 - Between Good and Fair
Deficiency	GLAZED BLOCK: CRACKS/SPALLING
Deficiency Location/Instance	Stairs A/Ground Floor, B/Ground Floor, C/Ground Floor - Vestibule, E/Ground Floor.

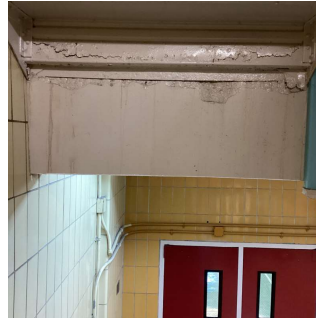
Stair C/Ground Floor

PLASTER: CRACKS/SPALLING

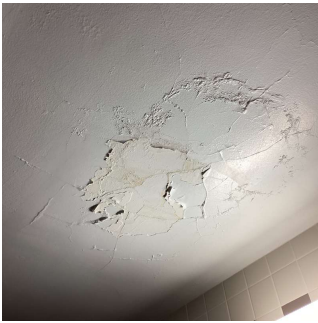
Question	Response
INTERIOR	
TOILET ROOMS - STAFF	
Ceiling	
Deficiency Photo1

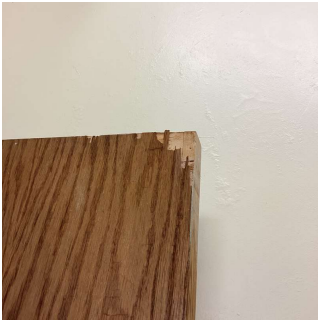
Violations	Room 224 No violations recorded.
Door(s)	
Condition	Inspected 5 - Poor
Deficiency	WOOD: DETERIORATED DOOR
Deficiency Location/Instance	Rooms 254, 329, 354, Women locker Room / Inside Kitchen, Men locker Room / Inside Kitchen, and others.
Deficiency Quantity	10
Quantity Uom	EACH
Potential Action	MAINTENANCE
Urgency of Action	PRIORITY 3
Purpose of Action	LEVEL 2
Deficiency Photo1

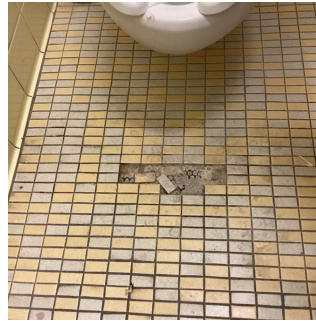
Violations	Men locker Room / Inside Kitchen No violations recorded.
Floor Finish	
Condition	Inspected 3 - Fair
Deficiency	CERAMIC TILE: BROKEN/MISSING TILES
Deficiency Location/Instance	Rooms G/62, 124, 324, Women locker Room / Inside Kitchen, Men locker Room / Inside Kitchen, and others.
Deficiency Quantity	40
Quantity Uom	S.F.
Potential Action	REPLACE
Urgency of Action	PRIORITY 3
Purpose of Action	LEVEL 2

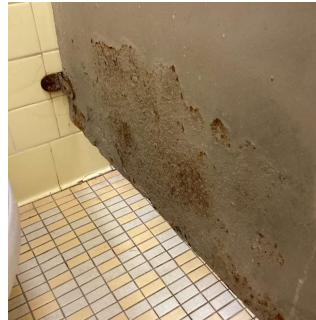
Men locker Room / Inside Kitchen

RUST - MAJOR

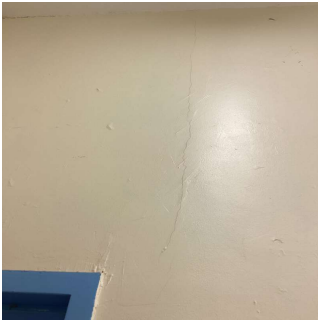
PLASTER: CRACKS/SPALLING

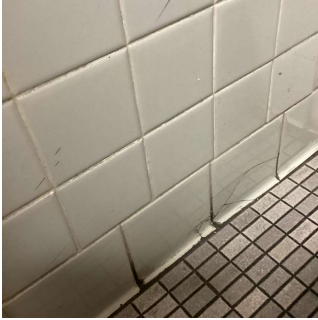
Women locker Room / Inside Kitchen
Violations	No violations recorded.
Deficiency	CERAMIC TILE: BROKEN/ MISSING
Deficiency Location/Instance	Rooms G/62, 124, 154, 324
Deficiency Quantity	30
Quantity Uom	S.F.
Potential Action	REPLACE
Urgency of Action	PRIORITY 3
Purpose of Action	LEVEL 2
Deficiency Photo1

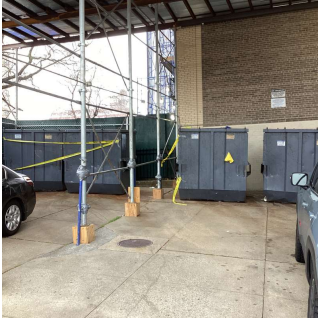
Question	Response
SITE	
CONTAINERIZATION	
Deficiency Photo1

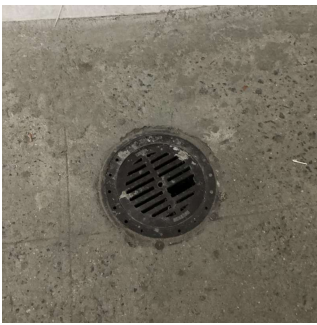
Question	Response
SITE	
Drainage System for Concrete	
Catch Basins/Manhole - Surrounded by concrete	
Deficiency Photo1

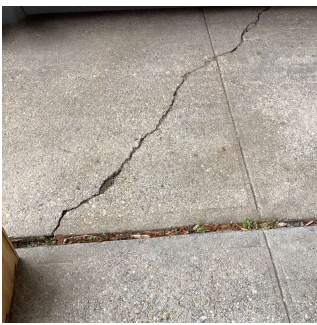
Violations	Near Exit 4 No violations recorded.
Culverts - Concrete Covering	Does not Exist
Drainage System for Soil	Does not Exist
DRINKING FOUNTAINS	Does not Exist
FENCES	Inaccessible
IRRIGATION SYSTEM	Does not Exist
PAVING	Inspected
Student Non-Use	Inspected
Gravel Exists?	No
Asphalt	Does not Exist
Concrete	Inspected
Condition	3 - Fair
Deficiency	DAMAGED/DETERIORATED/MISSING SECTIONS
Deficiency Location/Instance	182nd Street
Deficiency Quantity	100
Quantity Uom	S.F.
Potential Action	REPLACE
Urgency of Action	PRIORITY 3
Purpose of Action	LEVEL 2
Deficiency Photo1

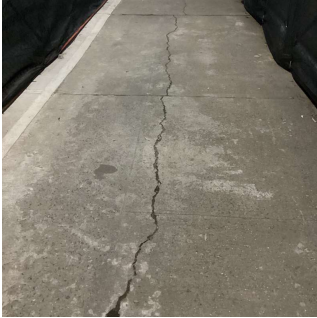
Question	Response
SITE	
PAVING	
Site Sidewalks & Walkways	
Concrete	
Deficiency Quantity	800
Quantity Uom	S.F.
Potential Action	REPLACE
Urgency of Action	PRIORITY 3
Purpose of Action	LEVEL 2
Deficiency Photo1

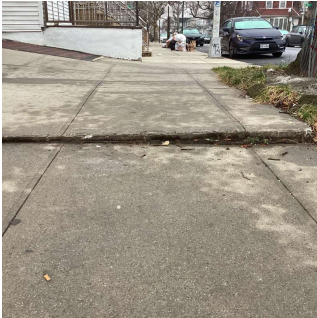
Near Exit 3
Violations	No violations recorded.
Pavers	Does not Exist
DOT Sidewalk	Inspected
Asphalt	Does not Exist
Concrete	Inspected
Condition	4 - Between Fair and Poor
Deficiency	HEAVING
Deficiency Location/Instance	89th Avenue
Deficiency Quantity	100
Quantity Uom	S.F.
Potential Action	REPLACE
Urgency of Action	PRIORITY 3
Purpose of Action	LEVEL 2
Deficiency Photo1

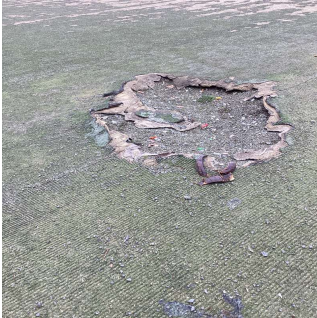
Question	Response
SITE	
PLAYING SURFACE	
Playing Field	
Urgency of Action	PRIORITY 5
Purpose of Action	LEVEL 6
Deficiency Photo1

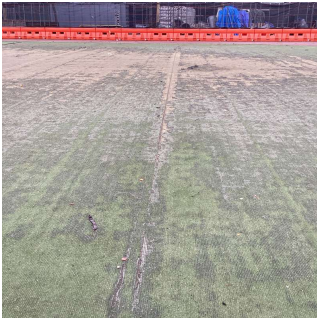
Near Playground
Violations	No violations recorded.
Deficiency	ARTIFICIAL TURF: DAMAGED/WORN OUT
Deficiency Location/Instance	Schoolyard
Deficiency Quantity	10,000
Quantity Uom	S.F.
Potential Action	REPLACE
Urgency of Action	PRIORITY 3
Purpose of Action	LEVEL 2
Deficiency Photo1
