NYC Department of Education
Building Condition Assessment Survey 2023 - 2024

Architectural Inspection

Asset: P.S. 242 - (ECC) - QUEENS, 29-66 137TH STREET, New York, 11354

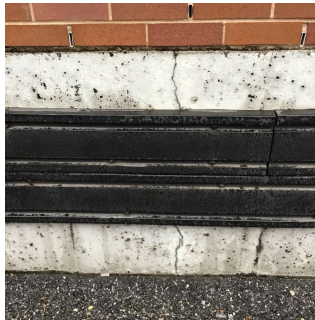
Facade C

CAST IN PLACE / PRE-CAST CONCRETE: MINOR
CRACKS/SPALLING

REPAIR

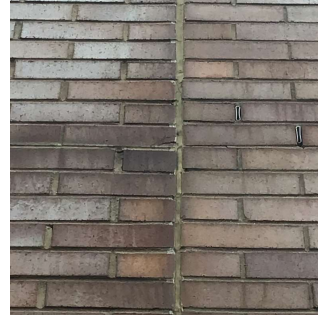
Facade C

BRICK: MINOR CRACKS AND SPALLING

PRIORITY 3
LEVEL 2

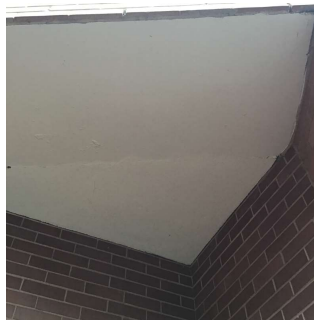
Facade B

STUCCO/PLASTER: MINOR CRACKS/SPALLING

REPAIR

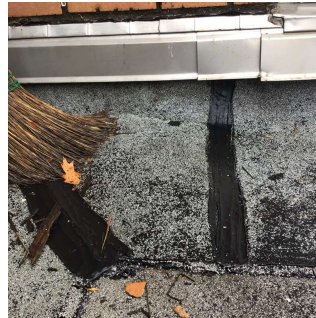
Roof 3

Question	Response
EXTERIOR	
ROOF	
Roofing	
ROOFING	
Deficiency Photo1	 
Violations	Roof 1 No violations recorded.
Instance on Modified Bitumen: All Roofs except Roof 1	Inspected
Instance Condition	3 - Fair
Instance Photo

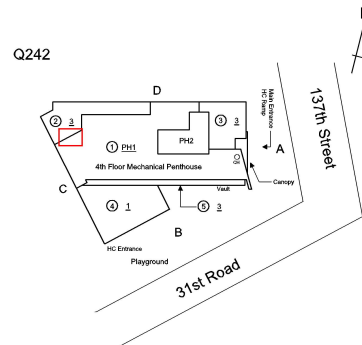
PH1
 No violations recorded.

**BULKHEAD/PENTHOUSE WALLS/EXTERIOR: DETERIORATED
JOINTS**

20
 S.F.
 REPOINT
 PRIORITY 3
 LEVEL 2

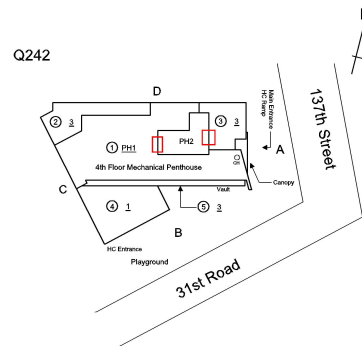
Deficiency **BULKHEAD/PENTHOUSE WALLS/EXTERIOR: CRACKS/SPALLING - MINOR**

30
 S.F.
 REPAIR
 PRIORITY 3
 LEVEL 2

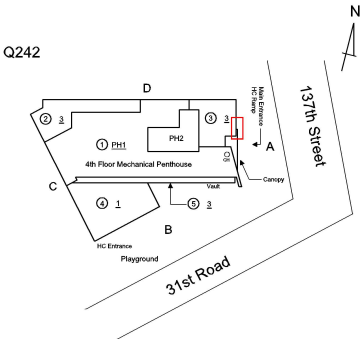
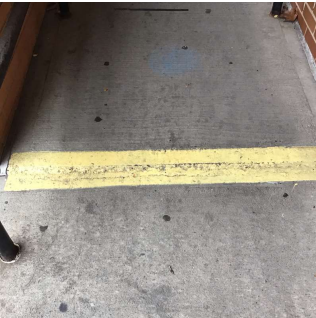
Question	Response
EXTERIOR	
STAIRS/RAMPS: EXTERIOR	
RAILINGS	Inspected
Condition	2 - Between Good and Fair
Deficiency	No deficiencies recorded
STAIRS/RAMPS	Inspected
Condition	4 - Between Fair and Poor
Deficiency	CONCRETE: CRACKS/SPALLING - MAJOR
Roof Plan reference

Deficiency Quantity	20
Quantity Uom	S.F.
Potential Action	REPLACE
Urgency of Action	PRIORITY 4
Purpose of Action	LEVEL 2
Deficiency Photo1

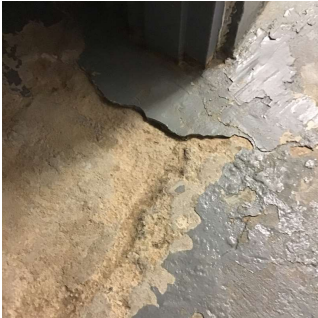
Question	Response
EXTERIOR	Inspected
WINDOWS	
WINDOWS	
Installation Year	2001
Source of Installation	Custodial Staff
Deficiency	No deficiencies recorded
INTERIOR	Inspected
POOLS	Does not Exist
STRUCTURAL	Inspected
COLUMNS/BEAMS/BEARING WALLS	Inspected
Condition	2 - Between Good and Fair
Deficiency	No deficiencies recorded
FLOOR STRUCTURE	Inspected
Condition	3 - Fair
Deficiency	CONCRETE SLAB ON GRADE: THRU CRACKS
Deficiency Location/Instance	Basement
Deficiency Quantity	40
Quantity Uom	S.F.
Potential Action	REPAIR
Urgency of Action	PRIORITY 3
Purpose of Action	LEVEL 5
Deficiency Photo1

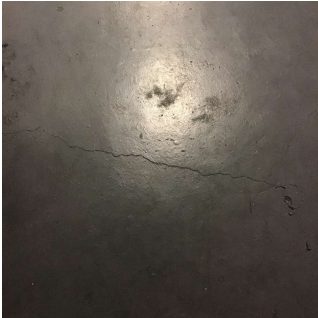
PH2

Violations	Basement No violations recorded.
Deficiency	METAL DECK AND CONCRETE: DETERIORATED
Deficiency Location/Instance	PH1, PH2, Electrical Panel Room, Water Meter Room, Machine Room, Fan Room
Deficiency Quantity	180
Quantity Uom	S.F.
Potential Action	REPAIR
Urgency of Action	PRIORITY 3
Purpose of Action	LEVEL 5
Deficiency Photo1

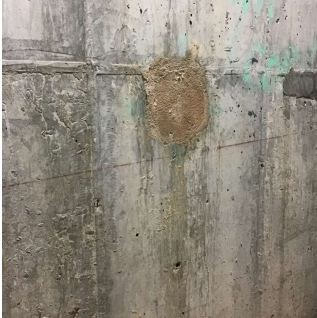
Question	Response
INTERIOR	Inspected
STRUCTURAL	
FLOOR STRUCTURE	Inspected
Violations	No violations recorded.
FOUNDATION WALLS	Inspected
Material Type(s)	Concrete
Condition	4 - Between Fair and Poor
Deficiency	CONCRETE: WATER INFILTRATION IN NON- INSTRUCTIONAL SPACE
Deficiency Location/Instance	Basement - Gas Meter Room, Stair A/Basement, Pump Room
Deficiency Quantity	300
Quantity Uom	S.F.
Potential Action	INSTALL WATERPROOFING
Urgency of Action	PRIORITY 5
Purpose of Action	LEVEL 5
Deficiency Photo1

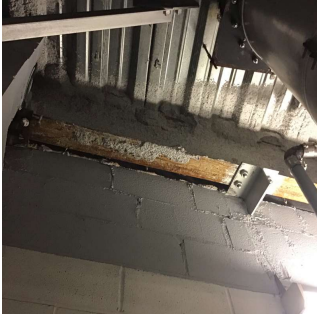
PH1 - Boiler Room
Violations	No violations recorded.

Basement - Gas Meter Room
Violations	No violations recorded.
ROOF STRUCTURE	Inspected
Condition	3 - Fair
Deficiency	STEEL COLUMNS/BEAMS: DETERIORATED/MISSING SPRAY-ON FIREPROOFING
Deficiency Location/Instance	PH - Boiler Room
Deficiency Quantity	40
Quantity Uom	S.F.
Potential Action	REPLACE
Urgency of Action	PRIORITY 3
Purpose of Action	LEVEL 5
Deficiency Photo1

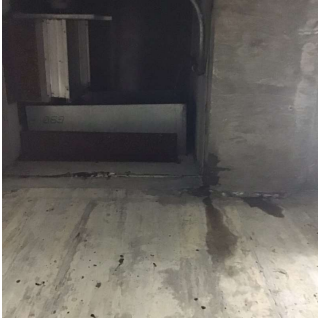
Foundation Walls	Inspected
Deficiency	No deficiencies recorded
Slab Structure	Inspected
Condition	2 - Between Good and Fair
Deficiency	No deficiencies recorded
Vault/Ash Hoist Doors and Framing	Inspected
Condition	5 - Poor
Deficiency	WATER INFILTRATION
Deficiency Location/Instance	Basement
Deficiency Quantity	10
Quantity Uom	S.F.
Potential Action	REPAIR
Urgency of Action	PRIORITY 5
Purpose of Action	LEVEL 2
Deficiency Photo1

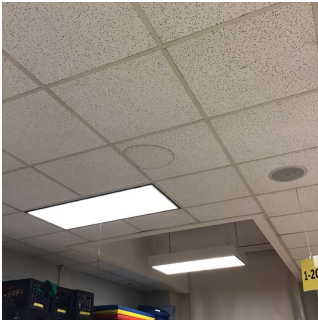
Instance on 1st Floor	Inspected
Condition	2 - Between Good and Fair
Deficiency	ACOUSTIC TILES: DAMAGED/MISSING
Deficiency Location/Instance	Left Side
Deficiency Quantity	10
Quantity Uom	S.F.
Potential Action	REPLACE
Urgency of Action	PRIORITY 3
Purpose of Action	LEVEL 2
Deficiency Photo1

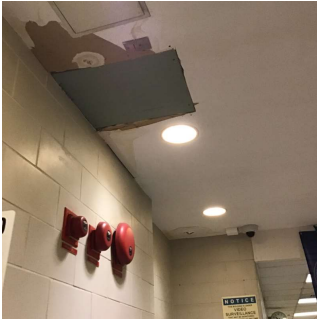
Question	Response
INTERIOR	
CAFETERIA	
Walls	
Deficiency Photo1	 
Violations	Center No violations recorded.
Window Curtains/Shades/Blinds	
Instance on 1st Floor	Does not Exist
CLASSROOMS/CORRIDORS/ADMIN SPACES	
Ceiling	Inspected
Condition	2 - Between Good and Fair
Deficiency	GYP SUM BOARD: DAMAGED/DETERIORATED
Deficiency Location/Instance	Main Entrance Lobby
Deficiency Quantity	60
Quantity Uom	S.F.
Potential Action	REPLACE
Urgency of Action	PRIORITY 3
Purpose of Action	LEVEL 2
Deficiency Photo1

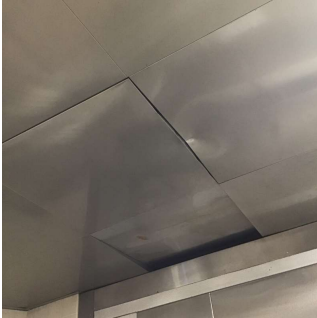
Question	Response
INTERIOR	
KITCHEN	
Ceiling	
Instance on 1st Floor	Inspected
Condition	3 - Fair
Deficiency	METAL PAN: DAMAGED/MISSING
Deficiency Location/Instance	Right Side, Serving area
Deficiency Quantity	20
Quantity Uom	S.F.
Potential Action	REPLACE
Urgency of Action	PRIORITY 3
Purpose of Action	LEVEL 2
Deficiency Photo1

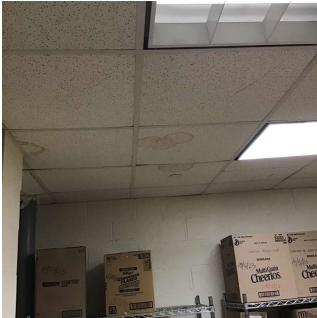
Violations	Right Side No violations recorded.
Deficiency	ACOUSTIC TILES: DAMAGED/MISSING
Deficiency Location/Instance	Room 176F
Deficiency Quantity	30
Quantity Uom	S.F.
Potential Action	REPLACE
Urgency of Action	PRIORITY 3
Purpose of Action	LEVEL 2
Deficiency Photo1

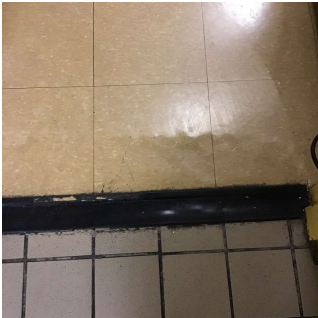
Violations	Room 176F No violations recorded.
Door(s)	
Instance on 1st Floor	Inspected
Condition	2 - Between Good and Fair
Deficiency	No deficiencies recorded
Floor Finish	
Instance on 1st Floor	Inspected
Condition	2 - Between Good and Fair
Deficiency	VINYL TILES: DETERIORATED SUBSTRATE
Deficiency Location/Instance	Room 176F, Office

Question	Response
INTERIOR	
KITCHEN	
Floor Finish	
Deficiency Quantity	20
Quantity Uom	S.F.
Potential Action	REPLACE
Urgency of Action	PRIORITY 3
Purpose of Action	LEVEL 2
Deficiency Photo1

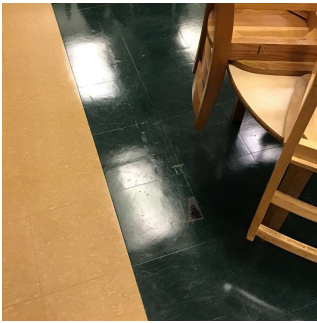
Room 176F
Violations	No violations recorded.
Walls	
Instance on 1st Floor	Inspected
Condition	2 - Between Good and Fair
Deficiency	No deficiencies recorded
LIBRARY	
Instance on Room 203 (600 SF)	Inspected
Built-in Furnishing	
Instance on Room 203 (600 SF)	Does not Exist
Ceiling	
Instance on Room 203 (600 SF)	Inspected
Condition	2 - Between Good and Fair
Deficiency	No deficiencies recorded
Door(s)	
Instance on Room 203 (600 SF)	Inspected
Condition	2 - Between Good and Fair
Deficiency	No deficiencies recorded
Floor Finish	
Instance on Room 203 (600 SF)	Inspected
Condition	2 - Between Good and Fair
Deficiency	VINYL TILES: BROKEN/DETERIORATED/MISSING TILES
Deficiency Location/Instance	Center
Deficiency Quantity	10
Quantity Uom	S.F.
Potential Action	REPLACE

Urgency of Action	PRIORITY 3
Purpose of Action	LEVEL 2

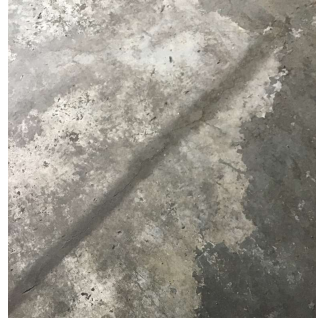
Stair A/Bulkhead

CONCRETE: CRACKS/SPALLING - MAJOR

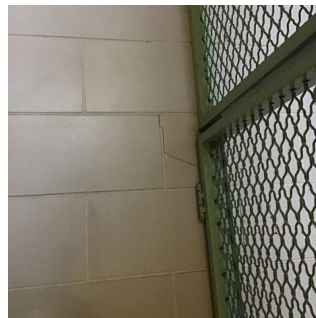
GLAZED BLOCK: CRACKS/SPALLING

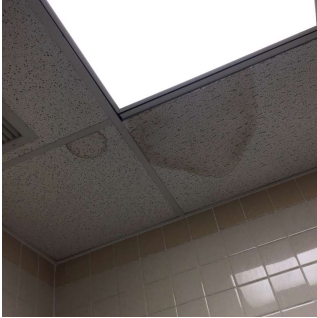
Question	Response
INTERIOR	
STAIRS/RAMPS: INTERIOR	Inspected
Walls	Inspected
Violations	Stair B/3 No violations recorded.
TOILET ROOMS - STAFF	Inspected
Ceiling	Inspected
Condition	3 - Fair
Deficiency	ACOUSTIC TILES: DAMAGED/MISSING
Deficiency Location/Instance	Rooms 317, 109
Deficiency Quantity	20
Quantity Uom	S.F.
Potential Action	REPLACE
Urgency of Action	PRIORITY 3
Purpose of Action	LEVEL 2
Deficiency Photo1

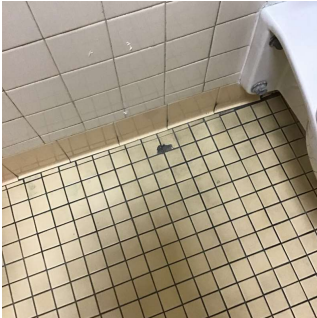
Violations	Room 317 No violations recorded.
Door(s)	Inspected
Condition	2 - Between Good and Fair
Deficiency	No deficiencies recorded
Floor Finish	Inspected
Condition	2 - Between Good and Fair
Deficiency	CERAMIC TILE: BROKEN/MISSING TILES
Deficiency Location/Instance	Room 109
Deficiency Quantity	10
Quantity Uom	S.F.
Potential Action	REPLACE
Urgency of Action	PRIORITY 3
Purpose of Action	LEVEL 2
Deficiency Photo1

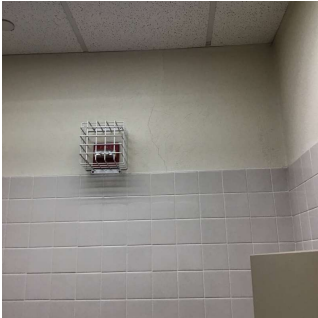
Question	Response
INTERIOR	
TOILET ROOMS - STAFF	Inspected
Stalls	Inspected
Condition	2 - Between Good and Fair
Deficiency	No deficiencies recorded
Walls	Inspected
Condition	2 - Between Good and Fair
Deficiency	PLASTER: CRACKS/SPALLING
Deficiency Location/Instance	Room 176D
Deficiency Quantity	10
Quantity Uom	S.F.
Potential Action	REPLACE
Urgency of Action	PRIORITY 3
Purpose of Action	LEVEL 2
Deficiency Photo1

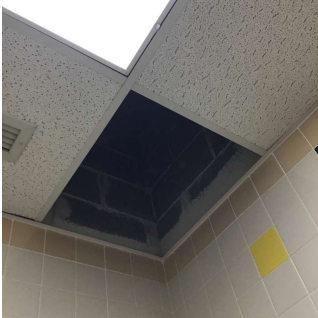
Room 176D
Violations	No violations recorded.
TOILET ROOMS - STUDENTS	Inspected
Ceiling	Inspected
Condition	2 - Between Good and Fair
Deficiency	ACOUSTIC TILES: DAMAGED/MISSING
Deficiency Location/Instance	Rooms 309A, 201A, 112
Deficiency Quantity	30
Quantity Uom	S.F.
Potential Action	REPLACE
Urgency of Action	PRIORITY 3
Purpose of Action	LEVEL 2
Deficiency Photo1

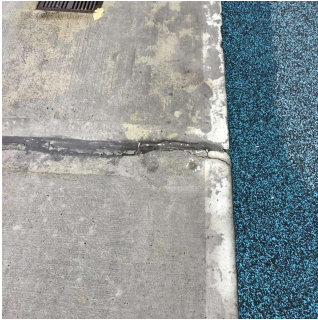
Question	Response
SITE	
PAVING	Inspected
Student Non-Use	Does not Exist
Student Use	Does not Exist
Site Sidewalks & Walkways	Inspected
Asphalt	Does not Exist
Concrete	Inspected
Condition	2 - Between Good and Fair
Deficiency	CRACKS - MAJOR
Deficiency Location/Instance	Exit 2, near Entrance, Rear of Building
Deficiency Quantity	30
Quantity Uom	S.F.
Potential Action	REPLACE
Urgency of Action	PRIORITY 3
Purpose of Action	LEVEL 2
Deficiency Photo1

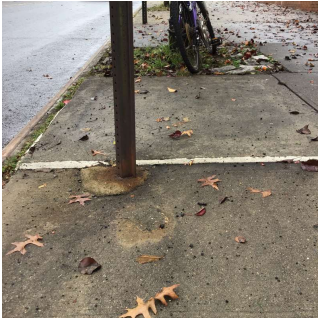
Violations	Exit 2 No violations recorded.
Pavers	Does not Exist
DOT Sidewalk	Inspected
Asphalt	Does not Exist
Concrete	Inspected
Condition	3 - Fair
Deficiency	HEAVING
Deficiency Location/Instance	31st Road, 137th Street
Deficiency Quantity	100
Quantity Uom	S.F.
Potential Action	REPLACE
Urgency of Action	PRIORITY 3
Purpose of Action	LEVEL 2
Deficiency Photo1

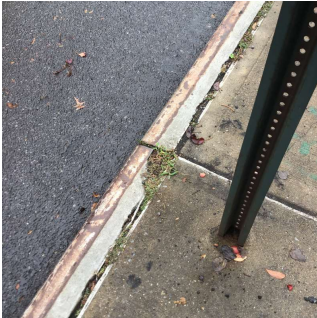
Question	Response
SITE	
PAVING	
DOT Sidewalk	
Concrete	
Deficiency	DAMAGED CURBS
Deficiency Location/Instance	31st Road, 137th Street
Deficiency Quantity	30
Quantity Uom	L.F.
Potential Action	REPLACE
Urgency of Action	PRIORITY 3
Purpose of Action	LEVEL 2
Deficiency Photo1

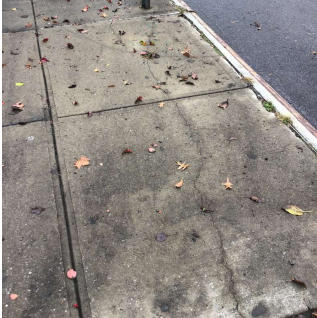
Violations	31st Road No violations recorded.
Deficiency	DAMAGED/DETERIORATED/MISSING SECTIONS
Deficiency Location/Instance	31st Road, 137th Street
Deficiency Quantity	150
Quantity Uom	S.F.
Potential Action	REPLACE
Urgency of Action	PRIORITY 3
Purpose of Action	LEVEL 2
Deficiency Photo1

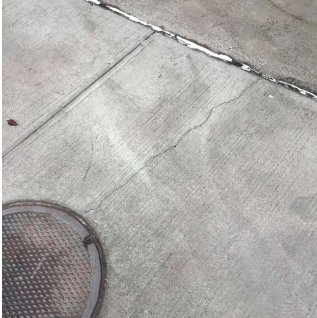
Question	Response
SITE	
PLAYGROUNDS	
Pavement	
Instance on Along 31st Road	Inspected
Condition	3 - Fair
Deficiency	CONCRETE: CRACKS - MAJOR
Deficiency Location/Instance	Left Side
Deficiency Quantity	50
Quantity Uom	S.F.
Potential Action	REPLACE
Urgency of Action	PRIORITY 3
Purpose of Action	LEVEL 2
Deficiency Photo1
