NYC Department of Education
Building Condition Assessment Survey 2023 - 2024

Architectural Inspection

Asset: P.S. 244 ECC (@ FRANKLIN AVE) - Q, 137-20 FRANKLIN AVE, New York, 11355

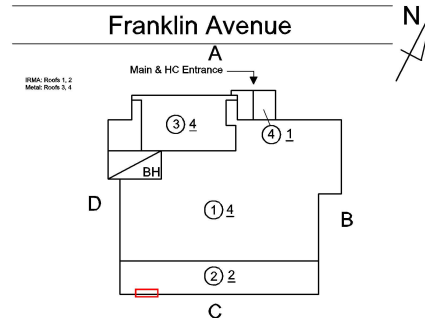
Question	Response
Architectural	
EXTERIOR	Inspected
AREAWAY	Does not Exist
AWNINGS AND CANOPIES	Inspected
Condition	2 - Between Good and Fair
Deficiency	No deficiencies recorded
CHIMNEY	Does not Exist
COPING	Inspected
Condition	2 - Between Good and Fair
Deficiency	No deficiencies recorded
CORNICE	Does not Exist
DOORS	Inspected
DOORS AND FRAMES	Inspected
Condition	3 - Fair
Deficiency	METAL: DETERIORATED DOOR AND FRAME - MINOR DETERIORATION
Roof Plan reference	Q244

2
 EACH
 MAINTENANCE
 PRIORITY 3

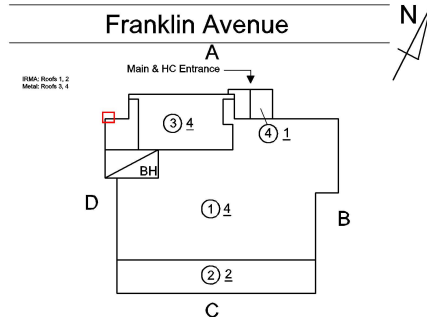
Violations	Facade C - Exit 3 No violations recorded.
DOOR HARDWARE	Inspected
Condition	2 - Between Good and Fair
Deficiency	No deficiencies recorded
LINTELS	Inspected
Condition	2 - Between Good and Fair
Deficiency	No deficiencies recorded
TRANSOM/SIDE LIGHT	Inspected
Condition	2 - Between Good and Fair
Deficiency	No deficiencies recorded
EXTERIOR WALLS	Inspected
Material Type(s)	Masonry, Concrete
Replacement Quantity	19,000
Replacement Uom	S.F.
Instance on All Facades	Inspected
Instance Condition	2 - Between Good and Fair
Instance Quantity	19,000
Instance Quantity Uom	S.F.
Deficiency	BRICK: MINOR CRACKS AND SPALLING
Roof Plan reference	Q244

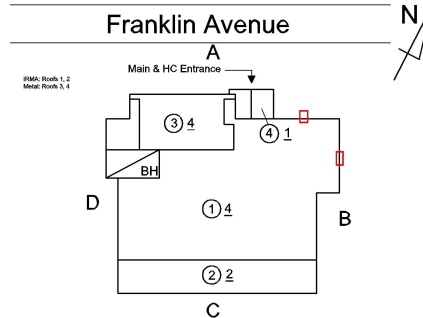
CAST IN PLACE / PRE-CAST CONCRETE: DETERIORATED JOINTS

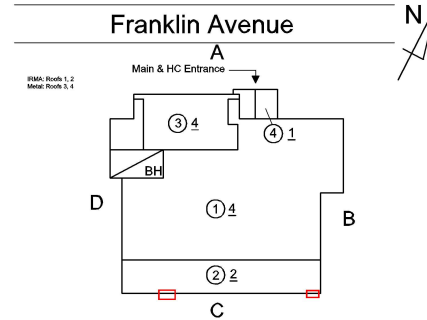
BRICK: DETERIORATED MASONRY SILLS - MINOR

20
 L.F.
 REPAIR
 PRIORITY 3
 LEVEL 2

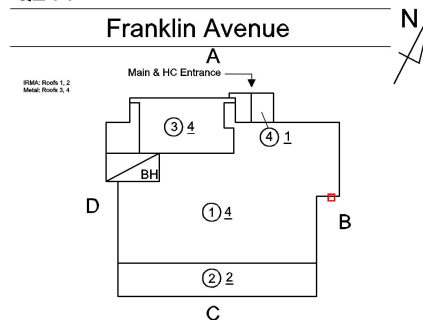
Question	Response
EXTERIOR	
EXTERIOR WALLS	Inspected
	Facade C
Violations	No violations recorded.
EXTERIOR SOFFITS	Does not Exist
LOADING DOCK	Does not Exist
LOUVER	Inspected
Condition	2 - Between Good and Fair
Deficiency	No deficiencies recorded
PARAPETS	Inspected
Material Type(s)	Masonry
Replacement Quantity	3,300
Replacement Uom	C.F.
Instance on All Facades	Inspected
Instance Condition	2 - Between Good and Fair
Instance Quantity	3,300
Instance Quantity Uom	C.F.
Deficiency	No deficiencies recorded
PLAZA DECK	Does not Exist
ROOF	Inspected
Roofing	Inspected
Replacement Quantity	12,000
Replacement Uom	S.F.
ROOF HATCH/SMOKE HATCH	Inspected
Condition	2 - Between Good and Fair
Deficiency	No deficiencies recorded
LEADERS, GUTTERS, DOWNSPOUTS, SCUPPERS	Inspected
Condition	3 - Fair
Deficiency	DAMAGED/MISSING
Roof Plan reference	Q244

Deficiency Quantity	10
Quantity Uom	L.F.
Potential Action	REPLACE
Urgency of Action	PRIORITY 4
Purpose of Action	LEVEL 2

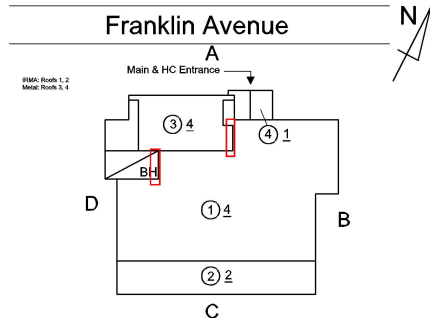
<p>Roof 3</p>
Instance Quantity	3,000
Instance Quantity Uom	S.F.
Does the roof have major mechanical equipment sitting on Dunnage Steel less than 18" above the Roofing?	No
Does this roof instance have a Sustainable Roof System?	No
Do solar panels exist on these roofs?	No
Is/Are the roof(s) suitable for Solar Panel installation?	No
Installation Year	2008
Source of Installation	Custodial Staff
Deficiency	METAL: ROOFING: DAMAGED OR MISSING SNOW GUARDS
Roof Plan reference	<p>Q244</p>

Deficiency Quantity	20
Quantity Uom	L.F.
Potential Action	REPLACE
Urgency of Action	PRIORITY 4

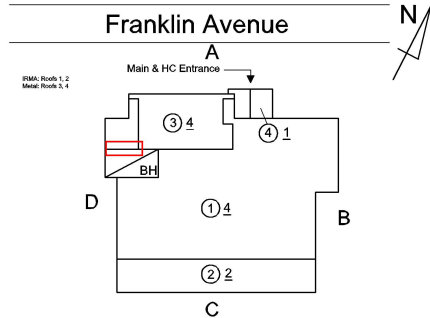
Roof 3
Violations	No violations recorded.
ROOFING DRAINS	Inspected
Condition	2 - Between Good and Fair
Deficiency	No deficiencies recorded
Specialties	Inspected
BULKHEAD/PENTHOUSE	Inspected
Condition	2 - Between Good and Fair
Deficiency	BULKHEAD/PENTHOUSE WALLS/INTERIOR: GYPSUM BOARD DAMAGED/DETERIORATED
Roof Plan reference	Q244

Deficiency Quantity	20
Quantity Uom	S.F.
Potential Action	REPLACE
Urgency of Action	PRIORITY 3
Purpose of Action	LEVEL 2
Deficiency Photo1
