NYC Department of Education
Building Condition Assessment Survey 2023 - 2024

Architectural Inspection

Asset: P.S. 245 ECC (@ SENECA AVE) - Q, 378 SENECA AVE, New York, 11385

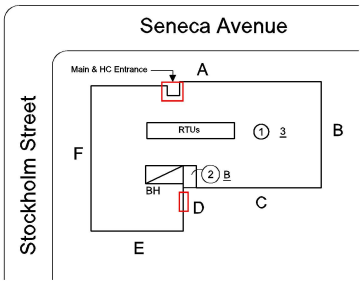
Question	Response
EXTERIOR	
COPING	Inspected
Condition	2 - Between Good and Fair
Deficiency	No deficiencies recorded
CORNICE	Does not Exist
DOORS	Inspected
DOORS AND FRAMES	Inspected
Condition	5 - Poor
Deficiency	METAL: DETERIORATED DOOR AND FRAME - MAJOR DETERIORATION
Roof Plan reference	<div style="text-align: right;">

</div>
Deficiency Quantity	4
Quantity Uom	EACH
Potential Action	REPLACE
Urgency of Action	PRIORITY 4
Purpose of Action	LEVEL 2
Deficiency Photo1

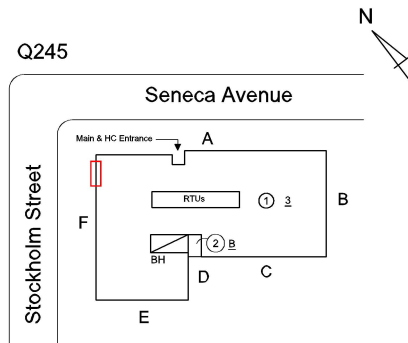
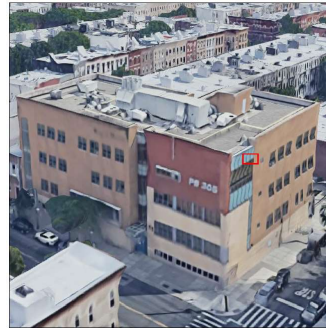
METAL/GLASS CURT WALL: WATER INFILTRATION IN INSTRUCTIONAL SPACE

REPAIR

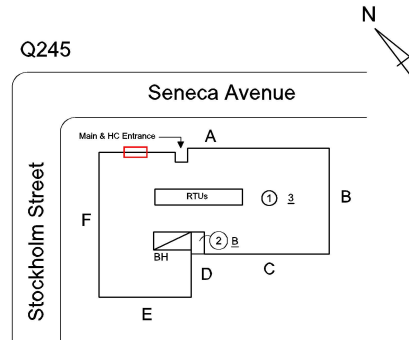
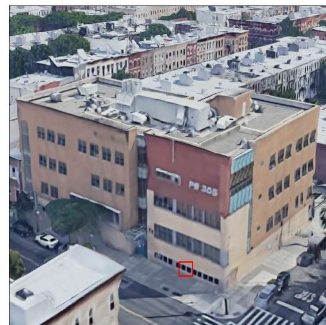
BRICK: DETERIORATED MASONRY SILLS - MINOR

REPAIR

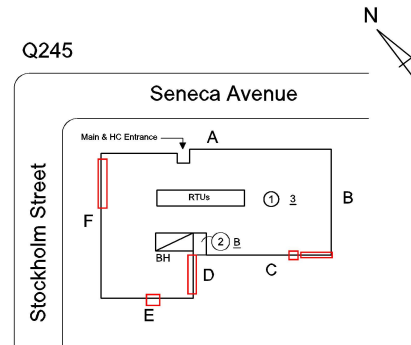
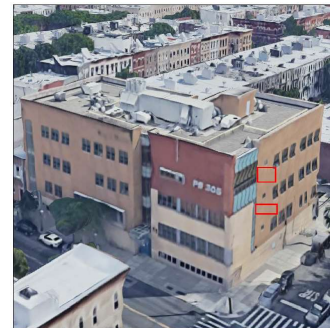
BRICK: DETERIORATED CONTROL/EXPANSION JOINTS

80
L.F.
MAINTENANCE
PRIORITY 3
LEVEL 2
No photo recorded
No violations recorded.

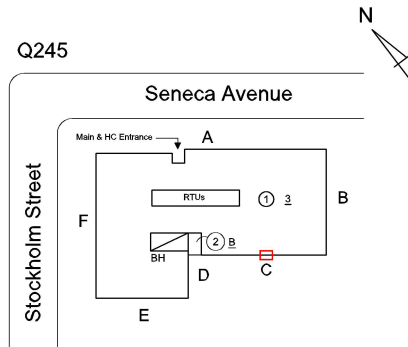
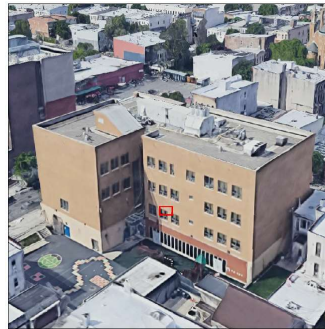
BRICK: MAJOR / THRU CRACKS

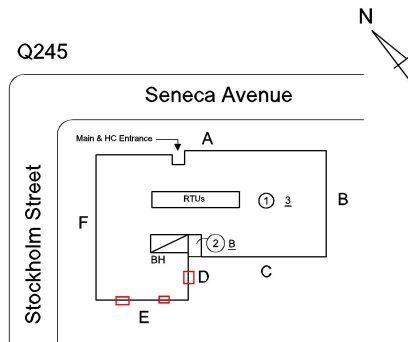
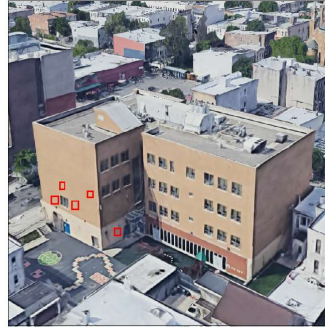
BRICK: DETERIORATED JOINTS

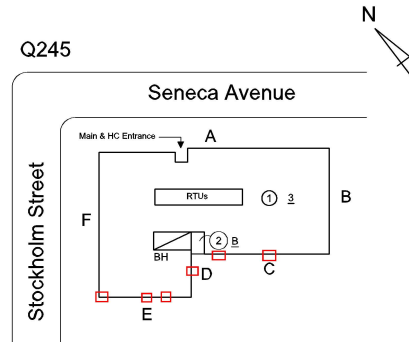
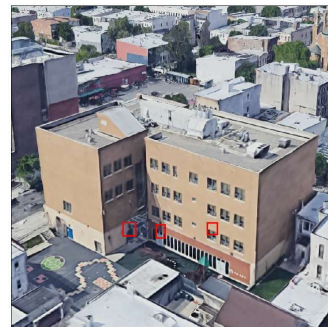
BRICK: MINOR CRACKS AND SPALLING

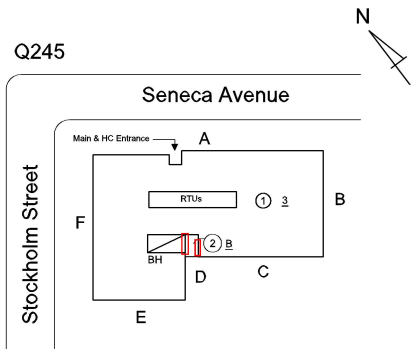
Facade E
Violations	No violations recorded.
EXTERIOR SOFFITS	Does not Exist
LOADING DOCK	Does not Exist
LOUVER	Inspected
Condition	2 - Between Good and Fair
Deficiency	No deficiencies recorded
PARAPETS	Inspected
Material Type(s)	Concrete, Masonry
Replacement Quantity	5,000
Replacement Uom	C.F.
Instance on All Roofs	Inspected
Instance Condition	3 - Fair
Instance Quantity	5,000
Instance Quantity Uom	C.F.
Deficiency	BRICK: MINOR CRACKS, SPALLING
Roof Plan reference

Deficiency Quantity	20
Quantity Uom	S.F.
Potential Action	REPAIR
Urgency of Action	PRIORITY 3
Purpose of Action	LEVEL 2

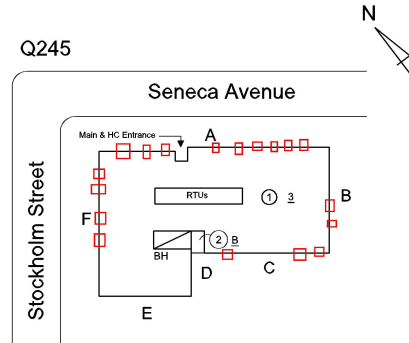
CONCRETE: MINOR CRACKS, SPALLING

REPAIR

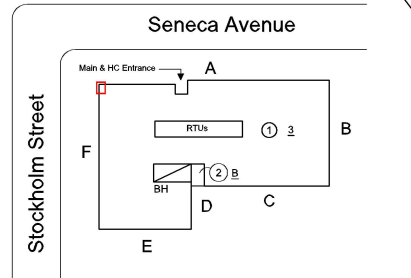
BRICK: DETERIORATED JOINTS

10
S.F.
REPOINT
PRIORITY 3
LEVEL 2

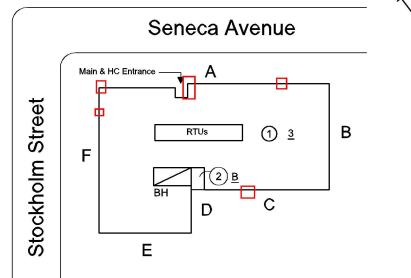
CONCRETE: MAJOR DETERIORATION/CRACKS

40
S.F.
REMOVE AND REBUILD
PRIORITY 4
LEVEL 2

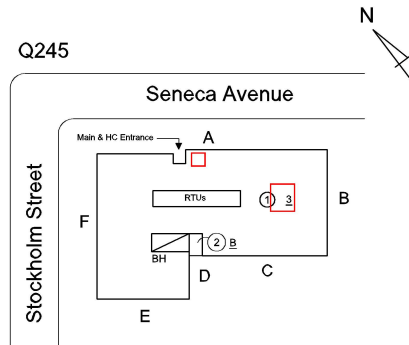
Is/Are the roof(s) suitable for Solar Panel installation?	No
Installation Year	2008
Source of Installation	Custodial Staff
Deficiency	IRMA: ROOFING: MAJOR ACTIVE ROOF LEAKS IN INSTRUCTIONAL SPACE

Roof 1 - Room 301 shown, Roof 1 - Room 305 similar
No violations recorded.

REPLACE ROOFING WITHOUT MAJOR EQUIPMENT
REMOVAL

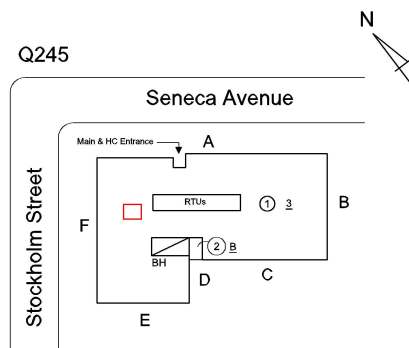
IRMA: ROOFING: DETERIORATED PAVERS WITH INTEGRAL
INSULATION

REPLACE

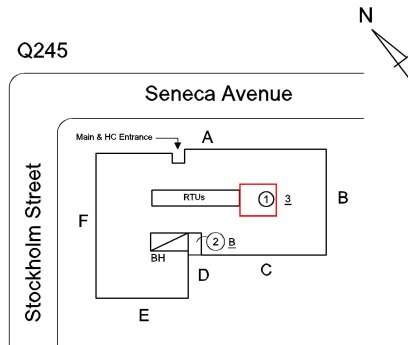
IRMA: ROOFING: DAMAGED INSULATION

REPLACE

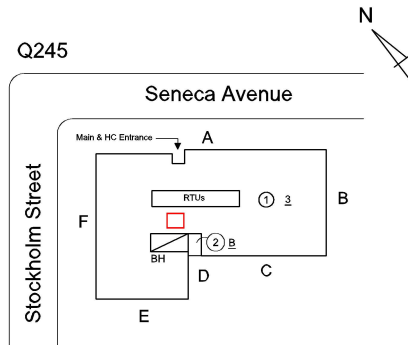
IRMA: ROOFING: MAJOR ACTIVE ROOF LEAKS IN NON-INSTRUCTIONAL SPACE

Roof 1 - Room 307
 No violations recorded.

100
 S.F.
 REPLACE ROOFING WITHOUT MAJOR EQUIPMENT
 REMOVAL
 PRIORITY 5
 LEVEL 2

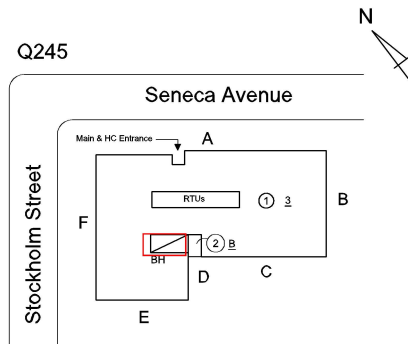
BULKHEAD/PENTHOUSE WALLS/INTERIOR: GYPSUM
 BOARD DAMAGED/DETERIORATED

REPLACE
PRIORITY 3
LEVEL 2

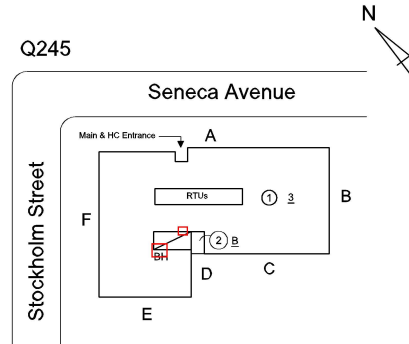
BULKHEAD/PENTHOUSE WALLS/EXTERIOR:
CRACKS/SPALLING - MINOR

30
S.F.
REPAIR
PRIORITY 3
LEVEL 2

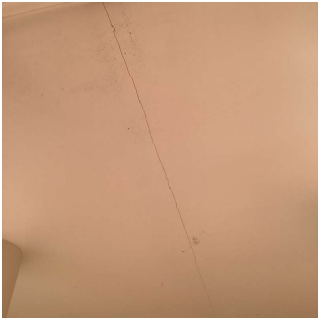
Question	Response
INTERIOR	
CAFETERIA	
Instance on Basement	Inspected
Instance on Basement	Inspected
Ceiling	
Instance on Basement	Inspected
Condition	2 - Between Good and Fair
Deficiency	ACOUSTIC TILES: DAMAGED/MISSING
Deficiency Location/Instance	Near Serving area, Center, Near Entrance
Deficiency Quantity	30
Quantity Uom	S.F.
Potential Action	REPLACE
Urgency of Action	PRIORITY 3
Purpose of Action	LEVEL 2
Deficiency Photo1	 
	Near Serving area
Violations	No violations recorded.
Deficiency	GYPSUM BOARD: DAMAGED/DETERIORATED
Deficiency Location/Instance	Stage area, Near Entrance
Deficiency Quantity	20
Quantity Uom	S.F.
Potential Action	REPLACE
Urgency of Action	PRIORITY 3
Purpose of Action	LEVEL 2
Deficiency Photo1

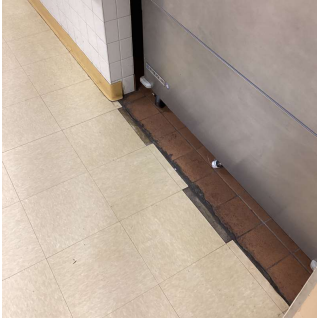
Question	Response
INTERIOR	
CAFETERIA	
Floor Finish	
Condition	2 - Between Good and Fair
Deficiency	VINYL TILES: BROKEN/DETERIORATED/MISSING TILES
Deficiency Location/Instance	Near Serving area
Deficiency Quantity	10
Quantity Uom	S.F.
Potential Action	REPLACE
Urgency of Action	PRIORITY 3
Purpose of Action	LEVEL 2
Deficiency Photo1

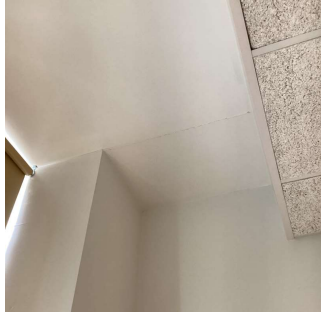
Question	Response
INTERIOR	
KITCHEN	
Floor Finish	
Instance on Basement	Inspected
Condition	2 - Between Good and Fair
Deficiency	No deficiencies recorded
Walls	
Instance on Basement	Inspected
Condition	2 - Between Good and Fair
Deficiency	GYPSUM BOARD: DETERIORATED
Deficiency Location/Instance	Rooms B01D, B01E
Deficiency Quantity	40
Quantity Uom	S.F.
Potential Action	REPLACE
Urgency of Action	PRIORITY 3
Purpose of Action	LEVEL 2
Deficiency Photo1	 
	Room B01D
Violations	No violations recorded.
LIBRARY	
Instance on Room 311	Inspected
Instance on Room 311	Inspected
Built-in Furnishing	
Instance on Room 311	Does not Exist
Ceiling	
Instance on Room 311	Inspected
Condition	2 - Between Good and Fair
Deficiency	GYPSUM BOARD: DAMAGED/DETERIORATED
Deficiency Location/Instance	Left Side Near Windows
Deficiency Quantity	10
Quantity Uom	S.F.
Potential Action	REPLACE
Urgency of Action	PRIORITY 3
Purpose of Action	LEVEL 2
Deficiency Photo1

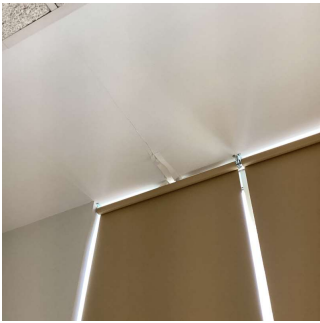
Question	Response
INTERIOR	
LIBRARY	
Ceiling	
Violations	Left Side Near Windows No violations recorded.
Deficiency	GYPSUM BOARD: DAMAGED/DETERIORATED - ACTIVE LEAK
Deficiency Location/Instance	Left Side Near Windows
Deficiency Quantity	10
Quantity Uom	S.F.
Potential Action	REPLACE
Urgency of Action	PRIORITY 5
Purpose of Action	LEVEL 2
Deficiency Photo1

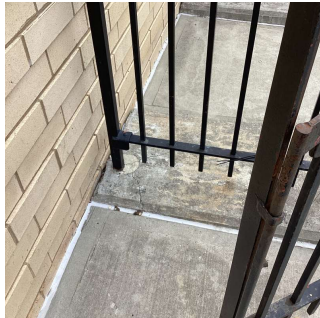
Violations	Stockholm Street No violations recorded.
Deficiency	CONCRETE CURB: DAMAGED/DETERIORATED
Deficiency Location/Instance	Stockholm Street
Deficiency Quantity	10
Quantity Uom	S.F.
Potential Action	REPLACE
Urgency of Action	PRIORITY 3
Purpose of Action	LEVEL 2
Deficiency Photo1

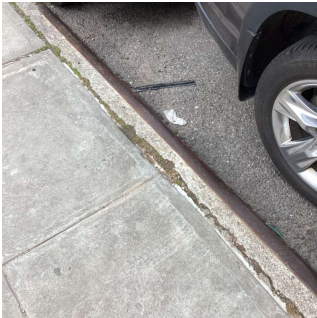
Seneca Avenue
Violations	No violations recorded.
Deficiency	DAMAGED CURBS
Deficiency Location/Instance	Stockholm Street, Seneca Avenue
Deficiency Quantity	20
Quantity Uom	L.F.
Potential Action	REPLACE
Urgency of Action	PRIORITY 3
Purpose of Action	LEVEL 2
Deficiency Photo1

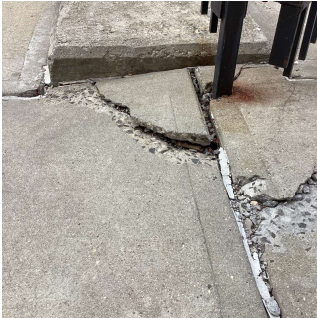
Violations	Stockholm Street No violations recorded.
Deficiency	CAST IN PLACE CONCRETE: CRACKS/SPALLING - MAJOR
Deficiency Location/Instance	Stockholm Street
Deficiency Quantity	25
Quantity Uom	S.F.
Potential Action	REPLACE
Urgency of Action	PRIORITY 5
Purpose of Action	LEVEL 6
Deficiency Photo1
