**NYC Department of Education**  
**Building Condition Assessment Survey 2023 - 2024**

Architectural Inspection

Q247

**Asset:** P.S. /I.S. 128 - QUEENS, 69-10 65TH DRIVE, New York, 11379

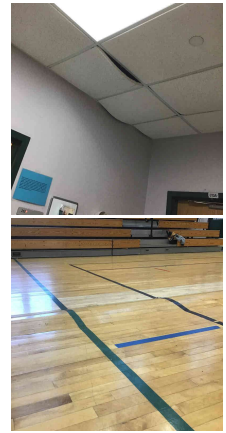
No	Potential Falling Debris	Loose Acoustic Tile Ceiling is a potential safety hazard.	INTERIOR   CLASSROOMS /CORRIDORS/ ADMIN SPACES   Ceiling	Room 206E, Corridor near Room 213	Robert DeJesus	Fireman
No	Tripping Hazard	Severely buckling wood floor is a potential tripping hazard.	INTERIOR   GYMNASIUM   Floor Finish	Near Windows	Robert DeJesus	Fireman

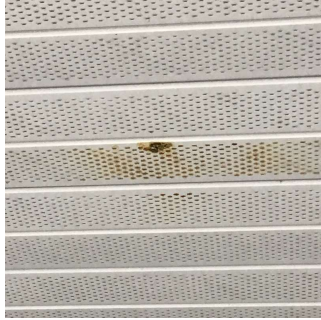
METAL: WATER PENETRATION

Violations	Facade A No violations recorded.
<b>CHIMNEY</b>	Inspected
Material Type(s)	Metal
Condition	2 - Between Good and Fair
Deficiency	No deficiencies recorded
<b>COPING</b>	Inspected
Condition	3 - Fair
Deficiency	CAST STONE: DISINTEGRATING / FREEZE THAW
Roof Plan reference	<p>Q247</p>

100  
 S.F.  
 REPLACE  
 PRIORITY 5  
 LEVEL 2

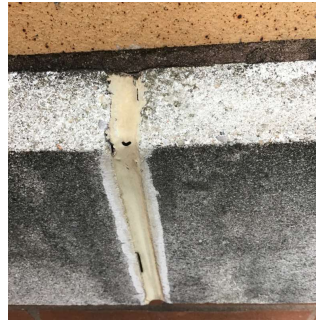
Facade C

CAST IN PLACE / PRE-CAST CONCRETE: DETERIORATED JOINTS

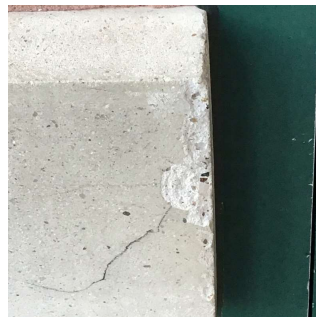
Facade A

CAST IN PLACE / PRE-CAST CONCRETE: MINOR CRACKS/SPALLING

REPAIR

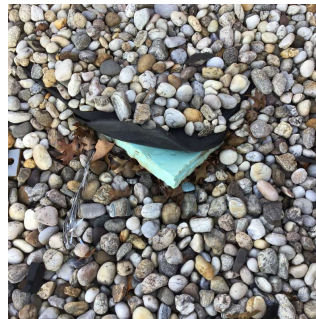
Roof 1

IRMA: ROOFING: DAMAGED INSULATION

45  
 S.F.  
 REPLACE  
 PRIORITY 4  
 LEVEL 2

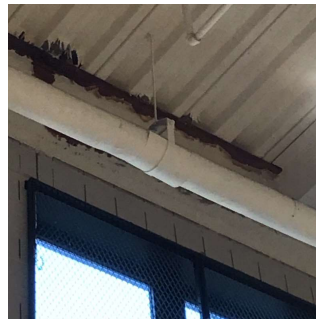
Roof 2 - Gymnasium  
No violations recorded.

IRMA: ROOFING: MAJOR ACTIVE ROOF LEAKS IN INSTRUCTIONAL SPACE

100  
S.F.  
REPLACE ROOFING WITHOUT MAJOR EQUIPMENT  
REMOVAL  
PRIORITY 5  
LEVEL 2

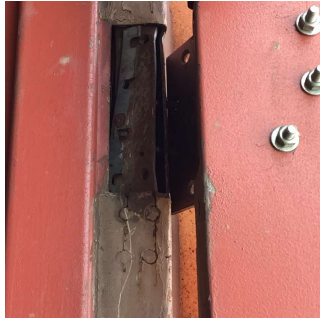
Violations	Roof 1 No violations recorded.
<b>Specialties</b>	Inspected
<b>BULKHEAD/PENTHOUSE</b>	Inspected
Condition	3 - Fair
Deficiency	BULKHEAD/PENTHOUSE DOORS: DETERIORATED DOOR AND FRAME
Roof Plan reference	Q247
Deficiency Quantity	1
Quantity Uom	EACH
Potential Action	REPLACE DOOR AND FRAME
Urgency of Action	PRIORITY 4
Purpose of Action	LEVEL 2
Deficiency Photo1

Violations	PH1 No violations recorded.
Deficiency	BULKHEAD/PENTHOUSE WALLS/EXTERIOR: CRACKS/SPALLING - MINOR

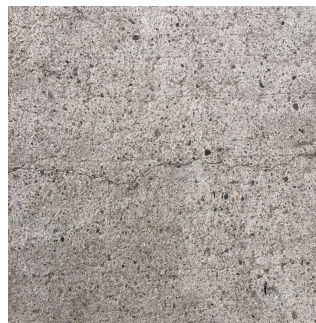
Facade E

**CONCRETE: CRACKS/SPALLING - MINOR**

REPAIR

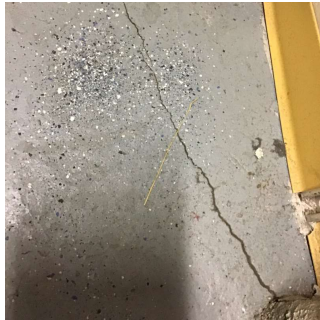
Violations	Facade F - Room 208 No violations recorded.
<b>INTERIOR</b>	
<b>POOLS</b>	Does not Exist
<b>STRUCTURAL</b>	Inspected
<b>COLUMNS/BEAMS/BEARING WALLS</b>	Inspected
Condition	2 - Between Good and Fair
Deficiency	No deficiencies recorded
<b>FLOOR STRUCTURE</b>	
Condition	3 - Fair
Deficiency	CONCRETE SLAB ON GRADE: THRU CRACKS
Deficiency Location/Instance	Basement - Rooms C17, C21B, C06
Deficiency Quantity	30
Quantity Uom	S.F.
Potential Action	REPLACE
Urgency of Action	PRIORITY 4
Purpose of Action	LEVEL 5
Deficiency Photo1

Violations	Basement - Room C17 No violations recorded.
Deficiency	CONCRETE SLAB ON GRADE: THRU CRACKS
Deficiency Location/Instance	Basement - Rooms C16, C14, C21C, C06A, C02A
Deficiency Quantity	40
Quantity Uom	S.F.
Potential Action	REPAIR
Urgency of Action	PRIORITY 3
Purpose of Action	LEVEL 5

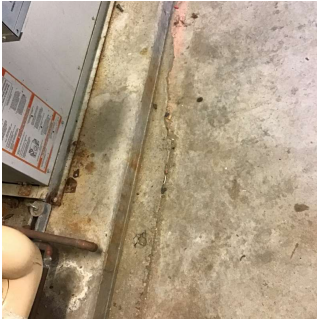
Basement - Room C16
Violations	No violations recorded.
Deficiency	CONCRETE: CRACKS/SPALLED/REINFORCEMENT EXPOSED
Deficiency Location/Instance	PH1
Deficiency Quantity	10
Quantity Uom	S.F.
Potential Action	REPAIR
Urgency of Action	PRIORITY 3
Purpose of Action	LEVEL 5
Deficiency Photo1

PH1
Violations	No violations recorded.
<b>FOUNDATION WALLS</b>	
	Inspected
Material Type(s)	Concrete
Condition	2 - Between Good and Fair
Deficiency	No deficiencies recorded
<b>ROOF STRUCTURE</b>	
	Inspected
Condition	2 - Between Good and Fair
Deficiency	No deficiencies recorded
<b>VAULTS-BUNKERS</b>	
	Does not Exist
<b>AUDITORIUM</b>	
	Inspected
Instance on Basement (358 Seats)	Inspected
<b>Ceiling</b>	
Instance on Basement (358 Seats)	Inspected
Condition	2 - Between Good and Fair
Deficiency	GYPSUM BOARD: DAMAGED/DETERIORATED
Deficiency Location/Instance	Near Rooms 115A, 115B, Entrances, Stage.

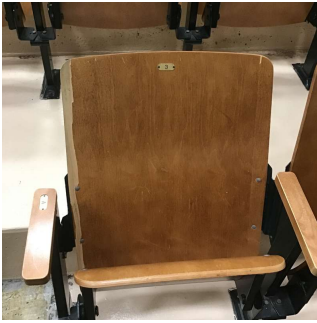
Question	Response
<b>INTERIOR</b>	
<b>AUDITORIUM</b>	
<b>Fixed Seating</b>	
Deficiency Photo1

Seat A/3
Violations	No violations recorded.
<b>Floor Finish</b>	
Instance on Basement (358 Seats)	Inspected
Condition	3 - Fair
Deficiency	RUBBER NOSING: DETERIORATED
Deficiency Location/Instance	Near Seats B/1, G/1, H/1, J/101, K/101, and others
Deficiency Quantity	10
Quantity Uom	L.F.
Potential Action	MAINTENANCE
Urgency of Action	PRIORITY 3
Purpose of Action	LEVEL 2
Deficiency Photo1

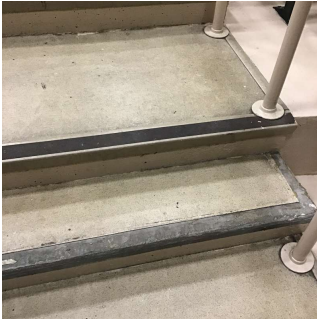
Near Seat B/1
Violations	No violations recorded.
Deficiency	CONCRETE: CRACKS
Deficiency Location/Instance	Near Seats A/104, D/106, J/106, K/106, M/106, and others.
Deficiency Quantity	100
Quantity Uom	S.F.
Potential Action	REPLACE
Urgency of Action	PRIORITY 3
Purpose of Action	LEVEL 2

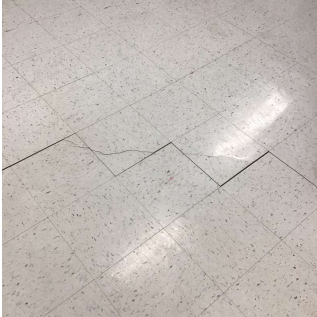
Question	Response
<b>INTERIOR</b>	
<b>CAFETERIA</b>	
<b>Door(s)</b>	
Instance on Basement	Inspected
Condition	2 - Between Good and Fair
Deficiency	No deficiencies recorded
<b>Fixed Equipment</b>	
Instance on Basement	Does not Exist
<b>Floor Finish</b>	
Instance on Basement	Inspected
Condition	2 - Between Good and Fair
Deficiency	VINYL TILES: BROKEN/DETERIORATED/MISSING TILES
Deficiency Location/Instance	Near Drinking Fountain, Center
Deficiency Quantity	20
Quantity Uom	S.F.
Potential Action	REPLACE
Urgency of Action	PRIORITY 3
Purpose of Action	LEVEL 2
Deficiency Photo1

Violations	Near Drinking Fountain No violations recorded.
Deficiency	VINYL TILES: DETERIORATED SUBSTRATE
Deficiency Location/Instance	Near Drinking Fountain, Serving Area, Entrance
Deficiency Quantity	30
Quantity Uom	S.F.
Potential Action	REPLACE
Urgency of Action	PRIORITY 3
Purpose of Action	LEVEL 2
Deficiency Photo1

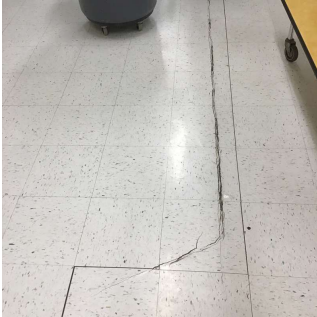
Violations	Near Drinking Fountain No violations recorded.

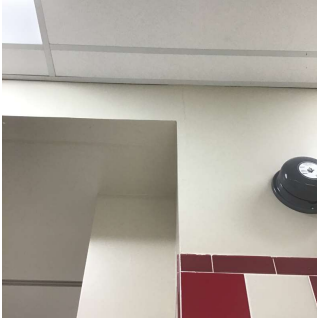
Question	Response
<b>INTERIOR</b>	
<b>CAFETERIA</b>	
<b>Stage</b>	
Instance on Basement	Does not Exist
<b>Walls</b>	
Instance on Basement	Inspected
Condition	2 - Between Good and Fair
Deficiency	GYPSUM BOARD: DETERIORATED
Deficiency Location/Instance	Near Stair C
Deficiency Quantity	10
Quantity Uom	S.F.
Potential Action	REPLACE
Urgency of Action	PRIORITY 3
Purpose of Action	LEVEL 2
Deficiency Photo1

Violations	Near Stair C No violations recorded.
Deficiency	CERAMIC TILE: BROKEN/ MISSING
Deficiency Location/Instance	Near Serving Area, Drinking Fountain
Deficiency Quantity	10
Quantity Uom	S.F.
Potential Action	REPLACE
Urgency of Action	PRIORITY 3
Purpose of Action	LEVEL 2
Deficiency Photo1

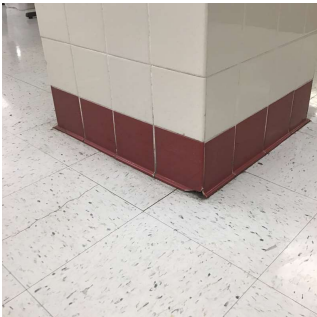
Violations	Near Serving Area No violations recorded.
<b>Window Curtains/Shades/Blinds</b>	
Instance on Basement	Does not Exist
<b>CLASSROOMS/CORRIDORS/ADMIN SPACES</b>	
<b>Ceiling</b>	Inspected
Condition	2 - Between Good and Fair

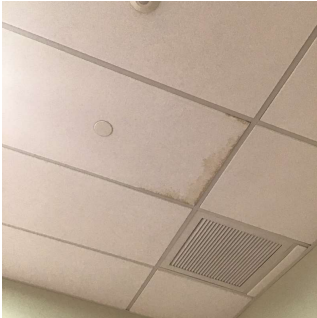
Corridor near Room 213
Violations	No violations recorded.
Deficiency	ACOUSTIC TILES: DAMAGED/MISSING
Deficiency Location/Instance	Rooms 125, 201, 310, 416, Corridor near Room 433G, and others.
Deficiency Quantity	200
Quantity Uom	S.F.
Potential Action	REPLACE
Urgency of Action	PRIORITY 3
Purpose of Action	LEVEL 2
Deficiency Photo1

Corridor near Room 433G
Violations	No violations recorded.
<b>Door(s)</b>	Inspected
Condition	5 - Poor
Deficiency	WOOD: DETERIORATED DOOR
Deficiency Location/Instance	Rooms C09, 110, 206, 406, 414, and others.
Deficiency Quantity	7
Quantity Uom	EACH
Potential Action	MAINTENANCE
Urgency of Action	PRIORITY 3
Purpose of Action	LEVEL 2

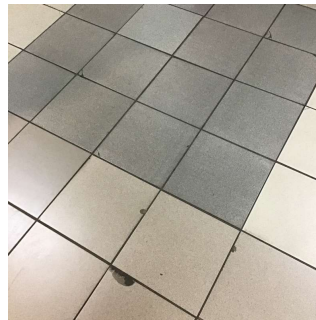
Near Elevator A/1

CERAMIC TILE: BROKEN/MISSING TILES

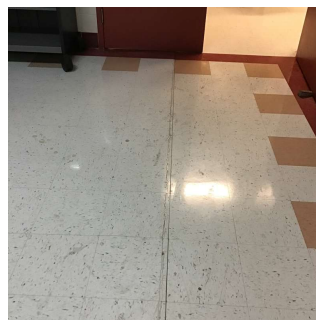
VINYL TILES: DETERIORATED SUBSTRATE

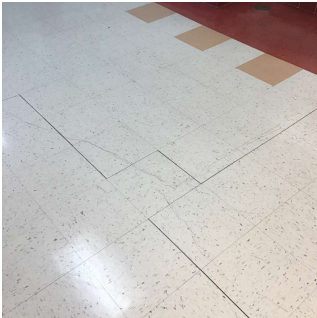
Question	Response
<b>INTERIOR</b>	
<b>CLASSROOMS/CORRIDORS/ADMIN SPACES</b>	
<b>Floor Finish</b>	
Violations	Corridor near Room C10 No violations recorded.
Deficiency	VINYL TILES: BROKEN/DETERIORATED/MISSING TILES
Deficiency Location/Instance	Room 415, Corridor near Room C10
Deficiency Quantity	20
Quantity Uom	S.F.
Potential Action	REPLACE
Urgency of Action	PRIORITY 3
Purpose of Action	LEVEL 2
Deficiency Photo1

Violations	Corridor near Room C10 No violations recorded.
<b>Walls</b>	Inspected
Condition	2 - Between Good and Fair
Deficiency	CERAMIC TILE: BROKEN/ MISSING
Deficiency Location/Instance	Corridor near Rooms 215 2, 220
Deficiency Quantity	10
Quantity Uom	S.F.
Potential Action	REPLACE
Urgency of Action	PRIORITY 3
Purpose of Action	LEVEL 2
Deficiency Photo1

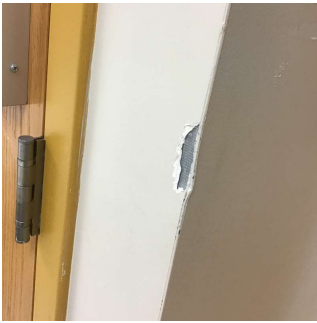
Violations	Corridor near Room 215 2 No violations recorded.
Deficiency	GYPSUM BOARD: DETERIORATED
Deficiency Location/Instance	Rooms 105, 108, 125, 408, 435, and others.

Room 125
Violations	No violations recorded.
<b>Specialties</b>	Does not Exist
<b>GYMNASIUM</b>	
Instance on 2nd Floor	Inspected
<b>Ceiling</b>	Inspected
Instance on 2nd Floor	Inspected
Condition	2 - Between Good and Fair
Deficiency	No deficiencies recorded
<b>Door(s)</b>	Inspected
Instance on 2nd Floor	Inspected
Condition	2 - Between Good and Fair
Deficiency	No deficiencies recorded
<b>Fixed Equipment</b>	Inspected
Instance on 2nd Floor	Inspected
Condition	2 - Between Good and Fair
Deficiency	No deficiencies recorded
<b>Floor Finish</b>	Inspected
Instance on 2nd Floor	Inspected
Condition	2 - Between Good and Fair
Deficiency	WOOD: DAMAGED/DETERIORATED
Deficiency Location/Instance	Near Windows
Deficiency Quantity	100
Quantity Uom	S.F.
Potential Action	REPLACE
Urgency of Action	PRIORITY 5
Purpose of Action	LEVEL 6

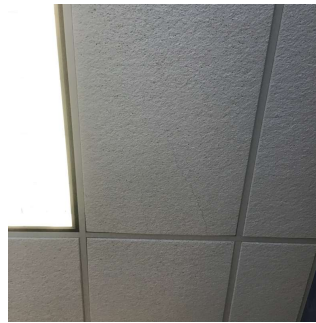
<b>Built-in Furnishing</b>	
Instance on Room 303	Does not Exist
<b>Ceiling</b>	
Instance on Room 303	Inspected
Condition	2 - Between Good and Fair
Deficiency	ACOUSTIC TILES: DAMAGED/MISSING
Deficiency Location/Instance	Near Windows
Deficiency Quantity	10
Quantity Uom	S.F.
Potential Action	REPLACE
Urgency of Action	PRIORITY 3
Purpose of Action	LEVEL 2

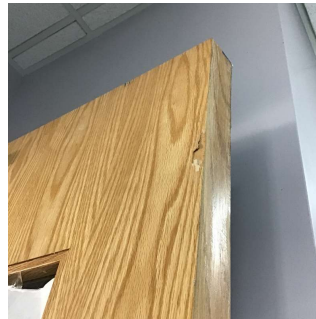
Instance on Room 303	Inspected
Condition	3 - Fair
Deficiency	WOOD: DETERIORATED DOOR
Deficiency Location/Instance	Entrance
Deficiency Quantity	1
Quantity Uom	EACH
Potential Action	MAINTENANCE
Urgency of Action	PRIORITY 3
Purpose of Action	LEVEL 2
Deficiency Photo1

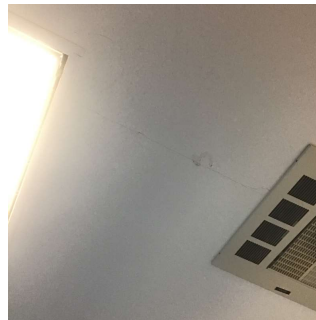
Near center

GYP SUM BOARD: DAMAGED/DETERIORATED

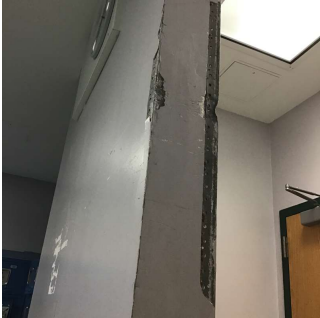
Question	Response
<b>INTERIOR</b>	
<b>LOCKER ROOM</b>	
<b>Walls</b>	
Condition	2 - Between Good and Fair
Deficiency	GYP SUM BOARD: DETERIORATED
Deficiency Location/Instance	Near Entrance
Deficiency Quantity	30
Quantity Uom	S.F.
Potential Action	REPLACE
Urgency of Action	PRIORITY 3
Purpose of Action	LEVEL 2
Deficiency Photo1

Near Entrance
Violations	No violations recorded.
Instance on Room 215B (206 Lockers)	Inspected
Condition	2 - Between Good and Fair
Deficiency	GYP SUM BOARD: DETERIORATED
Deficiency Location/Instance	Near Entrance
Deficiency Quantity	10
Quantity Uom	S.F.
Potential Action	REPLACE
Urgency of Action	PRIORITY 3
Purpose of Action	LEVEL 2
Deficiency Photo1

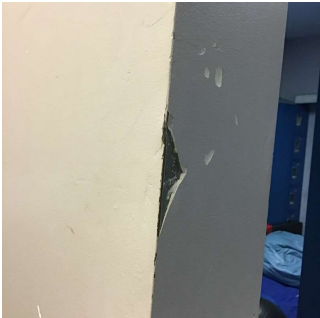
Near Entrance
Violations	No violations recorded.
<b>MULTI-PURPOSE ROOM</b>	Does not Exist
<b>SCIENCE DEMO ROOM</b>	Does not Exist
<b>SCIENCE LAB</b>	Inspected
Instance on Room 202	Inspected
Alternative use	Yes
Instance on Room 403A	Inspected
Alternative use	No

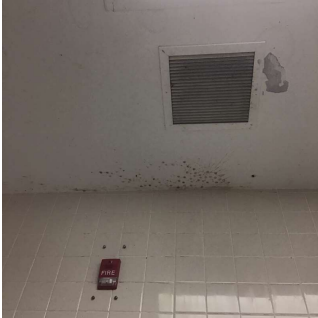
Question	Response
<b>INTERIOR</b>	
<b>TOILET ROOMS - STUDENTS</b>	Inspected
<b>Ceiling</b>	Inspected
Condition	2 - Between Good and Fair
Deficiency	GYPSUM BOARD: DAMAGED/DETERIORATED
Deficiency Location/Instance	Rooms 212A, 407, 433G, C10A
Deficiency Quantity	40
Quantity Uom	S.F.
Potential Action	REPLACE
Urgency of Action	PRIORITY 3
Purpose of Action	LEVEL 2
Deficiency Photo1

Violations	Room C10A No violations recorded.
<b>Door(s)</b>	Inspected
Condition	3 - Fair
Deficiency	WOOD: DAMAGED LOUVER
Deficiency Location/Instance	Room C10A
Deficiency Quantity	1
Quantity Uom	EACH
Potential Action	MAINTENANCE
Urgency of Action	PRIORITY 3
Purpose of Action	LEVEL 2
Deficiency Photo1

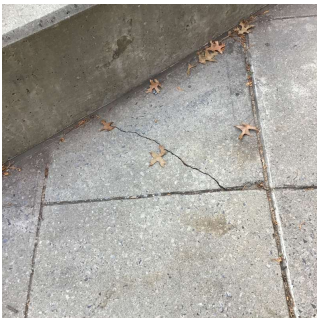
Violations	Schoolyard No violations recorded.
<b>Concrete</b>	Does not Exist
<b>Pavers</b>	Does not Exist
<b>Site Sidewalks &amp; Walkways</b>	Inspected
<b>Asphalt</b>	Inspected
Condition	1 - Good
Deficiency	No deficiencies recorded
<b>Concrete</b>	Inspected
Condition	3 - Fair
Deficiency	DAMAGED/DETERIORATED/MISSING SECTIONS
Deficiency Location/Instance	Near Exits 1, 2
Deficiency Quantity	50
Quantity Uom	S.F.
Potential Action	REPLACE
Urgency of Action	PRIORITY 3
Purpose of Action	LEVEL 2
Deficiency Photo1

Violations	Near Exit 2 No violations recorded.
<b>Pavers</b>	Does not Exist
<b>DOT Sidewalk</b>	Inspected
<b>Asphalt</b>	Does not Exist

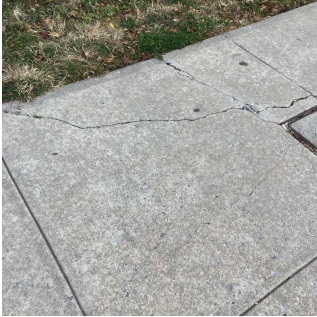
Question	Response
<b>SITE</b>	
<b>PAVING</b>	
<b>DOT Sidewalk</b>	
<b>Asphalt</b>	Does not Exist
<b>Concrete</b>	Inspected
Condition	4 - Between Fair and Poor
Deficiency	DAMAGED/DETERIORATED/MISSING SECTIONS
Deficiency Location/Instance	69th Street, 70th Street , juniper Valley Road.
Deficiency Quantity	650
Quantity Uom	S.F.
Potential Action	REPLACE
Urgency of Action	PRIORITY 3
Purpose of Action	LEVEL 2
Deficiency Photo1

Juniper Valley
Violations	No violations recorded.
<b>Deficiency</b>	<b>DAMAGED CURBS</b>
Deficiency Location/Instance	65th Drive, 69th Street, 70th Street , juniper Valley Road.
Deficiency Quantity	60
Quantity Uom	L.F.
Potential Action	REPLACE
Urgency of Action	PRIORITY 3
Purpose of Action	LEVEL 2
Deficiency Photo1
