NYC Department of Education
Building Condition Assessment Survey 2023 - 2024

Architectural Inspection

Asset: P.S. 254 - QUEENS, 84-40 101ST STREET, New York, 11418

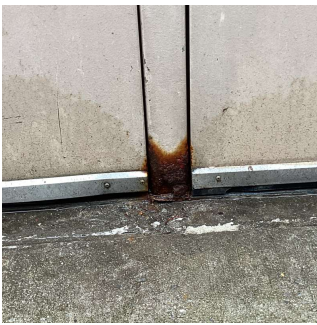
METAL: DETERIORATED DOOR AND FRAME - MAJOR DETERIORATION

2
EACH
REPLACE
PRIORITY 4
LEVEL 2

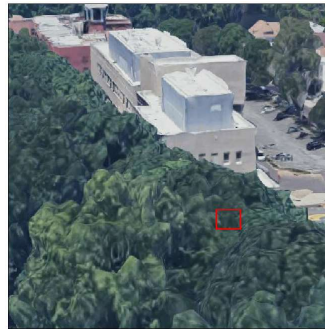
Deficiency Quantity	10
Quantity Uom	S.F.
Potential Action	MAINTENANCE
Urgency of Action	PRIORITY 3
Purpose of Action	LEVEL 2
Deficiency Photo1	No photo recorded
Violations	No violations recorded.
EXTERIOR WALLS	Inspected
Material Type(s)	Masonry
Replacement Quantity	39,000
Replacement Uom	S.F.
Instance on All Facades	Inspected
Instance Condition	4 - Between Fair and Poor
Instance Quantity	39,000
Instance Quantity Uom	S.F.
Deficiency	BRICK: MINOR CRACKS AND SPALLING

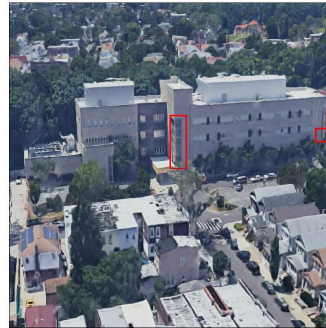
GLASS BLOCK: WATER INFILTRATION IN INSTRUCTIONAL SPACE

500

REPAIR

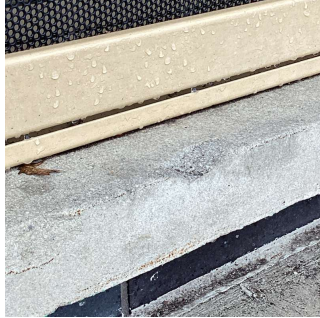
BRICK: DETERIORATED MASONRY SILLS - MINOR

Question	Response
EXTERIOR	
EXTERIOR WALLS	
Potential Action	REPAIR
Urgency of Action	PRIORITY 3
Purpose of Action	LEVEL 2
Deficiency Photo1

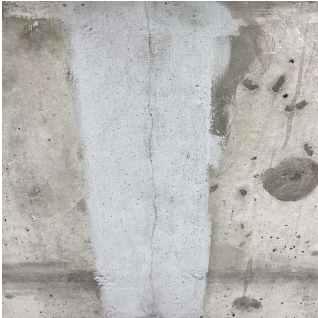
Facade A
Violations	No violations recorded.
EXTERIOR SOFFITS	
Condition	Inspected
Deficiency	2 - Between Good and Fair
	No deficiencies recorded
LOADING DOCK	
	Does not Exist
LOUVER	
Condition	Inspected
Deficiency	2 - Between Good and Fair
	No deficiencies recorded
PARAPETS	
Material Type(s)	Inspected
Replacement Quantity	Concrete
Replacement Uom	6,000
	C.F.
Instance on All Facades	Inspected
Instance Condition	3 - Fair
Instance Quantity	6,000
Instance Quantity Uom	C.F.
Deficiency	CONCRETE: MINOR CRACKS, SPALLING
Roof Plan reference

Deficiency Quantity	120
Quantity Uom	S.F.
Potential Action	REPAIR
Urgency of Action	PRIORITY 3
Purpose of Action	LEVEL 2

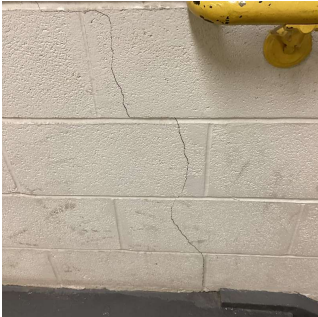
Deficiency **BULKHEAD/PENTHOUSE WALLS/INTERIOR: CMU CRACKS/SPALLING**

20
S.F.
REPLACE
PRIORITY 3
LEVEL 2

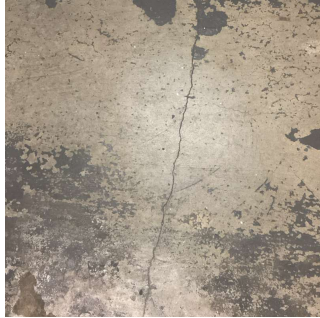
Question	Response
INTERIOR	
STRUCTURAL	
COLUMNS/BEAMS/BEARING WALLS	
Purpose of Action	LEVEL 5
Deficiency Photo1	 
Violations	Basement - Room C06 No violations recorded.
Deficiency	STEEL COLUMNS/BEAMS: DETERIORATED CONCRETE FIREPROOFING
Deficiency Location/Instance	Facade C
Deficiency Quantity	10
Quantity Uom	S.F.
Potential Action	REPLACE
Urgency of Action	PRIORITY 3
Purpose of Action	LEVEL 5
Deficiency Photo1	 
Violations	Facade C No violations recorded.
FLOOR STRUCTURE	Inspected
Condition	3 - Fair
Deficiency	METAL DECK AND CONCRETE: DETERIORATED
Deficiency Location/Instance	Basement - Room C20
Deficiency Quantity	20
Quantity Uom	S.F.
Potential Action	REPAIR
Urgency of Action	PRIORITY 4
Purpose of Action	LEVEL 5
Deficiency Photo1	No photo recorded
Violations	No violations recorded.
Deficiency	CONCRETE SLAB ON GRADE: THRU CRACKS
Deficiency Location/Instance	Basement - Corridor, Rooms C04, C06, C10, C13, C16
Deficiency Quantity	200

Question	Response
INTERIOR	
STRUCTURAL	
FLOOR STRUCTURE	
Urgency of Action	PRIORITY 3
Purpose of Action	LEVEL 5
Deficiency Photo1

Quantity Uom	S.F.
Potential Action	REPAIR

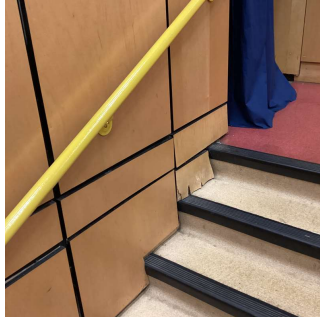
Question	Response
INTERIOR	
AUDITORIUM	
Floor Finish	
Deficiency Photo1	 
	Near Seat J/3
Violations	No violations recorded.
Sliding-folding Partition	
Instance on 1st Floor (366 Seats)	Does not Exist
Stage	
Instance on 1st Floor (366 Seats)	Inspected
Stage	Inspected
Instance on 1st Floor (366 Seats)	Inspected
Condition	3 - Fair
Deficiency	DAMAGED STEPS
Deficiency Location/Instance	Left and Right Side
Deficiency Quantity	20
Quantity Uom	S.F.
Potential Action	REPLACE
Urgency of Action	PRIORITY 3
Purpose of Action	LEVEL 2
Deficiency Photo1	 
	Left Side
Violations	No violations recorded.
Deficiency	DAMAGED FASCIA
Deficiency Location/Instance	Left Side
Deficiency Quantity	10
Quantity Uom	S.F.
Potential Action	REPLACE
Urgency of Action	PRIORITY 3
Purpose of Action	LEVEL 2

Question	Response
INTERIOR	
AUDITORIUM	
Stage	
Stage	
Deficiency Photo1

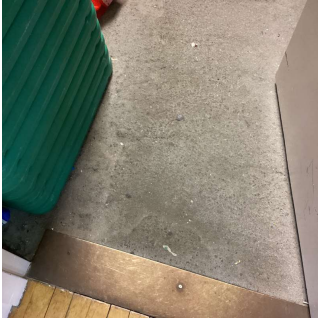
Question	Response
INTERIOR	
GYMNASIUM	
Fixed Equipment	
Condition	2 - Between Good and Fair
Deficiency	No deficiencies recorded
Floor Finish	
Instance on 2nd Floor	Inspected
Condition	2 - Between Good and Fair
Deficiency	CONCRETE: CRACKS
Deficiency Location/Instance	Room 201A
Deficiency Quantity	25
Quantity Uom	S.F.
Potential Action	REPLACE
Urgency of Action	PRIORITY 3
Purpose of Action	LEVEL 2
Deficiency Photo1

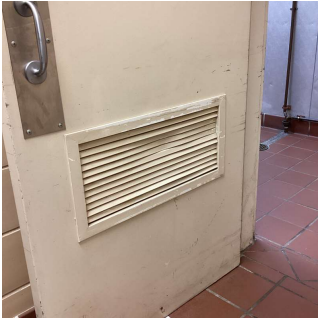
Question	Response
INTERIOR	
KITCHEN	
Door(s)	
Deficiency Quantity	1
Quantity Uom	EACH
Potential Action	MAINTENANCE
Urgency of Action	PRIORITY 3
Purpose of Action	LEVEL 2
Deficiency Photo1

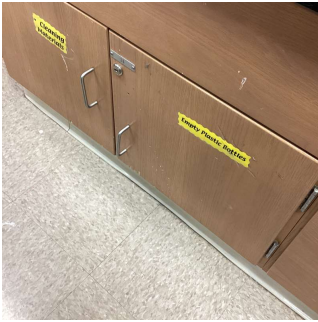
Question	Response
INTERIOR	
LIBRARY	Inspected
Walls	
Deficiency	No deficiencies recorded
LOCKER ROOM	Does not Exist
MULTI-PURPOSE ROOM	Does not Exist
SCIENCE DEMO ROOM	Does not Exist
SCIENCE LAB	Inspected
Instance on Room 413	Inspected
Alternative use	No
Fixed Equipment	
Instance on Room 413	Inspected
Condition	3 - Fair
Deficiency	CABINETRY: MISSING/DAMAGED
Deficiency Location/Instance	Room 413
Deficiency Quantity	10
Quantity Uom	L.F.
Potential Action	REPLACE
Urgency of Action	PRIORITY 3
Purpose of Action	LEVEL 2
Deficiency Photo1

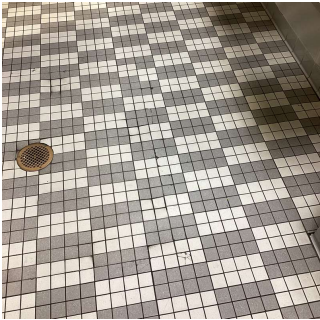
Question	Response
INTERIOR	
TOILET ROOMS - STAFF	
Door(s)	Inspected
	Inside Kitchen
Violations	No violations recorded.
Floor Finish	Inspected
Condition	2 - Between Good and Fair
Deficiency	CERAMIC TILE: BROKEN/MISSING TILES
Deficiency Location/Instance	1st Floor - Women, 1st Floor - Men
Deficiency Quantity	20
Quantity Uom	S.F.
Potential Action	REPLACE
Urgency of Action	PRIORITY 3
Purpose of Action	LEVEL 2
Deficiency Photo1

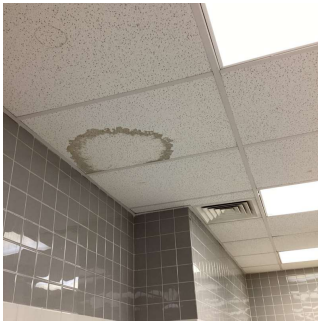
Violations	1st Floor - Women No violations recorded.
Stalls	Inspected
Condition	2 - Between Good and Fair
Deficiency	No deficiencies recorded
Walls	Inspected
Condition	2 - Between Good and Fair
Deficiency	No deficiencies recorded
TOILET ROOMS - STUDENTS	
Ceiling	Inspected
Condition	2 - Between Good and Fair
Deficiency	ACOUSTIC TILES: DAMAGED/MISSING
Deficiency Location/Instance	4th Floor - Boys, Girls, 3rd Floor - Boys, Girls, 2nd Floor - Boys and others
Deficiency Quantity	80
Quantity Uom	S.F.

Potential Action	REPLACE
Urgency of Action	PRIORITY 3
Purpose of Action	LEVEL 2

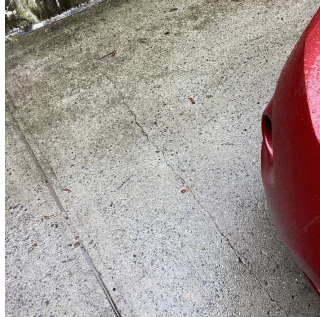
Violations	101th Street No violations recorded.
IRRIGATION SYSTEM	Does not Exist
PAVING	Inspected
Student Non-Use	Inspected
Gravel Exists?	No
Asphalt	Does not Exist
Concrete	Inspected
Condition	3 - Fair
Deficiency	CRACKS - MAJOR

Deficiency Location/Instance	Driveway near Schoolyard
Deficiency Quantity	100
Quantity Uom	S.F.
Potential Action	REPLACE
Urgency of Action	PRIORITY 3
Purpose of Action	LEVEL 2

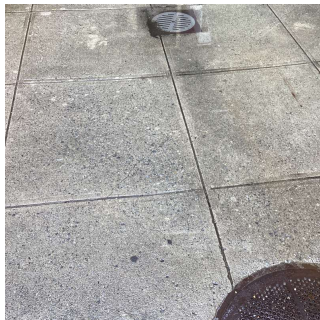
Violations	Schoolyard No violations recorded.
Concrete	Inspected
Condition	2 - Between Good and Fair
Deficiency	No deficiencies recorded
Pavers	Does not Exist
Site Sidewalks & Walkways	Inspected
Asphalt	Does not Exist
Concrete	Inspected
Condition	3 - Fair
Deficiency	CRACKS - MAJOR
Deficiency Location/Instance	Exit 1, Near Exit 7
Deficiency Quantity	75
Quantity Uom	S.F.
Potential Action	REPLACE
Urgency of Action	PRIORITY 3
Purpose of Action	LEVEL 2
Deficiency Photo1

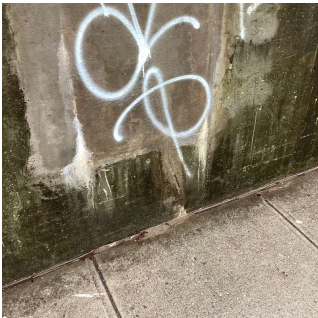
Question	Response
SITE	
PLAYGROUNDS	
Safety Surfacing	
Instance on Northwest Side of Building	Inspected
Condition	2 - Between Good and Fair
Deficiency	No deficiencies recorded
Unpaved Area	
Instance on Northwest Side of Building	Inspected
Condition	2 - Between Good and Fair
Deficiency	No deficiencies recorded
PLAYING SURFACE	
	Does not Exist
RETAINING WALLS	
Are there any Retaining Walls 6' OR higher facing public street/sidewalk?	Inspected
	No
Condition	3 - Fair
Deficiency	CAST IN PLACE CONCRETE: CRACKS/SPALLING - MAJOR
Deficiency Location/Instance	101th Street
Deficiency Quantity	40
Quantity Uom	S.F.
Potential Action	REPLACE
Urgency of Action	PRIORITY 3
Purpose of Action	LEVEL 2
Deficiency Photo1

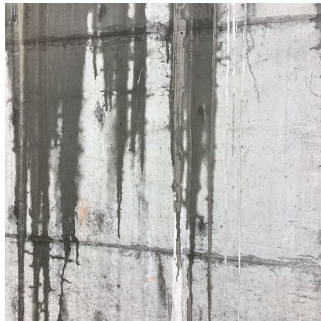
Deficiency	No deficiencies recorded
Bleachers	
	Does not Exist
SITE WALLS (NOT RETAINING WALLS)	
	Inspected
Condition	3 - Fair
Deficiency	CAST IN PLACE CONCRETE: CRACKS/SPALLING - MAJOR
Deficiency Location/Instance	Near Playground
Deficiency Quantity	20
Quantity Uom	S.F.
Potential Action	REPLACE
Urgency of Action	PRIORITY 3

Question	Response
SITE	
SITE WALLS (NOT RETAINING WALLS)	
Purpose of Action	LEVEL 2
Deficiency Photo1
