NYC Department of Education
Building Condition Assessment Survey 2023 - 2024

Architectural Inspection

Q260

Asset: P.S. 307- QUEENS, 40-20 100TH STREET, New York, 11368

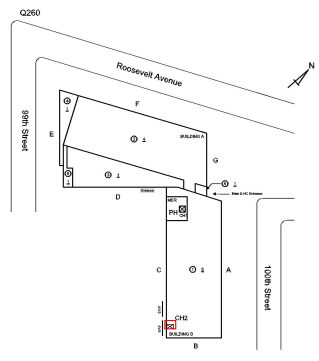
Question	Response
EXTERIOR	
CHIMNEY	
Condition	5 - Poor
Deficiency	METAL: LOOSE OR MISSING SUPPORTS
Roof Plan reference

Deficiency Quantity	3
Quantity Uom	EACH
Potential Action	REPLACE
Urgency of Action	PRIORITY 5
Purpose of Action	LEVEL 6
Deficiency Photo1

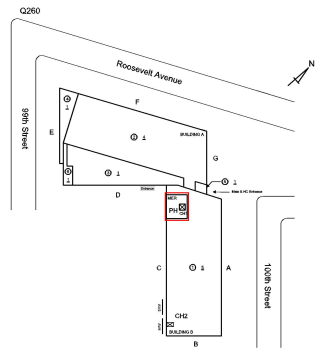
Violations	CH2 No violations recorded.
COPING	
Condition	Inspected
Condition	3 - Fair
Deficiency	CAST STONE: DETERIORATED BED JOINT
Roof Plan reference

Deficiency Quantity	50
Quantity Uom	L.F.
Potential Action	REPOINT
Urgency of Action	PRIORITY 3
Purpose of Action	LEVEL 2

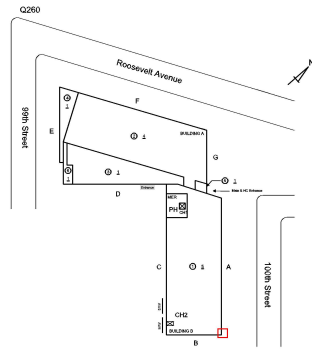
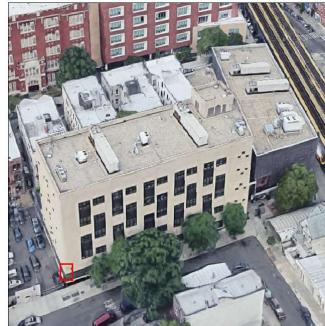
BRICK: MAJOR / THRU CRACKS

10
S.F.
REMOVE AND REBUILD
PRIORITY 4
LEVEL 2

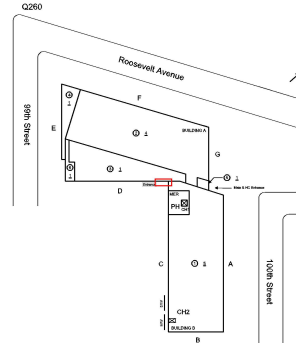
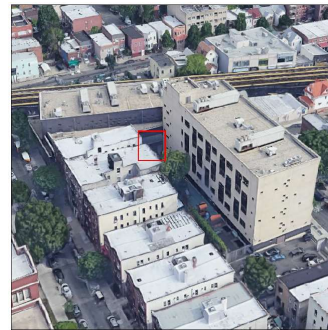
GLASS BLOCK: DETERIORATED JOINTS

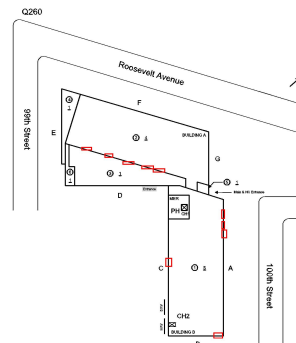
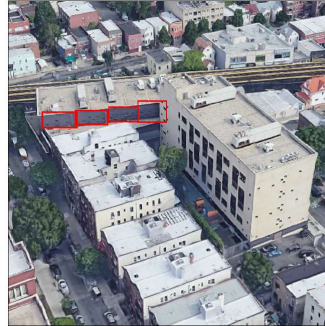
BRICK: MINOR CRACKS AND SPALLING

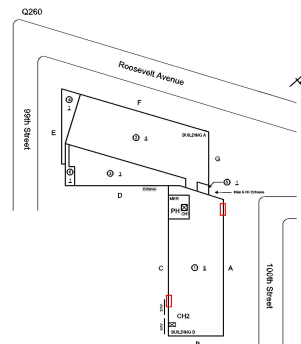
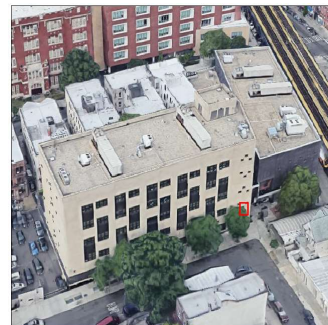
BRICK: DETERIORATED MASONRY SILLS - MINOR

REPAIR

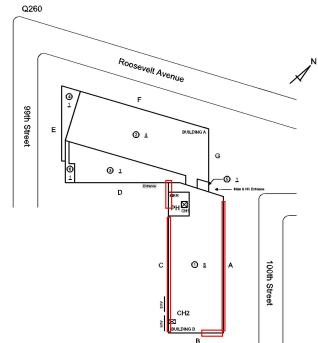
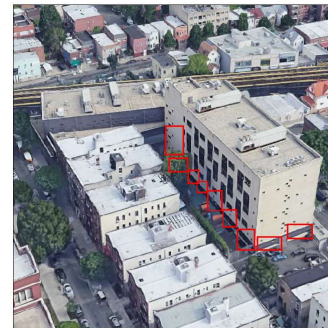
BRICK: DETERIORATED JOINTS

100
S.F.
REPOINT
PRIORITY 3
LEVEL 2

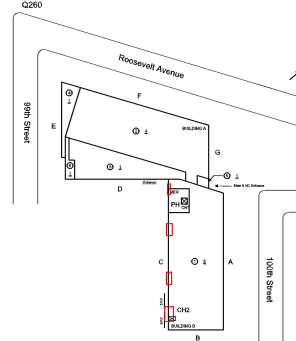
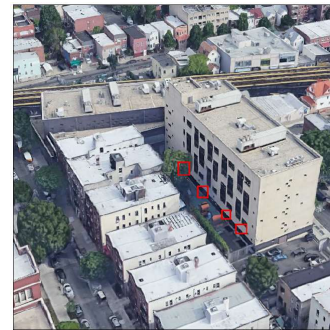
BRICK: MASONRY SILLS - DETERIORATED JOINTS

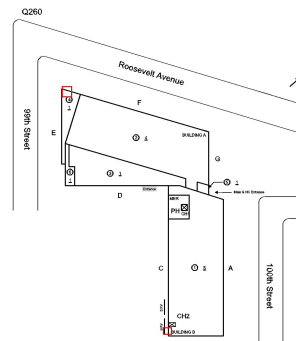
BRICK: DETERIORATED CONTROL/EXPANSION JOINTS

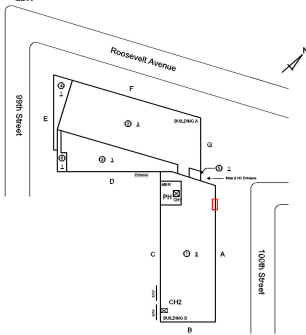
Violations	Roof 2 No violations recorded.
Deficiency	CONCRETE: DETERIORATED CONTROL/EXPANSION JOINT
Roof Plan reference

Deficiency Quantity	10
Quantity Uom	L.F.
Potential Action	MAINTENANCE
Urgency of Action	PRIORITY 3
Purpose of Action	LEVEL 2
Deficiency Photo1	No photo recorded
Violations	No violations recorded.
PLAZA DECK	Does not Exist
ROOF	Inspected
Roofing	Inspected
Replacement Quantity	29,000
Replacement Uom	S.F.
ROOF HATCH/SMOKE HATCH	Inspected
Condition	2 - Between Good and Fair
Deficiency	No deficiencies recorded
LEADERS, GUTTERS, DOWNSPOUTS, SCUPPERS	Inspected
Condition	2 - Between Good and Fair
Deficiency	No deficiencies recorded
ROOF BARRIER/FENCE	Inspected
Condition	2 - Between Good and Fair
Deficiency	No deficiencies recorded
ROOF CAGE	Does not Exist
ROOFING	Inspected
Instance on IRMA: Roofs 1 - 4	Inspected
Instance Condition	5 - Poor

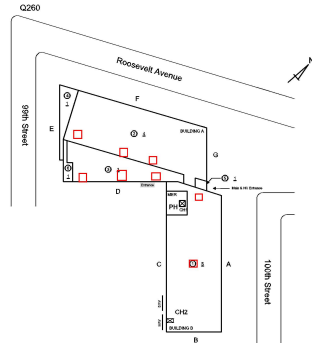
DETERIORATED

REPLACE

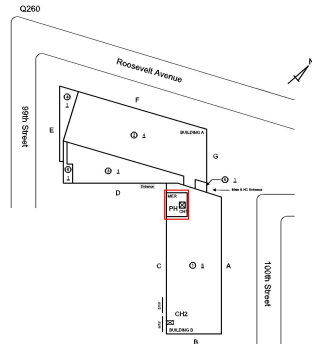
BULKHEAD/PENTHOUSE WALLS/EXTERIOR: DETERIORATED JOINTS

Question	Response
EXTERIOR	
ROOF	
Specialties	
BULKHEAD/PENTHOUSE	
Potential Action	REPOINT
Urgency of Action	PRIORITY 3
Purpose of Action	LEVEL 2
Deficiency Photo1	 
Violations	PH No violations recorded.
CUPOLA/ SPIRES/ TOWERS	Does not Exist
DORMER	Does not Exist
DUNNAGE STEEL	Does not Exist
SKYLIGHT/ROOF VENT	Does not Exist
ROOF/GRAVITY TANK	Does not Exist
STAIRS/RAMPS: EXTERIOR	Does not Exist
WINDOWS	Inspected
Replacement Quantity	7,500
Replacement Uom	S.F.
EXTERIOR GUARDS	Inspected
Condition	2 - Between Good and Fair
Deficiency	No deficiencies recorded
LINTELS	Inspected
Condition	2 - Between Good and Fair
Deficiency	No deficiencies recorded
WINDOWS	Inspected
Material Type(s)	Aluminum
Instance on Aluminum - Other: All Facades	Inspected
Instance Condition	2 - Between Good and Fair
Instance Quantity	7,500
Instance Quantity Uom	S.F.
Are these windows insulated	Yes
Installation Year	2008
Source of Installation	Custodial Staff

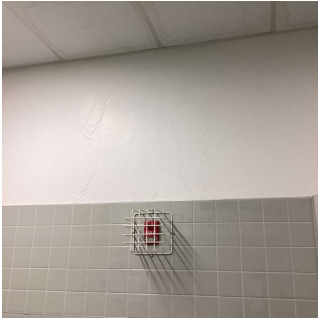
Question	Response
INTERIOR	
CLASSROOMS/CORRIDORS/ADMIN SPACES	
Floor Finish	Inspected
Violations	Corridor Near Exit 1 No violations recorded.
Walls	Inspected
Condition	2 - Between Good and Fair
Deficiency	GYPSUM BOARD: DETERIORATED - ACTIVE LEAK
Deficiency Location/Instance	Corridor near Room 507
Deficiency Quantity	20
Quantity Uom	S.F.
Potential Action	REPLACE
Urgency of Action	PRIORITY 5
Purpose of Action	LEVEL 2
Deficiency Photo1

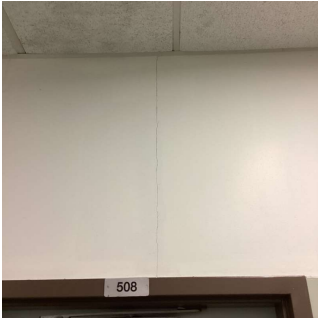
Violations	Corridor near Room 507 No violations recorded.
Deficiency	GYPSUM BOARD: DETERIORATED
Deficiency Location/Instance	Corridor near Rooms 514, 508, 407, 406, 405 and others
Deficiency Quantity	200
Quantity Uom	S.F.
Potential Action	REPLACE
Urgency of Action	PRIORITY 3
Purpose of Action	LEVEL 2
Deficiency Photo1

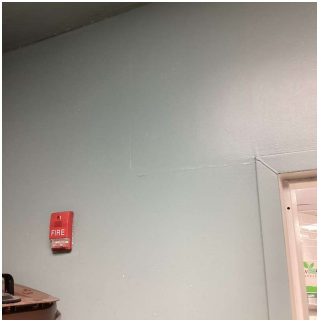
Violations	Serving area No violations recorded.
Walls	
Instance on 1st Floor	Inspected
Condition	2 - Between Good and Fair
Deficiency	GYP SUM BOARD: DETERIORATED
Deficiency Location/Instance	Near Room 132B
Deficiency Quantity	20
Quantity Uom	S.F.
Potential Action	REPLACE
Urgency of Action	PRIORITY 3
Purpose of Action	LEVEL 2
Deficiency Photo1

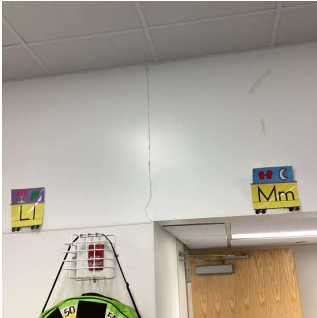
Question	Response
INTERIOR	
MULTI-PURPOSE ROOM	
Stage	
Instance on Basement (1200 SF)	Does not Exist
Walls	
Instance on Basement (1200 SF)	Inspected
Condition	2 - Between Good and Fair
Deficiency	GYPSUM BOARD: DETERIORATED
Deficiency Location/Instance	Near Entrance, Left Side
Deficiency Quantity	40
Quantity Uom	S.F.
Potential Action	REPLACE
Urgency of Action	PRIORITY 3
Purpose of Action	LEVEL 2
Deficiency Photo1

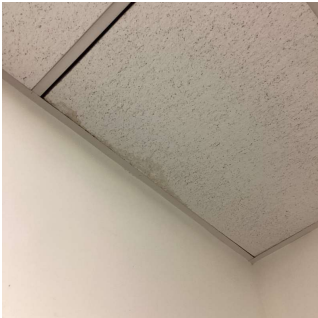
Violations	Stair A/5 No violations recorded.
TOILET ROOMS - STAFF	
Ceiling	
Condition	Inspected
Condition	2 - Between Good and Fair
Deficiency	ACOUSTIC TILES: DAMAGED/MISSING
Deficiency Location/Instance	Room 224
Deficiency Quantity	10
Quantity Uom	S.F.
Potential Action	REPLACE
Urgency of Action	PRIORITY 3
Purpose of Action	LEVEL 2
Deficiency Photo1

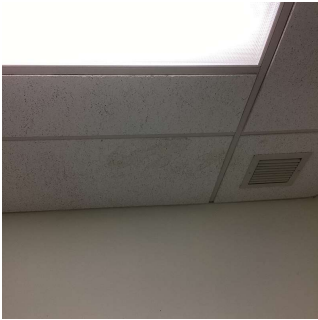
Violations	Room 502 No violations recorded.
Deficiency	ACOUSTIC TILES: DAMAGED/MISSING
Deficiency Location/Instance	Rooms 128A, 230C
Deficiency Quantity	20
Quantity Uom	S.F.
Potential Action	REPLACE
Urgency of Action	PRIORITY 3
Purpose of Action	LEVEL 2
Deficiency Photo1

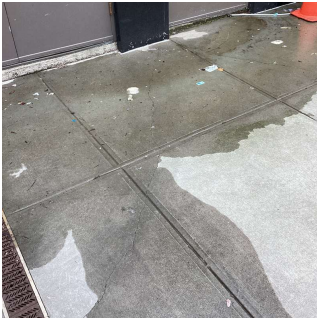
Schoolyard
Violations	No violations recorded.
Pavers	Does not Exist
Site Sidewalks & Walkways	Inspected
Asphalt	Does not Exist
Concrete	Inspected
Condition	3 - Fair
Deficiency	CRACKS - MAJOR
Deficiency Location/Instance	Exits 8, 3
Deficiency Quantity	225
Quantity Uom	S.F.
Potential Action	REPLACE
Urgency of Action	PRIORITY 3
Purpose of Action	LEVEL 2
Deficiency Photo1

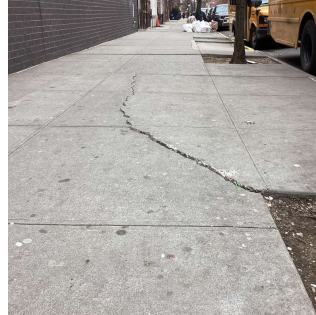
99th Street

Exit 8
Violations	No violations recorded.
Pavers	Does not Exist
DOT Sidewalk	Inspected
Asphalt	Does not Exist
Concrete	Inspected
Condition	4 - Between Fair and Poor
Deficiency	HEAVING
Deficiency Location/Instance	99th Street, Roosevelt Avenue
Deficiency Quantity	300
Quantity Uom	S.F.
Potential Action	REPLACE
Urgency of Action	PRIORITY 3

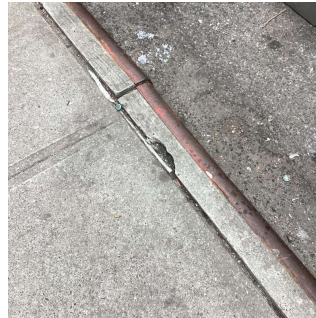
99th Street

Deficiency

DAMAGED CURBS

REPLACE

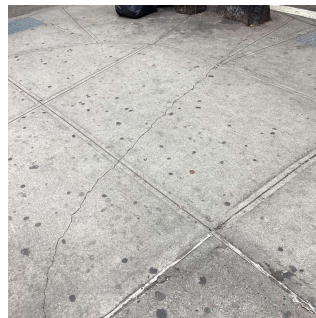
Deficiency

DAMAGED/DETERIORATED/MISSING SECTIONS

REPLACE

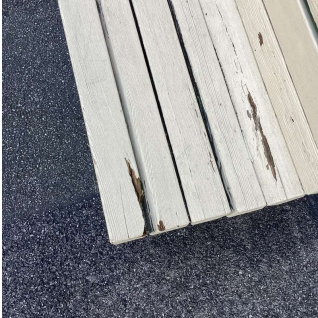
Question	Response
SITE	
PAVING	Inspected
DOT Sidewalk	
Concrete	Inspected
Violations	Roosevelt Avenue No violations recorded.
Pavers	Does not Exist
PLAYGROUNDS	Inspected
Instance on Rear of Building	Inspected
Benches	
Instance on Rear of Building	Inspected
Condition	4 - Between Fair and Poor
Deficiency	DAMAGED/DETERIORATED
Deficiency Location/Instance	Rear of Building
Deficiency Quantity	2
Quantity Uom	EACH
Potential Action	REPLACE
Urgency of Action	PRIORITY 3
Purpose of Action	LEVEL 2
Deficiency Photo1

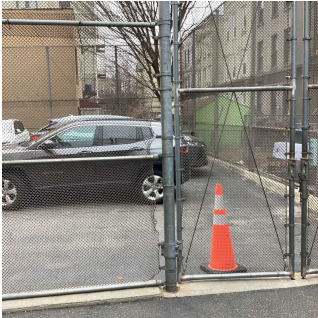
Violations	Near Entrance

Violations	Rear of Building No violations recorded.
Fence	
Instance on Rear of Building	Inspected
Condition	3 - Fair
Deficiency	CHAIN LINK: DAMAGED/DETERIORATED
Deficiency Location/Instance	Near Entrance
Deficiency Quantity	100
Quantity Uom	S.F.
Potential Action	REPLACE
Urgency of Action	PRIORITY 3
Purpose of Action	LEVEL 2
Deficiency Photo1

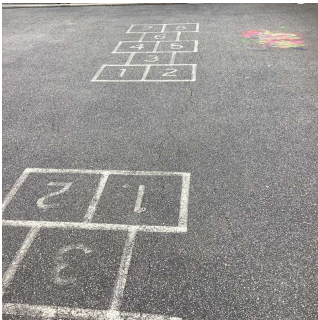
Question	Response
SITE	
PLAYGROUNDS	Inspected
Fence	
Violations	No violations recorded.
Pavement	
Instance on Rear of Building	Inspected
Condition	3 - Fair
Deficiency	ASPHALT: CRACKS - MAJOR
Deficiency Location/Instance	Near benches, Near Exit 2
Deficiency Quantity	100
Quantity Uom	S.F.
Potential Action	REPLACE
Urgency of Action	PRIORITY 3
Purpose of Action	LEVEL 2
Deficiency Photo1

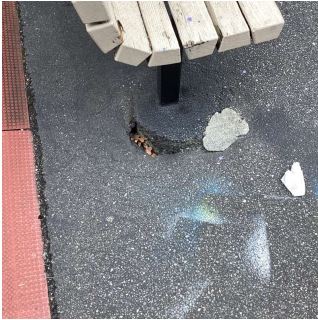
Violations	Near benches No violations recorded.
Deficiency	ASPHALT: POTHOLES
Deficiency Location/Instance	Near benches
Deficiency Quantity	20
Quantity Uom	S.F.
Potential Action	REPAIR
Urgency of Action	PRIORITY 3
Purpose of Action	LEVEL 2
Deficiency Photo1

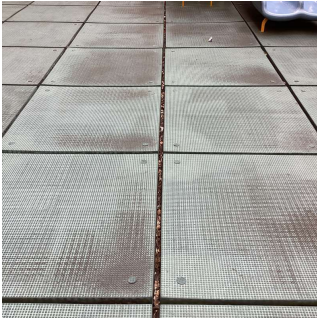
Question	Response
SITE	
PLAYGROUNDS	
Safety Surfacing	
Deficiency	DETERIORATED/MISSING
Deficiency Location/Instance	Center, Near Exits 5, 6, Near Entrance
Deficiency Quantity	250
Quantity Uom	S.F.
Potential Action	REPLACE
Urgency of Action	PRIORITY 5
Purpose of Action	LEVEL 6
Deficiency Photo1

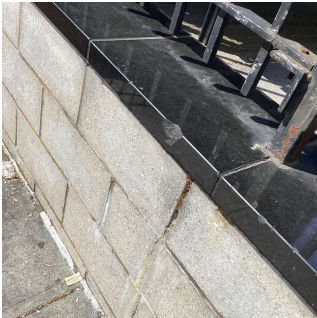
Violations	Center No violations recorded.
Unpaved Area	
Instance on Rear of Building	Does not Exist
PLAYING SURFACE	
	Does not Exist
RETAINING WALLS	
Are there any Retaining Walls 6' OR higher facing public street/sidewalk?	Inspected No
Condition	3 - Fair
Deficiency	CAST IN PLACE CONCRETE: DETERIORATED COPING STONE
Deficiency Location/Instance	100th Street
Deficiency Quantity	10
Quantity Uom	S.F.
Potential Action	REPLACE
Urgency of Action	PRIORITY 3
Purpose of Action	LEVEL 2
Deficiency Photo1

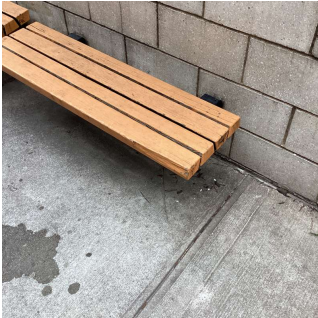
100th Street
Violations	No violations recorded.
SEATING	Inspected
Benches	Inspected
Concrete	Does not Exist
Metal/Wood/Plastic	Inspected
Condition	5 - Poor
Deficiency	DAMAGED/DETERIORATED
Deficiency Location/Instance	Near Main Entrance
Deficiency Quantity	4
Quantity Uom	EACH
Potential Action	REPLACE
Urgency of Action	PRIORITY 3
Purpose of Action	LEVEL 2
Deficiency Photo1

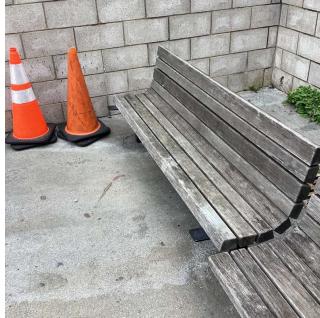
Near Main Entrance
Violations	No violations recorded.
Deficiency	DAMAGED/DETERIORATED
Deficiency Location/Instance	Schoolyard
Deficiency Quantity	1
Quantity Uom	EACH
Potential Action	REPLACE
Urgency of Action	PRIORITY 5
Purpose of Action	LEVEL 6

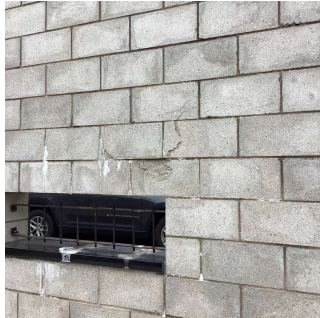
Violations	Schoolyard No violations recorded.
Bleachers	Does not Exist
SITE WALLS (NOT RETAINING WALLS)	Inspected
Condition	3 - Fair
Deficiency	MASONRY UNIT: CRACKS/SPALLING - MAJOR
Deficiency Location/Instance	Roosevelt Avenue, Near Main Entrance, 100th Street
Deficiency Quantity	80
Quantity Uom	S.F.
Potential Action	REPLACE
Urgency of Action	PRIORITY 3
Purpose of Action	LEVEL 2
Deficiency Photo1
