NYC Department of Education
Building Condition Assessment Survey 2023 - 2024

Architectural Inspection

Q262

Asset: P.S. 262 - QUEENS, 95-16 89TH AVENUE, New York, 11421

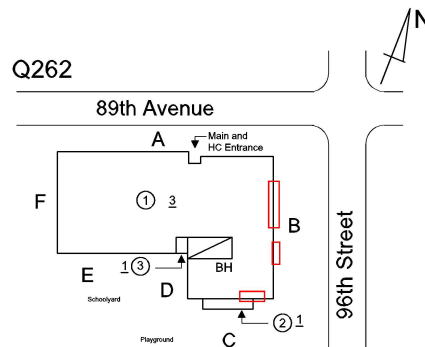
Question	Response
Architectural	
EXTERIOR	Inspected
AREAWAY	Does not Exist
AWNINGS AND CANOPIES	Inspected
Condition	2 - Between Good and Fair
Deficiency	No deficiencies recorded
CHIMNEY	Does not Exist
COPING	Inspected
Condition	2 - Between Good and Fair
Deficiency	METAL: DETERIORATED JOINTS
Roof Plan reference

Deficiency Quantity	30
Quantity Uom	L.F.
Potential Action	REPAIR
Urgency of Action	PRIORITY 3
Purpose of Action	LEVEL 2

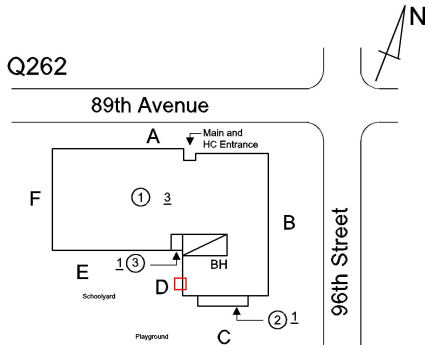
Violations	Roof 1 No violations recorded.
CORNICE	Does not Exist
DOORS	Inspected
DOORS AND FRAMES	Inspected
Condition	3 - Fair
Deficiency	ROLL-UP DOOR: DETERIORATED DOOR AND FRAME - MINOR DETERIORATION
Roof Plan reference

Deficiency Quantity	60
Quantity Uom	S.F.
Potential Action	MAINTENANCE
Urgency of Action	PRIORITY 3
Purpose of Action	LEVEL 2
Deficiency Photo1	No photo recorded
Violations	No violations recorded.
DOOR HARDWARE	Inspected
Condition	3 - Fair
Deficiency	No deficiencies recorded
LINTELS	Inspected
Condition	2 - Between Good and Fair
Deficiency	No deficiencies recorded
TRANSOM/SIDE LIGHT	Inspected
Condition	2 - Between Good and Fair
Deficiency	No deficiencies recorded
EXTERIOR WALLS	Inspected
Material Type(s)	Masonry, Steel
Replacement Quantity	30,000
Replacement Uom	S.F.
Instance on All Facades	Inspected

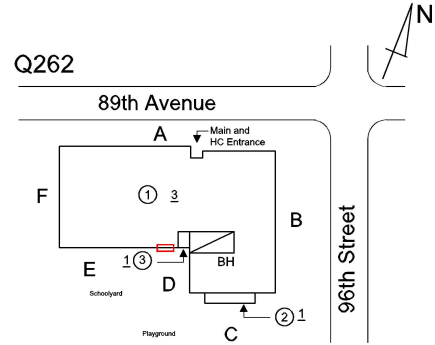
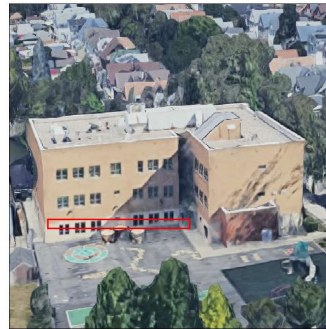
Question	Response
EXTERIOR	
EXTERIOR WALLS	
Instance Condition	3 - Fair
Instance Quantity	30,000
Instance Quantity Uom	S.F.
Deficiency	BRICK: DETERIORATED MASONRY SILLS - MINOR
Roof Plan reference	<p>Q262</p>
Elevation	
Deficiency Quantity	10
Quantity Uom	L.F.
Potential Action	REPAIR
Urgency of Action	PRIORITY 3
Purpose of Action	LEVEL 2
Deficiency Photo1	
Violations	Facade E No violations recorded.
Deficiency	BRICK: MASONRY SILLS - DETERIORATED JOINTS

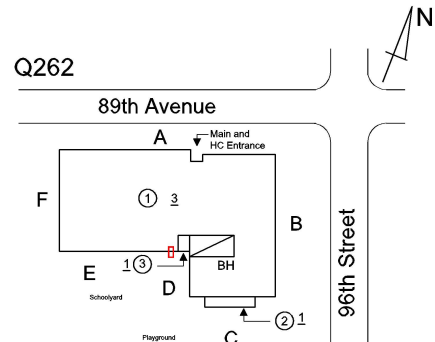
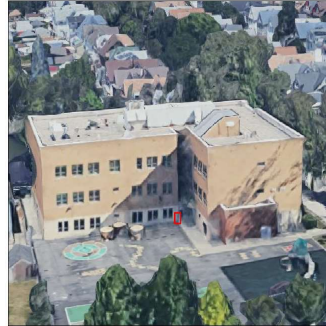
BRICK: DETERIORATED CONTROL/EXPANSION JOINTS

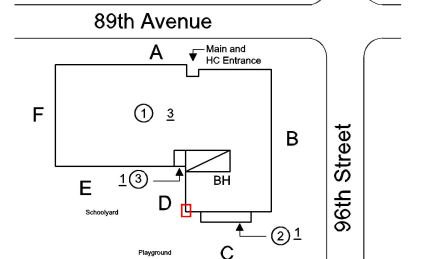
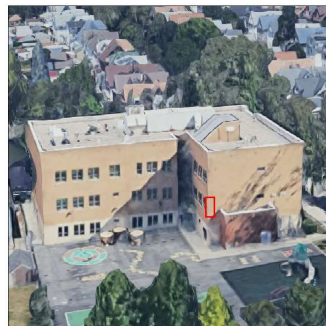
BRICK: CRACKS/DISPLACED/SPALLED BRICK AT BUILDING CORNERS

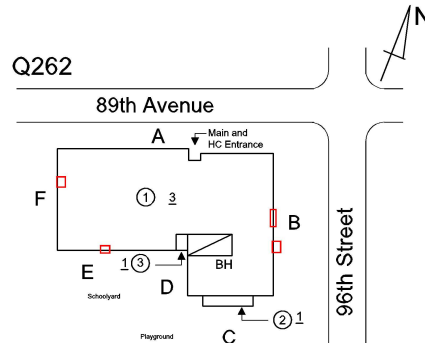
CONCRETE: MINOR CRACKS, SPALLING

REPAIR

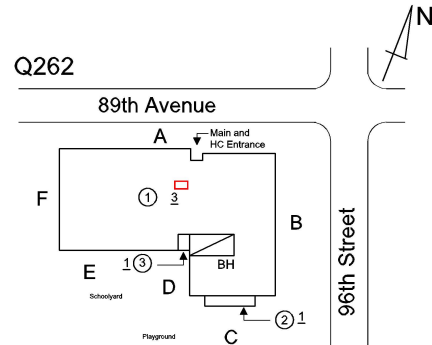
Is/Are the roof(s) suitable for Solar Panel installation?	No
Installation Year	2008
Source of Installation	Custodial Staff
Deficiency	IRMA: ROOFING: DAMAGED INSULATION

10
S.F.
REPLACE
PRIORITY 4
LEVEL 2

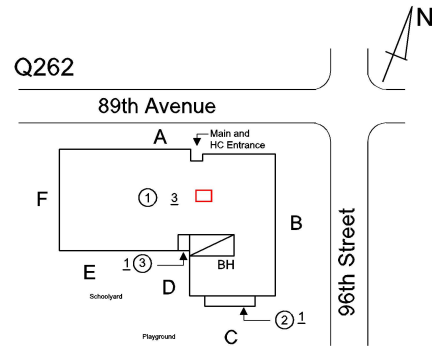
IRMA: ROOFING: MAJOR ACTIVE ROOF LEAKS IN INSTRUCTIONAL SPACE

400
S.F.
REPLACE ROOFING WITHOUT MAJOR EQUIPMENT REMOVAL
PRIORITY 5
LEVEL 2

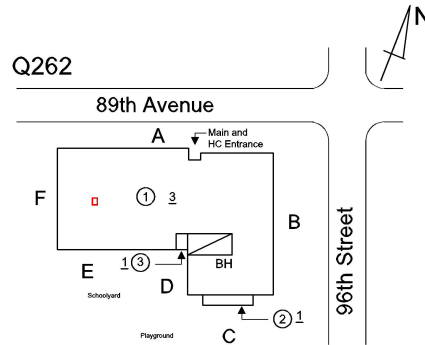
DETERIORATED

REPLACE

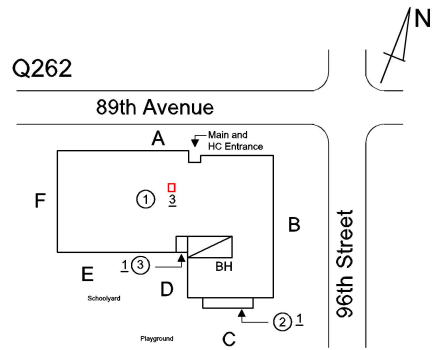
ROOFING DRAINS

1
EACH
MAINTENANCE
PRIORITY 5
LEVEL 2

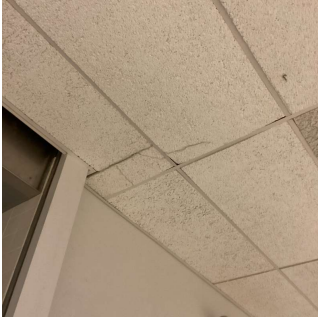
Violations	Near Serving Area No violations recorded.

Question	Response
INTERIOR	
STRUCTURAL	Inspected
COLUMNS/BEAMS/BEARING WALLS	Inspected
Condition	2 - Between Good and Fair
Deficiency	No deficiencies recorded
FLOOR STRUCTURE	Inspected
Condition	2 - Between Good and Fair
Deficiency	No deficiencies recorded
FOUNDATION WALLS	Inspected
Material Type(s)	Concrete
Condition	2 - Between Good and Fair
Deficiency	No deficiencies recorded
ROOF STRUCTURE	Inspected
Condition	2 - Between Good and Fair
Deficiency	No deficiencies recorded
VAULTS-BUNKERS	Does not Exist
AUDITORIUM	Does not Exist
CAFETERIA	Inspected
Instance on Basement	Inspected
Ceiling	
Instance on Basement	Inspected
Condition	2 - Between Good and Fair
Deficiency	ACOUSTIC TILES: DAMAGED/MISSING
Deficiency Location/Instance	Near Serving Area
Deficiency Quantity	20
Quantity Uom	S.F.
Potential Action	REPLACE
Urgency of Action	PRIORITY 3
Purpose of Action	LEVEL 2
Deficiency Photo1

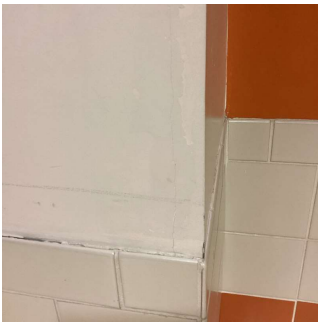
Question	Response
INTERIOR	
CLASSROOMS/CORRIDORS/ADMIN SPACES	
Ceiling	
Deficiency Photo1	 
	Near Elevator/3
Violations	No violations recorded.
Door(s)	Inspected
Condition	2 - Between Good and Fair
Deficiency	No deficiencies recorded
Floor Finish	Inspected
Condition	2 - Between Good and Fair
Deficiency	No deficiencies recorded
Walls	Inspected
Condition	2 - Between Good and Fair
Deficiency	GYPSUM BOARD: DETERIORATED - ACTIVE LEAK
Deficiency Location/Instance	Corridor near Room 311
Deficiency Quantity	10
Quantity Uom	S.F.
Potential Action	REPLACE
Urgency of Action	PRIORITY 5
Purpose of Action	LEVEL 2
Deficiency Photo1	 
	Corridor near Room 311
Violations	No violations recorded.
Deficiency	GYPSUM BOARD: DETERIORATED
Deficiency Location/Instance	Corridor near Elevator/1
Deficiency Quantity	10
Quantity Uom	S.F.
Potential Action	REPLACE
Urgency of Action	PRIORITY 3
Purpose of Action	LEVEL 2

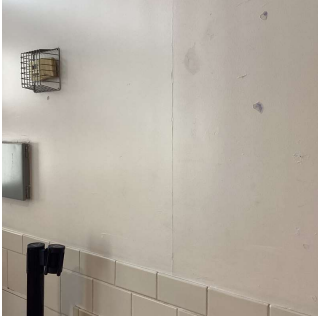
Question	Response
INTERIOR	
STAIRS/RAMPS: INTERIOR	
Railings	Inspected
Condition	2 - Between Good and Fair
Deficiency	No deficiencies recorded
Stairs and Landings	Inspected
Condition	2 - Between Good and Fair
Deficiency	No deficiencies recorded
Walls	Inspected
Condition	2 - Between Good and Fair
Deficiency	GYPSUM BOARD: DETERIORATED
Deficiency Location/Instance	Stairs A/Vestibule, Basement, B/Basement, 1
Deficiency Quantity	50
Quantity Uom	S.F.
Potential Action	REPLACE
Urgency of Action	PRIORITY 3
Purpose of Action	LEVEL 2
Deficiency Photo1

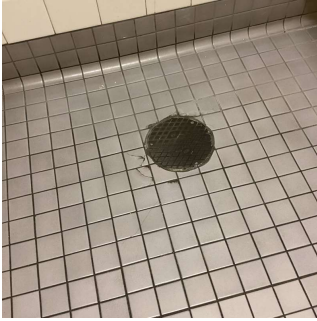
Boys - Basement
Violations	No violations recorded.
Stalls	Inspected
Condition	2 - Between Good and Fair
Deficiency	No deficiencies recorded

Question	Response
INTERIOR	
TOILET ROOMS - STAFF	
Floor Finish	
Deficiency Photo1	 
	Room 207
Violations	No violations recorded.
Stalls	Inspected
Condition	2 - Between Good and Fair
Deficiency	No deficiencies recorded
Walls	Inspected
Condition	2 - Between Good and Fair
Deficiency	No deficiencies recorded
TOILET ROOMS - STUDENTS	
Ceiling	Inspected
Condition	2 - Between Good and Fair
Deficiency	No deficiencies recorded
Door(s)	Inspected
Condition	2 - Between Good and Fair
Deficiency	No deficiencies recorded
Floor Finish	Inspected
Condition	2 - Between Good and Fair
Deficiency	CERAMIC TILE: BROKEN/MISSING TILES
Deficiency Location/Instance	Boys - Basement
Deficiency Quantity	10
Quantity Uom	S.F.
Potential Action	REPLACE
Urgency of Action	PRIORITY 3
Purpose of Action	LEVEL 2
Deficiency Photo1
