**NYC Department of Education**  
**Building Condition Assessment Survey 2023 - 2024**

Architectural Inspection

**Asset:** P.S./I.S. 266 - QUEENS, 74-10 COMMONWEALTH BLVD, New York, 11426

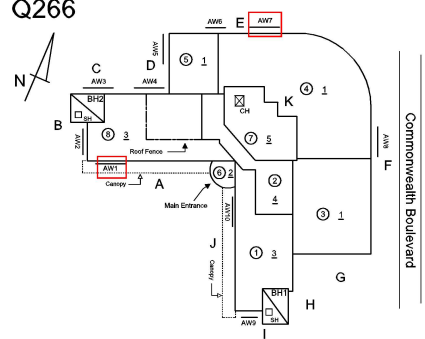
Question	Response
<b>Architectural</b>	
<b>EXTERIOR</b>	Inspected
<b>AREAWAY</b>	Inspected
Instance on AW1-AW10	Inspected
Instance Condition	3 - Fair
Instance Quantity	10
Instance Quantity Uom	EACH
Deficiency	AREAWAY WALLS: CRACKS AND SPALLING
Roof Plan reference	<b>Q266</b>

Deficiency Quantity	30
Quantity Uom	S.F.
Potential Action	REPAIR
Urgency of Action	PRIORITY 3
Purpose of Action	LEVEL 2

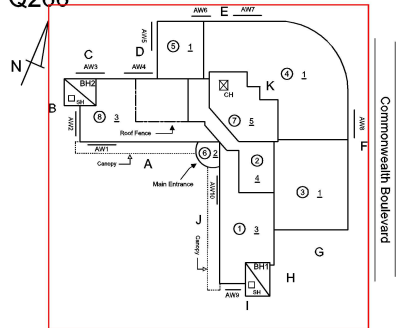
Violations	Facade A - AW1 No violations recorded.
<b>AWNINGS AND CANOPIES</b>	
Condition	Inspected
Deficiency	2 - Between Good and Fair No deficiencies recorded
<b>CHIMNEY</b>	
Material Type(s)	Inspected Metal
Condition	2 - Between Good and Fair
Deficiency	No deficiencies recorded
<b>COPING</b>	
Condition	Inspected 3 - Fair
Deficiency	CAST STONE: DETERIORATED TRANSVERSE JOINTS
Roof Plan reference	Q266

Deficiency Quantity	50
Quantity Uom	L.F.
Potential Action	MAINTENANCE
Urgency of Action	PRIORITY 3
Purpose of Action	LEVEL 2
Deficiency Photo1

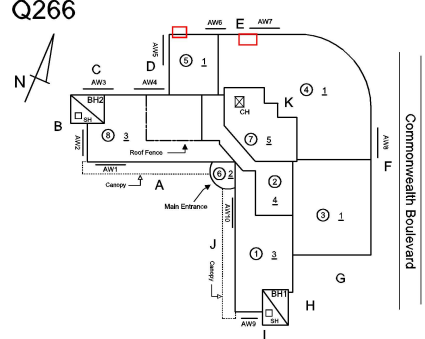
Question	Response
<b>EXTERIOR</b>	
<b>DOORS</b>	Inspected
<b>DOORS AND FRAMES</b>	Inspected
Condition	4 - Between Fair and Poor
Deficiency	METAL: DETERIORATED DOOR AND FRAME - MAJOR DETERIORATION
Roof Plan reference	<p><b>Q266</b></p>

Deficiency Quantity	3
Quantity Uom	EACH
Potential Action	REPLACE
Urgency of Action	PRIORITY 4
Purpose of Action	LEVEL 2
Deficiency Photo1

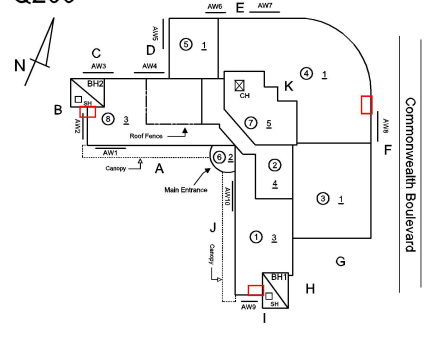
Violations	<p>Facade E</p> <p>No violations recorded.</p>
Deficiency	METAL: DETERIORATED DOOR AND FRAME - MINOR DETERIORATION
Roof Plan reference	<p><b>Q266</b></p>

Deficiency Quantity	6
Quantity Uom	EACH
Potential Action	MAINTENANCE
Urgency of Action	PRIORITY 3
Purpose of Action	LEVEL 2
Deficiency Photo1	No photo recorded
Violations	No violations recorded.

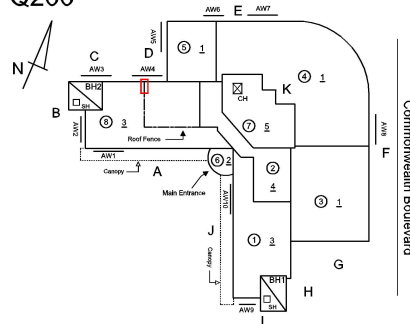
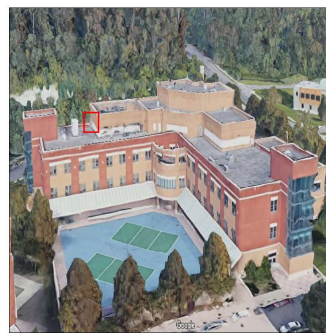
BRICK: MINOR CRACKS AND SPALLING

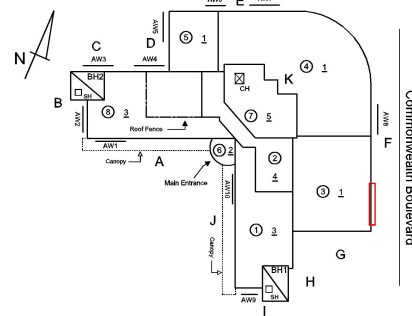
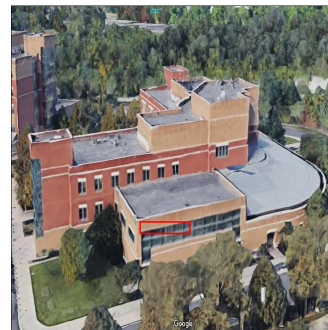
**BRICK: RELIEVING ANGLES - MAJOR DETERIORATION**

REPLACE

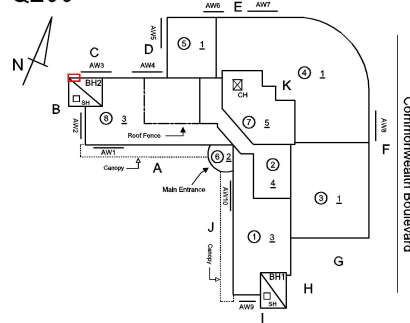
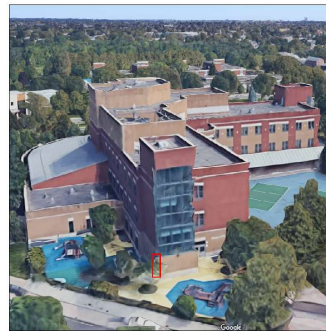
BRICK: CRACKS/DISPLACED/SPALLED BRICK AT BUILDING CORNERS

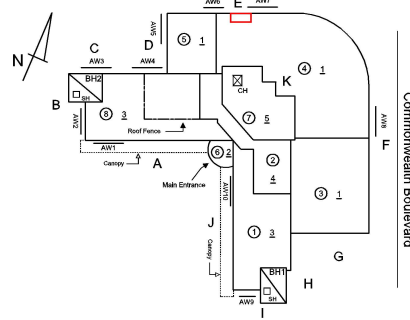
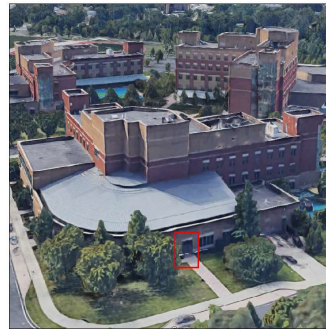
CONCRETE: MINOR CRACKS/SPALLING

REPAIR

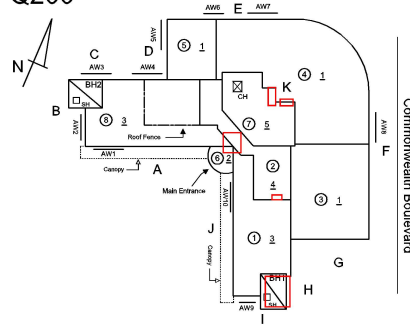
BRICK: MINOR CRACKS, SPALLING

REPAIR

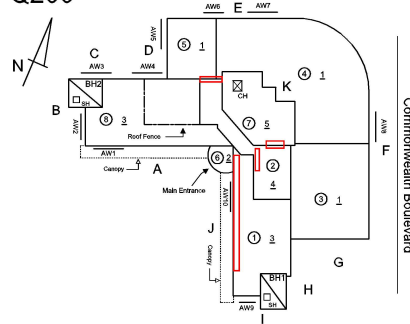
**BRICK: DETERIORATED JOINTS**

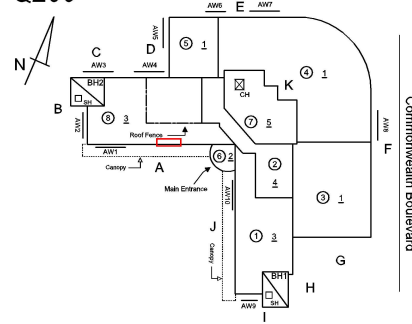
**BRICK: DETERIORATED JOINTS**

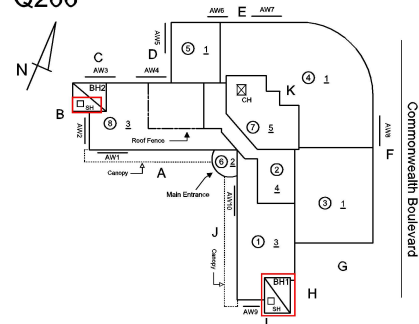
WATER INFILTRATION

2  
EACH  
REPAIR  
PRIORITY 5  
LEVEL 2

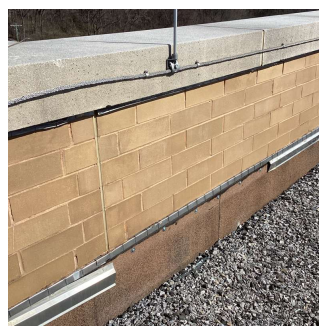
Question	Response
<b>EXTERIOR</b>	
<b>ROOF</b>	
<b>Roofing</b>	
<b>ROOF HATCH/SMOKE HATCH</b>	Inspected
Deficiency Photo1	 
	Roof 1 - Bulkhead 1
Violations	No violations recorded.
<b>LEADERS, GUTTERS, DOWNSPOUTS, SCUPPERS</b>	Does not Exist
<b>ROOF BARRIER/FENCE</b>	Inspected
Condition	2 - Between Good and Fair
Deficiency	No deficiencies recorded
<b>ROOF CAGE</b>	Does not Exist
<b>ROOFING</b>	Inspected
Instance on IRMA: All Roofs except Roof 4	Inspected
Instance Condition	3 - Fair
Instance Photo	 
	Roof 1
Instance Quantity	40,000
Instance Quantity Uom	S.F.
Does the roof have major mechanical equipment sitting on Dunnage Steel less than 18" above the Roofing?	No
Does this roof instance have a Sustainable Roof System?	No
Do solar panels exist on these roofs?	No
Is/Are the roof(s) suitable for Solar Panel installation?	No
Installation Year	2003
Source of Installation	Custodial Staff
Deficiency	IRMA: FLASHING: CAP FLASHING MISSING

Question	Response
<b>EXTERIOR</b>	
<b>ROOF</b>	
<b>Roofing</b>	
<b>ROOFING</b>	
Quantity Uom Potential Action Urgency of Action Purpose of Action Deficiency Photo1	L.F. INSTALL NEW PRIORITY 4 LEVEL 2

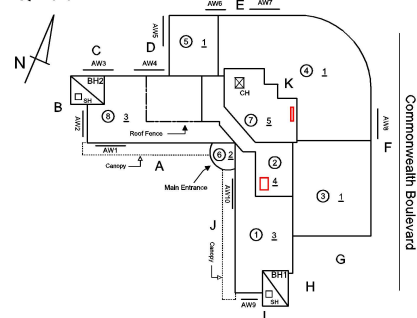
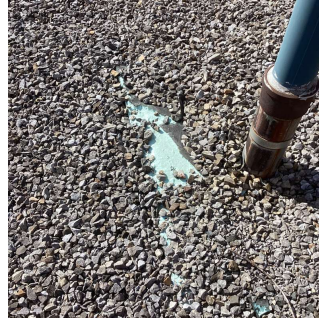
Violations	Roof 7 No violations recorded.
Deficiency	IRMA: ROOFING: DAMAGED INSULATION
Roof Plan reference	Q266

Deficiency Quantity Quantity Uom Potential Action Urgency of Action Purpose of Action Deficiency Photo1	20 S.F. REPLACE PRIORITY 4 LEVEL 2

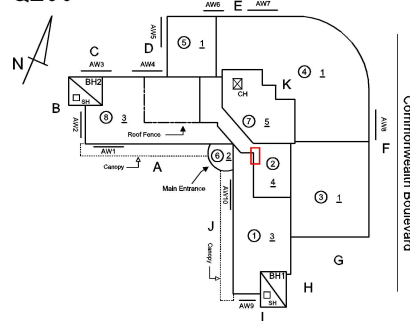
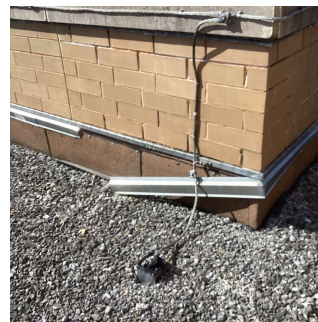
Violations	Roof 2 No violations recorded.
Deficiency	IRMA: FLASHING: CAP FLASHING DAMAGED

10  
L.F.  
REPLACE  
PRIORITY 4  
LEVEL 2

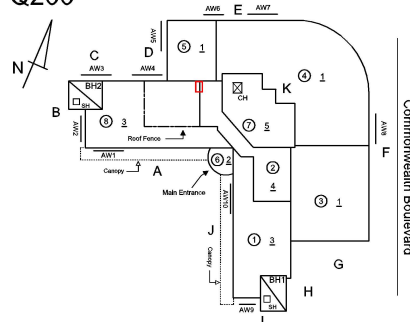
IRMA: FLASHING: PITCH POCKET DETERIORATED - MAJOR

1  
EACH  
REPLACE  
PRIORITY 4  
LEVEL 2

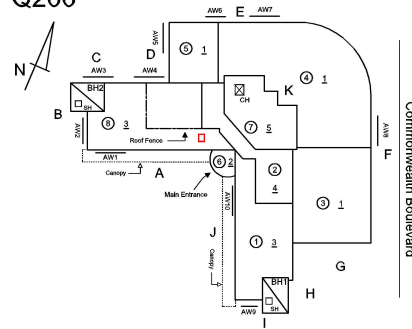
**IRMA: ROOFING: MAJOR ACTIVE ROOF LEAKS IN INSTRUCTIONAL SPACE**

**REPLACE ROOFING WITHOUT MAJOR EQUIPMENT REMOVAL**

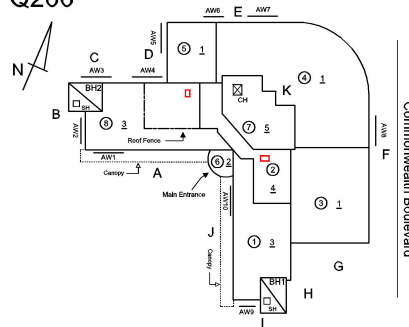
DETERIORATED

REPLACE

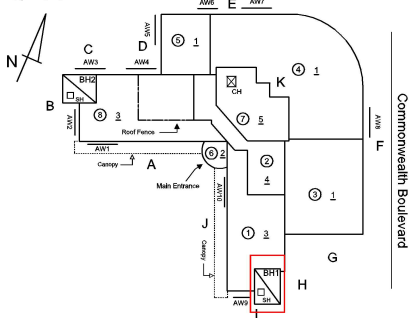
Question	Response
<b>EXTERIOR</b>	
<b>ROOF</b>	
<b>Specialties</b>	
<b>BULKHEAD/PENTHOUSE</b>	Inspected
Condition	3 - Fair
Deficiency	BULKHEAD/PENTHOUSE WALLS/INTERIOR: GYPSUM BOARD DAMAGED/DETERIORATED
Roof Plan reference	Q266

Deficiency Quantity	30
Quantity Uom	S.F.
Potential Action	REPLACE
Urgency of Action	PRIORITY 4
Purpose of Action	LEVEL 2
Deficiency Photo1

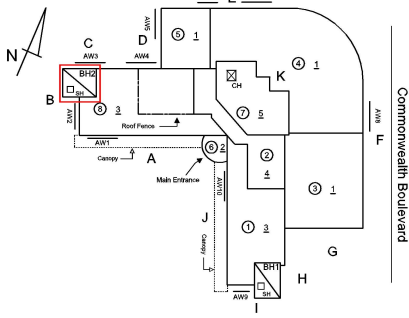
Violations	Roof 1 - Bulkhead 1 No violations recorded.
Deficiency	BULKHEAD/PENTHOUSE WALLS/EXTERIOR: EFFLORESCENCE
Roof Plan reference	Q266

Deficiency Quantity	30
Quantity Uom	S.F.
Potential Action	MAINTENANCE
Urgency of Action	PRIORITY 1
Purpose of Action	LEVEL 1
Deficiency Photo1	No photo recorded

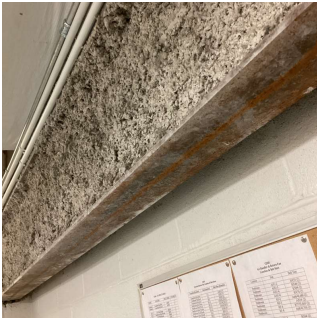
Question	Response
<b>INTERIOR</b>	
<b>STRUCTURAL</b>	
<b>COLUMNS/BEAMS/BEARING WALLS</b>	
Deficiency Quantity	30
Quantity Uom	S.F.
Potential Action	REPLACE
Urgency of Action	PRIORITY 3
Purpose of Action	LEVEL 5
Deficiency Photo1

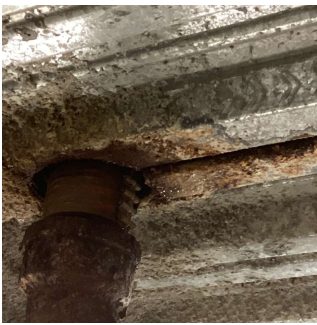
Basement - Room C2
Violations	No violations recorded.
Deficiency	METAL DECK AND CONCRETE: DETERIORATED
Deficiency Location/Instance	Basement - Crawl Space
Deficiency Quantity	10
Quantity Uom	S.F.
Potential Action	REPAIR
Urgency of Action	PRIORITY 4
Purpose of Action	LEVEL 5

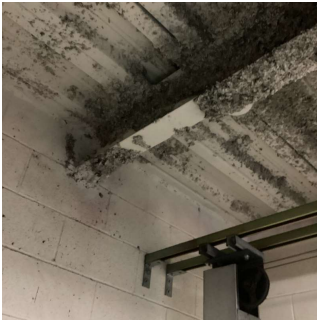
Violations	Basement - Crawl Space No violations recorded.
<b>FOUNDATION WALLS</b>	
Material Type(s)	Inspected Concrete
Condition	2 - Between Good and Fair
Deficiency	No deficiencies recorded
<b>ROOF STRUCTURE</b>	
Condition	Inspected 3 - Fair
Deficiency	STEEL COLUMNS/BEAMS: DETERIORATED/MISSING SPRAY-ON FIREPROOFING
Deficiency Location/Instance	Roof 7 - Elevator Machine Room, Chiller Room 403
Deficiency Quantity	30
Quantity Uom	S.F.
Potential Action	REPLACE
Urgency of Action	PRIORITY 3
Purpose of Action	LEVEL 5
Deficiency Photo1

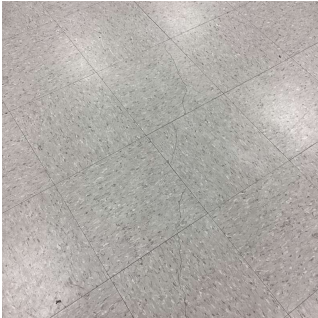
Question	Response
<b>INTERIOR</b>	
<b>CAFETERIA</b>	
<b>Door(s)</b>	
Instance on 1st Floor - Staff (500 SF)	Inspected
Condition	2 - Between Good and Fair
Deficiency	No deficiencies recorded
<b>Fixed Equipment</b>	
Instance on 1st Floor - Staff (500 SF)	Does not Exist
Instance on 1st Floor - Students	Does not Exist
<b>Floor Finish</b>	
Instance on 1st Floor - Staff (500 SF)	Inspected
Condition	2 - Between Good and Fair
Deficiency	VINYL TILES: BROKEN/DETERIORATED/MISSING TILES
Deficiency Location/Instance	Near center, Entrance
Deficiency Quantity	30
Quantity Uom	S.F.
Potential Action	REPLACE
Urgency of Action	PRIORITY 3
Purpose of Action	LEVEL 2
Deficiency Photo1

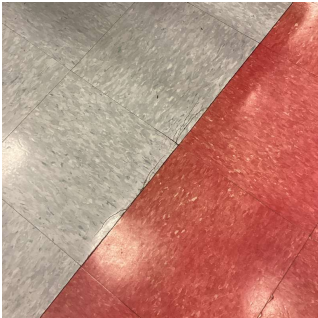
Violations	Near center No violations recorded.
Instance on 1st Floor - Students	Inspected
Condition	2 - Between Good and Fair
Deficiency	VINYL TILES: BROKEN/DETERIORATED/MISSING TILES
Deficiency Location/Instance	Near Entrance, Center, Columns, Windows

Deficiency Quantity	50
Quantity Uom	S.F.
Potential Action	REPLACE
Urgency of Action	PRIORITY 3
Purpose of Action	LEVEL 2
Deficiency Photo1

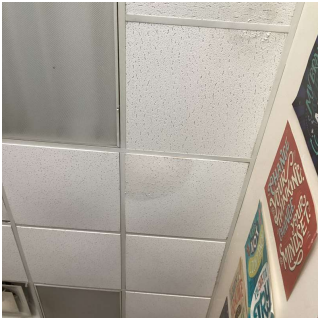
Question	Response
<b>INTERIOR</b>	
<b>CAFETERIA</b>	Inspected
<b>Window Curtains/Shades/Blinds</b>	
Instance on 1st Floor - Students	Does not Exist
Instance on 1st Floor - Staff (500 SF)	Does not Exist
<b>CLASSROOMS/CORRIDORS/ADMIN SPACES</b>	Inspected
<b>Ceiling</b>	Inspected
Condition	2 - Between Good and Fair
Deficiency	ACOUSTIC TILES: DAMAGED/MISSING - ACTIVE LEAK
Deficiency Location/Instance	Room 311
Deficiency Quantity	10
Quantity Uom	S.F.
Potential Action	REPLACE
Urgency of Action	PRIORITY 5
Purpose of Action	LEVEL 2
Deficiency Photo1

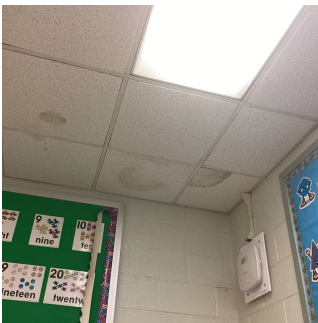
Violations	Room 311 No violations recorded.
Deficiency	ACOUSTIC TILES: DAMAGED/MISSING
Deficiency Location/Instance	Room 101, 104, 129, 302, 312, and others
Deficiency Quantity	200
Quantity Uom	S.F.
Potential Action	REPLACE
Urgency of Action	PRIORITY 3
Purpose of Action	LEVEL 2
Deficiency Photo1

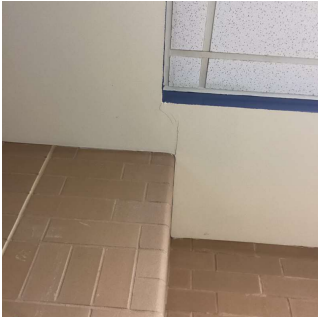
Violations	Room 104 No violations recorded.
Deficiency	GYPSUM BOARD: DAMAGED/DETERIORATED

Deficiency Location/Instance	Corridor Near Elevator A/1, Stair B/3
Deficiency Quantity	20
Quantity Uom	S.F.
Potential Action	REPLACE
Urgency of Action	PRIORITY 3

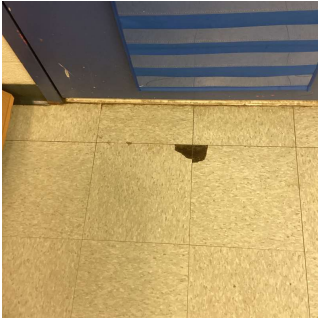
Violations	Corridor Near Elevator A/1 No violations recorded.
<b>Door(s)</b>	Inspected
Condition	2 - Between Good and Fair
Deficiency	No deficiencies recorded
<b>Floor Finish</b>	Inspected
Condition	2 - Between Good and Fair
Deficiency	VINYL TILES: BROKEN/DETERIORATED/MISSING TILES
Deficiency Location/Instance	Room 101, Corridor near Room 212
Deficiency Quantity	20
Quantity Uom	S.F.
Potential Action	REPLACE
Urgency of Action	PRIORITY 3
Purpose of Action	LEVEL 2
Deficiency Photo1

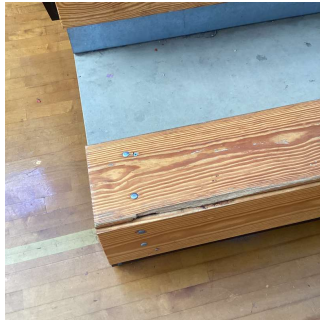
Question	Response
<b>INTERIOR</b>	
<b>GYMNASIUM</b>	
<b>Fixed Equipment</b>	
Deficiency	No deficiencies recorded
<b>Floor Finish</b>	
Instance on 1st Floor	Inspected
Condition	2 - Between Good and Fair
Deficiency	No deficiencies recorded
<b>Seating</b>	
Instance on 1st Floor	Inspected
Condition	2 - Between Good and Fair
Deficiency	DAMAGED BLEACHERS
Deficiency Location/Instance	Near Exits 7, 8, Center
Deficiency Quantity	30
Quantity Uom	S.F.
Potential Action	REPLACE
Urgency of Action	PRIORITY 3
Purpose of Action	LEVEL 2
Deficiency Photo1

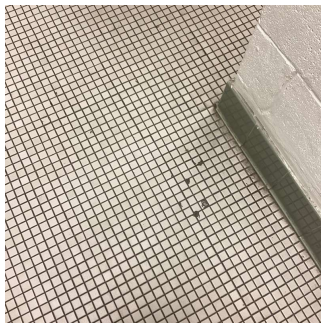
Entrance	Entrance
Violations	No violations recorded.
<b>Floor Finish</b>	
Instance on 1st Floor - Girls (236 Lockers, 800 SF)	Inspected
Condition	2 - Between Good and Fair
Deficiency	CERAMIC TILE: BROKEN/MISSING TILES
Deficiency Location/Instance	Near center
Deficiency Quantity	10
Quantity Uom	S.F.
Potential Action	REPLACE
Urgency of Action	PRIORITY 3
Purpose of Action	LEVEL 2

Violations	Near center No violations recorded.
<b>Locker Room Lockers</b>	
Instance on 1st Floor - Boys (252 Lockers, 800 SF)	Inspected
Condition	2 - Between Good and Fair
Deficiency	No deficiencies recorded
Instance on 1st Floor - Girls (236 Lockers, 800 SF)	Inspected
Condition	2 - Between Good and Fair
Deficiency	No deficiencies recorded
<b>Walls</b>	
Instance on 1st Floor - Boys (252 Lockers, 800 SF)	Inspected
Condition	2 - Between Good and Fair
Deficiency	No deficiencies recorded
Instance on 1st Floor - Girls (236 Lockers, 800 SF)	Inspected
Condition	2 - Between Good and Fair
Deficiency	No deficiencies recorded
<b>MULTI-PURPOSE ROOM</b>	Does not Exist
<b>SCIENCE DEMO ROOM</b>	Does not Exist
<b>SCIENCE LAB</b>	Inspected
Instance on Room 321	Inspected
Alternative use	No
Instance on Room 325	Inspected
Alternative use	No

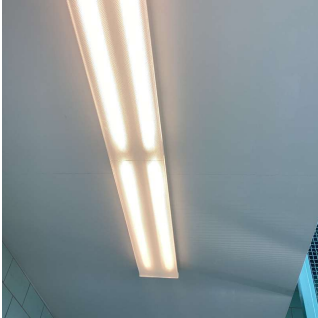
Violations	Stair A/2 No violations recorded.
Deficiency	GYPSUM BOARD: DAMAGED/DETERIORATED - ACTIVE LEAK
Deficiency Location/Instance	Stair C/3
Deficiency Quantity	10
Quantity Uom	S.F.
Potential Action	REPLACE
Urgency of Action	PRIORITY 5
Purpose of Action	LEVEL 2
Deficiency Photo1

Question	Response
<b>INTERIOR</b>	
<b>STAIRS/RAMPS: INTERIOR</b>	Inspected
Do Letter Stair Signs Exist?	Yes
<b>Ceiling</b>	Inspected
Condition	2 - Between Good and Fair
Deficiency	GYPSUM BOARD: DAMAGED/DETERIORATED
Deficiency Location/Instance	Stair A/1, 2
Deficiency Quantity	20
Quantity Uom	S.F.
Potential Action	REPLACE
Urgency of Action	PRIORITY 3
Purpose of Action	LEVEL 2
Deficiency Photo1

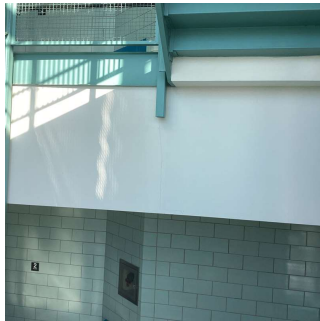
Question	Response
<b>INTERIOR</b>	
<b>STAIRS/RAMPS: INTERIOR</b>	
<b>Stairs and Landings</b>	
Condition	2 - Between Good and Fair
Deficiency	TERRAZZO: CRACKS
Deficiency Location/Instance	Stair C/2
Deficiency Quantity	10
Quantity Uom	S.F.
Potential Action	REPLACE
Urgency of Action	PRIORITY 3
Purpose of Action	LEVEL 2
Deficiency Photo1	 
	Stair C/2
Violations	No violations recorded.
<b>Walls</b>	
Condition	2 - Between Good and Fair
Deficiency	GLAZED BLOCK: CRACKS/SPALLING
Deficiency Location/Instance	Stair B/1
Deficiency Quantity	10
Quantity Uom	S.F.
Potential Action	REPLACE
Urgency of Action	PRIORITY 3
Purpose of Action	LEVEL 2
Deficiency Photo1	 
	Stair B/1
Violations	No violations recorded.
Deficiency	GYPSUM BOARD: DETERIORATED
Deficiency Location/Instance	Stair A/2
Deficiency Quantity	10
Quantity Uom	S.F.
Potential Action	REPLACE
Urgency of Action	PRIORITY 3
Purpose of Action	LEVEL 2

Violations	Stair A/2 No violations recorded.
<b>TOILET ROOMS - STAFF</b>	Inspected
<b>Ceiling</b>	Inspected
Condition	2 - Between Good and Fair
Deficiency	No deficiencies recorded
<b>Door(s)</b>	Inspected
Condition	4 - Between Fair and Poor
Deficiency	METAL CLAD WOOD: DETERIORATED DOOR
Deficiency Location/Instance	Room 126
Deficiency Quantity	1
Quantity Uom	EACH
Potential Action	MAINTENANCE
Urgency of Action	PRIORITY 3
Purpose of Action	LEVEL 2
Deficiency Photo1
