**NYC Department of Education**  
**Building Condition Assessment Survey 2023 - 2024**

Architectural Inspection

**Asset:** P.S. 268 - QUEENS, 92-07 175 STREET, New York, 11433

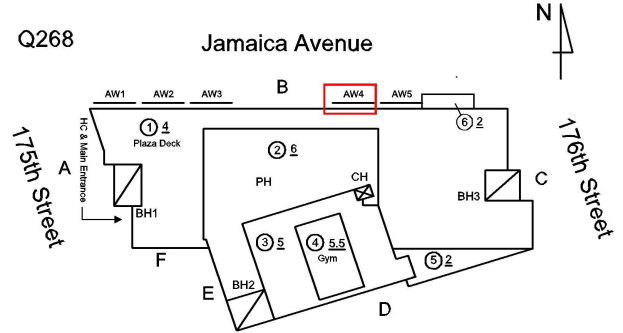
Roof Plan reference

Question	Response
<b>Architectural</b>	
<b>EXTERIOR</b>	Inspected
<b>AREAWAY</b>	Inspected
Instance on AW1-AW5	Inspected
Instance Condition	3 - Fair
Instance Quantity	5
Instance Quantity Uom	EACH
Deficiency	AREAWAY WALLS: CRACKS AND SPALLING

20  
S.F.  
REPAIR  
PRIORITY 3  
LEVEL 2

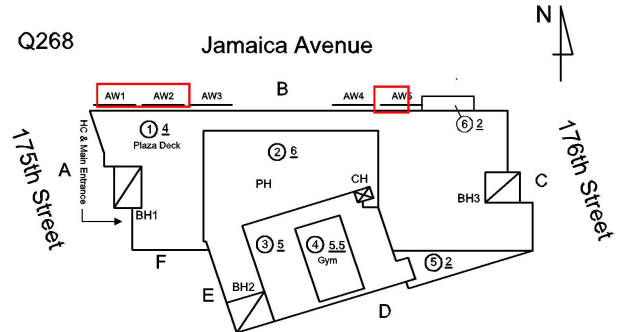
Roof Plan reference

AREAWAY WALLS: CRACKS AND SPALLING

20  
S.F.  
REPLACE  
PRIORITY 4  
LEVEL 2

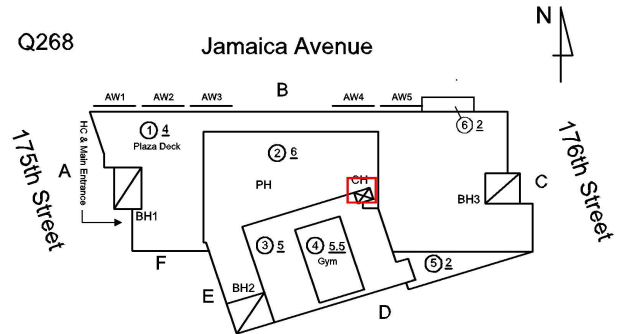
AW1
Violations	No violations recorded.
<b>AWNINGS AND CANOPIES</b>	
	Does not Exist
<b>CHIMNEY</b>	
Material Type(s)	Masonry
Condition	3 - Fair
Deficiency	BRICK: MAJOR / THRU CRACKS
Roof Plan reference	<p>Q268</p>

Deficiency Quantity	20
Quantity Uom	S.F.
Potential Action	REMOVE AND REBUILD
Urgency of Action	PRIORITY 4
Purpose of Action	LEVEL 2
Deficiency Photo1

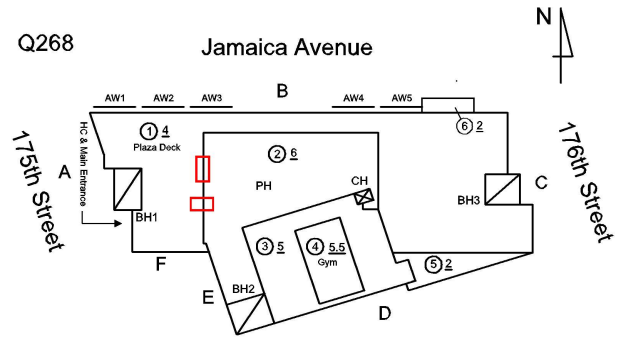
Q268

CH
Violations	No violations recorded.
<b>COPING</b>	
Condition	Inspected
Deficiency	3 - Fair
	CAST STONE: CRACKED/BROKEN PIECES

20  
L.F.  
REPLACE-IN-KIND  
PRIORITY 4  
LEVEL 2

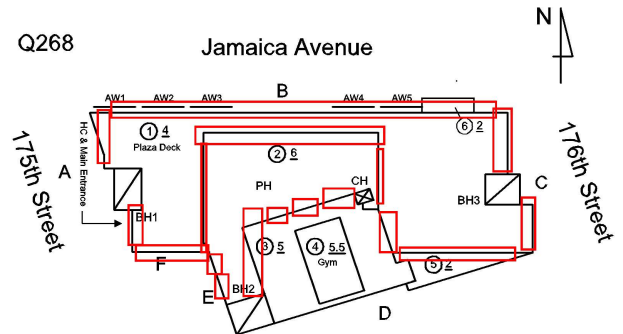
Roof Plan reference

CAST STONE: DETERIORATED TRANSVERSE JOINTS

200  
L.F.  
MAINTENANCE  
PRIORITY 3  
LEVEL 2

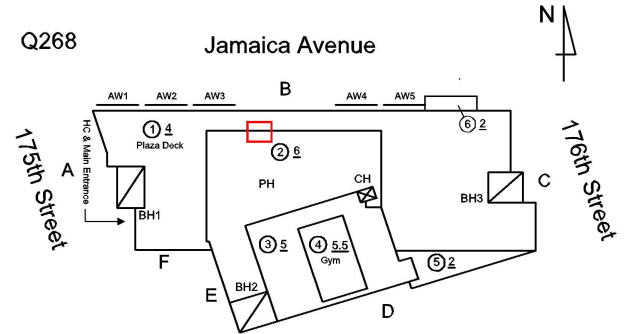
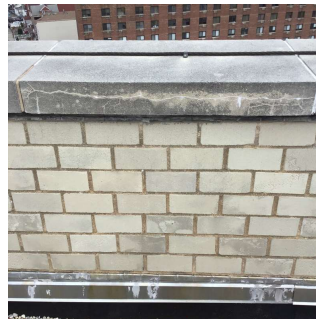
Roof Plan reference

CAST STONE: DISINTEGRATING / FREEZE THAW

REPLACE-IN-KIND

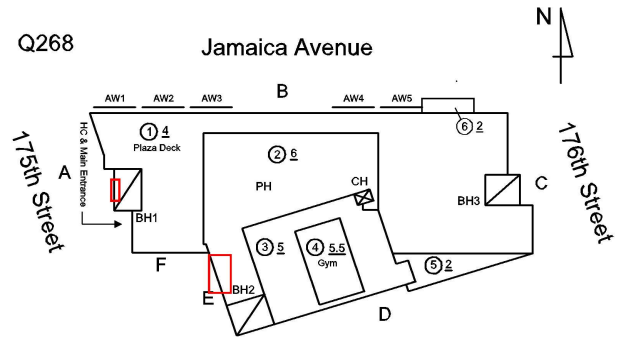
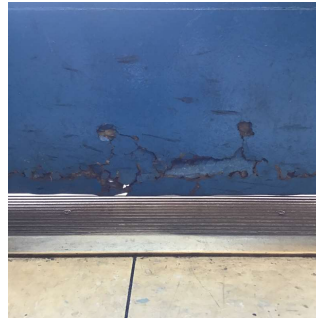
Roof Plan reference

METAL: DETERIORATED DOOR - MAJOR DETERIORATION

3  
 EACH  
 REPLACE  
 PRIORITY 4  
 LEVEL 2

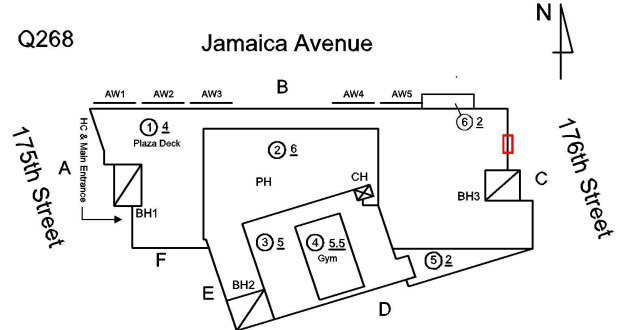
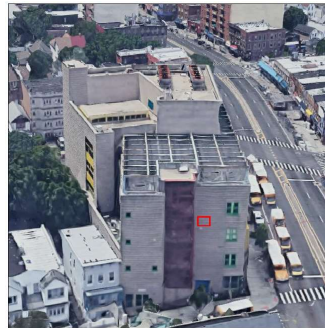
Roof Plan reference

BRICK: MAJOR / THRU CRACKS

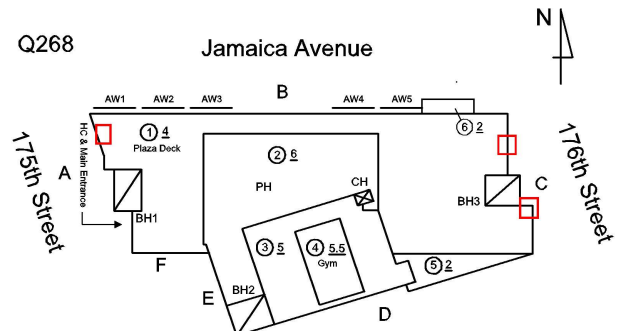
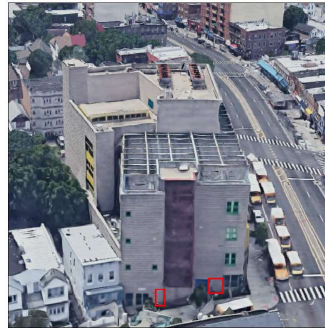
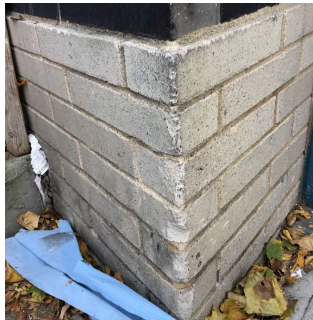
Roof Plan reference

BRICK: MINOR CRACKS AND SPALLING

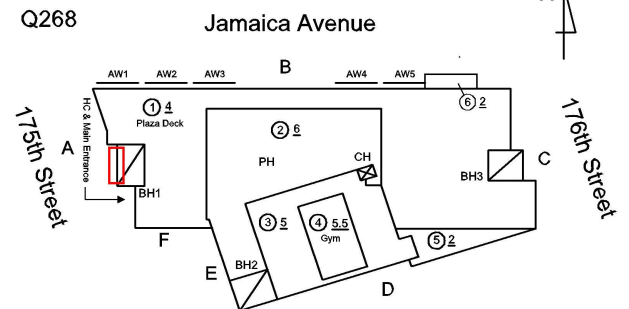
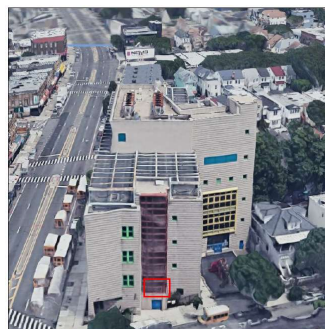
Roof Plan reference

METAL/GLASS CURT WALL: DAMAGED TRIM

REPLACE

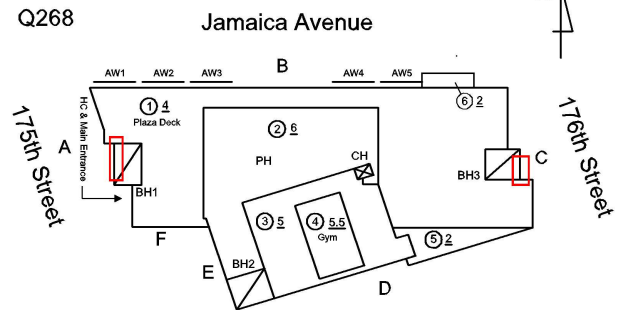
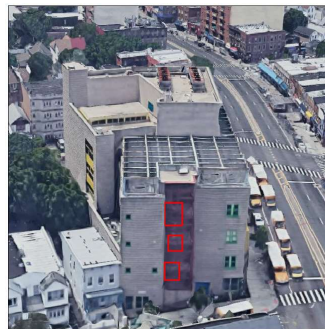
Roof Plan reference

METAL/GLASS CURT WALL: BROKEN GLASS

120  
S.F.  
REPLACE  
PRIORITY 3  
LEVEL 4

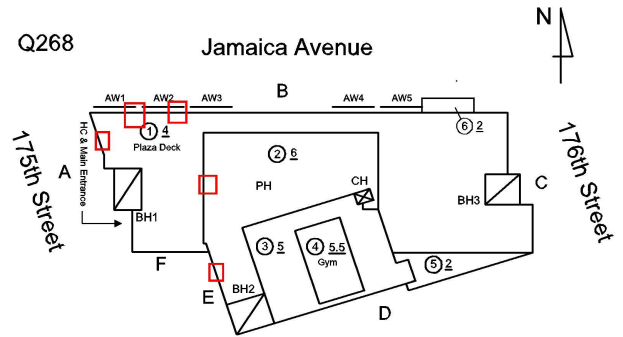
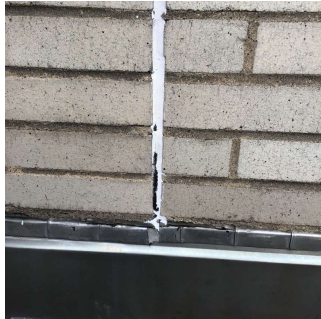
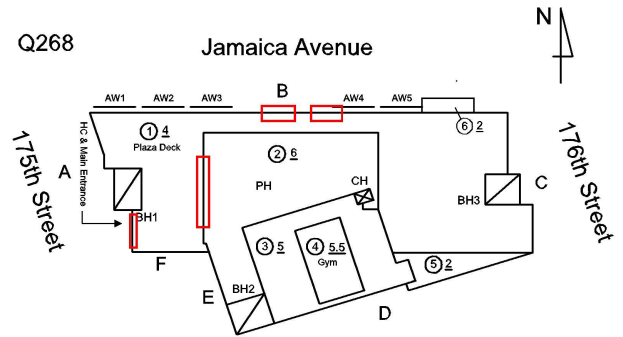
Violations	Roof 1 No violations recorded.
Deficiency	BRICK: DETERIORATED JOINTS

60  
S.F.  
REPOINT  
PRIORITY 3  
LEVEL 2

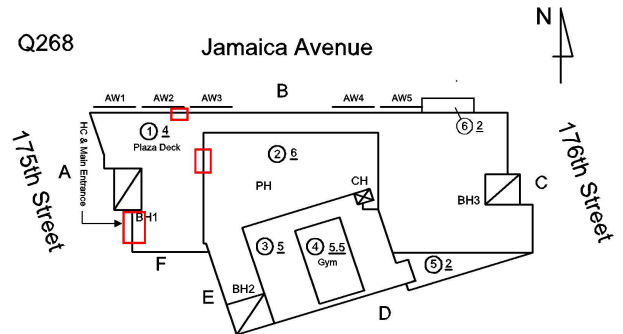
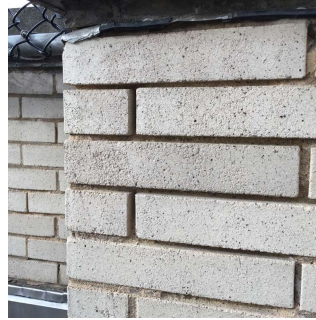
BRICK: DETERIORATED JOINTS

20  
S.F.  
REPOINT  
PRIORITY 4  
LEVEL 2

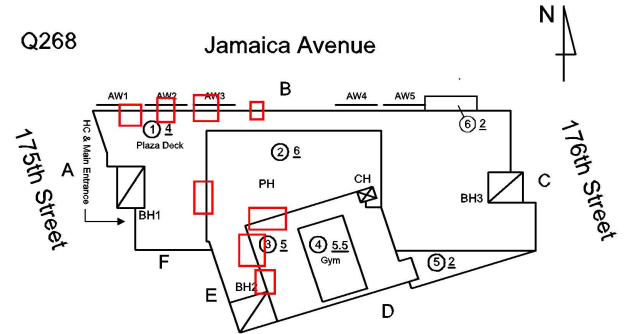
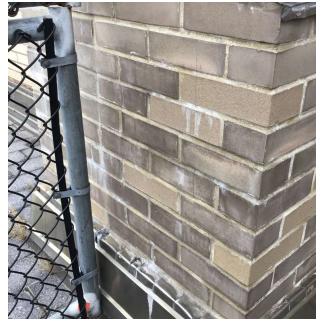
Roof Plan reference

BRICK: EFFLORESCENCE

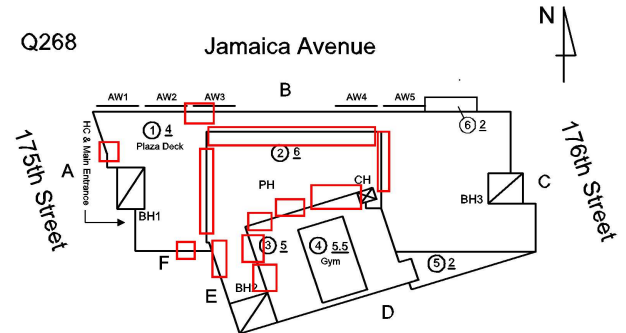
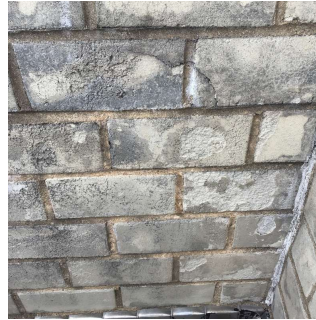
Roof Plan reference

BRICK: MINOR CRACKS, SPALLING

Deficiency Quantity	300
Quantity Uom	S.F.
Potential Action	REPAIR
Urgency of Action	PRIORITY 3
Purpose of Action	LEVEL 2
Deficiency Photo1

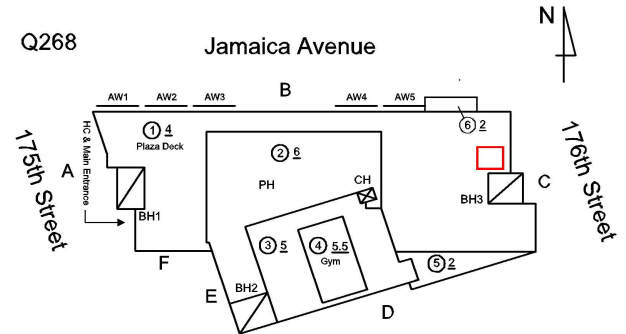
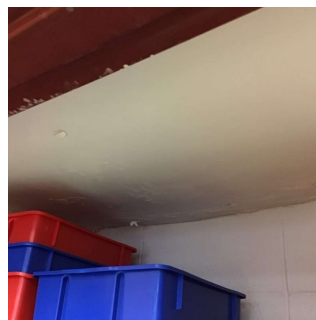
Roof Plan reference

Deficiency PAVERS: MAJOR ACTIVE PLAZA DECK LEAKS IN INSTRUCTIONAL SPACE

Deficiency Quantity	100
Quantity Uom	S.F.
Potential Action	REPLACE
Urgency of Action	PRIORITY 5
Purpose of Action	LEVEL 2
Deficiency Photo1

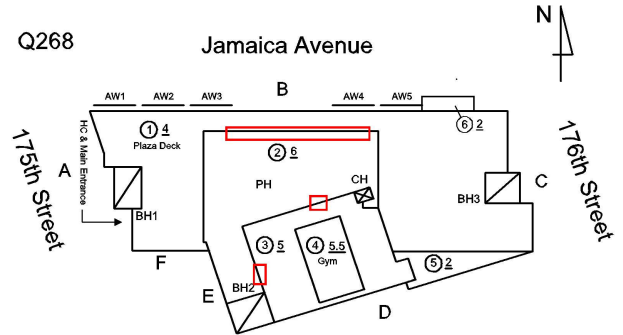
Roof Plan reference

Deficiency BUILT-UP: FLASHING: CAP FLASHING DAMAGED

100  
L.F.  
REPLACE  
PRIORITY 4  
LEVEL 2

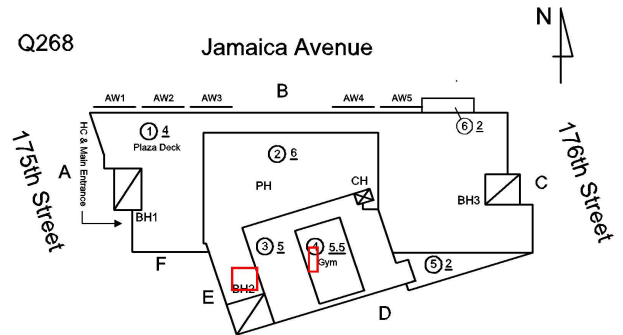
Roof Plan reference

Deficiency BUILT-UP: ROOFING: LOSS OF GRAVEL

50  
S.F.  
INSTALL NEW GRAVEL  
PRIORITY 3  
LEVEL 2

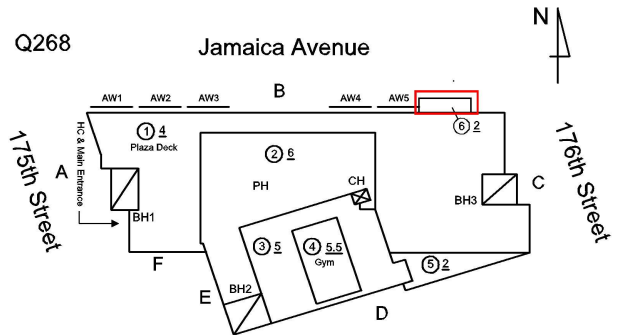
Roof Plan reference

SINGLE PLY, FULLY ADHERED ROOF: ROOFING: MAJOR ACTIVE ROOF LEAKS IN INSTRUCTIONAL SPACE

300  
S.F.  
REPLACE ROOFING WITHOUT MAJOR EQUIPMENT  
REMOVAL  
PRIORITY 5  
LEVEL 2

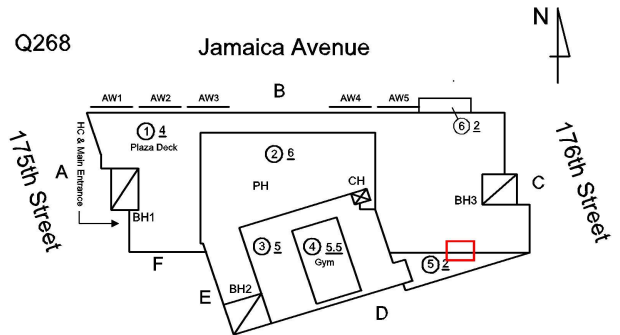
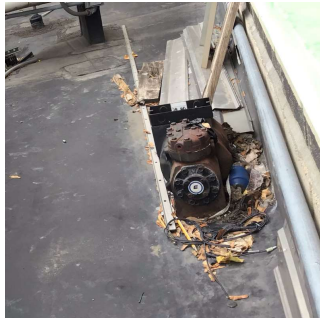
Roof Plan reference

SINGLE PLY, FULLY ADHERED ROOF: FLASHING: CAP  
FLASHING DAMAGED

10  
L.F.  
REPLACE  
PRIORITY 4  
LEVEL 2

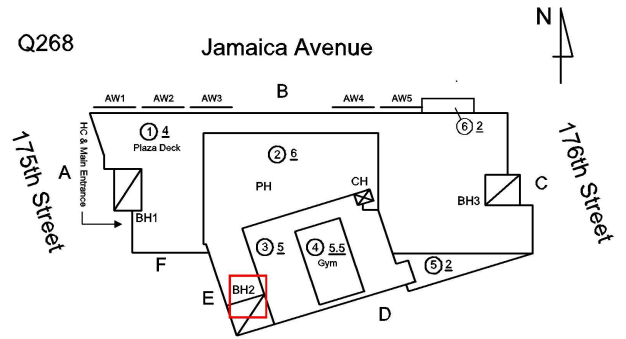
Violations	Roof 5 No violations recorded.
<b>ROOFING DRAINS</b>	Inspected
Condition	2 - Between Good and Fair
Deficiency	No deficiencies recorded
<b>Specialties</b>	Inspected
<b>BULKHEAD/PENTHOUSE</b>	Inspected
Condition	3 - Fair
Deficiency	BULKHEAD/PENTHOUSE ROOF: MAJOR LEAKAGE
Roof Plan reference	<p>Q268</p>

Deficiency Quantity	100
Quantity Uom	S.F.
Potential Action	REPLACE
Urgency of Action	PRIORITY 5
Purpose of Action	LEVEL 2
Deficiency Photo1

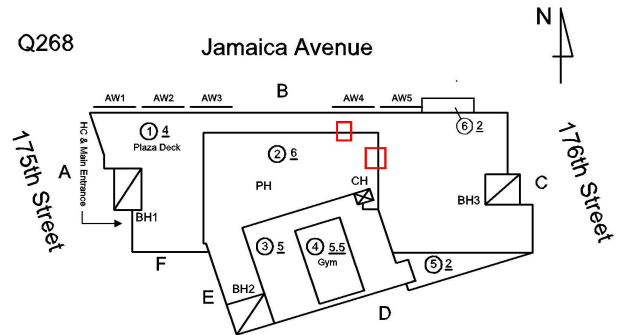
Violations	BH2 - Stair C/Roof No violations recorded.
Deficiency	BULKHEAD/PENTHOUSE WALLS/EXTERIOR: CRACKS/SPALLING - MINOR

20  
S.F.  
REPAIR  
PRIORITY 3  
LEVEL 2

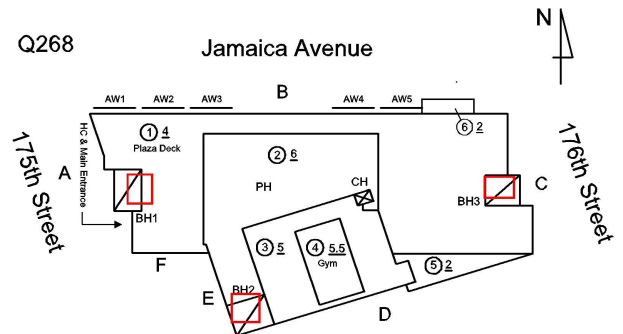
Roof Plan reference

**BULKHEAD/PENTHOUSE CEILING: GYPSUM BOARD DAMAGED/DETERIORATED**

40  
S.F.  
REPLACE  
PRIORITY 3  
LEVEL 2

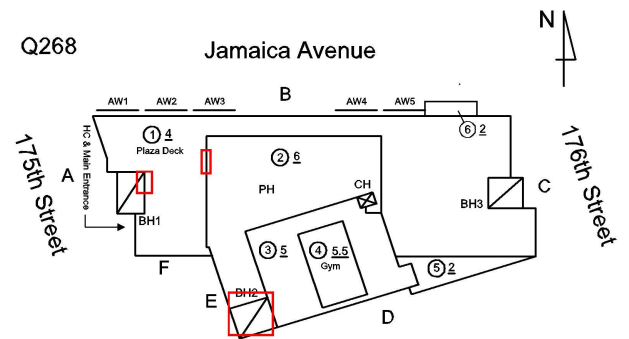
Roof Plan reference

**BULKHEAD/PENTHOUSE WALLS/EXTERIOR: DETERIORATED JOINTS**

80

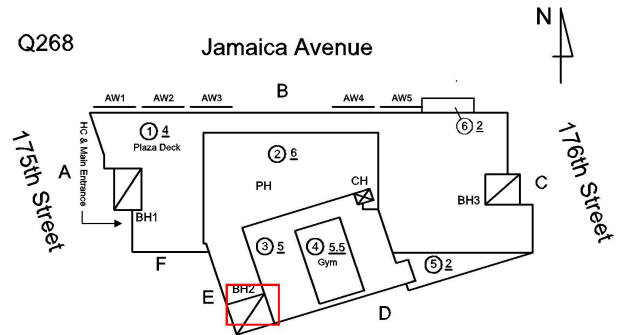
Roof Plan reference

**BULKHEAD/PENTHOUSE CEILING: GYPSUM BOARD DAMAGED/DETERIORATED**

40  
 S.F.  
 REPLACE  
 PRIORITY 4  
 LEVEL 2

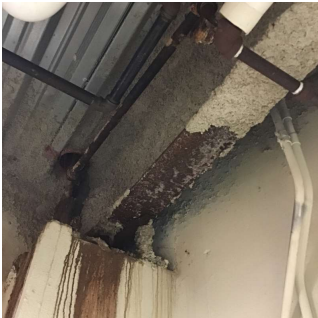
Question	Response
<b>EXTERIOR</b>	
<b>WINDOWS</b>	
<b>WINDOWS</b>	
Instance Quantity Uom	S.F.
Are these windows insulated	Yes
Installation Year	2003
Source of Installation	Custodial Staff
Deficiency	No deficiencies recorded
Instance on Aluminum - Double Hung: All Facades	Inspected
Instance Condition	3 - Fair
Instance Quantity	4,500
Instance Quantity Uom	S.F.
Are these windows insulated	Yes
Installation Year	2003
Source of Installation	Custodial Staff
Deficiency	No deficiencies recorded
<b>INTERIOR</b>	Inspected
<b>POOLS</b>	Does not Exist
<b>STRUCTURAL</b>	Inspected
<b>COLUMNS/BEAMS/BEARING WALLS</b>	Inspected
Condition	3 - Fair
Deficiency	STEEL COLUMNS/BEAMS: DETERIORATED/MISSING SPRAY-ON FIREPROOFING
Deficiency Location/Instance	Basement - Fire Pump Room, Boiler Room
Deficiency Quantity	20
Quantity Uom	S.F.
Potential Action	REPLACE
Urgency of Action	PRIORITY 4
Purpose of Action	LEVEL 5
Deficiency Photo1

Violations	Basement - Fire Pump Room No violations recorded.

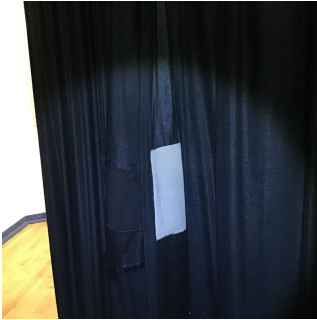
Question	Response
<b>INTERIOR</b>	
<b>AUDITORIUM</b>	
<b>Stage</b>	
<b>Stage Curtain Rigging</b>	Inspected
Deficiency	No deficiencies recorded
<b>Stage Curtains</b>	Inspected
Instance on 2nd Floor (325 Seats)	Inspected
Condition	4 - Between Fair and Poor
Deficiency	WORN/DETERIORATED
Deficiency Location/Instance	Right and Left Side
Deficiency Quantity	400
Quantity Uom	S.F.
Potential Action	REPLACE
Urgency of Action	PRIORITY 3
Purpose of Action	LEVEL 2
Deficiency Photo1

Right Side
Violations	No violations recorded.
<b>Walls</b>	
Instance on 2nd Floor (325 Seats)	Inspected
Condition	2 - Between Good and Fair
Deficiency	WOOD PANELING: DETERIORATED
Deficiency Location/Instance	Left Side of Stage
Deficiency Quantity	20
Quantity Uom	S.F.
Potential Action	REPLACE
Urgency of Action	PRIORITY 3
Purpose of Action	LEVEL 2
Deficiency Photo1

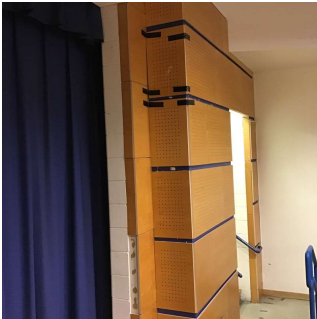
Left Side of Stage
Violations	No violations recorded.
Deficiency	MASONRY: CRACKS/SPALLING

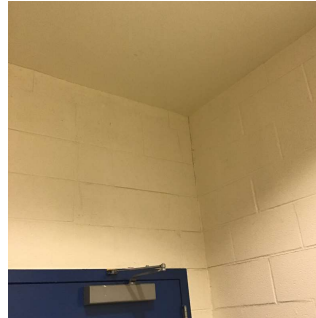
Right Side of Stage

Deficiency Location/Instance	Right and Left Side of Stage
Deficiency Quantity	20

Quantity Uom	S.F.
Potential Action	REPLACE
Urgency of Action	PRIORITY 3
Purpose of Action	LEVEL 2
Deficiency Photo1

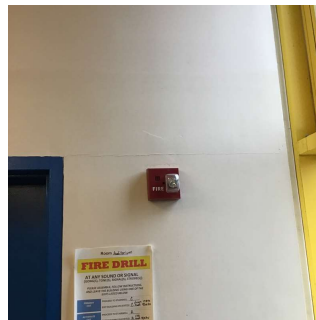
Near Stair C

Deficiency	GYPSUM BOARD: DETERIORATED
Deficiency Location/Instance	Near Stair C, Near Entrance
Deficiency Quantity	20
Quantity Uom	S.F.
Potential Action	REPLACE
Urgency of Action	PRIORITY 3
Purpose of Action	LEVEL 2
Deficiency Photo1

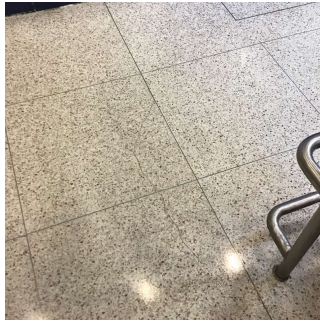
Question	Response
<b>INTERIOR</b>	
<b>CLASSROOMS/CORRIDORS/ADMIN SPACES</b>	
<b>Ceiling</b>	
Deficiency Photo1	 
	Room 316
Violations	No violations recorded.
<b>Door(s)</b>	Inspected
Condition	2 - Between Good and Fair
Deficiency	No deficiencies recorded
<b>Floor Finish</b>	Inspected
Condition	2 - Between Good and Fair
Deficiency	TERRAZZO: CRACKS
Deficiency Location/Instance	Corridor near Room 101, Main Entrance Lobby
Deficiency Quantity	40
Quantity Uom	S.F.
Potential Action	REPLACE
Urgency of Action	PRIORITY 3
Purpose of Action	LEVEL 2
Deficiency Photo1

Corridor near Room 101
Violations	No violations recorded.
Deficiency	VINYL TILES: BROKEN/DETERIORATED/MISSING TILES
Deficiency Location/Instance	Corridor near Rooms 413, 401, C13, Near Cafeteria, Room 313 and others
Deficiency Quantity	80
Quantity Uom	S.F.
Potential Action	REPLACE
Urgency of Action	PRIORITY 3
Purpose of Action	LEVEL 2

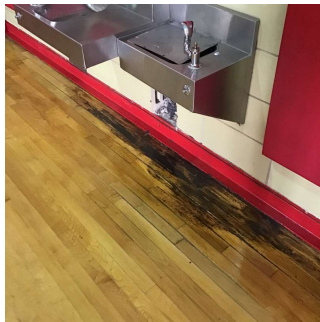
Violations	Near Stair C/4 No violations recorded.
<b>Door(s)</b>	
Instance on 4th Floor	Inspected
Condition	2 - Between Good and Fair
Deficiency	No deficiencies recorded
<b>Fixed Equipment</b>	
Instance on 4th Floor	Inspected
Condition	2 - Between Good and Fair
Deficiency	No deficiencies recorded
<b>Floor Finish</b>	
Instance on 4th Floor	Inspected
Condition	2 - Between Good and Fair
Deficiency	WOOD: DAMAGED/DETERIORATED
Deficiency Location/Instance	Near Drinking Fountain
Deficiency Quantity	20
Quantity Uom	S.F.
Potential Action	REPLACE
Urgency of Action	PRIORITY 3
Purpose of Action	LEVEL 2
Deficiency Photo1

Violations	Near Drinking Fountain No violations recorded.
<b>Seating</b>	
Instance on 4th Floor	Does not Exist
<b>Sliding-folding Partition</b>	
Instance on 4th Floor	Does not Exist
<b>Stage</b>	
Instance on 4th Floor	Does not Exist

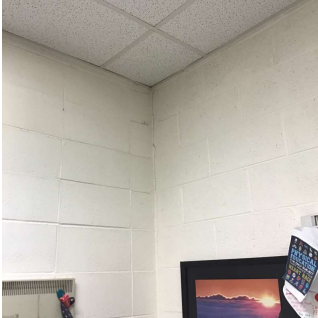
Question	Response
<b>INTERIOR</b>	
<b>GYMNASIUM</b>	
<b>Walls</b>	
Instance on 4th Floor	Inspected
Condition	2 - Between Good and Fair
Deficiency	MASONRY: CRACKS/SPALLING
Deficiency Location/Instance	Office, Storage Room
Deficiency Quantity	20
Quantity Uom	S.F.
Potential Action	REPLACE
Urgency of Action	PRIORITY 3
Purpose of Action	LEVEL 2
Deficiency Photo1

Violations	Office No violations recorded.
Deficiency	GLAZED BLOCK: CRACKS/SPALLING
Deficiency Location/Instance	Near Drinking Fountain, Near Windows
Deficiency Quantity	20
Quantity Uom	S.F.
Potential Action	REPLACE
Urgency of Action	PRIORITY 3
Purpose of Action	LEVEL 2
Deficiency Photo1

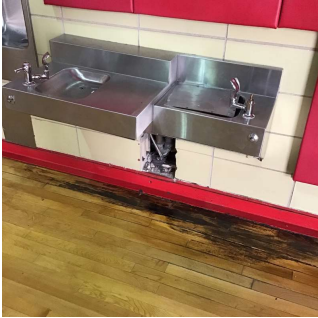
Violations	Near Drinking Fountain No violations recorded.
Deficiency	WALL PADDING: DETERIORATED
Deficiency Location/Instance	Left and Right Side
Deficiency Quantity	80
Quantity Uom	S.F.
Potential Action	REPLACE
Urgency of Action	PRIORITY 3
Purpose of Action	LEVEL 2

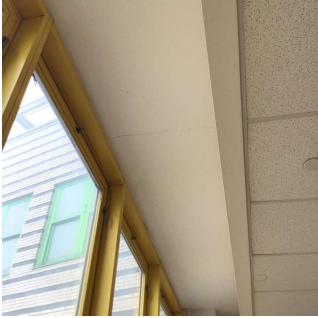
Question	Response
<b>INTERIOR</b>	
<b>KITCHEN</b>	
<b>Floor Finish</b>	
Instance on 1st Floor	Inspected
Condition	2 - Between Good and Fair
Deficiency	No deficiencies recorded
<b>Walls</b>	
Instance on 1st Floor	Inspected
Condition	2 - Between Good and Fair
Deficiency	No deficiencies recorded
<b>LIBRARY</b>	
Instance on Room 308	Inspected
<b>Built-in Furnishing</b>	
Instance on Room 308	Inspected
Condition	2 - Between Good and Fair
Deficiency	No deficiencies recorded
<b>Ceiling</b>	
Instance on Room 308	Inspected
Condition	3 - Fair
Deficiency	GYPSON BOARD: DAMAGED/DETERIORATED
Deficiency Location/Instance	Near Windows, Center
Deficiency Quantity	20
Quantity Uom	S.F.
Potential Action	REPLACE
Urgency of Action	PRIORITY 3
Purpose of Action	LEVEL 2
Deficiency Photo1

Near Windows
Violations	No violations recorded.
Deficiency	ACOUSTIC TILES: DAMAGED/MISSING
Deficiency Location/Instance	Rear, Near Entrance, Near Circulation desk

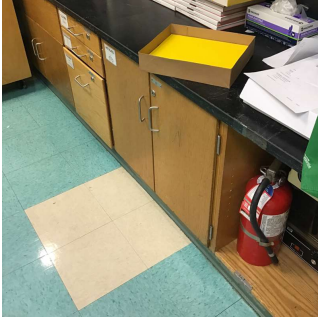
Question	Response
<b>INTERIOR</b>	
<b>SCIENCE LAB</b>	
<b>Fixed Equipment</b>	
Instance on Room 401	Inspected
Condition	3 - Fair
Deficiency	CABINETS: MISSING/DAMAGED
Deficiency Location/Instance	Room 410
Deficiency Quantity	10
Quantity Uom	L.F.
Potential Action	REPLACE
Urgency of Action	PRIORITY 3
Purpose of Action	LEVEL 2
Deficiency Photo1

Violations	Room 410 No violations recorded.
<b>SCIENCE PREP ROOM</b>	
Instance on Room 414	Inspected
Alternative use	No
<b>Fixed Equipment</b>	
Instance on Room 414	Inspected
Condition	2 - Between Good and Fair
Deficiency	No deficiencies recorded
<b>SHOWER ROOM</b>	
	Does not Exist
<b>STAIRS/RAMPS: INTERIOR</b>	
Do Letter Stair Signs Exist?	Inspected Yes
<b>Ceiling</b>	
Condition	Inspected 3 - Fair
Deficiency	GYPSUM BOARD: DAMAGED/DETERIORATED
Deficiency Location/Instance	Stairs A/1, 2, 3, B/3, 1 and others
Deficiency Quantity	200
Quantity Uom	S.F.
Potential Action	REPLACE
Urgency of Action	PRIORITY 3

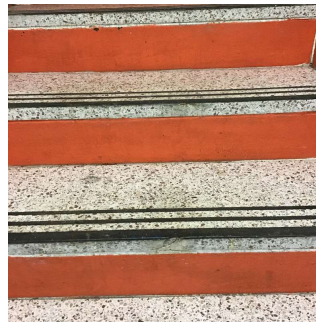
Stair B/Basement

CONCRETE: CRACKS/SPALLING - MAJOR

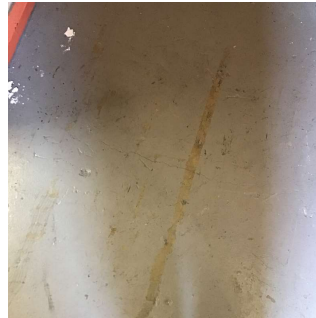
Stair C/Bulkhead

GYPSON BOARD: DETERIORATED

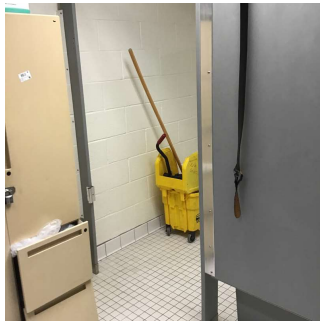
Question	Response
<b>INTERIOR</b>	
<b>TOILET ROOMS - STAFF</b>	
<b>Stalls</b>	
Deficiency Photo1

Violations	Room C28A No violations recorded.
<b>Walls</b>	Inspected
Condition	2 - Between Good and Fair
Deficiency	No deficiencies recorded
<b>TOILET ROOMS - STUDENTS</b>	
<b>Ceiling</b>	Inspected
Condition	2 - Between Good and Fair
Deficiency	GYPSON BOARD: DAMAGED/DETERIORATED
Deficiency Location/Instance	3rd Floor Boys
Deficiency Quantity	10
Quantity Uom	S.F.
Potential Action	REPLACE
Urgency of Action	PRIORITY 3
Purpose of Action	LEVEL 2
Deficiency Photo1

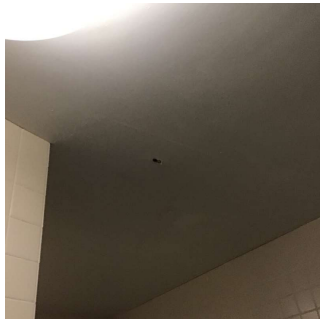
Violations	3rd Floor Boys No violations recorded.
<b>Door(s)</b>	Inspected
Condition	2 - Between Good and Fair
Deficiency	No deficiencies recorded
<b>Floor Finish</b>	Inspected
Condition	2 - Between Good and Fair
Deficiency	CERAMIC TILE: BROKEN/MISSING TILES
Deficiency Location/Instance	1st Floor - Girls, Boys
Deficiency Quantity	20
Quantity Uom	S.F.
Potential Action	REPLACE

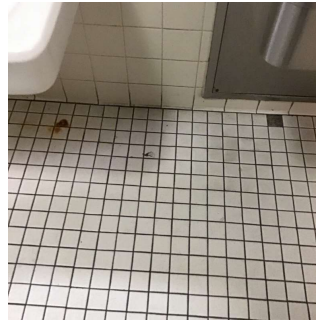
1st Floor - Girls

BROKEN/MISSING

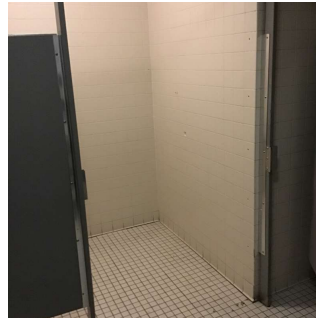
1st Floor - Girls

CERAMIC TILE: BROKEN/ MISSING

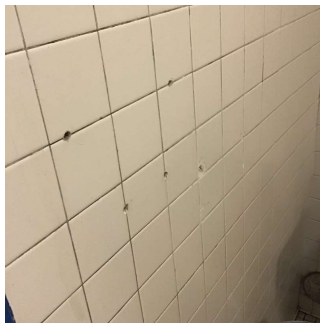
Question	Response
<b>INTERIOR</b>	
<b>TOILET ROOMS - STUDENTS</b>	
<b>Walls</b>	
Deficiency Photo1

Violations	4th Floor Boys No violations recorded.
<b>LIFE SAFETY</b>	Inspected
<b>F.D. HOLDING AREA</b>	Does not Exist
<b>STEEL STAIRS</b>	Does not Exist
<b>SITE</b>	Inspected
<b>CONTAINERIZATION</b>	Does not Exist
<b>Drainage System for Asphalt</b>	Inspected
<b>Catch Basins/Manhole - Surrounded by asphalt</b>	Inspected
Condition	2 - Between Good and Fair
Deficiency	No deficiencies recorded
<b>Culverts - Asphalt Covering</b>	Does not Exist
<b>Drainage System for Concrete</b>	Inspected
<b>Catch Basins/Manhole - Surrounded by concrete</b>	Inspected
Condition	2 - Between Good and Fair
Deficiency	No deficiencies recorded
<b>Culverts - Concrete Covering</b>	Does not Exist
<b>Drainage System for Soil</b>	Does not Exist
<b>DRINKING FOUNTAINS</b>	Does not Exist
<b>FENCES</b>	Inspected
Condition	3 - Fair
Deficiency	WROUGHT IRON: DAMAGED/DETERIORATED

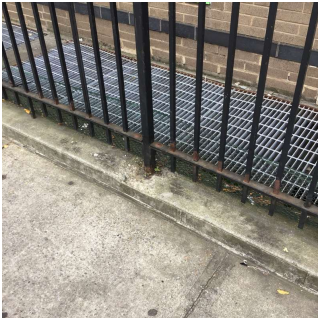
Question	Response
<b>SITE</b>	
<b>FENCES</b>	
Violations	Jamaica Avenue No violations recorded.
Deficiency	CONCRETE CURB: DAMAGED/DETERIORATED
Deficiency Location/Instance	Jamaica Avenue, 175th Street, 176th Street
Deficiency Quantity	30
Quantity Uom	S.F.
Potential Action	REPLACE
Urgency of Action	PRIORITY 3
Purpose of Action	LEVEL 2
Deficiency Photo1

Violations	Jamaica Avenue No violations recorded.
<b>IRRIGATION SYSTEM</b>	Does not Exist
<b>PAVING</b>	Inspected
<b>Student Non-Use</b>	Does not Exist
<b>Student Use</b>	Does not Exist
<b>Site Sidewalks &amp; Walkways</b>	Inspected
<b>Asphalt</b>	Does not Exist
<b>Concrete</b>	Inspected
Condition	3 - Fair
Deficiency	CRACKS - MAJOR
Deficiency Location/Instance	Main Entrance
Deficiency Quantity	50
Quantity Uom	S.F.
Potential Action	REPLACE
Urgency of Action	PRIORITY 3
Purpose of Action	LEVEL 2
Deficiency Photo1

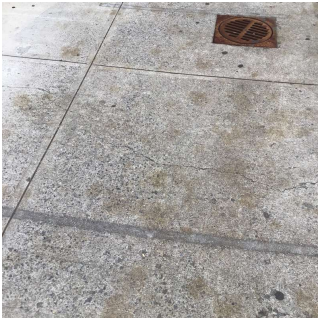
Violations	Main Entrance No violations recorded.
<b>Pavers</b>	Does not Exist

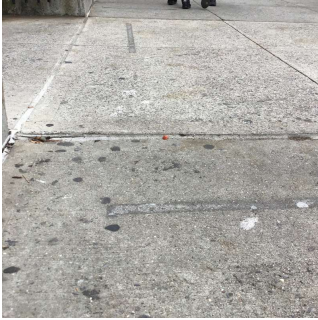
Question	Response
<b>SITE</b>	
<b>PAVING</b>	
<b>DOT Sidewalk</b>	Inspected
<b>Asphalt</b>	Does not Exist
<b>Concrete</b>	Inspected
Condition	4 - Between Fair and Poor
Deficiency	HEAVING
Deficiency Location/Instance	175th Street, Jamaica Avenue
Deficiency Quantity	50
Quantity Uom	S.F.
Potential Action	REPLACE
Urgency of Action	PRIORITY 3
Purpose of Action	LEVEL 2
Deficiency Photo1

175th Street
Violations	No violations recorded.
Deficiency	DAMAGED CURBS
Deficiency Location/Instance	Jamaica Avenue, 175th Street, 176th Street
Deficiency Quantity	80
Quantity Uom	L.F.
Potential Action	REPLACE
Urgency of Action	PRIORITY 3
Purpose of Action	LEVEL 2
Deficiency Photo1

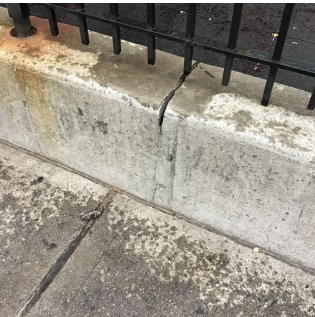
Question	Response
<b>SITE</b>	
<b>SITE WALLS (NOT RETAINING WALLS)</b>	
Urgency of Action	PRIORITY 3
Purpose of Action	LEVEL 2
Deficiency Photo1

175th Street
Violations	No violations recorded.
<b>STAIRS/RAMPS: EXTERIOR</b>	
	Does not Exist
<b>ARTWORK</b>	
Instance	Inspected
	Interior - 1st Floor Lobby, 2nd Floor Atrium, 2nd Floor near Auditorium entrance - 20090
Instance Photo
