NYC Department of Education
Building Condition Assessment Survey 2023 - 2024

Architectural Inspection

Asset: P.S. 270 - QUEENS, 233-15 MERRICK BLVD, New York, 11422

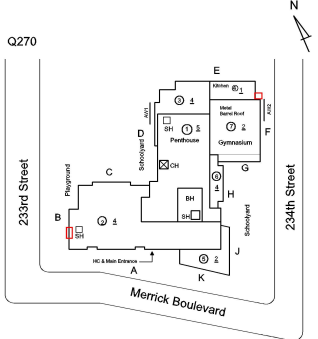
Violations	Roof 2 No violations recorded.
CORNICE	Does not Exist
DOORS	Inspected
DOORS AND FRAMES	Inspected
Condition	4 - Between Fair and Poor
Deficiency	METAL CLAD: DETERIORATED DOOR AND FRAME - MINOR DETERIORATION
Roof Plan reference

Deficiency Quantity	2
Quantity Uom	EACH
Potential Action	MAINTENANCE
Urgency of Action	PRIORITY 3
Purpose of Action	LEVEL 2
Deficiency Photo1

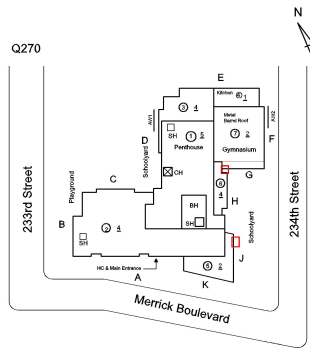
Violations	Facade F No violations recorded.
Deficiency	METAL: DETERIORATED DOOR AND FRAME - MAJOR DETERIORATION

4
EACH
REPLACE
PRIORITY 4
LEVEL 2

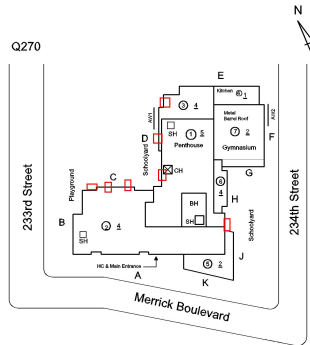
METAL: DETERIORATED DOOR AND FRAME - MINOR DETERIORATION

10
EACH
MAINTENANCE
PRIORITY 3
LEVEL 2

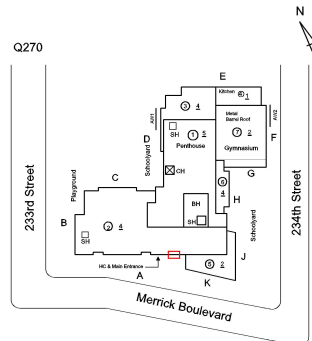
STONE: DETERIORATED JOINTS

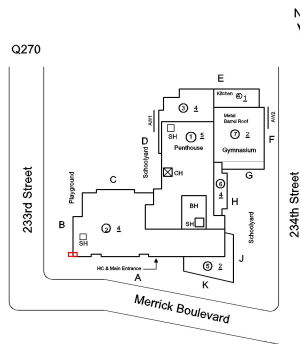
STONE: CRACKS AT BUILDING CORNERS

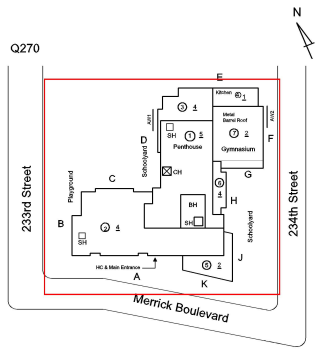
Facade A
Violations	No violations recorded.
EXTERIOR SOFFITS	
Condition	Inspected
Deficiency	2 - Between Good and Fair
	No deficiencies recorded
LOADING DOCK	
	Does not Exist
LOUVER	
Condition	Inspected
Deficiency	2 - Between Good and Fair
	No deficiencies recorded
PARAPETS	
Material Type(s)	Inspected
Replacement Quantity	Masonry
Replacement Uom	6,000
	C.F.
Instance on All Facades	Inspected
Instance Condition	3 - Fair
Instance Quantity	6,000
Instance Quantity Uom	C.F.
Deficiency	BRICK: EFFLORESCENCE
Roof Plan reference

Deficiency Quantity	Q270
Quantity Uom	1,000
Potential Action	S.F.
Urgency of Action	MAINTENANCE
Purpose of Action	PRIORITY 1
Deficiency Photo1	LEVEL 1
Violations	No photo recorded
	No violations recorded.
PLAZA DECK	
	Does not Exist
ROOF	
	Inspected

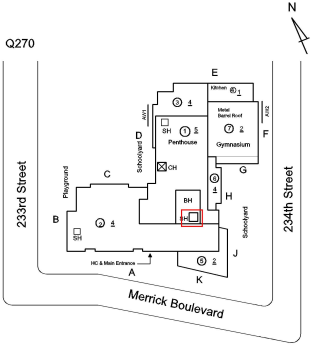
Question	Response
EXTERIOR	
ROOF	
Roofing	Inspected
Replacement Quantity	20,400
Replacement Uom	S.F.
ROOF HATCH/SMOKE HATCH	Inspected
Condition	5 - Poor
Deficiency	WATER INFILTRATION
Roof Plan reference

Deficiency Quantity	1
Quantity Uom	EACH
Potential Action	REPAIR
Urgency of Action	PRIORITY 5
Purpose of Action	LEVEL 2
Deficiency Photo1

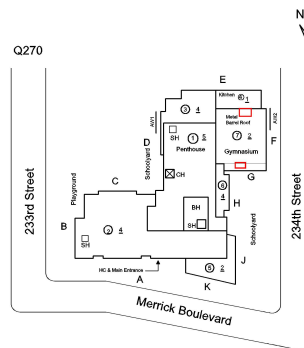
Instance Quantity	2,000
Instance Quantity Uom	S.F.
Does the roof have major mechanical equipment sitting on Dunnage Steel less than 18" above the Roofing?	No
Does this roof instance have a Sustainable Roof System?	No
Do solar panels exist on these roofs?	No
Is/Are the roof(s) suitable for Solar Panel installation?	No
Installation Year	2003
Source of Installation	Custodial Staff
Deficiency	METAL: ROOFING: MAJOR ACTIVE ROOF LEAKS IN INSTRUCTIONAL SPACE

Deficiency Quantity	100
Quantity Uom	S.F.
Potential Action	REPLACE
Urgency of Action	PRIORITY 5
Purpose of Action	LEVEL 2

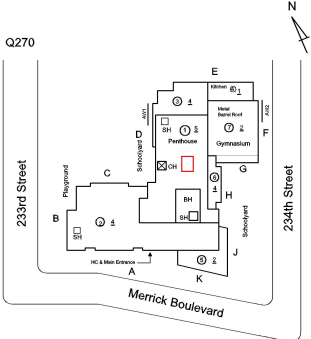
Question	Response
EXTERIOR	
ROOF	
Roofing	
ROOFING	
Deficiency Photo1	 
	Roof 7 - Gymnasium
Violations	No violations recorded.
ROOFING DRAINS	Inspected
Condition	2 - Between Good and Fair
Deficiency	No deficiencies recorded
Specialties	Inspected
BULKHEAD/PENTHOUSE	Inspected
Condition	3 - Fair
Deficiency	BULKHEAD/PENTHOUSE WALLS/INTERIOR: GYPSUM BOARD DAMAGED/DETERIORATED
Roof Plan reference	 
Deficiency Quantity	30
Quantity Uom	S.F.
Potential Action	REPLACE
Urgency of Action	PRIORITY 3
Purpose of Action	LEVEL 2
Deficiency Photo1	 
Violations	Roof 1 - Bulkhead
	No violations recorded.
Deficiency	BULKHEAD/PENTHOUSE ROOF: DETERIORATED

Deficiency Quantity	100
Quantity Uom	S.F.
Potential Action	REPAIR
Urgency of Action	PRIORITY 3
Purpose of Action	LEVEL 2
Deficiency Photo1

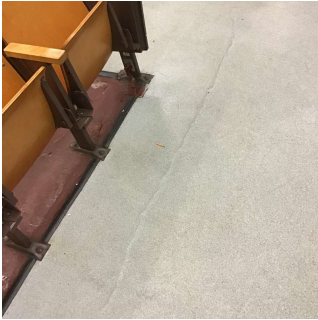
Question	Response
INTERIOR	
AUDITORIUM	
Door(s)	
Instance on Basement (298 Seats)	Inspected
Condition	2 - Between Good and Fair
Deficiency	No deficiencies recorded
Fixed H/C Lift	
Instance on Basement (298 Seats)	Does not Exist
Fixed Seating	
Instance on Basement (298 Seats)	Inspected
Condition	2 - Between Good and Fair
Deficiency	No deficiencies recorded
Floor Finish	
Instance on Basement (298 Seats)	Inspected
Condition	2 - Between Good and Fair
Deficiency	SHEET VINYL: DETERIORATED SUBSTRATE
Deficiency Location/Instance	Front Center, In Front on Stage
Deficiency Quantity	60
Quantity Uom	S.F.
Potential Action	REPLACE
Urgency of Action	PRIORITY 3
Purpose of Action	LEVEL 2
Deficiency Photo1

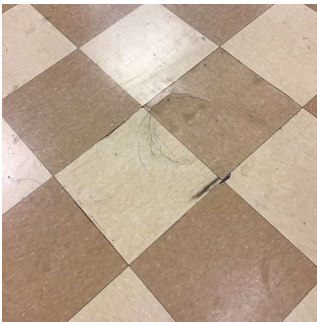
Violations	Right Entrance No violations recorded.
Fixed Equipment	
Instance on 1st Floor	Does not Exist
Floor Finish	
Instance on 1st Floor	Inspected
Condition	2 - Between Good and Fair
Deficiency	VINYL TILES: DETERIORATED SUBSTRATE
Deficiency Location/Instance	Center, Near Exit E/1
Deficiency Quantity	20
Quantity Uom	S.F.
Potential Action	REPLACE
Urgency of Action	PRIORITY 3
Purpose of Action	LEVEL 2
Deficiency Photo1

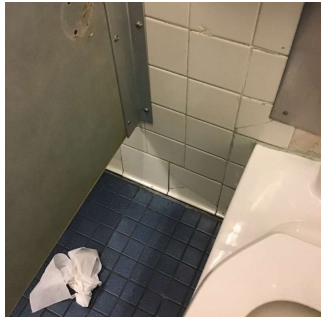
Question	Response
INTERIOR	
TOILET ROOMS - STUDENTS	
Walls	
Purpose of Action	LEVEL 2
Deficiency Photo1

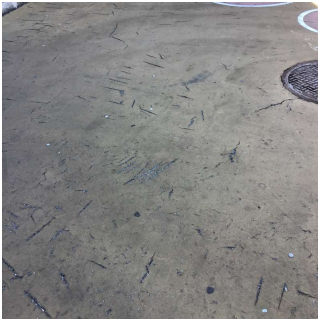
Violations	Along 234 Street No violations recorded.
IRRIGATION SYSTEM	Does not Exist
PAVING	Inspected
Student Non-Use	Inspected
Gravel Exists?	No
Asphalt	Does not Exist
Concrete	Inspected
Condition	2 - Between Good and Fair
Deficiency	No deficiencies recorded
Pavers	Does not Exist
Student Use	Inspected
Gravel Exists?	No
Asphalt	Inspected
Condition	4 - Between Fair and Poor
Deficiency	CRACKS - MAJOR
Deficiency Location/Instance	Schoolyard along 233rd Street, 234 street, center courtyard,
Deficiency Quantity	700
Quantity Uom	S.F.
Potential Action	REPLACE
Urgency of Action	PRIORITY 3
Purpose of Action	LEVEL 2
Deficiency Photo1
