NYC Department of Education
Building Condition Assessment Survey 2023 - 2024

Architectural Inspection

Asset: P.S. 273 - QUEENS, 88-07 102ND STREET, New York, 11418

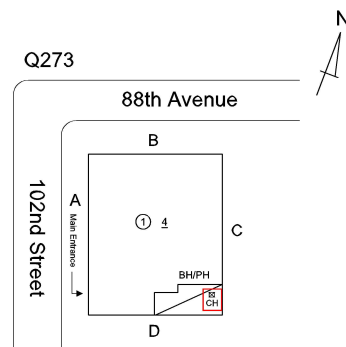
| Question | Response |
|---|---|
| Roof Plan reference | |

| Question | Response |
|---|---|
| Condition | 3 - Fair |
| Deficiency | METAL: DENTS, MAJOR RUSTING |

| Deficiency Quantity | 10 |

| Potential Action | REPLACE-UPGRADE |

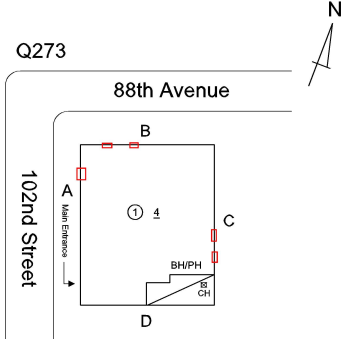
| Question | Response |
|---|--|
| Roof Plan reference | |

| Question | Response |
|---|--|
| Condition | Inspected 2 - Between Good and Fair |
| Deficiency | CAST STONE: DETERIORATED TRANSVERSE JOINTS |
| Deficiency Quantity | 20 |

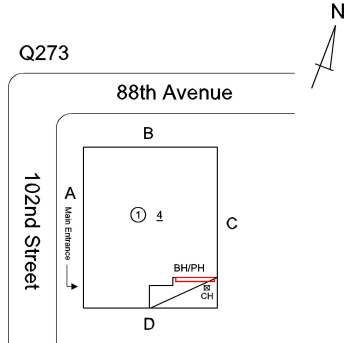
| Question | Response |
|---|--|
| Roof Plan reference | |

| Question | Response |
|---|--|
| Deficiency | IRMA: FLASHING: CAP FLASHING MISSING |
| Deficiency Quantity | 20 |

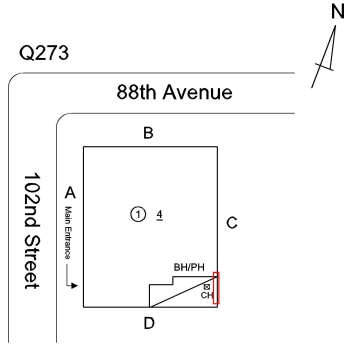
| Question | Response |
|---|--|
| Roof Plan reference | |

| Question | Response |
|---|--|
| Deficiency | IRMA: FLASHING: CAP FLASHING DAMAGED |
| Deficiency Quantity | 20 |

| Question | Response |
|---|--|
| Potential Action | REPLACE |
