**NYC Department of Education**  
**Building Condition Assessment Survey 2023 - 2024**

Architectural Inspection

Q276

**Asset: THE WILLIAM WORDSWORTH EDUCATIONAL COMPLEX - QUEENS, 108-29 155 STREET, New York, 11433**

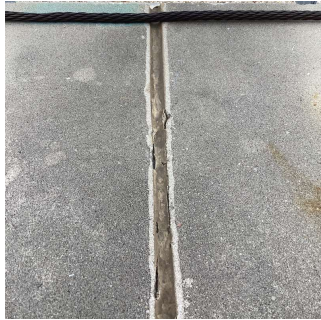
Question	Response
<b>EXTERIOR</b>	
<b>COPING</b>	
Deficiency Photo1

Violations	Roof 1 No violations recorded.
<b>CORNICE</b>	Does not Exist
<b>DOORS</b>	Inspected
<b>DOORS AND FRAMES</b>	Inspected
Condition	3 - Fair
Deficiency	METAL: DETERIORATED DOOR AND FRAME - MINOR DETERIORATION
Roof Plan reference	Q276

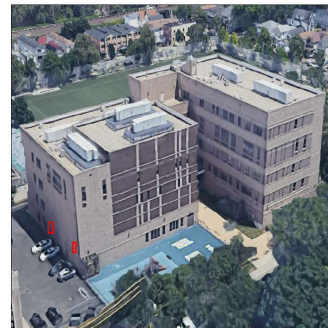
Deficiency	<b>BRICK: DETERIORATED CONTROL/EXPANSION JOINTS</b>
------------	---

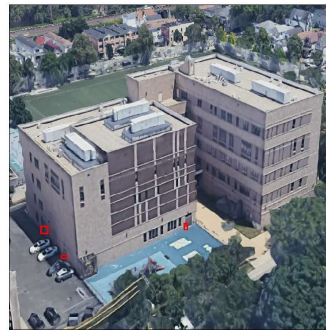
**BRICK: MINOR CRACKS AND SPALLING**

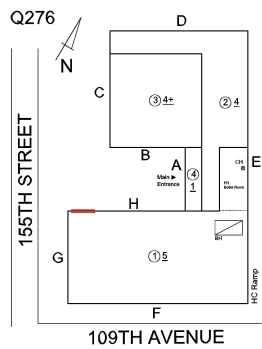
Question	Response
<b>EXTERIOR</b>	
<b>PARAPETS</b>	
Roof Plan reference

Deficiency Quantity	20
Quantity Uom	S.F.
Potential Action	REPAIR
Urgency of Action	PRIORITY 3
Purpose of Action	LEVEL 2
Deficiency Photo1

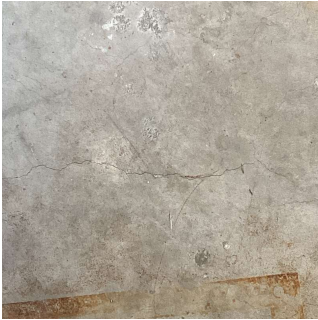
Violations	Room 135 (Rooms 141, 145 similar) No violations recorded.
Deficiency	CONCRETE: CRACKS/SPALLED/REINFORCEMENT EXPOSED
Deficiency Location/Instance	PH
Deficiency Quantity	40
Quantity Uom	S.F.
Potential Action	REPAIR
Urgency of Action	PRIORITY 3
Purpose of Action	LEVEL 5
Deficiency Photo1

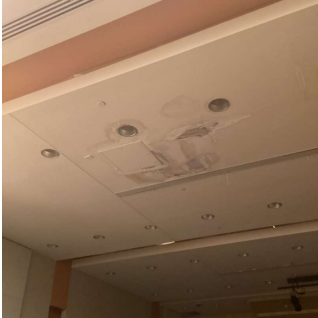
Violations	PH No violations recorded.
<b>FOUNDATION WALLS</b>	Inspected
Material Type(s)	Concrete
Condition	2 - Between Good and Fair
Deficiency	No deficiencies recorded
<b>ROOF STRUCTURE</b>	Inspected
Condition	2 - Between Good and Fair
Deficiency	No deficiencies recorded
<b>VAULTS-BUNKERS</b>	Does not Exist
<b>AUDITORIUM</b>	Inspected
Instance on 4th Floor (322 Seats)	Inspected
<b>Ceiling</b>	Inspected
Instance on 4th Floor (322 Seats)	Inspected
Condition	2 - Between Good and Fair
Deficiency	GYPHUM BOARD: DAMAGED/DETERIORATED

Deficiency Location/Instance	Rear
Deficiency Quantity	40
Quantity Uom	S.F.
Potential Action	REPLACE

Question	Response
<b>INTERIOR</b>	
<b>AUDITORIUM</b>	
<b>Ceiling</b>	
Urgency of Action	PRIORITY 3
Purpose of Action	LEVEL 2
Deficiency Photo1

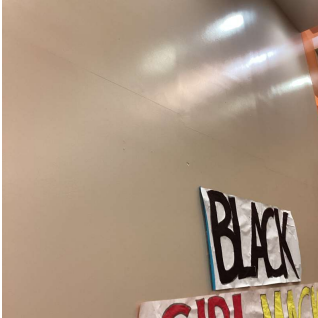
<b>Stage Curtain Rigging</b>	
Instance on 4th Floor (322 Seats)	Inspected
Condition	2 - Between Good and Fair
Deficiency	No deficiencies recorded
<b>Stage Curtains</b>	
Instance on 4th Floor (322 Seats)	Inspected
Condition	2 - Between Good and Fair
Deficiency	No deficiencies recorded
<b>Walls</b>	
Instance on 4th Floor (322 Seats)	Inspected
Condition	2 - Between Good and Fair
Deficiency	GYPSUM BOARD: DETERIORATED

Question	Response
<b>INTERIOR</b>	
<b>AUDITORIUM</b>	
<b>Walls</b>	
Deficiency Location/Instance	Left Side
Deficiency Quantity	30
Quantity Uom	S.F.
Potential Action	REPLACE
Urgency of Action	PRIORITY 3
Purpose of Action	LEVEL 2
Deficiency Photo1

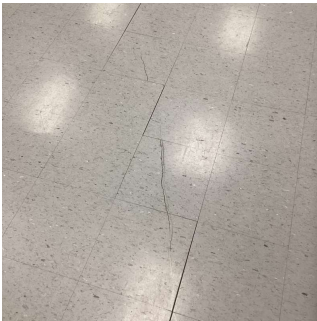
Violations	Left Side No violations recorded.
<b>Window Curtains/Shades/Blinds</b>	
Instance on 4th Floor (322 Seats)	Inspected
Condition	2 - Between Good and Fair
Deficiency	No deficiencies recorded
<b>CAFETERIA</b>	
Instance on 1st Floor	Inspected
<b>Ceiling</b>	
Instance on 1st Floor	Inspected
Condition	2 - Between Good and Fair
Deficiency	No deficiencies recorded
<b>Door(s)</b>	
Instance on 1st Floor	Inspected
Condition	2 - Between Good and Fair
Deficiency	No deficiencies recorded
<b>Fixed Equipment</b>	
Instance on 1st Floor	Does not Exist
<b>Floor Finish</b>	
Instance on 1st Floor	Inspected
Condition	2 - Between Good and Fair
Deficiency	VINYL TILES: DETERIORATED SUBSTRATE

Deficiency Location/Instance	Rear
Deficiency Quantity	15
Quantity Uom	S.F.
Potential Action	REPLACE
Urgency of Action	PRIORITY 3
Purpose of Action	LEVEL 2

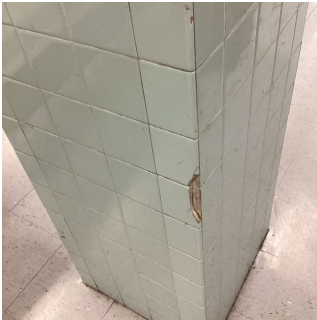
Violations	Rear No violations recorded.
<b>Sliding-folding Partition</b>	
Instance on 1st Floor	Does not Exist
<b>Stage</b>	
Instance on 1st Floor	Does not Exist
<b>Walls</b>	
Instance on 1st Floor	Inspected
Condition	2 - Between Good and Fair
Deficiency	CERAMIC TILE: BROKEN/ MISSING
Deficiency Location/Instance	Column
Deficiency Quantity	10
Quantity Uom	S.F.
Potential Action	REPLACE
Urgency of Action	PRIORITY 3
Purpose of Action	LEVEL 2
Deficiency Photo1

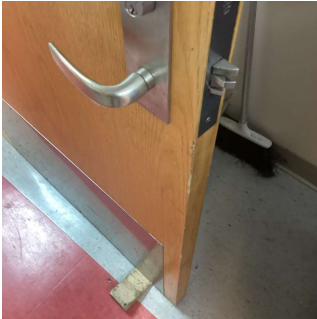
Question	Response
<b>INTERIOR</b>	
<b>CLASSROOMS/CORRIDORS/ADMIN SPACES</b>	
<b>Ceiling</b>	Inspected
Violations	No violations recorded.
<b>Door(s)</b>	Inspected
Condition	5 - Poor
Deficiency	WOOD: DETERIORATED DOOR
Deficiency Location/Instance	Rooms 512, 437, 430
Deficiency Quantity	3
Quantity Uom	EACH
Potential Action	MAINTENANCE
Urgency of Action	PRIORITY 3
Purpose of Action	LEVEL 2
Deficiency Photo1

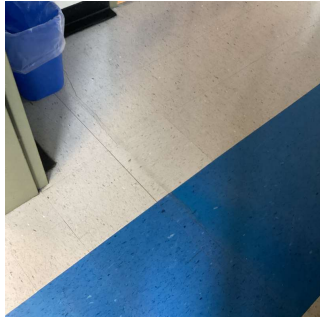
Violations	Main Entrance Vestibule No violations recorded.
<b>Floor Finish</b>	Inspected
Condition	2 - Between Good and Fair
Deficiency	VINYL TILES: DETERIORATED SUBSTRATE
Deficiency Location/Instance	Rooms 401, 405
Deficiency Quantity	20

Quantity Uom	S.F.
Potential Action	REPLACE
Urgency of Action	PRIORITY 3

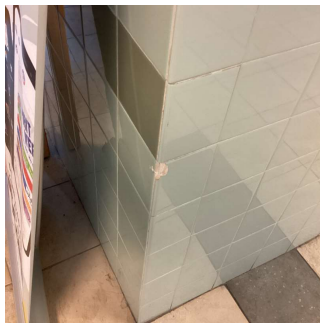
Violations	Corridor near room 512 No violations recorded.
Deficiency	CERAMIC TILE: BROKEN/ MISSING
Deficiency Location/Instance	Main Lobby
Deficiency Quantity	10
Quantity Uom	S.F.
Potential Action	REPLACE
Urgency of Action	PRIORITY 3
Purpose of Action	LEVEL 2

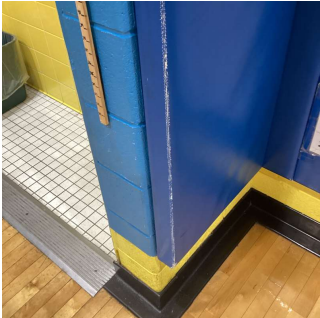
Question	Response
<b>INTERIOR</b>	
<b>GYMNASIUM</b>	
<b>Stage</b>	
Instance on 2nd Floor	Does not Exist
<b>Walls</b>	
Instance on 2nd Floor	Inspected
Condition	2 - Between Good and Fair
Deficiency	WALL PADDING: DETERIORATED
Deficiency Location/Instance	Perimeter
Deficiency Quantity	80
Quantity Uom	S.F.
Potential Action	REPLACE
Urgency of Action	PRIORITY 3
Purpose of Action	LEVEL 2
Deficiency Photo1

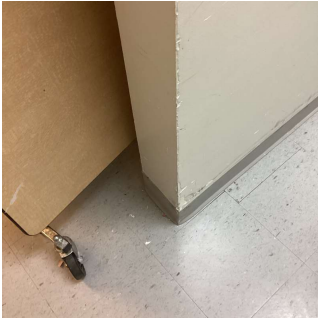
Condition	2 - Between Good and Fair
Deficiency	No deficiencies recorded
<b>Walls</b>	
Instance on 2nd Floor - Girls (268 Lockers)	Inspected
Condition	2 - Between Good and Fair
Deficiency	PLASTER: CRACKS/SPALLING
Deficiency Location/Instance	Near Entrance
Deficiency Quantity	10
Quantity Uom	S.F.
Potential Action	REPLACE
Urgency of Action	PRIORITY 3
Purpose of Action	LEVEL 2
Deficiency Photo1

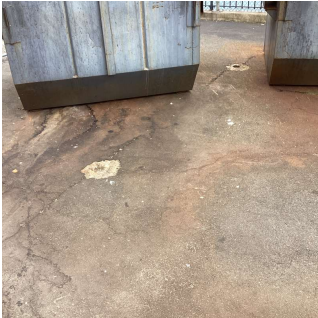
Containerization area

Violations	Along 155th Street No violations recorded.
<b>IRRIGATION SYSTEM</b>	Does not Exist
<b>PAVING</b>	Inspected
<b>Student Non-Use</b>	Inspected
Gravel Exists?	No
<b>Asphalt</b>	Inspected
Condition	4 - Between Fair and Poor
Deficiency	CRACKS - MAJOR
Deficiency Location/Instance	Containerization area, Parking Lot
Deficiency Quantity	900
Quantity Uom	S.F.

Potential Action	REPLACE
Urgency of Action	PRIORITY 3
Purpose of Action	LEVEL 2
Deficiency Photo1

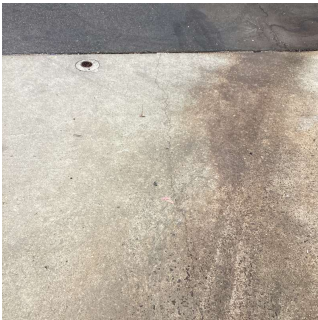
Question	Response
<b>SITE</b>	
<b>PAVING</b>	
<b>Student Non-Use</b>	
<b>Asphalt</b>	Inspected
Violations	No violations recorded.
<b>Concrete</b>	Inspected
Condition	2 - Between Good and Fair
Deficiency	CRACKS - MAJOR
Deficiency Location/Instance	Near Containerization area
Deficiency Quantity	30
Quantity Uom	S.F.
Potential Action	REPLACE
Urgency of Action	PRIORITY 3
Purpose of Action	LEVEL 2
Deficiency Photo1

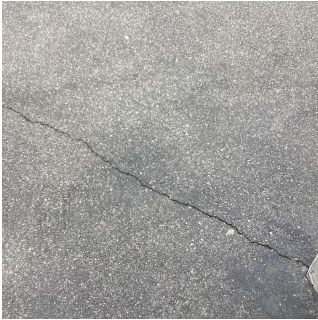
Violations	Near Containerization area No violations recorded.
<b>Pavers</b>	Does not Exist
<b>Student Use</b>	Does not Exist
<b>Site Sidewalks &amp; Walkways</b>	Inspected
<b>Asphalt</b>	Inspected
Condition	2 - Between Good and Fair
Deficiency	CRACKS - MAJOR
Deficiency Location/Instance	Near Park
Deficiency Quantity	30
Quantity Uom	S.F.
Potential Action	REPLACE
Urgency of Action	PRIORITY 3
Purpose of Action	LEVEL 2
Deficiency Photo1

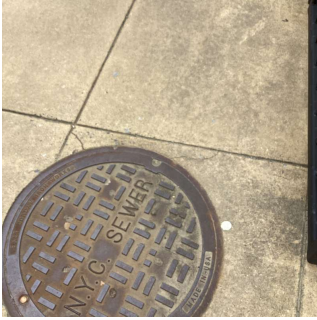
Question	Response
<b>SITE</b>	
<b>PAVING</b>	
<b>Site Sidewalks &amp; Walkways</b>	
<b>Concrete</b>	
Condition	3 - Fair
Deficiency	CRACKS - MAJOR
Deficiency Location/Instance	Main Entrance
Deficiency Quantity	100
Quantity Uom	S.F.
Potential Action	REPLACE
Urgency of Action	PRIORITY 3
Purpose of Action	LEVEL 2
Deficiency Photo1
