NYC Department of Education
Building Condition Assessment Survey 2023 - 2024

Architectural Inspection

Asset: PS 182 ANNEX - QUEENS, 88-13 PARSONS BOULEVARD, New York, 11432

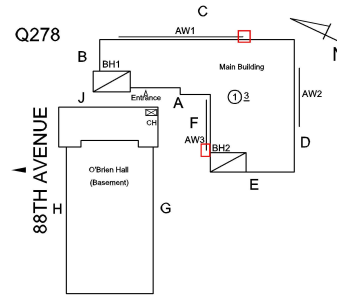
AREAWAY WALLS: CRACKS AND SPALLING

20
S.F.
REPLACE
PRIORITY 4
LEVEL 2

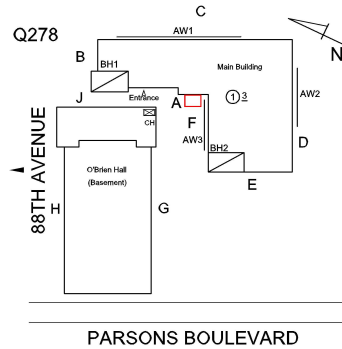
METAL: DETERIORATION/DAMAGED/MISSING PIECES

AWNINGS AND CANOPIES

10
S.F.
REPLACE
PRIORITY 4
LEVEL 2

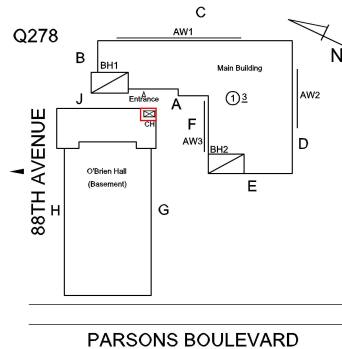
BRICK: MAJOR / THRU CRACKS

40
S.F.
REMOVE AND REBUILD
PRIORITY 4
LEVEL 2

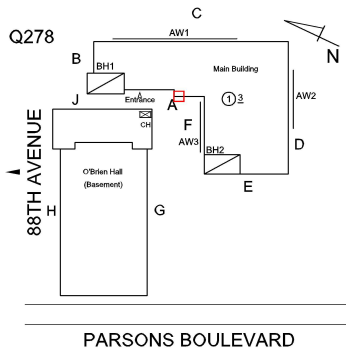
Violations	CH No violations recorded.
COPING	
Condition	Inspected 2 - Between Good and Fair
Deficiency	CAST STONE: DETERIORATED TRANSVERSE JOINTS
Roof Plan reference

Deficiency Quantity	10
Quantity Uom	L.F.
Potential Action	MAINTENANCE
Urgency of Action	PRIORITY 3
Purpose of Action	LEVEL 2
Deficiency Photo1

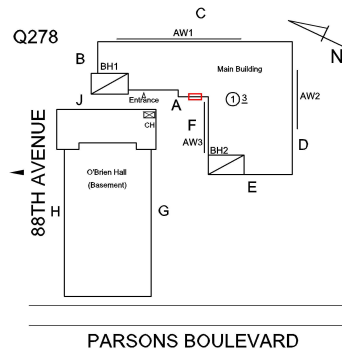
Violations	Roof 1 No violations recorded.
CORNICE	
	Does not Exist
DOORS	
	Inspected
DOORS AND FRAMES	
	Inspected
Condition	3 - Fair
Deficiency	METAL: DETERIORATED DOOR - MINOR DETERIORATION

DOORS AND FRAMES

1
EACH
MAINTENANCE
PRIORITY 3
LEVEL 2

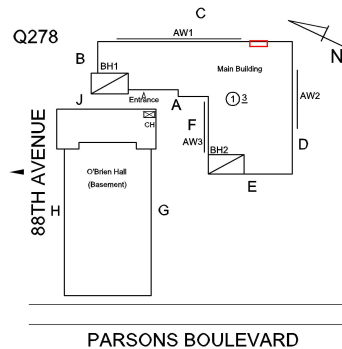
METAL: BROKEN GLASS

10
S.F.
MAINTENANCE

PRIORITY 3
LEVEL 2

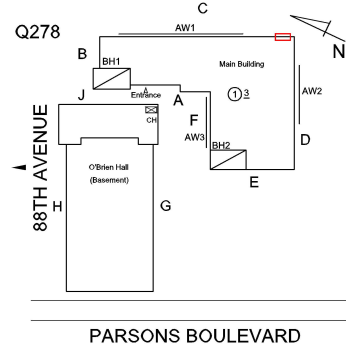
METAL: DENTED, MAJOR RUSTING

10
S.F.
REPLACE
PRIORITY 4
LEVEL 2

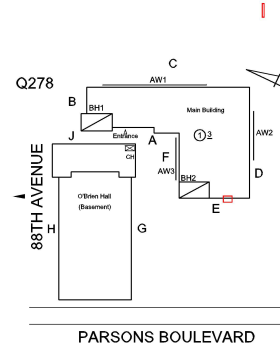
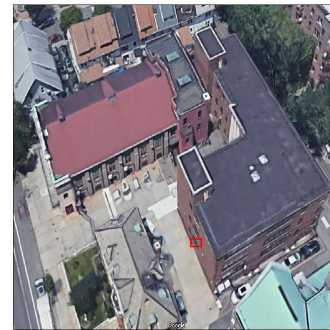
BRICK: MASONRY SILLS - DETERIORATED JOINTS

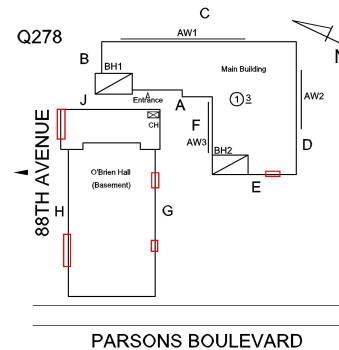
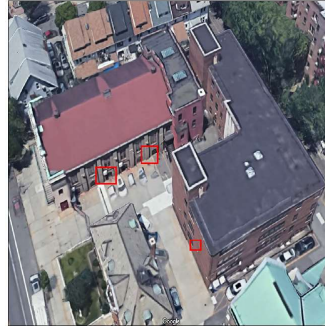
BRICK: DETERIORATED JOINTS

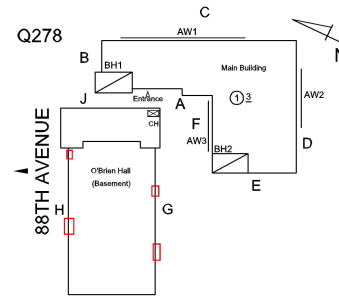
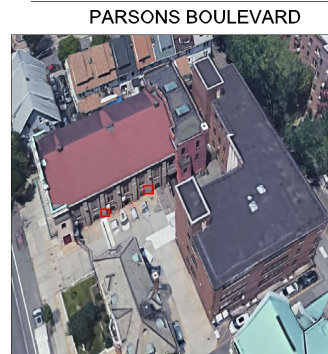
BRICK: MAJOR / THRU CRACKS

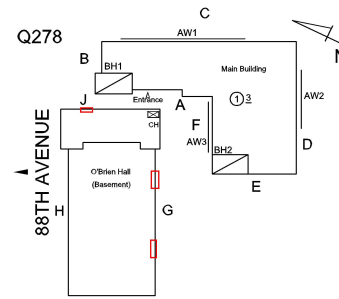
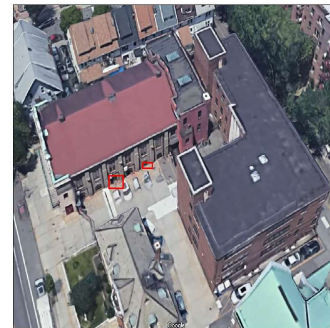
BRICK: DETERIORATED MASONRY SILLS - MAJOR

REMOVE AND REPLACE

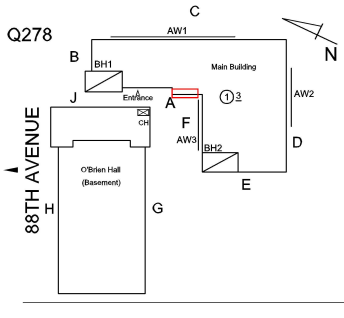
Question	Response
EXTERIOR	
PARAPETS	
Instance Condition	3 - Fair
Instance Quantity	600
Instance Quantity Uom	C.F.
Deficiency	BRICK: DETERIORATED JOINTS
Roof Plan reference

Deficiency Quantity	80
Quantity Uom	S.F.
Potential Action	REPOINT
Urgency of Action	PRIORITY 3
Purpose of Action	LEVEL 2
Deficiency Photo1

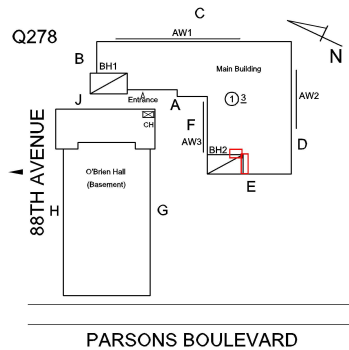
Question	Response
EXTERIOR	
ROOF	
Roofing	
ROOFING	
Instance Photo	 
	Roof 1
Instance Quantity	12,000
Instance Quantity Uom	S.F.
Does the roof have major mechanical equipment sitting on Dunnage Steel less than 18" above the Roofing?	No
Does this roof instance have a Sustainable Roof System?	No
Do solar panels exist on these roofs?	No
Is/Are the roof(s) suitable for Solar Panel installation?	Yes
Installation Year	2009
Source of Installation	Custodial Staff
Deficiency	MODIFIED BITUMEN: FLASHING: BASE FLASHING DETERIORATED
Roof Plan reference

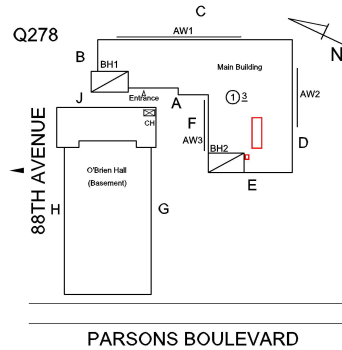
Deficiency Quantity	20
Quantity Uom	S.F.
Potential Action	REPLACE
Urgency of Action	PRIORITY 4
Purpose of Action	LEVEL 2
Deficiency Photo1	 
	Roof 1
Violations	No violations recorded.
Deficiency	MODIFIED BITUMEN: ROOFING: DELAMINATION

20
S.F.
REPLACE ROOFING WITHOUT MAJOR EQUIPMENT
REMOVAL
PRIORITY 4
LEVEL 2

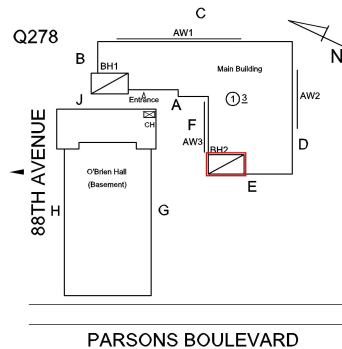
BULKHEAD/PENTHOUSE WALLS/INTERIOR: PLASTER
CRACKS/SPALLING

50
S.F.
REPLACE
PRIORITY 4

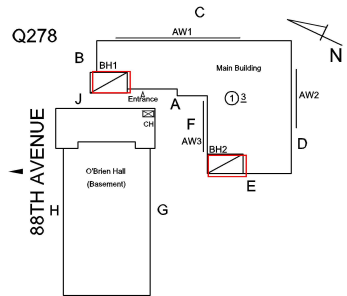
Violations	BH2 No violations recorded.
Deficiency	BULKHEAD/PENTHOUSE WALLS/EXTERIOR: DETERIORATED JOINTS
Roof Plan reference

Deficiency Quantity	200
Quantity Uom	S.F.
Potential Action	REPOINT
Urgency of Action	PRIORITY 3
Purpose of Action	LEVEL 2
Deficiency Photo1

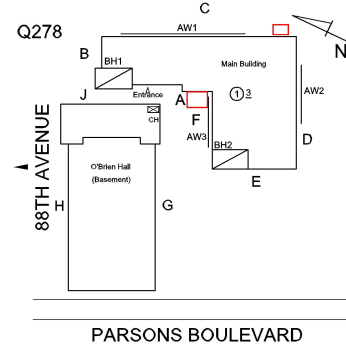
STONE: DETERIORATED JOINTS

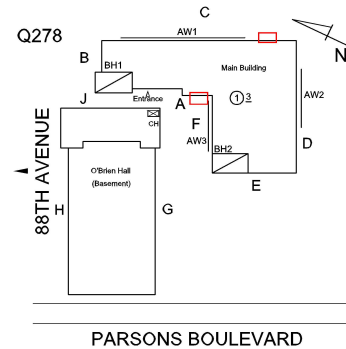
STONE: DETERIORATED JOINTS AT COPING STONES

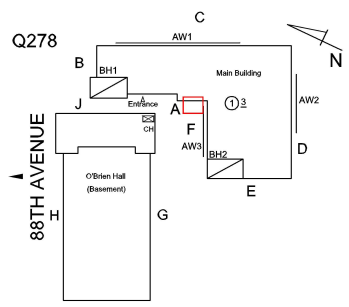
Violations	Facade A No violations recorded.
RAILINGS	Inspected
Condition	2 - Between Good and Fair
Deficiency	No deficiencies recorded
STAIRS/RAMPS	Inspected
Condition	5 - Poor
Deficiency	STONE: DETERIORATED JOINTS
Roof Plan reference

Deficiency Quantity	20
Quantity Uom	L.F.
Potential Action	REPOINT
Urgency of Action	PRIORITY 4
Purpose of Action	LEVEL 2
Deficiency Photo1

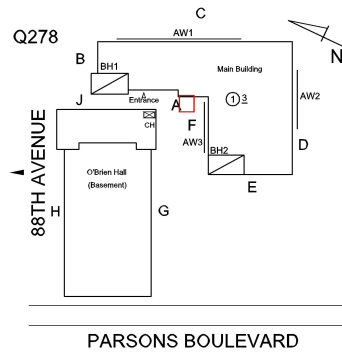
Violations	Facade A No violations recorded.
Deficiency	STONE: DETERIORATED SUBSTRATE

20
S.F.
REPLACE SUBSTRATE AND RESET
PRIORITY 5
LEVEL 6

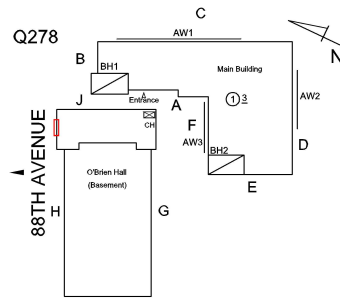
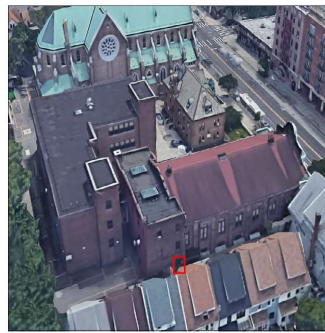
Question	Response
EXTERIOR	
WINDOWS	
EXTERIOR GUARDS	
Elevation	 
Deficiency Quantity	30
Quantity Uom	S.F.
Potential Action	REPLACE
Urgency of Action	PRIORITY 4
Purpose of Action	LEVEL 2
Deficiency Photo1	 
Violations	Facade J No violations recorded.
LINTELS	Inspected
Condition	2 - Between Good and Fair
Deficiency	No deficiencies recorded
WINDOWS	Inspected
Material Type(s)	Aluminum, Steel, Solid Wood
Instance on Wood: Basement - Boiler Room - O'Brien Hall	Inspected
Instance Condition	5 - Poor
Instance Quantity	30
Instance Quantity Uom	S.F.
Are these windows insulated	No
Installation Year	1965
Source of Installation	Inspector Estimate
Deficiency	WOOD: DETERIORATED

30
S.F.
REPLACE WINDOW
PRIORITY 4
LEVEL 2

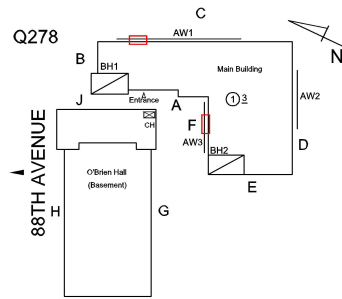
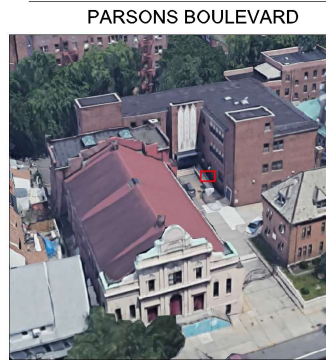
Instance on Steel: Basement - Main Building	Inspected
Instance Condition	5 - Poor
Instance Quantity	500
Instance Quantity Uom	S.F.
Are these windows insulated	No
Installation Year	1965
Source of Installation	Inspector Estimate
Deficiency	STEEL: BROKEN PANE

90
S.F.
MAINTENANCE
PRIORITY 3
LEVEL 2

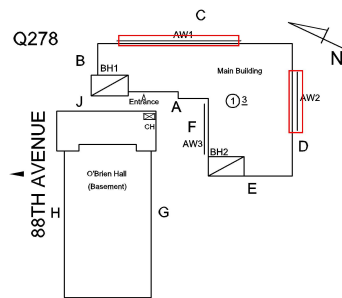
STEEL: DETERIORATED

Question	Response
EXTERIOR	
WINDOWS	
WINDOWS	
Elevation	 
Deficiency Quantity	300
Quantity Uom	S.F.
Potential Action	REPLACE WINDOW
Urgency of Action	PRIORITY 4
Purpose of Action	LEVEL 2
Deficiency Photo1	 
Violations	Facade D - Multipurpose Room No violations recorded.
Instance on Aluminum - Double Hung: Facade G - O'Brien Hall - Multipurpose Room	Inspected
Instance Condition	2 - Between Good and Fair
Instance Quantity	400
Instance Quantity Uom	S.F.
Are these windows insulated	Yes
Installation Year	2011
Source of Installation	Custodial Staff
Deficiency	No deficiencies recorded
Instance on Aluminum - Double Hung: Facades A-F	Inspected
Instance Condition	2 - Between Good and Fair
Instance Quantity	1,700
Instance Quantity Uom	S.F.
Are these windows insulated	Yes
Installation Year	2011
Source of Installation	Inspector Estimate
Deficiency	No deficiencies recorded
INTERIOR	Inspected
POOLS	Does not Exist
STRUCTURAL	Inspected

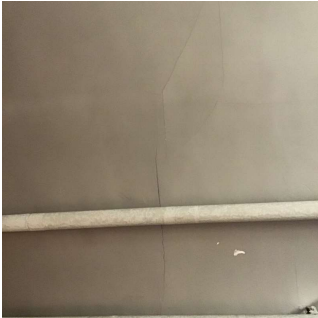
Question	Response
INTERIOR	
STRUCTURAL	
COLUMNS/BEAMS/BEARING WALLS	Inspected
Condition	2 - Between Good and Fair
Deficiency	No deficiencies recorded
FLOOR STRUCTURE	Inspected
Condition	3 - Fair
Deficiency	CONCRETE: CRACKS/SPALLED/REINFORCEMENT EXPOSED
Deficiency Location/Instance	Pump Room
Deficiency Quantity	40
Quantity Uom	S.F.
Potential Action	REPAIR
Urgency of Action	PRIORITY 3
Purpose of Action	LEVEL 5
Deficiency Photo1

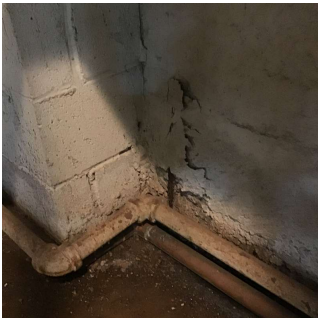
Pump Room
Violations	No violations recorded.
FOUNDATION WALLS	Inspected
Material Type(s)	Concrete, Masonry
Condition	4 - Between Fair and Poor
Deficiency	CONCRETE: CRACKED/SPALLED/REINFORCEMENT EXPOSED
Deficiency Location/Instance	Pump Room
Deficiency Quantity	10
Quantity Uom	S.F.
Potential Action	REPAIR
Urgency of Action	PRIORITY 4
Purpose of Action	LEVEL 5
Deficiency Photo1

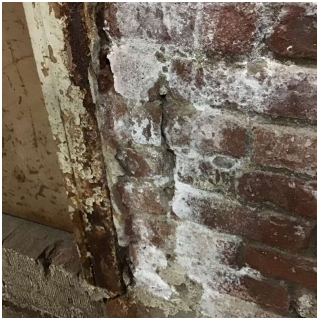
Violations	Basement - Boiler Room No violations recorded.
Deficiency	BRICK: CRACKED/SPALLED
Deficiency Location/Instance	Boiler Room
Deficiency Quantity	60
Quantity Uom	S.F.
Potential Action	RESTITCH
Urgency of Action	PRIORITY 4
Purpose of Action	LEVEL 5
Deficiency Photo1

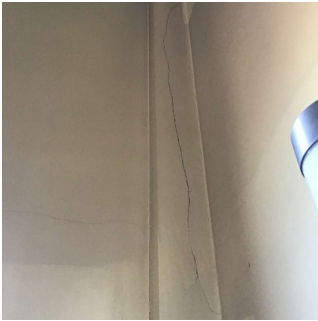
Violations	Boiler Room No violations recorded.
ROOF STRUCTURE	
Condition	Inspected 3 - Fair
Deficiency	STEEL COLUMNS/BEAMS: DETERIORATED CONCRETE FIREPROOFING
Deficiency Location/Instance	BH1, BH2
Deficiency Quantity	40
Quantity Uom	S.F.
Potential Action	REPLACE
Urgency of Action	PRIORITY 3
Purpose of Action	LEVEL 5

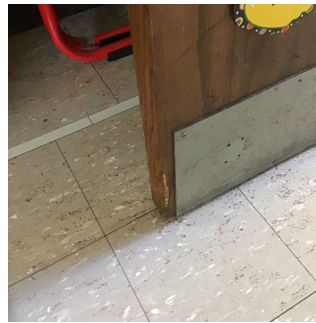
Room 301

Door(s)

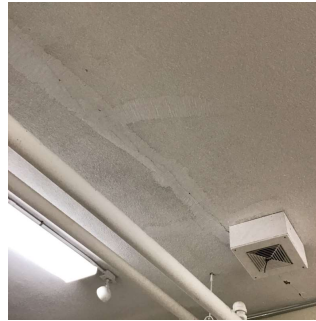
Ceiling	
Instance on Basement - O'Brien Hall	Inspected
Condition	2 - Between Good and Fair
Deficiency	PLASTER: CRACKS/SPALLING
Deficiency Location/Instance	Right Side
Deficiency Quantity	20
Quantity Uom	S.F.
Potential Action	REPLACE
Urgency of Action	PRIORITY 3
Purpose of Action	LEVEL 2

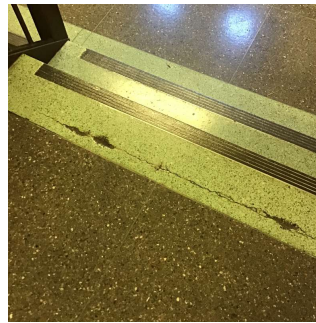
Stair B/1

VINYL TILES: BROKEN/DETERIORATED/MISSING TILES

REPLACE

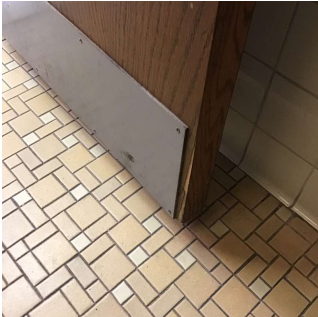
Question	Response
INTERIOR	
STAIRS/RAMPS: INTERIOR	
Walls	
Violations	Stair B/1 No violations recorded.
Deficiency	CERAMIC TILE: BROKEN/ MISSING
Deficiency Location/Instance	Stairs A/Basement, 3, B/3
Deficiency Quantity	30
Quantity Uom	S.F.
Potential Action	REPLACE
Urgency of Action	PRIORITY 3
Purpose of Action	LEVEL 2
Deficiency Photo1	 
Violations	Stair A/Basement No violations recorded.
TOILET ROOMS - STAFF	
Ceiling	Inspected
Condition	2 - Between Good and Fair
Deficiency	No deficiencies recorded
Door(s)	Inspected
Condition	5 - Poor
Deficiency	WOOD: DETERIORATED DOOR
Deficiency Location/Instance	Inside Room 216
Deficiency Quantity	1
Quantity Uom	EACH
Potential Action	MAINTENANCE
Urgency of Action	PRIORITY 3
Purpose of Action	LEVEL 2
Deficiency Photo1

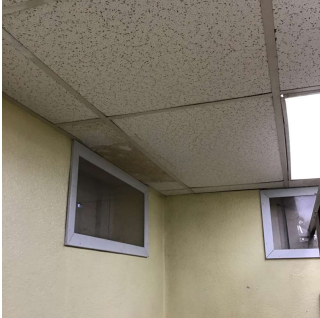
Question	Response
INTERIOR	
TOILET ROOMS - STAFF	
Stalls	Does not Exist
Walls	Inspected
Condition	2 - Between Good and Fair
Deficiency	No deficiencies recorded
TOILET ROOMS - STUDENTS	
Inspected	Inspected
Ceiling	Inspected
Condition	2 - Between Good and Fair
Deficiency	ACOUSTIC TILES: DAMAGED/MISSING
Deficiency Location/Instance	Basement - Boys OBrien Hall
Deficiency Quantity	10
Quantity Uom	S.F.
Potential Action	REPLACE
Urgency of Action	PRIORITY 3
Purpose of Action	LEVEL 2
Deficiency Photo1

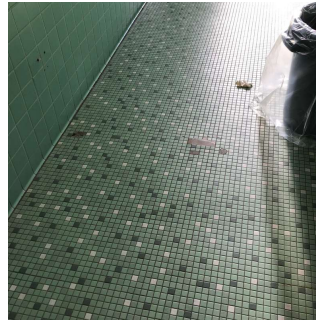
3rd Floor - Boys

Floor Finish
