NYC Department of Education
Building Condition Assessment Survey 2023 - 2024

Architectural Inspection

Q280

Asset: P.S. 280 - QUEENS, 34-20 94TH STREET, New York, 11372

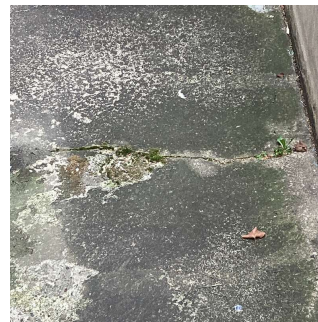
AW13

AREAWAY SLAB: CRACKS AND SPALLING

REPLACE

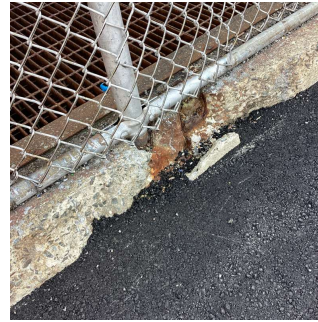
AW11

AREAWAY WALLS: CRACKS AND SPALLING

REPLACE

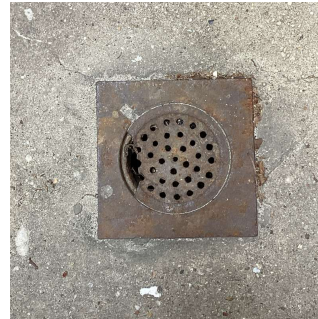
AW5

AREAWAY DRAINS: DETERIORATED

REPLACE

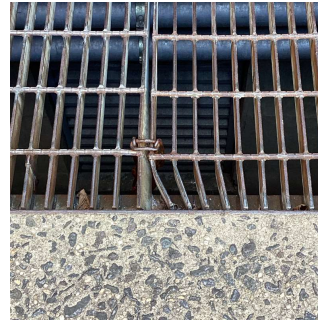
AW9

AREAWAY GRATINGS: MAJOR RUSTING / OR BROKEN

REPLACE

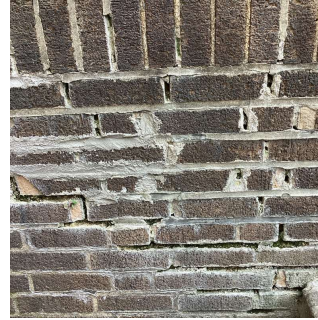
AW6

AREAWAY WALLS: DETERIORATED JOINTS

REPAIR

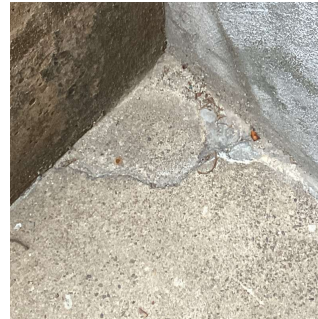
AW5

AREAWAY SLAB: CRACKS AND SPALLING

REPAIR

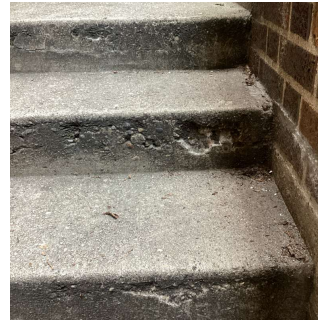
AW5

AREAWAY STAIRS: DETERIORATED TREADS/RISERS/NOSINGS

REPLACE

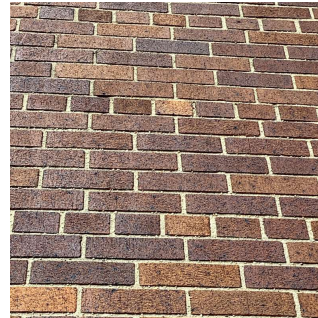
CH3

BRICK: DETERIORATED JOINTS

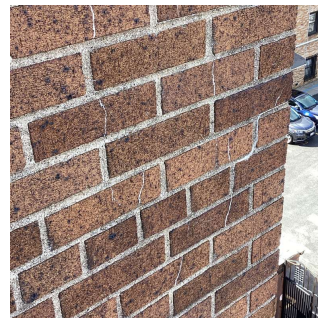
CH3

BRICK: MINOR CRACKS AND SPALLING

20
S.F.
RESTITCH
PRIORITY 3
LEVEL 2

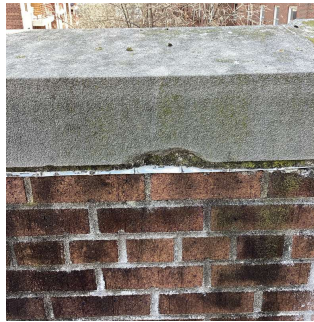
Roof 2
 No violations recorded.

Deficiency	CAST STONE: CRACKED/BROKEN PIECES
------------	-----------------------------------

Deficiency Quantity	20
Quantity Uom	L.F.
Potential Action	REPLACE-IN-KIND
Urgency of Action	PRIORITY 4
Purpose of Action	LEVEL 2
Deficiency Photo1

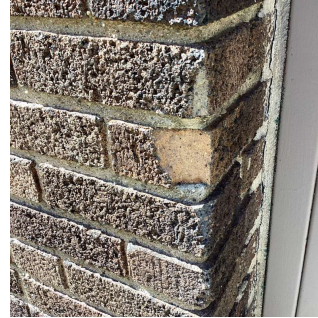
Facade A

Deficiency Quantity	2
Quantity Uom	EACH
Potential Action	MAINTENANCE
Urgency of Action	PRIORITY 3
Purpose of Action	LEVEL 2
Deficiency Photo1	No photo recorded
Violations	No violations recorded.
DOOR HARDWARE	Inspected
Condition	3 - Fair
Deficiency	No deficiencies recorded
LINTELS	Inspected
Condition	2 - Between Good and Fair
Deficiency	No deficiencies recorded
TRANSOM/SIDE LIGHT	Inspected
Condition	2 - Between Good and Fair
Deficiency	No deficiencies recorded
EXTERIOR WALLS	Inspected
Material Type(s)	Masonry
Replacement Quantity	30,000
Replacement Uom	S.F.
Instance on All Facades	Inspected
Instance Condition	3 - Fair
Instance Quantity	30,000
Instance Quantity Uom	S.F.
Deficiency	BRICK: MAJOR / THRU CRACKS
Roof Plan reference

REMOVE AND REBUILD
PRIORITY 4
LEVEL 2

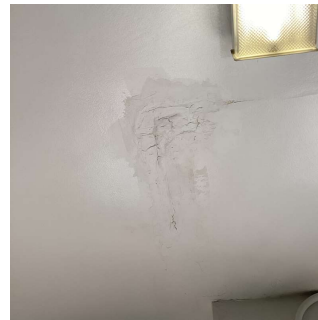
Facade B - Corridor near Stair A/2 (Old Building)

BRICK: WATER INFILTRATION IN INSTRUCTIONAL SPACE

100
S.F.
REPAIR
PRIORITY 5
LEVEL 2

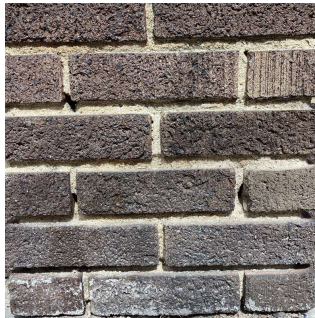
Facade B

BRICK: DETERIORATED JOINTS

50
S.F.
REPOINT
PRIORITY 4
LEVEL 2

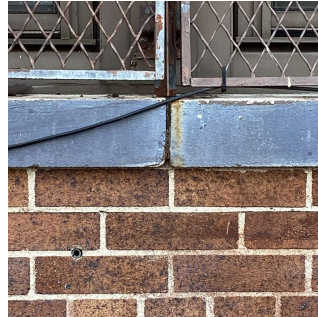
Facade C

BRICK: MASONRY SILLS - DETERIORATED JOINTS

REPOINT
 PRIORITY 3
 LEVEL 2

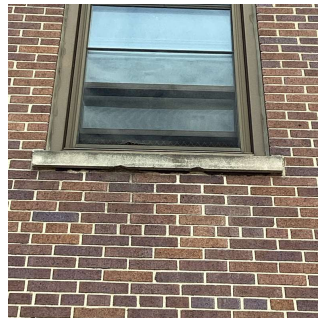
Facade C

BRICK: DETERIORATED MASONRY SILLS - MINOR

10
 L.F.
 REPAIR
 PRIORITY 3
 LEVEL 2

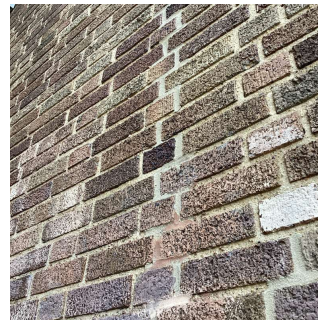
Facade C

BRICK: DETERIORATED JOINTS

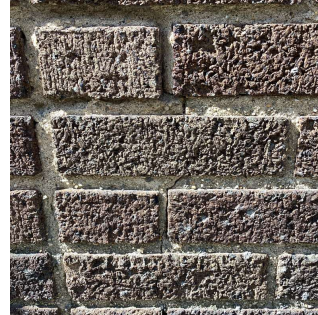
Facade A

BRICK: MINOR CRACKS AND SPALLING

RESTITCH
PRIORITY 3
LEVEL 2

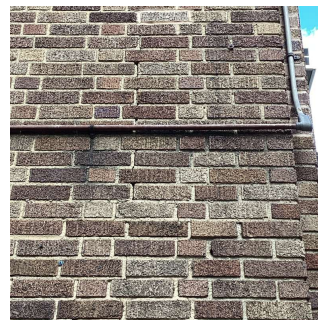
Facade B

BRICK: CRACKS/DISPLACED/SPALLED BRICK AT BUILDING CORNERS

20
S.F.
REMOVE AND REBUILD
PRIORITY 4
LEVEL 2

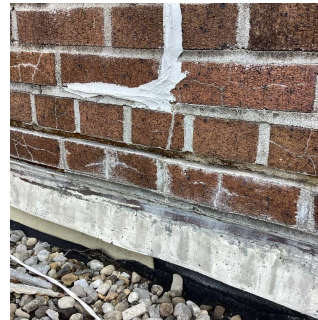
Roof 2

Deficiency Quantity	40
Quantity Uom	S.F.
Potential Action	REPAIR
Urgency of Action	PRIORITY 3
Purpose of Action	LEVEL 2
Deficiency Photo1	 
Violations	Facade A - Bridge No violations recorded.
LOADING DOCK	Does not Exist
LOUVER	Inspected
Condition	2 - Between Good and Fair
Deficiency	No deficiencies recorded
PARAPETS	Inspected
Material Type(s)	Masonry, Metal
Replacement Quantity	4,000
Replacement Uom	C.F.
Instance on All Facades	Inspected
Instance Condition	4 - Between Fair and Poor
Instance Quantity	4,000
Instance Quantity Uom	C.F.
Deficiency	BRICK: DETERIORATED JOINTS

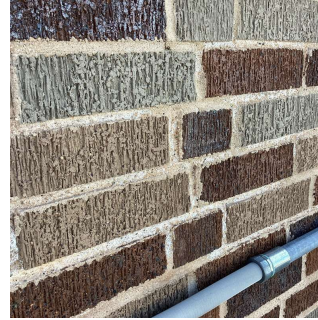
Roof 1

BRICK: DETERIORATED JOINTS

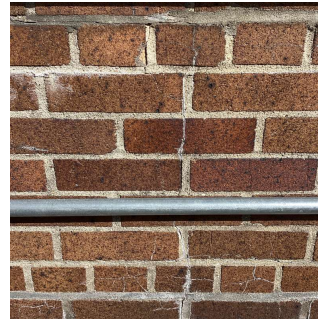
Roof 2

BRICK: MINOR CRACKS, SPALLING

REPAIR

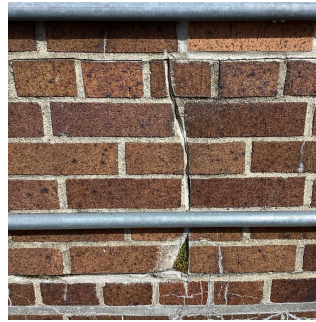
Roof 2

BRICK: MAJOR DETERIORATION/CRACKS

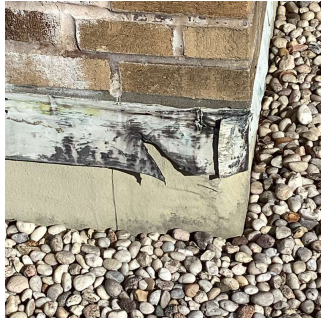
Deficiency	IRMA: FLASHING: CAP FLASHING DAMAGED
------------	--------------------------------------

Deficiency Quantity	60
Quantity Uom	L.F.
Potential Action	REPLACE
Urgency of Action	PRIORITY 4
Purpose of Action	LEVEL 2
Deficiency Photo1

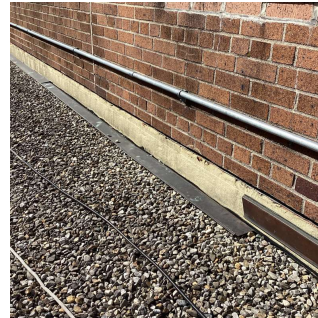
Roof 2

Deficiency	IRMA: FLASHING: CAP FLASHING MISSING
------------	--------------------------------------

Deficiency Quantity	30
Quantity Uom	L.F.
Potential Action	INSTALL NEW
Urgency of Action	PRIORITY 4
Purpose of Action	LEVEL 2

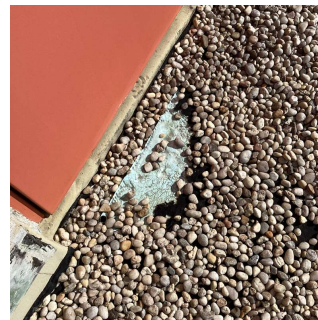
Roof 1 - BH3

IRMA: ROOFING: DAMAGED INSULATION

REPLACE

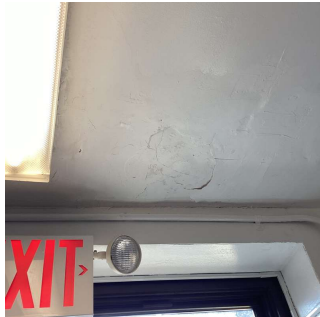
IRMA: ROOFING: MAJOR ACTIVE ROOF LEAKS IN INSTRUCTIONAL SPACE

Violations	Roof 1 - Corridor near Stair A/3 (Roof 2 - Room 306 similar) No violations recorded.
ROOFING DRAINS	Inspected
Condition	2 - Between Good and Fair
Deficiency	No deficiencies recorded
Specialties	Inspected
BULKHEAD/PENTHOUSE	Inspected
Condition	4 - Between Fair and Poor
Deficiency	BULKHEAD/PENTHOUSE WALLS/EXTERIOR: WATER INFILTRATION
Roof Plan reference

REPLACE ROOFING WITHOUT MAJOR EQUIPMENT REMOVAL

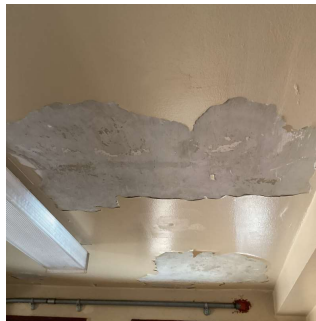
BH3
No violations recorded.

BULKHEAD/PENTHOUSE ROOF: MAJOR LEAKAGE

100
S.F.
REPLACE
PRIORITY 5
LEVEL 2

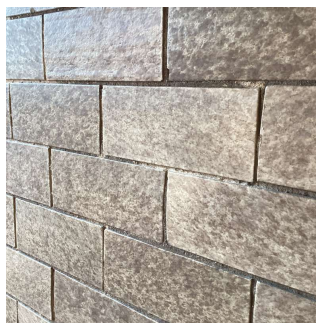
BH1
No violations recorded.

Deficiency **BULKHEAD/PENTHOUSE WALLS/INTERIOR: GLAZED BLOCK DETERIORATED JOINTS**

20
S.F.
REPOINT
PRIORITY 3
LEVEL 2

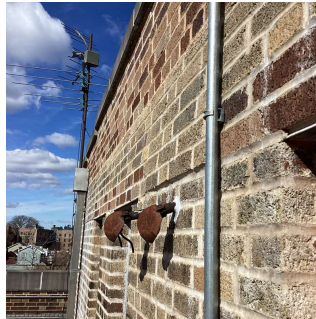
BH3
No violations recorded.

Deficiency **BULKHEAD/PENTHOUSE WALLS/EXTERIOR: BULGING/BOWING**

40
S.F.
REPAIR
PRIORITY 3
LEVEL 2

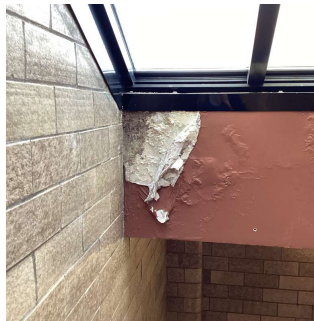
SK2

WATER INFILTRATION

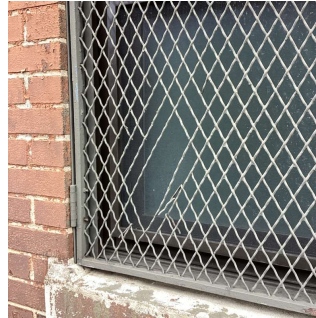
Facade C

DETERIORATED/TORN-OUT/MISSING

90
S.F.
REPLACE
PRIORITY 4
LEVEL 2

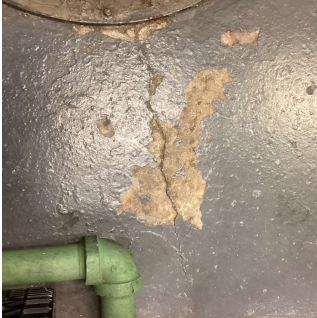
Question	Response
EXTERIOR	
WINDOWS	
WINDOWS	
Deficiency Photo1	 
Violations	No violations recorded.
Instance on Steel: Portion of Facade E (Original Building)	Inspected
Instance Condition	3 - Fair
Instance Quantity	100
Instance Quantity Uom	S.F.
Are these windows insulated	No
Installation Year	1966
Source of Installation	Custodial Staff
Deficiency	No deficiencies recorded
INTERIOR	Inspected
POOLS	Does not Exist
STRUCTURAL	Inspected
COLUMNS/BEAMS/BEARING WALLS	Inspected
Condition	3 - Fair
Deficiency	STEEL COLUMNS/BEAMS: DETERIORATED CONCRETE FIREPROOFING
Deficiency Location/Instance	Boiler Room
Deficiency Quantity	40
Quantity Uom	S.F.
Potential Action	REPLACE
Urgency of Action	PRIORITY 4
Purpose of Action	LEVEL 5
Deficiency Photo1	 
Violations	No violations recorded.
FLOOR STRUCTURE	Inspected
Condition	3 - Fair
Deficiency	CONCRETE SLAB ON GRADE: THRU CRACKS

Question	Response
INTERIOR	
STRUCTURAL	
FLOOR STRUCTURE	
Deficiency Location/Instance	Boiler Room
Deficiency Quantity	50
Quantity Uom	S.F.
Potential Action	REPAIR
Urgency of Action	PRIORITY 3
Purpose of Action	LEVEL 5
Deficiency Photo1

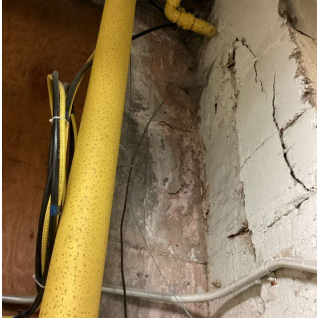
Violations	Boiler Room No violations recorded.
FOUNDATION WALLS	
Material Type(s)	Inspected Concrete
Condition	4 - Between Fair and Poor
Deficiency	CONCRETE: WATER INFILTRATION IN NON- INSTRUCTIONAL SPACE
Deficiency Location/Instance	Boiler Room, Corridor between Oil Tank and Boiler Room
Deficiency Quantity	200
Quantity Uom	S.F.
Potential Action	INSTALL WATERPROOFING
Urgency of Action	PRIORITY 5
Purpose of Action	LEVEL 5
Deficiency Photo1

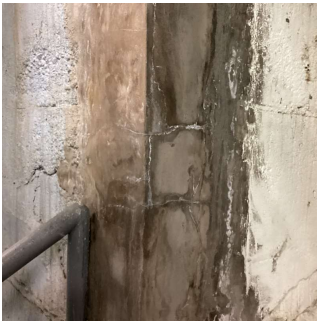
Violations	Boiler Room No violations recorded.
Deficiency	CONCRETE: CRACKED/SPALLED/REINFORCEMENT EXPOSED
Deficiency Location/Instance	Boiler Room, Corridor between Oil Tank and Boiler Room, Room C07
Deficiency Quantity	80
Quantity Uom	S.F.

Potential Action	REPAIR
Urgency of Action	PRIORITY 4
Purpose of Action	LEVEL 5

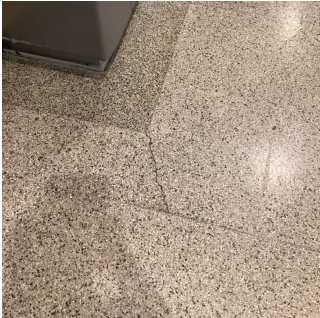
Question	Response
INTERIOR	
AUDITORIUM	
Fixed Seating	
Deficiency	No deficiencies recorded
Floor Finish	
Instance on 1st Floor (170 Seats)	Inspected
Condition	2 - Between Good and Fair
Deficiency	TERRAZZO: CRACKS
Deficiency Location/Instance	Right and Left Side Near Windows, Left and Right Side near Stage
Deficiency Quantity	60
Quantity Uom	S.F.
Potential Action	REPLACE
Urgency of Action	PRIORITY 3
Purpose of Action	LEVEL 2
Deficiency Photo1

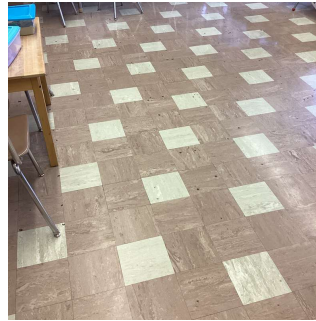
Room 302

Violations	Room 317 No violations recorded.
Floor Finish	Inspected
Condition	4 - Between Fair and Poor
Deficiency	VINYL TILES: BROKEN/DETERIORATED/MISSING TILES
Deficiency Location/Instance	Rooms 305, 304, 302, 203, 113 and others
Deficiency Quantity	500
Quantity Uom	S.F.
Potential Action	REPLACE
Urgency of Action	PRIORITY 3
Purpose of Action	LEVEL 2

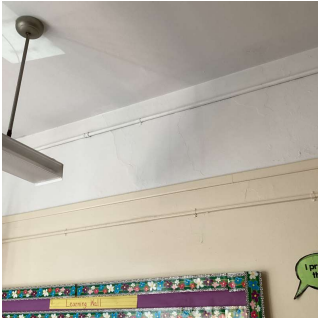
Question	Response
INTERIOR	
CLASSROOMS/CORRIDORS/ADMIN SPACES	
Walls	
Violations	Corridor near Room 301 No violations recorded.
Deficiency	PLASTER: CRACKS/SPALLING
Deficiency Location/Instance	Rooms 322, 317, 316 Corridor near Room 321
Deficiency Quantity	40
Quantity Uom	S.F.
Potential Action	REPLACE
Urgency of Action	PRIORITY 3
Purpose of Action	LEVEL 2
Deficiency Photo1

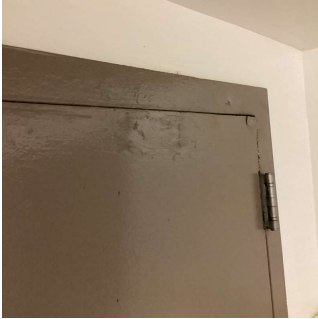
Question	Response
INTERIOR	
SCIENCE PREP ROOM	Inspected
Fixed Equipment	
Deficiency	No deficiencies recorded
SHOWER ROOM	Does not Exist
STAIRS/RAMPS: INTERIOR	Inspected
Do Letter Stair Signs Exist?	Partially
Ceiling	Inspected
Condition	2 - Between Good and Fair
Deficiency	No deficiencies recorded
Door(s)	Inspected
Condition	3 - Fair
Deficiency	METAL: DETERIORATED DOOR
Deficiency Location/Instance	Stair A/Basement, B/Basement New Building
Deficiency Quantity	2
Quantity Uom	EACH
Potential Action	MAINTENANCE
Urgency of Action	PRIORITY 3
Purpose of Action	LEVEL 2
Deficiency Photo1

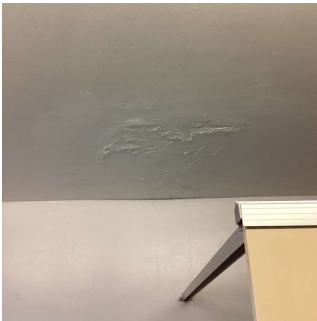
Violations	Room 104 No violations recorded.
TOILET ROOMS - STUDENTS	
Ceiling	Inspected
Condition	2 - Between Good and Fair
Deficiency	PLASTER: CRACKS/SPALLING - ACTIVE LEAK
Deficiency Location/Instance	Room 216
Deficiency Quantity	20
Quantity Uom	S.F.
Potential Action	REPLACE
Urgency of Action	PRIORITY 5
Purpose of Action	LEVEL 2

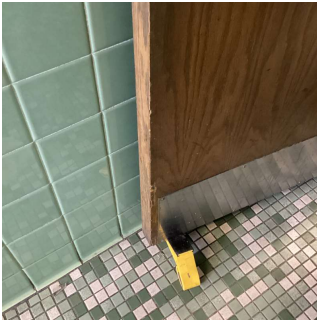
Violations	Room 216 No violations recorded.
Door(s)	Inspected
Condition	5 - Poor
Deficiency	WOOD: DETERIORATED DOOR
Deficiency Location/Instance	Room 216
Deficiency Quantity	1
Quantity Uom	EACH
Potential Action	MAINTENANCE
Urgency of Action	PRIORITY 3
Purpose of Action	LEVEL 2
Deficiency Photo1

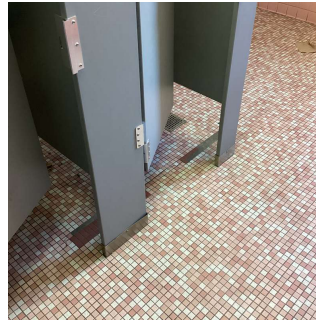
Room 210

Violations	Room 216 No violations recorded.
Floor Finish	Inspected
Condition	2 - Between Good and Fair
Deficiency	CERAMIC TILE: BROKEN/MISSING TILES
Deficiency Location/Instance	Rooms 210, 216
Deficiency Quantity	20
Quantity Uom	S.F.
Potential Action	REPLACE
Urgency of Action	PRIORITY 3
Purpose of Action	LEVEL 2

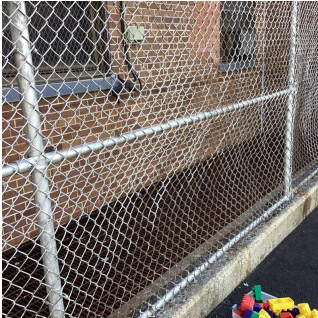
Question	Response
SITE	
FENCES	
Violations	94th Street No violations recorded.
Deficiency	CHAIN LINK: DAMAGED/DETERIORATED
Deficiency Location/Instance	Schoolyard
Deficiency Quantity	300
Quantity Uom	S.F.
Potential Action	REPLACE
Urgency of Action	PRIORITY 3
Purpose of Action	LEVEL 2
Deficiency Photo1

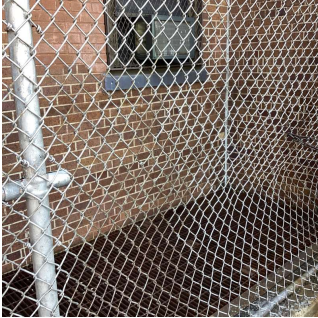
Violations	Schoolyard No violations recorded.
Deficiency	CHAIN LINK: DAMAGED POST/RAIL
Deficiency Location/Instance	Near Exit 12
Deficiency Quantity	10
Quantity Uom	L.F.
Potential Action	REPLACE
Urgency of Action	PRIORITY 3
Purpose of Action	LEVEL 2
Deficiency Photo1

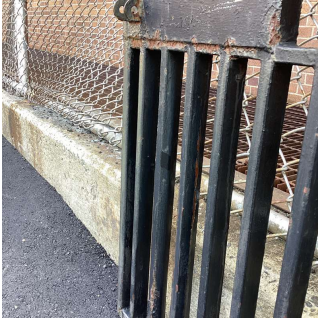
Violations	Near Exit 12 No violations recorded.
Deficiency	CHAIN LINK: DAMAGED/DETERIORATED
Deficiency Location/Instance	Near Exit 12
Deficiency Quantity	50
Quantity Uom	S.F.
Potential Action	REPLACE
Urgency of Action	PRIORITY 5
Purpose of Action	LEVEL 6

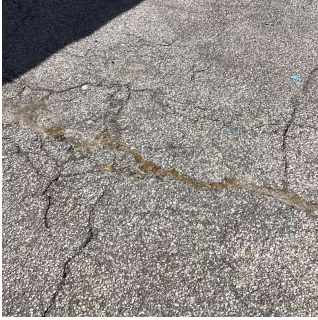
Violations	Near Exit 12 No violations recorded.
IRRIGATION SYSTEM	Does not Exist
PAVING	Inspected
Student Non-Use	Inspected
Gravel Exists?	No
Asphalt	Inspected
Condition	3 - Fair
Deficiency	CRACKS - MAJOR
Deficiency Location/Instance	Near Exit 12
Deficiency Quantity	100
Quantity Uom	S.F.
Potential Action	REPLACE
Urgency of Action	PRIORITY 3
Purpose of Action	LEVEL 2
Deficiency Photo1

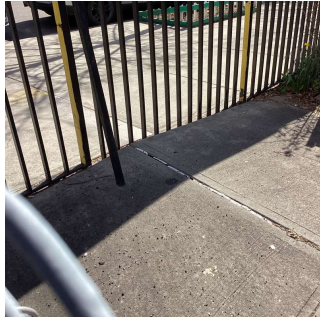
Violations	Near Exit 12 No violations recorded.
Concrete	Inspected
Condition	3 - Fair
Deficiency	HEAVING
Deficiency Location/Instance	94th Street
Deficiency Quantity	50
Quantity Uom	S.F.
Potential Action	REPLACE
Urgency of Action	PRIORITY 3
Purpose of Action	LEVEL 2

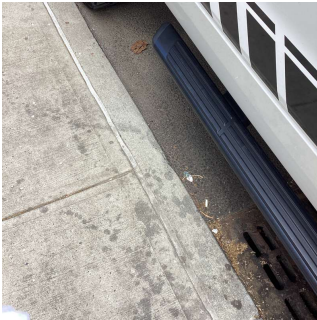
Question	Response
SITE	
PAVING	
DOT Sidewalk	
Concrete	
Condition	3 - Fair
Deficiency	DAMAGED CURBS
Deficiency Location/Instance	94th Street
Deficiency Quantity	10
Quantity Uom	L.F.
Potential Action	REPLACE
Urgency of Action	PRIORITY 3
Purpose of Action	LEVEL 2
Deficiency Photo1

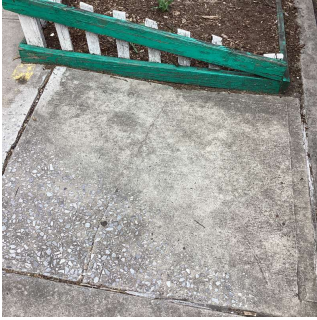
94th Street
Violations	No violations recorded.
Deficiency	DAMAGED/DETERIORATED/MISSING SECTIONS
Deficiency Location/Instance	94th Street, 93rd Street
Deficiency Quantity	250
Quantity Uom	S.F.
Potential Action	REPLACE
Urgency of Action	PRIORITY 3
Purpose of Action	LEVEL 2
Deficiency Photo1

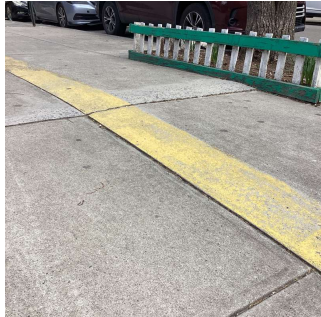
94th Street
Violations	No violations recorded.
Deficiency	HEAVING
Deficiency Location/Instance	94th Street, 93rd Street
Deficiency Quantity	175
Quantity Uom	S.F.
Potential Action	REPLACE
Urgency of Action	PRIORITY 3
Purpose of Action	LEVEL 2
