**NYC Department of Education
Building Condition Assessment Survey 2023 - 2024**

Architectural Inspection

Q287

Asset: P.S. 330 - QUEENS, 110-08 NORTHERN BOULEVARD, New York, 11368

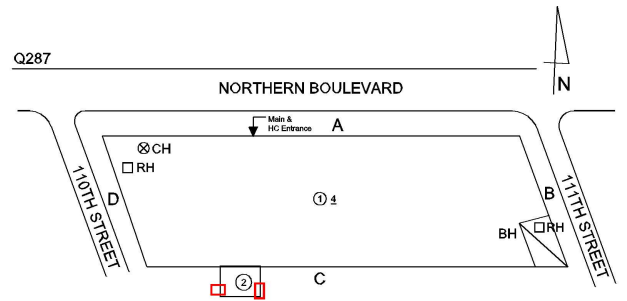
Question	Response
Architectural	
EXTERIOR	Inspected
AREAWAY	Does not Exist
AWNINGS AND CANOPIES	Inspected
Condition	2 - Between Good and Fair
Deficiency	No deficiencies recorded
CHIMNEY	Inspected
Material Type(s)	Metal
Condition	2 - Between Good and Fair
Deficiency	No deficiencies recorded
COPING	Inspected
Condition	3 - Fair
Deficiency	CAST STONE: CRACKED/BROKEN PIECES
Roof Plan reference

15
 L.F.
 REPLACE-IN-KIND
 PRIORITY 4
 LEVEL 2

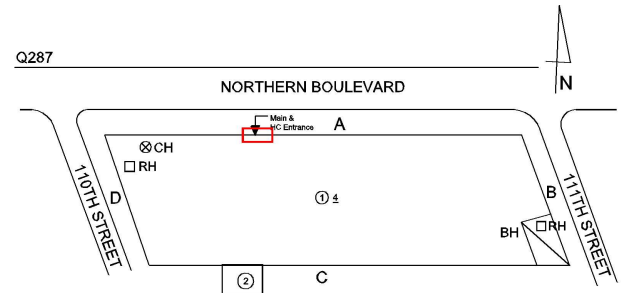
METAL: DENTED, MAJOR RUSTING

REPLACE

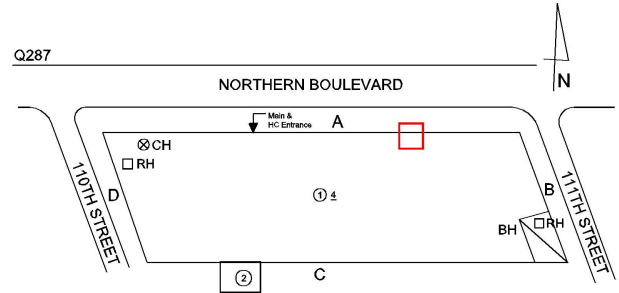
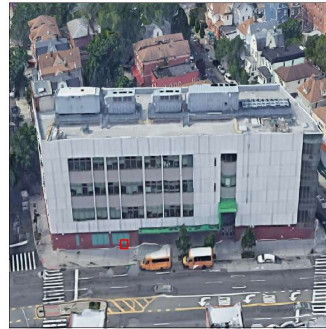
Question	Response
EXTERIOR	
DOORS	Inspected
TRANSOM/SIDE LIGHT	
Violations	No violations recorded.
EXTERIOR WALLS	Inspected
Material Type(s)	Concrete, Masonry
Replacement Quantity	21,000
Replacement Uom	S.F.
Instance on All Facades	Inspected
Instance Condition	3 - Fair
Instance Quantity	21,000
Instance Quantity Uom	S.F.
Deficiency	BRICK: DETERIORATED MASONRY SILLS - MAJOR
Roof Plan reference	 
Elevation	 
Deficiency Quantity	10
Quantity Uom	L.F.
Potential Action	REMOVE AND REPLACE
Urgency of Action	PRIORITY 4
Purpose of Action	LEVEL 2
Deficiency Photo1	 
Violations	Facade A No violations recorded.
Deficiency	BRICK: DETERIORATED MASONRY SILLS - MINOR

REPAIR

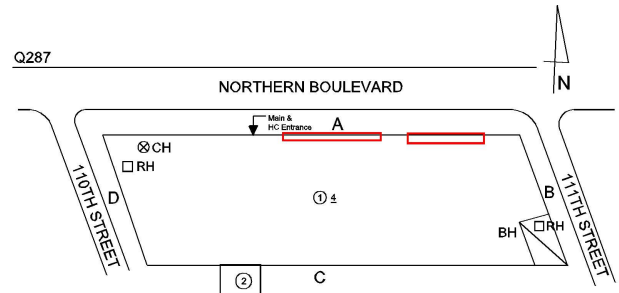
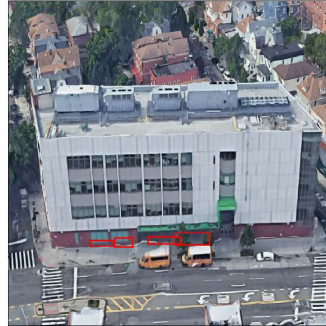
BRICK: MASONRY SILLS - DETERIORATED JOINTS

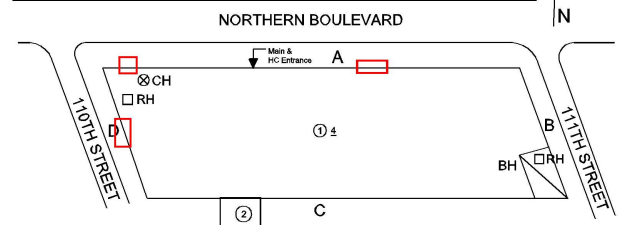
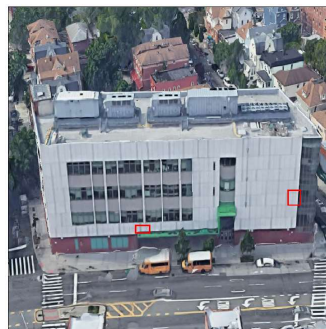
CAST IN PLACE / PRE-CAST CONCRETE: MAJOR
CRACKS/SPALLING

REPLACE

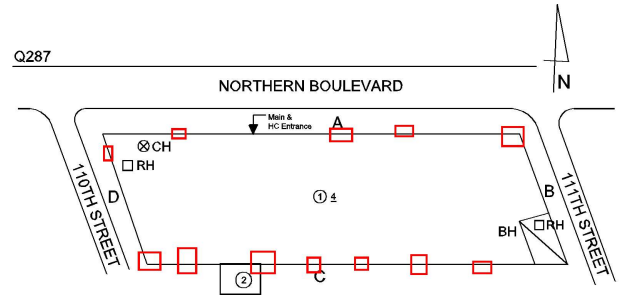
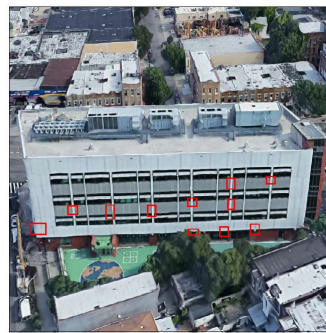
CAST IN PLACE / PRE-CAST CONCRETE: MINOR
CRACKS/SPALLING

270
S.F.
REPAIR
PRIORITY 3
LEVEL 2

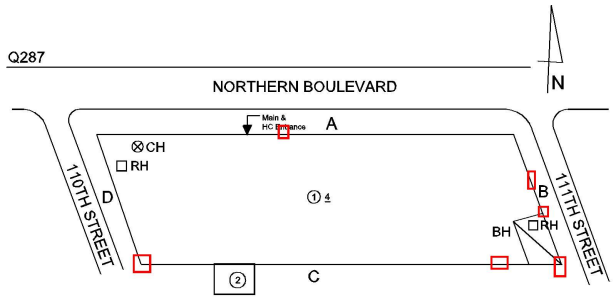
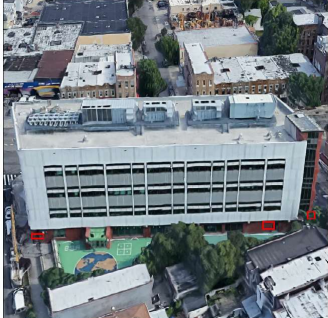
Question	Response
EXTERIOR	
EXTERIOR WALLS	
Deficiency	BRICK: MINOR CRACKS AND SPALLING
Roof Plan reference

Deficiency Quantity	60
Quantity Uom	S.F.
Potential Action	RESTITCH
Urgency of Action	PRIORITY 3
Purpose of Action	LEVEL 2
Deficiency Photo1

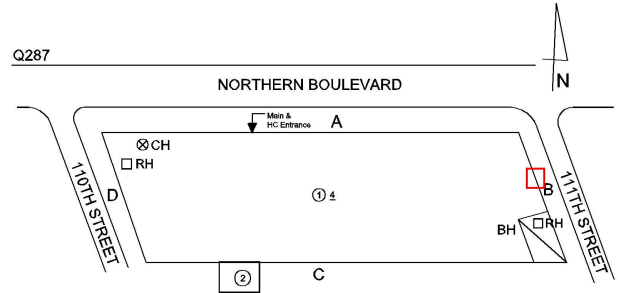
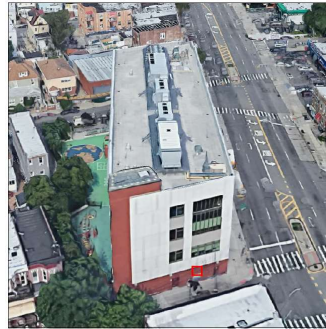
Violations	Facade C No violations recorded.
EXTERIOR SOFFITS	
Condition	Inspected
Deficiency	2 - Between Good and Fair
LOADING DOCK	
Condition	Does not Exist
LOUVER	
Condition	Inspected
Deficiency	3 - Fair BROKEN/ DENTED BLADES

20
 S.F.
 REPLACE
 PRIORITY 4
 LEVEL 2

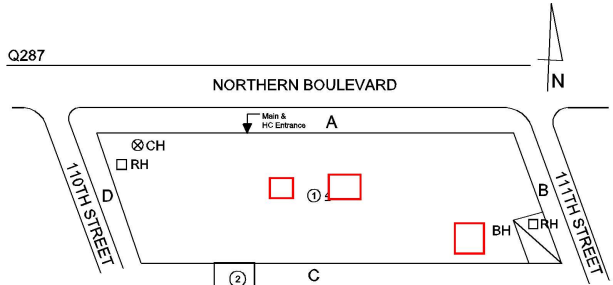
Roof 1
Instance Quantity	13,000
Instance Quantity Uom	S.F.
Does the roof have major mechanical equipment sitting on Dunnage Steel less than 18" above the Roofing?	No
Does this roof instance have a Sustainable Roof System?	No
Do solar panels exist on these roofs?	No
Is/Are the roof(s) suitable for Solar Panel installation?	Yes
Installation Year	2013
Source of Installation	Custodial Staff
Deficiency	IRMA: ROOFING: MAJOR ACTIVE ROOF LEAKS IN INSTRUCTIONAL SPACE
Roof Plan reference

Deficiency Quantity	300
Quantity Uom	S.F.
Potential Action	REPLACE ROOFING WITHOUT MAJOR EQUIPMENT REMOVAL
Urgency of Action	PRIORITY 5
Purpose of Action	LEVEL 2

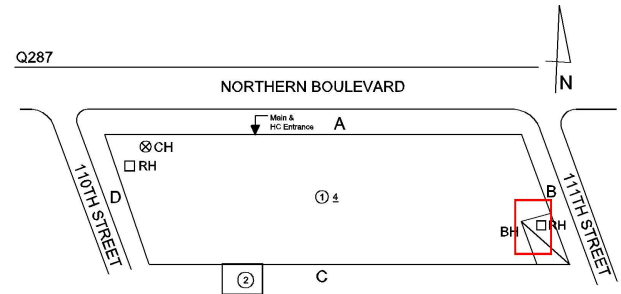
BULKHEAD/PENTHOUSE WALLS/EXTERIOR:
CRACKS/SPALLING - MAJOR

REPLACE

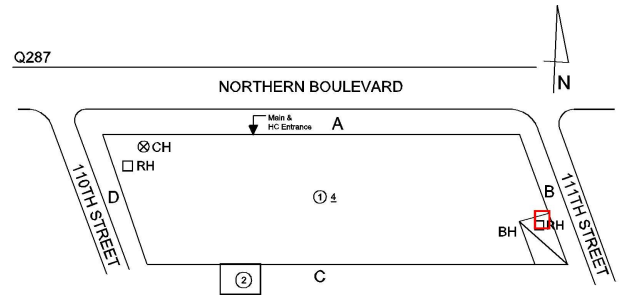
**BULKHEAD/PENTHOUSE WALLS/INTERIOR: CMU
 CRACKS/SPALLING**

15
 S.F.
 REPLACE
 PRIORITY 3
 LEVEL 2

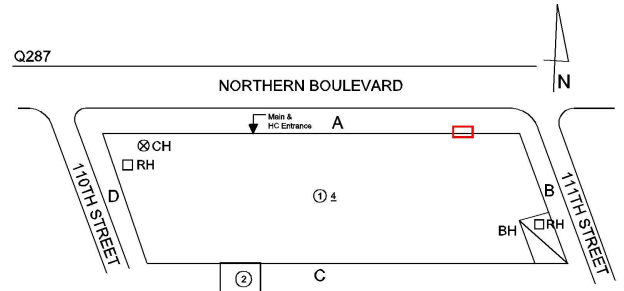
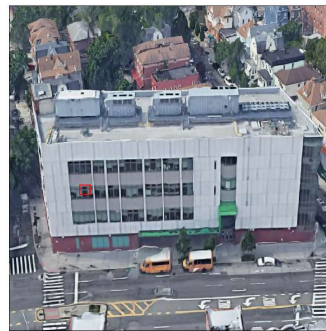
Deficiency	ALUMINUM - OTHER: AIR/WATER INFILTRATION
------------	--

Potential Action	REPLACE TRIM, SILLS OR WEATHERSTRIPPING
------------------	---

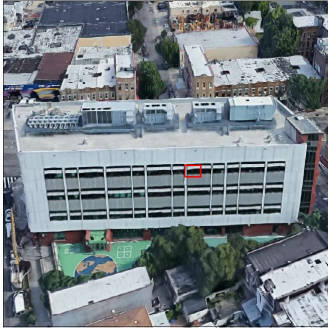
Question	Response
EXTERIOR	
WINDOWS	
WINDOWS	
Deficiency	ALUMINUM - OTHER: BROKEN PANE
Roof Plan reference	 
Elevation

Deficiency Quantity	90
Quantity Uom	S.F.
Potential Action	MAINTENANCE
Urgency of Action	PRIORITY 3
Purpose of Action	LEVEL 2
Deficiency Photo1	 
Violations	<p>Facade C - Room 410 (Facade A - Room 205, Facade D - Room 316 similar)</p> <p>No violations recorded.</p>
INTERIOR	Inspected
POOLS	Does not Exist
STRUCTURAL	Inspected
COLUMNS/BEAMS/BEARING WALLS	Inspected
Condition	3 - Fair
Deficiency	STEEL COLUMNS/BEAMS: DETERIORATED/MISSING SPRAY-ON FIREPROOFING
Deficiency Location/Instance	Basement
Deficiency Quantity	25
Quantity Uom	S.F.
Potential Action	REPLACE
Urgency of Action	PRIORITY 3

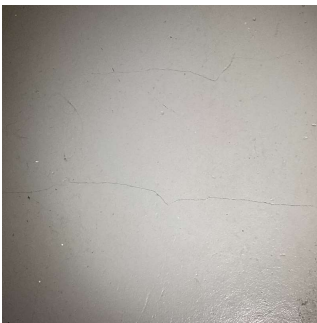
Room C02 (Room C23 similar)
Violations	No violations recorded.
Deficiency	CONCRETE: CRACKS/SPALLED/REINFORCEMENT EXPOSED
Deficiency Location/Instance	2nd, 3rd, 4th Floors
Deficiency Quantity	75
Quantity Uom	S.F.
Potential Action	REPAIR
Urgency of Action	PRIORITY 3
Purpose of Action	LEVEL 5

Violations	Boiler Room (Chiller Room, Room 215 similar) No violations recorded.
FOUNDATION WALLS	Inspected
Material Type(s)	Concrete
Condition	2 - Between Good and Fair
Deficiency	No deficiencies recorded
ROOF STRUCTURE	Inspected
Condition	3 - Fair
Deficiency	STEEL COLUMNS/BEAMS: DETERIORATED/MISSING PLASTER FIREPROOFING
Deficiency Location/Instance	BH
Deficiency Quantity	30
Quantity Uom	S.F.
Potential Action	REPLACE
Urgency of Action	PRIORITY 3
Purpose of Action	LEVEL 5
Deficiency Photo1

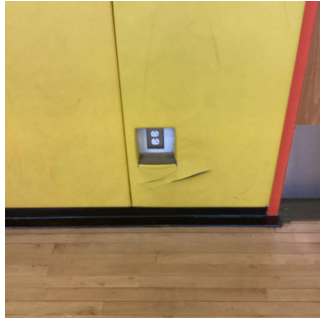
Near Entrance
Violations	No violations recorded.
Window Curtains/Shades/Blinds	Inspected
Instance on Basement	Inspected
Condition	2 - Between Good and Fair
Deficiency	No deficiencies recorded
INTERIOR DOOR HARDWARE	Inspected

Left Side
Violations	No violations recorded.
Stage Curtain Rigging	Inspected
Instance on Basement	Inspected
Condition	2 - Between Good and Fair
Deficiency	No deficiencies recorded
Stage Curtains	Inspected
Instance on Basement	Inspected
Condition	1 - Good
Deficiency	No deficiencies recorded
Walls	
Instance on Basement	Inspected
Condition	2 - Between Good and Fair
Deficiency	WALL PADDING: DETERIORATED
Deficiency Location/Instance	Near Entrance
Deficiency Quantity	20
Quantity Uom	S.F.
Potential Action	REPLACE
Urgency of Action	PRIORITY 3
Purpose of Action	LEVEL 2
Deficiency Photo1

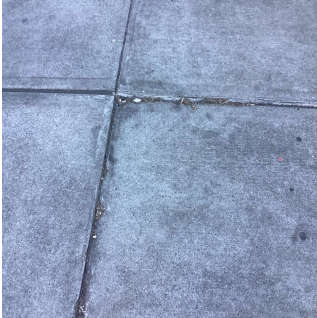
Violations	Northern Boulevard No violations recorded.
Deficiency	DAMAGED/DETERIORATED/MISSING SECTIONS
Deficiency Location/Instance	111th Street , Northern Boulevard, 110th Street

Violations	Schoolyard No violations recorded.
Concrete	Inspected
Condition	2 - Between Good and Fair
Deficiency	No deficiencies recorded
Pavers	Does not Exist
Site Sidewalks & Walkways	Inspected
Asphalt	Does not Exist
Concrete	Inspected
Condition	2 - Between Good and Fair
Deficiency	No deficiencies recorded
Pavers	Does not Exist
DOT Sidewalk	Inspected
Asphalt	Does not Exist
Concrete	Inspected
Condition	3 - Fair
Deficiency	HEAVING
Deficiency Location/Instance	Northern Boulevard
Deficiency Quantity	25
Quantity Uom	S.F.
Potential Action	REPLACE
Urgency of Action	PRIORITY 3
Purpose of Action	LEVEL 2
Deficiency Photo1

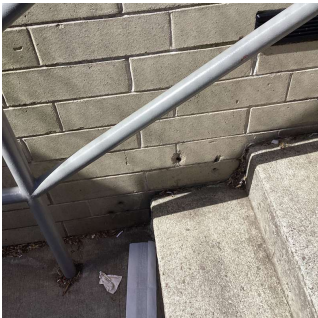
Playground Steps
Violations	No violations recorded.
Stairs/ramps	Inspected
Condition	2 - Between Good and Fair
Deficiency	CAST IN PLACE CONCRETE: CRACKS/SPALLING - MAJOR
Deficiency Location/Instance	Playground Step

Near ramp
Violations	No violations recorded.
SEATING	Does not Exist
SITE WALLS (NOT RETAINING WALLS)	Does not Exist
STAIRS/RAMPS: EXTERIOR	Inspected
Railings	Inspected
Condition	2 - Between Good and Fair
Deficiency	No deficiencies recorded
Site Cheek/flank Walls	Inspected
Condition	2 - Between Good and Fair
Deficiency	BRICK: CRACKS/SPALLING - MAJOR
Deficiency Location/Instance	Playground Steps
Deficiency Quantity	10
Quantity Uom	S.F.
Potential Action	REPLACE
Urgency of Action	PRIORITY 3
Purpose of Action	LEVEL 2
Deficiency Photo1
