NYC Department of Education
Building Condition Assessment Survey 2023 - 2024

Architectural Inspection

Q292

Asset: P.S. 92 - QUEENS, 99-01 34TH AVENUE, New York, 11368

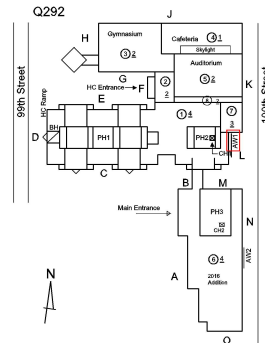
Question	Response
Architectural	
EXTERIOR	Inspected
AREAWAY	Inspected
Instance on AW1 - AW2	Inspected
Instance Condition	3 - Fair
Instance Quantity	2
Instance Quantity Uom	EACH
Deficiency	AREAWAY GRATINGS: MAJOR RUSTING / OR BROKEN
Roof Plan reference	
Deficiency Quantity	20
Quantity Uom	S.F.

Question	Response
EXTERIOR	
AREAWAY	
Potential Action	REPLACE
Urgency of Action	PRIORITY 4
Purpose of Action	LEVEL 2
Deficiency Photo1

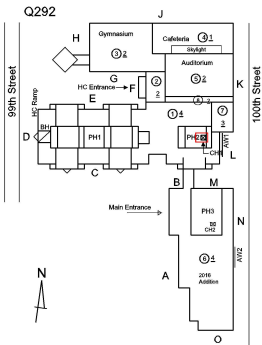
Violations	AW1 No violations recorded.
AWNINGS AND CANOPIES	
	Does not Exist
CHIMNEY	
Material Type(s)	Inspected Metal
Condition	3 - Fair
Deficiency	METAL: DENTS, MAJOR RUSTING
Roof Plan reference

Deficiency Quantity	10
Quantity Uom	S.F.
Potential Action	REPLACE-UPGRADE
Urgency of Action	PRIORITY 4
Purpose of Action	LEVEL 2
Deficiency Photo1

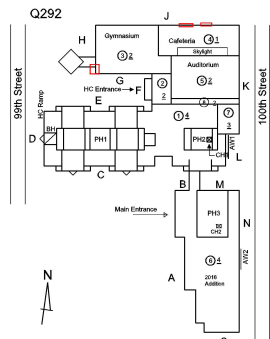
Question	Response
EXTERIOR	
CORNICE	Does not Exist
DOORS	Inspected
DOORS AND FRAMES	Inspected
Condition	5 - Poor
Deficiency	METAL: DETERIORATED DOOR AND FRAME - MINOR DETERIORATION
Roof Plan reference

Deficiency Quantity	6
Quantity Uom	EACH
Potential Action	MAINTENANCE
Urgency of Action	PRIORITY 3
Purpose of Action	LEVEL 2
Deficiency Photo1

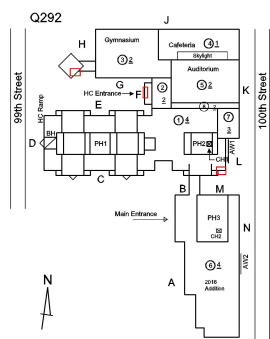
Violations	Facade J - Exit 8 No violations recorded.
Deficiency	METAL: DETERIORATED DOOR AND FRAME - MAJOR DETERIORATION
Roof Plan reference

Deficiency Quantity	8
Quantity Uom	EACH
Potential Action	REPLACE
Urgency of Action	PRIORITY 4
Purpose of Action	LEVEL 2

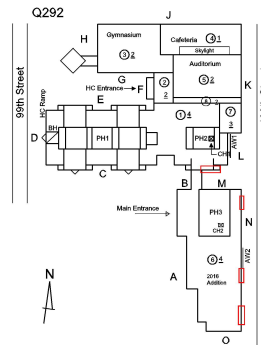
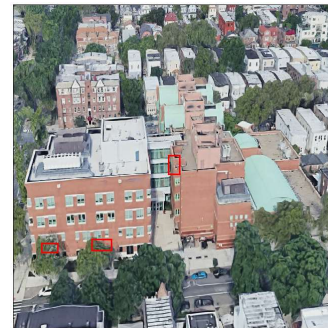
BRICK: EFFLORESCENCE

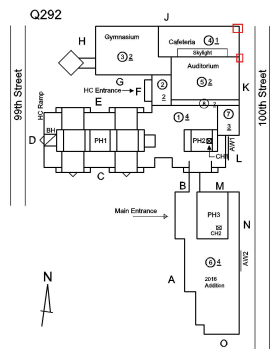
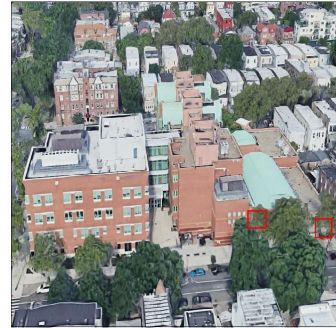
Question	Response
EXTERIOR	
EXTERIOR WALLS	
Violations	No violations recorded.
Deficiency	BRICK: MAJOR / THRU CRACKS
Roof Plan reference

Deficiency Quantity	20
Quantity Uom	S.F.
Potential Action	REMOVE AND REBUILD
Urgency of Action	PRIORITY 4
Purpose of Action	LEVEL 2
Deficiency Photo1

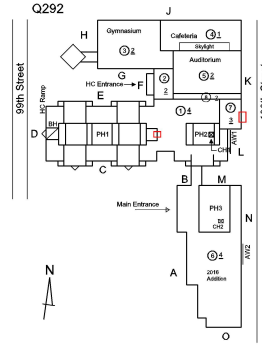
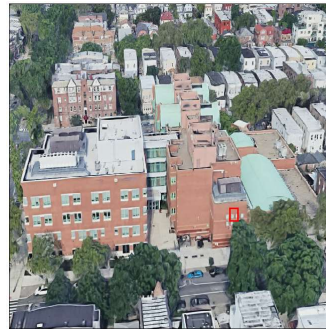
Violations	Facade K No violations recorded.
EXTERIOR SOFFITS	
Condition	Inspected
Deficiency	2 - Between Good and Fair
Deficiency	No deficiencies recorded
LOADING DOCK	
Condition	Does not Exist
LOUVER	
Condition	Inspected
Deficiency	3 - Fair
Deficiency	BROKEN/ DENTED BLADES

REPLACE

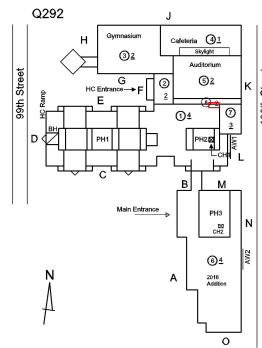
BRICK: MAJOR DETERIORATION/CRACKS

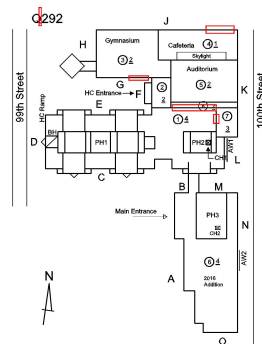
BRICK: EFFLORESCENCE

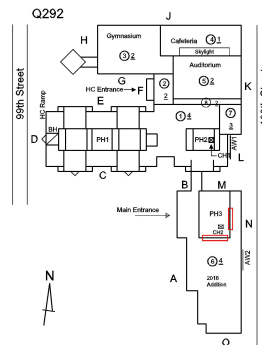
IRMA: FLASHING: CAP FLASHING MISSING

20
L.F.
INSTALL NEW
PRIORITY 4
LEVEL 2

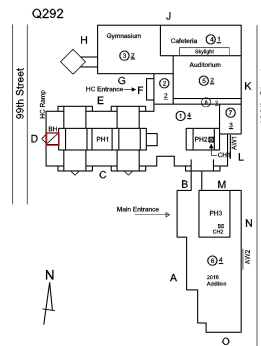
Deficiency **BULKHEAD/PENTHOUSE WALLS/INTERIOR: CMU DETERIORATED JOINTS**

20
S.F.
REPOINT
PRIORITY 3
LEVEL 2

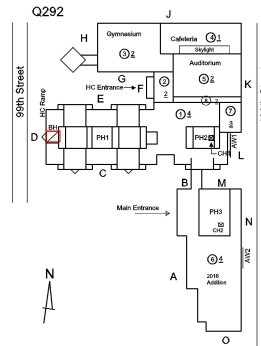
**BULKHEAD/PENTHOUSE WALLS/INTERIOR: CMU
CRACKS/SPALLING**

REPLACE

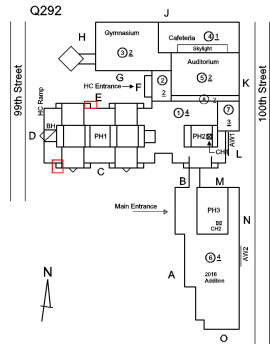
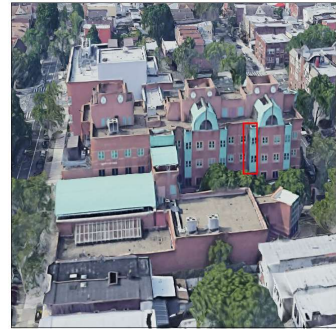
Question	Response
EXTERIOR	
WINDOWS	Inspected
Replacement Quantity	8,200
Replacement Uom	S.F.
EXTERIOR GUARDS	Inspected
Condition	2 - Between Good and Fair
Deficiency	No deficiencies recorded
LINTELS	Inspected
Condition	2 - Between Good and Fair
Deficiency	No deficiencies recorded
WINDOWS	Inspected
Material Type(s)	Aluminum
Instance on Aluminum - Other: 2016 Addition	Inspected
Instance Condition	1 - Good
Instance Quantity	3,100
Instance Quantity Uom	S.F.
Are these windows insulated	Yes
Installation Year	2016
Source of Installation	Custodial Staff
Deficiency	No deficiencies recorded
Instance on Aluminum - Double Hung: All Facades except 2016 Addition	Inspected
Instance Condition	3 - Fair
Instance Quantity	5,100
Instance Quantity Uom	S.F.
Are these windows insulated	Yes
Installation Year	2017
Source of Installation	Custodial Staff
Deficiency	ALUMINUM - DOUBLE HUNG: AIR/WATER INFILTRATION
Roof Plan reference

Deficiency Quantity	40
Quantity Uom	L.F.
Potential Action	REPLACE TRIM, SILLS OR WEATHERSTRIPPING

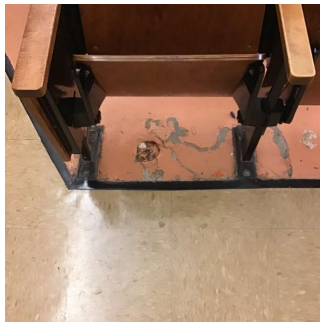
Violations	Seat A/2 No violations recorded.
Floor Finish	
Instance on 2nd Floor (256 Seats)	Inspected
Condition	2 - Between Good and Fair
Deficiency	CONCRETE: CRACKS
Deficiency Location/Instance	Near Stage, Center
Deficiency Quantity	50
Quantity Uom	S.F.
Potential Action	REPLACE
Urgency of Action	PRIORITY 3
Purpose of Action	LEVEL 2
Deficiency Photo1

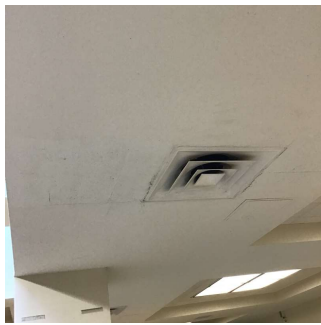
Violations	Rear of Stage No violations recorded.
CAFETERIA	
Instance on 1st Floor	Inspected
Instance on 1st Floor	Inspected
Ceiling	
Instance on 1st Floor	Inspected
Condition	2 - Between Good and Fair
Deficiency	GYPSUM BOARD: DAMAGED/DETERIORATED
Deficiency Location/Instance	Center near Skylight, Near Windows, near Serving area
Deficiency Quantity	40
Quantity Uom	S.F.
Potential Action	REPLACE

Violations	Center near Skylight No violations recorded.
Door(s)	
Instance on 1st Floor	Inspected
Condition	2 - Between Good and Fair
Deficiency	No deficiencies recorded
Fixed Equipment	
Instance on 1st Floor	Does not Exist
Floor Finish	
Instance on 1st Floor	Inspected
Condition	2 - Between Good and Fair
Deficiency	VINYL TILES: BROKEN/DETERIORATED/MISSING TILES
Deficiency Location/Instance	Near Serving area
Deficiency Quantity	10
Quantity Uom	S.F.
Potential Action	REPLACE
Urgency of Action	PRIORITY 3
Purpose of Action	LEVEL 2
Deficiency Photo1

Urgency of Action	PRIORITY 3
Purpose of Action	LEVEL 2

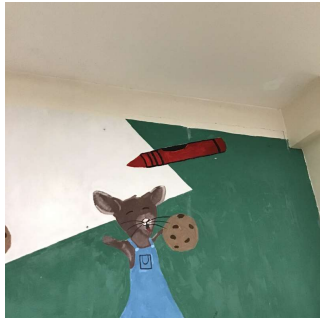
Violations	Near Serving area No violations recorded.
Sliding-folding Partition	
Instance on 1st Floor	Does not Exist
Stage	
Instance on 1st Floor	Does not Exist
Walls	
Instance on 1st Floor	Inspected
Condition	2 - Between Good and Fair
Deficiency	PLASTER: CRACKS/SPALLING
Deficiency Location/Instance	Left Side, Near Windows

Left Side
Violations	No violations recorded.
<hr/>	
Deficiency	GYPSUM BOARD: DETERIORATED
Deficiency Location/Instance	Center near Skylight
Deficiency Quantity	20
Quantity Uom	S.F.
Potential Action	REPLACE
Urgency of Action	PRIORITY 3
Purpose of Action	LEVEL 2
Deficiency Photo1

Question	Response
INTERIOR	
CAFETERIA	
Walls	
Deficiency Quantity	20
Quantity Uom	S.F.
Potential Action	REPLACE
Urgency of Action	PRIORITY 3
Purpose of Action	LEVEL 2
Deficiency Photo1

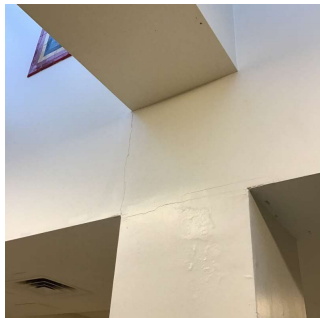
Center near Skylight
Violations	No violations recorded.
<hr/>	
Window Curtains/Shades/Blinds	
Instance on 1st Floor	Does not Exist
<hr/>	
CLASSROOMS/CORRIDORS/ADMIN SPACES	
Ceiling	Inspected
Condition	2 - Between Good and Fair
Deficiency	GYPSUM BOARD: DAMAGED/DETERIORATED - ACTIVE LEAK
Deficiency Location/Instance	Room 404
Deficiency Quantity	20
Quantity Uom	S.F.
Potential Action	REPLACE
Urgency of Action	PRIORITY 5
Purpose of Action	LEVEL 2

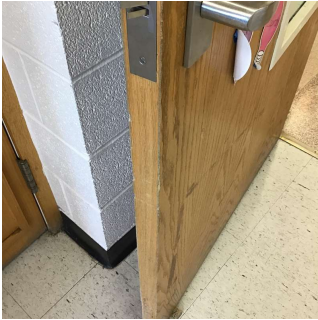
Question	Response
INTERIOR	
CLASSROOMS/CORRIDORS/ADMIN SPACES	
Ceiling	Inspected
Violations	No violations recorded.
Door(s)	Inspected
Condition	3 - Fair
Deficiency	WOOD: DETERIORATED DOOR
Deficiency Location/Instance	Rooms 408, 406
Deficiency Quantity	2
Quantity Uom	EACH
Potential Action	MAINTENANCE
Urgency of Action	PRIORITY 3
Purpose of Action	LEVEL 2
Deficiency Photo1

Violations	Room 408 No violations recorded.
Floor Finish	Inspected
Condition	2 - Between Good and Fair
Deficiency	CERAMIC TILE: BROKEN/MISSING TILES
Deficiency Location/Instance	Corridor near Main Entrance
Deficiency Quantity	10
Quantity Uom	S.F.
Potential Action	REPLACE
Urgency of Action	PRIORITY 3
Purpose of Action	LEVEL 2
Deficiency Photo1

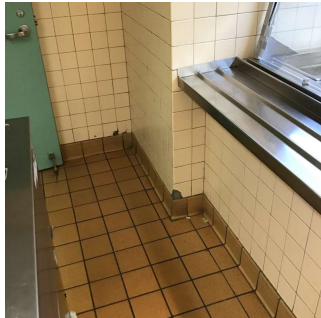
Room 120G
Violations	No violations recorded.
Deficiency	CERAMIC TILE: BROKEN/ MISSING
Deficiency Location/Instance	Serving area, Room 120D, Near Entrance
Deficiency Quantity	30
Quantity Uom	S.F.
Potential Action	REPLACE
Urgency of Action	PRIORITY 3
Purpose of Action	LEVEL 2
Deficiency Photo1

Serving area
Violations	No violations recorded.
LIBRARY	Inspected
Instance on Room 401/402	Inspected
Built-in Furnishing	
Instance on Room 401/402	Does not Exist
Ceiling	
Instance on Room 401/402	Inspected
Condition	3 - Fair
Deficiency	GYPSUM BOARD: DAMAGED/DETERIORATED - ACTIVE LEAK
Deficiency Location/Instance	Near circulation Desk
Deficiency Quantity	20
Quantity Uom	S.F.
Potential Action	REPLACE
Urgency of Action	PRIORITY 5
Purpose of Action	LEVEL 2

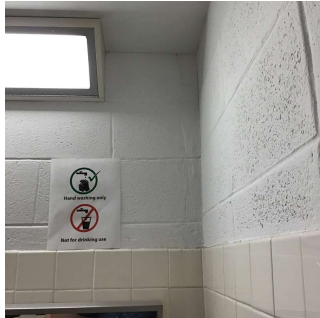
Violations	Room 313 No violations recorded.
Stalls	Inspected
Condition	2 - Between Good and Fair
Deficiency	No deficiencies recorded
Walls	Inspected
Condition	2 - Between Good and Fair
Deficiency	MASONRY: CRACKS/SPALLING
Deficiency Location/Instance	Room 212
Deficiency Quantity	10
Quantity Uom	S.F.
Potential Action	REPLACE
Urgency of Action	PRIORITY 3
Purpose of Action	LEVEL 2
Deficiency Photo1

Violations	Room 212 No violations recorded.
Deficiency	CERAMIC TILE: BROKEN/ MISSING
Deficiency Location/Instance	Rooms 413, 412, 212, 113
Deficiency Quantity	40
Quantity Uom	S.F.
Potential Action	REPLACE
Urgency of Action	PRIORITY 3
Purpose of Action	LEVEL 2

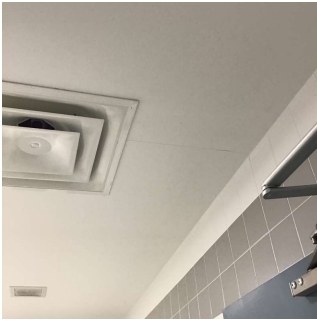
Violations	Room 125 No violations recorded.
Door(s)	Inspected
Condition	4 - Between Fair and Poor
Deficiency	METAL: DAMAGED LOUVER
Deficiency Location/Instance	Rooms 122, 121
Deficiency Quantity	2
Quantity Uom	EACH
Potential Action	MAINTENANCE
Urgency of Action	PRIORITY 3
Purpose of Action	LEVEL 2

Violations	Room 212 No violations recorded.
TOILET ROOMS - STUDENTS	
Ceiling	Inspected
Condition	2 - Between Good and Fair
Deficiency	GYPSUM BOARD: DAMAGED/DETERIORATED
Deficiency Location/Instance	Rooms 414, 314, 125, 124
Deficiency Quantity	40
Quantity Uom	S.F.
Potential Action	REPLACE
Urgency of Action	PRIORITY 3
Purpose of Action	LEVEL 2
Deficiency Photo1

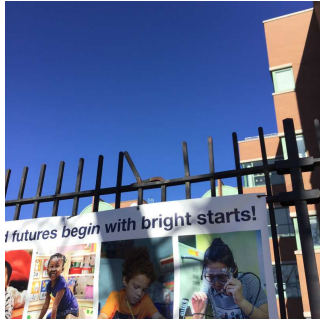
Question	Response
SITE	
Drainage System for Soil	Inspected
Catch Basins/Manhole - Surrounded by Soil	Inspected
Condition	2 - Between Good and Fair
Deficiency	No deficiencies recorded
Culverts - Soil Covering	Does not Exist
DRINKING FOUNTAINS	Does not Exist
FENCES	Inspected
Condition	2 - Between Good and Fair
Deficiency	WROUGHT IRON: DAMAGED/DETERIORATED
Deficiency Location/Instance	34th Avenue
Deficiency Quantity	40
Quantity Uom	S.F.
Potential Action	REPLACE
Urgency of Action	PRIORITY 3
Purpose of Action	LEVEL 2
Deficiency Photo1

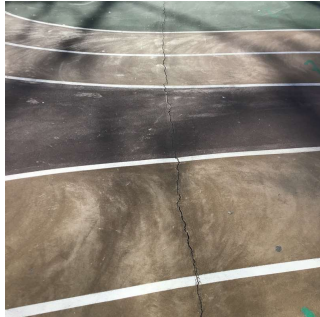
Violations	34th Avenue No violations recorded.
IRRIGATION SYSTEM	Does not Exist
PAVING	Inspected
Student Non-Use	Inspected
Gravel Exists?	No
Asphalt	Does not Exist
Concrete	Inspected
Condition	2 - Between Good and Fair
Deficiency	No deficiencies recorded
Pavers	Does not Exist
Student Use	Inspected
Gravel Exists?	No
Asphalt	Inspected
Condition	4 - Between Fair and Poor
Deficiency	CRACKS - MAJOR

Deficiency Location/Instance	Schoolyard
Deficiency Quantity	1,200
Quantity Uom	S.F.
Potential Action	REPLACE
Urgency of Action	PRIORITY 3
Purpose of Action	LEVEL 2

Question	Response
SITE	
PAVING	
Student Use	
Asphalt	
Deficiency Photo1

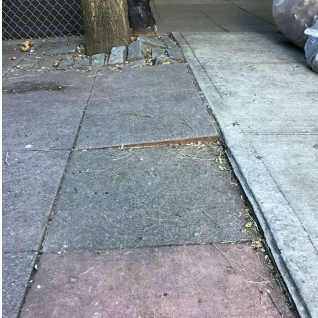
Question	Response
SITE	
PAVING	
Site Sidewalks & Walkways	Inspected
Pavers	
Deficiency Photo1

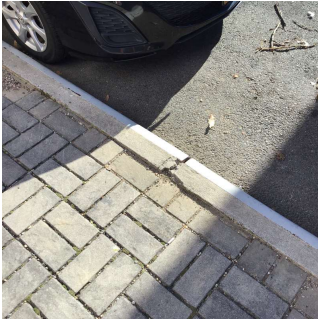
34th Avenue
Violations	No violations recorded.
Deficiency	DAMAGED/DETERIORATED/MISSING SECTIONS
Deficiency Location/Instance	100th Street
Deficiency Quantity	75
Quantity Uom	S.F.
Potential Action	REPLACE
Urgency of Action	PRIORITY 3
Purpose of Action	LEVEL 2

Near 99th Street
Violations	No violations recorded.
DOT Sidewalk	Inspected
Asphalt	Does not Exist
Concrete	Inspected
Condition	3 - Fair
Deficiency	DAMAGED CURBS
Deficiency Location/Instance	34th Avenue
Deficiency Quantity	10
Quantity Uom	L.F.
Potential Action	REPLACE
Urgency of Action	PRIORITY 3
Purpose of Action	LEVEL 2
Deficiency Photo1

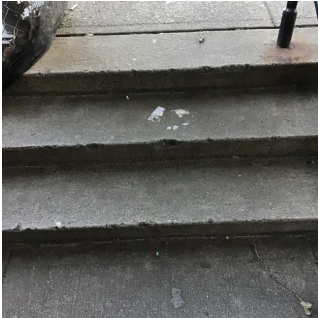
Violations	99th Street No violations recorded.
ARTWORK	
Instance	Inspected Interior - Four Floors - 100031
Instance Photo

Question	Response
SITE	
STAIRS/RAMPS: EXTERIOR	
Site Cheek/flank Walls	Inspected 99th Street
Violations	No violations recorded.
Stairs/ramps	Inspected
Condition	2 - Between Good and Fair
Deficiency	CAST IN PLACE CONCRETE: CRACKS/SPALLING - MAJOR
Deficiency Location/Instance	99th Street
Deficiency Quantity	10
Quantity Uom	S.F.
Potential Action	REPLACE
Urgency of Action	PRIORITY 3
Purpose of Action	LEVEL 2
Deficiency Photo1
