**NYC Department of Education**  
**Building Condition Assessment Survey 2023 - 2024**

Architectural Inspection

**Asset:** P.S. 298 - QUEENS, 50-51 98TH STREET, 11368

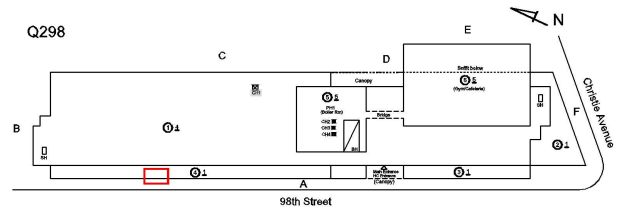
Question	Response
<b>Architectural</b>	
<b>EXTERIOR</b>	Inspected
<b>AREAWAY</b>	Does not Exist
<b>AWNINGS AND CANOPIES</b>	Inspected
Condition	3 - Fair
Deficiency	CONCRETE: MAJOR CRACKS/SPALLING
Roof Plan reference	
Deficiency Quantity	25
Quantity Uom	S.F.
Potential Action	REPAIR
Urgency of Action	PRIORITY 4
Purpose of Action	LEVEL 2
Deficiency Photo1	
Violations	Facade F No violations recorded.
<b>CHIMNEY</b>	Inspected
Material Type(s)	Metal
Condition	2 - Between Good and Fair
Deficiency	No deficiencies recorded
<b>COPING</b>	Inspected
Condition	3 - Fair
Deficiency	CAST STONE: CRACKED/BROKEN PIECES

**COPING**

10  
L.F.  
REPLACE-IN-KIND  
PRIORITY 4  
LEVEL 2

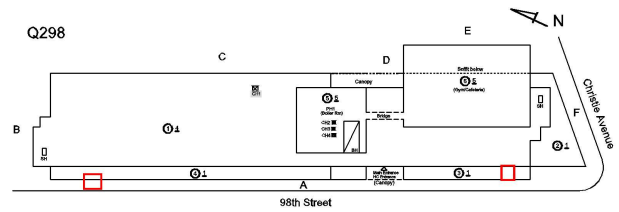
Roof Plan reference

**CAST STONE: DETERIORATED BED JOINT**

20  
L.F.  
REPOINT  
PRIORITY 3  
LEVEL 2

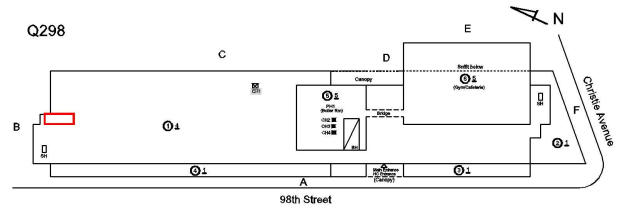
Roof Plan reference

METAL: DETERIORATED DOOR - MINOR DETERIORATION

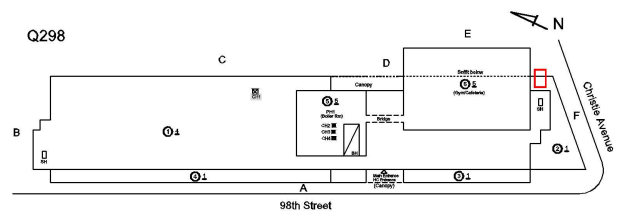
Roof Plan reference

METAL: DETERIORATED DOOR AND FRAME - MAJOR DETERIORATION

REPLACE

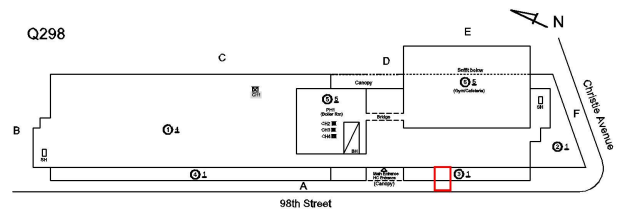
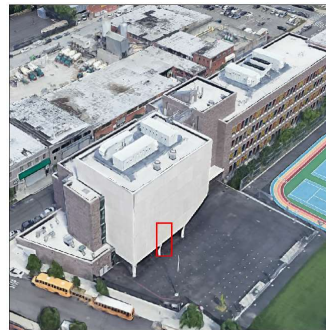
Roof Plan reference

CERAMIC TILE: CHIPPED, SPALLED, BROKEN PIECES

REPLACE

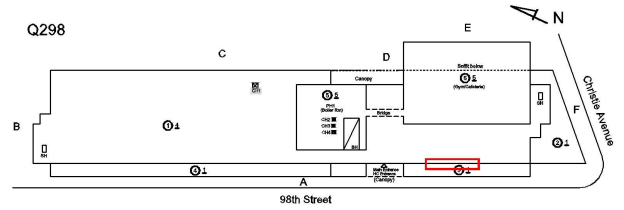
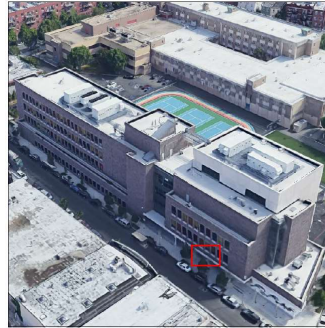
Roof Plan reference

CERAMIC TILE: DETERIORATED JOINTS

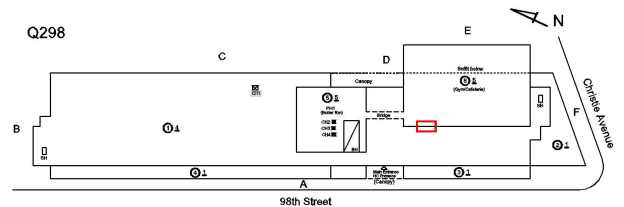
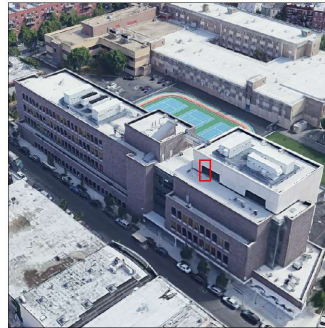
Roof Plan reference

METAL/GLASS CURT WALL: BROKEN GLASS

REPLACE

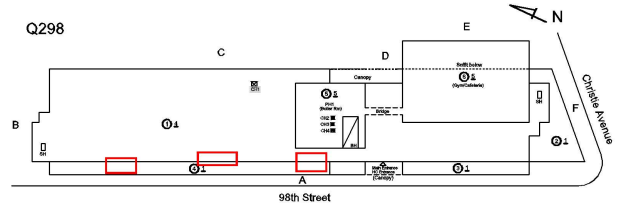
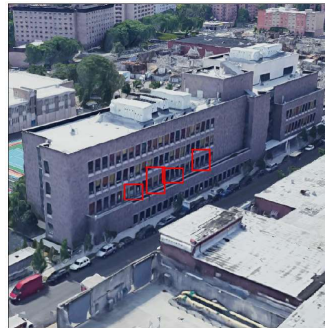
Roof Plan reference

**BRICK: MASONRY SILLS - DETERIORATED JOINTS**

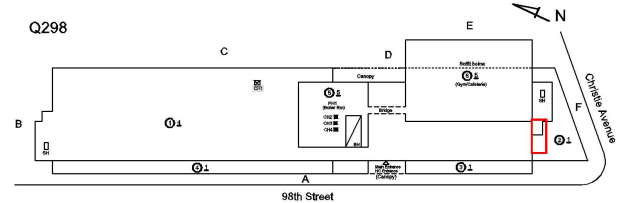
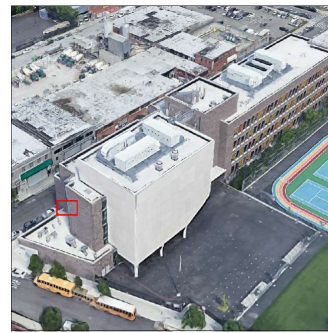
Roof Plan reference

**BRICK: WATER INFILTRATION IN INSTRUCTIONAL SPACE**

REPAIR

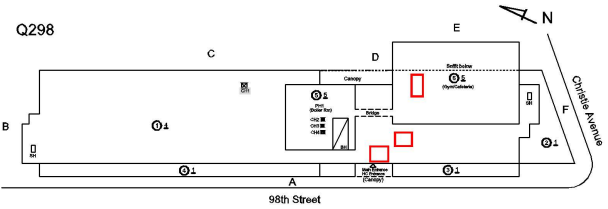
Roof Plan reference

Roof 1
Instance Quantity	32,000
Instance Quantity Uom	S.F.
Does the roof have major mechanical equipment sitting on Dunnage Steel less than 18" above the Roofing?	No
Does this roof instance have a Sustainable Roof System?	No
Do solar panels exist on these roofs?	No
Is/Are the roof(s) suitable for Solar Panel installation?	Yes
Installation Year	2017
Source of Installation	Custodial Staff
Deficiency	IRMA: ROOFING: DETERIORATED PAVERS WITH INTEGRAL INSULATION

REPLACE

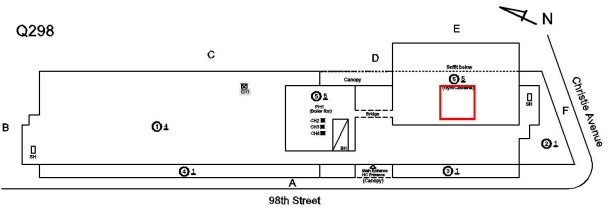
Roof Plan reference

IRMA: ROOFING: MAJOR ACTIVE ROOF LEAKS IN INSTRUCTIONAL SPACE

REPLACE ROOFING WITHOUT MAJOR EQUIPMENT REMOVAL

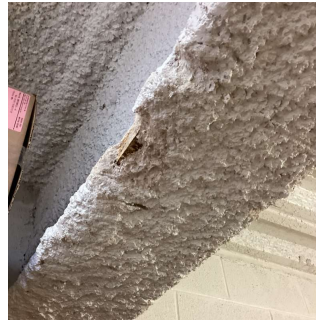
PH1

**COLUMNS/BEAMS/BEARING WALLS**

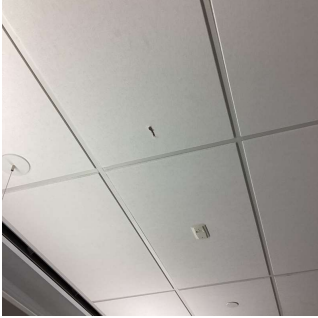
Question	Response
<b>INTERIOR</b>	
<b>CAFETERIA</b>	Inspected
<b>Window Curtains/Shades/Blinds</b>	
Instance on 1st Floor	Does not Exist
<b>CLASSROOMS/CORRIDORS/ADMIN SPACES</b>	Inspected
<b>Ceiling</b>	Inspected
Condition	2 - Between Good and Fair
Deficiency	ACOUSTIC TILES: DAMAGED/MISSING
Deficiency Location/Instance	Room 319, Corridor near Room 317, Main Entrance Lobby
Deficiency Quantity	30
Quantity Uom	S.F.
Potential Action	REPLACE
Urgency of Action	PRIORITY 3
Purpose of Action	LEVEL 2
Deficiency Photo1

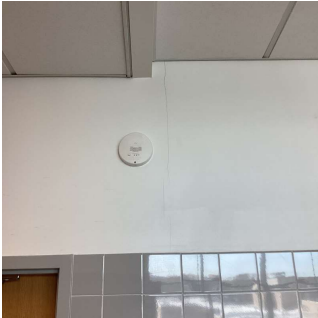
Violations	Room 319 No violations recorded.
<b>Door(s)</b>	Inspected
Condition	2 - Between Good and Fair
Deficiency	No deficiencies recorded
<b>Floor Finish</b>	Inspected
Condition	2 - Between Good and Fair
Deficiency	No deficiencies recorded
<b>Walls</b>	Inspected
Condition	2 - Between Good and Fair
Deficiency	GYPSUM BOARD: DETERIORATED
Deficiency Location/Instance	Corridor near Rooms 457, 404, Corridor near Stairs A/4, C/3

Deficiency Quantity	40
Quantity Uom	S.F.
Potential Action	REPLACE
Urgency of Action	PRIORITY 3
Purpose of Action	LEVEL 2
Deficiency Photo1

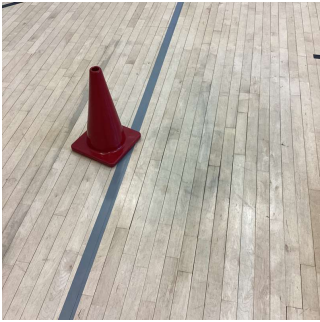
Question	Response
<b>INTERIOR</b>	
<b>CLASSROOMS/CORRIDORS/ADMIN SPACES</b>	Inspected
<b>Walls</b>	Inspected
Violations	No violations recorded.
<b>Specialties</b>	Does not Exist
<b>GYMNASIUM</b>	Inspected
Instance on 4th Floor	Inspected
<b>Ceiling</b>	
Instance on 4th Floor	Does not Exist
<b>Door(s)</b>	
Instance on 4th Floor	Inspected
Condition	2 - Between Good and Fair
Deficiency	No deficiencies recorded
<b>Fixed Equipment</b>	
Instance on 4th Floor	Inspected
Condition	2 - Between Good and Fair
Deficiency	No deficiencies recorded
<b>Floor Finish</b>	
Instance on 4th Floor	Inspected
Condition	2 - Between Good and Fair
Deficiency	WOOD: DAMAGED/DETERIORATED
Deficiency Location/Instance	Center
Deficiency Quantity	20
Quantity Uom	S.F.
Potential Action	REPLACE
Urgency of Action	PRIORITY 3
Purpose of Action	LEVEL 2
Deficiency Photo1

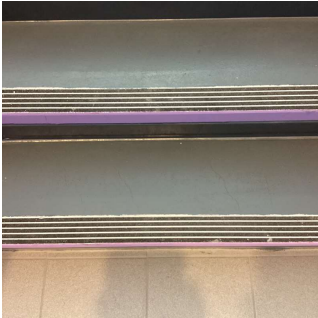
Question	Response
<b>INTERIOR</b>	
<b>STAIRS/RAMPS: INTERIOR</b>	
<b>Railings</b>	Inspected
Condition	2 - Between Good and Fair
Deficiency	No deficiencies recorded
<b>Stairs and Landings</b>	Inspected
Condition	2 - Between Good and Fair
Deficiency	CONCRETE: CRACKS/SPALLING - MAJOR
Deficiency Location/Instance	Stair A/4
Deficiency Quantity	10
Quantity Uom	S.F.
Potential Action	REPLACE
Urgency of Action	PRIORITY 3
Purpose of Action	LEVEL 2
Deficiency Photo1

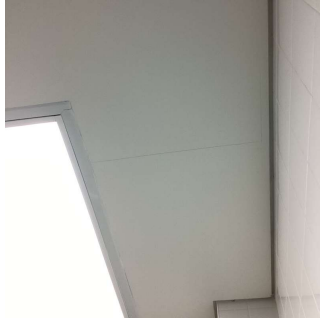
<b>Walls</b>	Inspected
Condition	2 - Between Good and Fair
Deficiency	No deficiencies recorded
<b>TOILET ROOMS - STUDENTS</b>	
<b>Ceiling</b>	Inspected
Condition	2 - Between Good and Fair
Deficiency	GYPSUM BOARD: DAMAGED/DETERIORATED
Deficiency Location/Instance	Rooms 150B, 303
Deficiency Quantity	20
Quantity Uom	S.F.
Potential Action	REPLACE

Question	Response
<b>INTERIOR</b>	
<b>TOILET ROOMS - STUDENTS</b>	
<b>Ceiling</b>	
Urgency of Action	PRIORITY 3
Purpose of Action	LEVEL 2
Deficiency Photo1

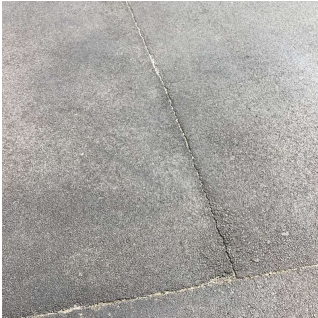
Question	Response
<b>SITE</b>	
<b>FENCES</b>	Inspected
Condition	2 - Between Good and Fair
Deficiency	No deficiencies recorded
<b>IRRIGATION SYSTEM</b>	Does not Exist
<b>PAVING</b>	Inspected
<b>Student Non-Use</b>	Inspected
Gravel Exists?	No
<b>Asphalt</b>	Does not Exist
<b>Concrete</b>	Inspected
Condition	2 - Between Good and Fair
Deficiency	No deficiencies recorded
<b>Pavers</b>	Does not Exist
<b>Student Use</b>	Inspected
Gravel Exists?	No
<b>Asphalt</b>	Inspected
Condition	3 - Fair
Deficiency	CRACKS - MAJOR
Deficiency Location/Instance	Schoolyard
Deficiency Quantity	200
Quantity Uom	S.F.
Potential Action	REPLACE
Urgency of Action	PRIORITY 3
Purpose of Action	LEVEL 2
Deficiency Photo1

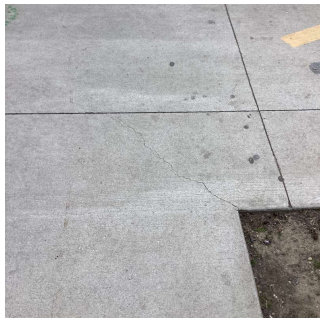
Violations	Exit 5 No violations recorded.
<b>Pavers</b>	Does not Exist
<b>DOT Sidewalk</b>	Inspected
<b>Asphalt</b>	Does not Exist
<b>Concrete</b>	Inspected
Condition	3 - Fair
Deficiency	DAMAGED/DETERIORATED/MISSING SECTIONS
Deficiency Location/Instance	98th Street, Christie Avenue
Deficiency Quantity	200
Quantity Uom	S.F.
Potential Action	REPLACE
Urgency of Action	PRIORITY 3
Purpose of Action	LEVEL 2
Deficiency Photo1

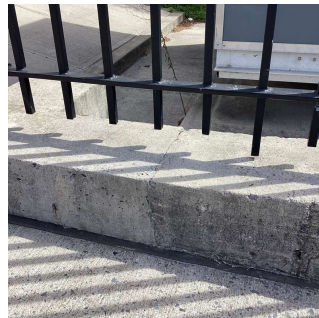
Question	Response
<b>SITE</b>	
<b>RETAINING WALLS</b>	
Urgency of Action	PRIORITY 3
Purpose of Action	LEVEL 2
Deficiency Photo1
