NYC Department of Education
Building Condition Assessment Survey 2023 - 2024

Architectural Inspection

Asset: GABRIELA MISTRAL CAMPUS - QUEENS, 98-11 44TH AVENUE, New York, 11368

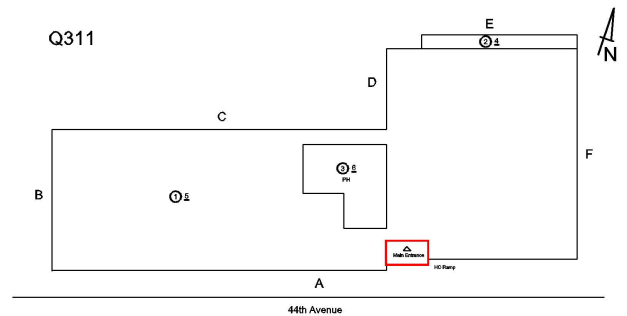
Question	Response
Architectural	
EXTERIOR	Inspected
AREAWAY	Does not Exist
AWNINGS AND CANOPIES	Inspected
Condition	3 - Fair
Deficiency	METAL: WATER PENETRATION
Roof Plan reference

50
S.F.
REPLACE
PRIORITY 5
LEVEL 2

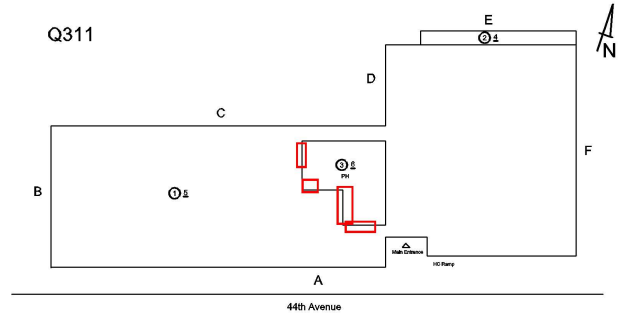
Roof Plan reference

Deficiency	CAST STONE: DETERIORATED TRANSVERSE JOINTS
------------	--

Deficiency Quantity	30
Quantity Uom	L.F.
Potential Action	MAINTENANCE
Urgency of Action	PRIORITY 3
Purpose of Action	LEVEL 2
Deficiency Photo1	No photo recorded
Violations	No violations recorded.

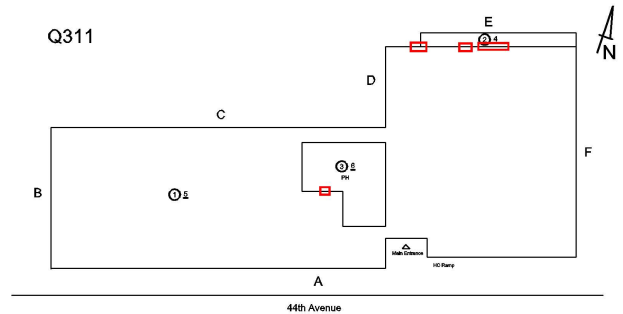
Roof Plan reference

Deficiency	CAST STONE: CRACKED/BROKEN PIECES
------------	-----------------------------------

Deficiency Quantity	20
Quantity Uom	L.F.
Potential Action	REPLACE-IN-KIND
Urgency of Action	PRIORITY 4
Purpose of Action	LEVEL 2

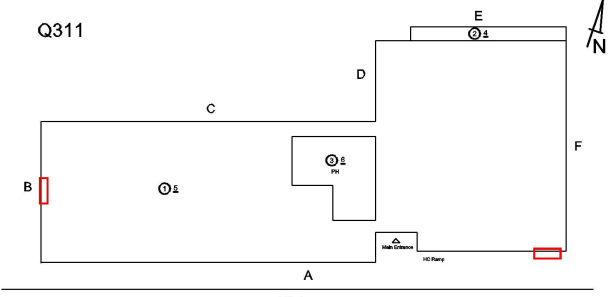
Question	Response
EXTERIOR	
COPING	Inspected
Violations	Roof 1 No violations recorded.
CORNICE	Does not Exist
DOORS	Inspected
DOORS AND FRAMES	Inspected
Condition	3 - Fair
Deficiency	METAL: DETERIORATED DOOR AND FRAME - MINOR DETERIORATION
Roof Plan reference

<p align="center">Q311</p> <p align="center">44th Avenue</p>
Deficiency Quantity	4
Quantity Uom	EACH
Potential Action	MAINTENANCE
Urgency of Action	PRIORITY 3
Purpose of Action	LEVEL 2
Deficiency Photo1

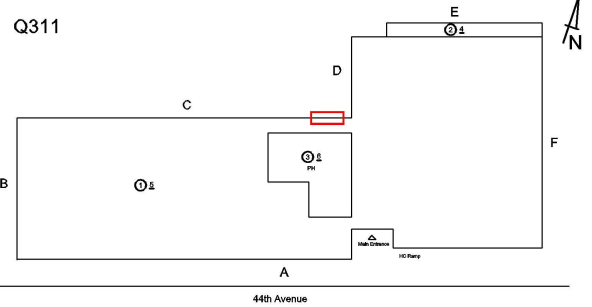
Roof Plan reference

<p align="center">Facade A - Exit 4</p>
Violations	No violations recorded.
DOOR HARDWARE	Inspected
Condition	3 - Fair
Deficiency	No deficiencies recorded
LINTELS	Inspected
Condition	2 - Between Good and Fair
Deficiency	No deficiencies recorded
TRANSOM/SIDE LIGHT	Inspected
Condition	2 - Between Good and Fair
Deficiency	METAL: BROKEN GLASS

Deficiency Quantity	10
Quantity Uom	S.F.
Potential Action	MAINTENANCE
Urgency of Action	PRIORITY 3
Purpose of Action	LEVEL 2
Deficiency Photo	No photo recorded
Violations	No violations recorded.

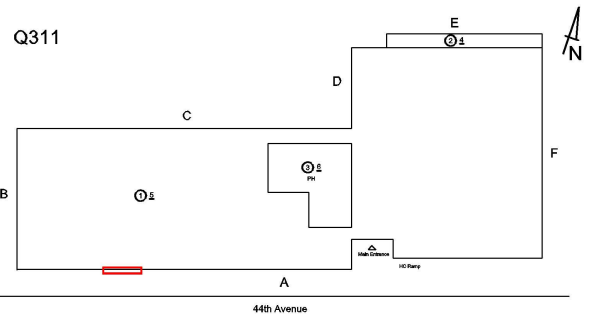
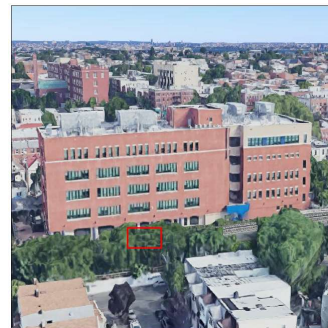
Roof Plan reference

BRICK: DETERIORATED JOINTS

Deficiency Quantity	10
Quantity Uom	S.F.
Potential Action	REPOINT
Urgency of Action	PRIORITY 3

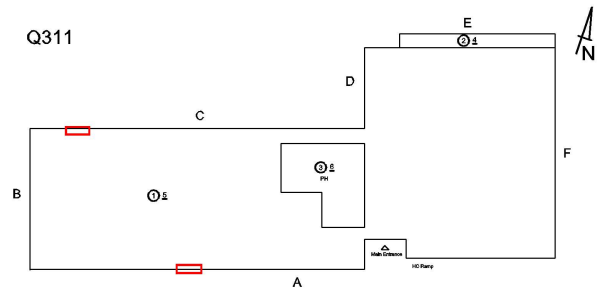
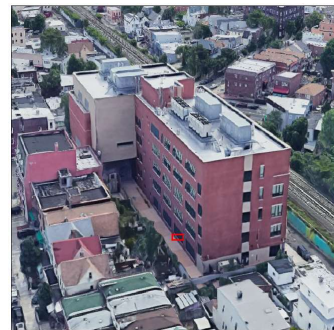
Roof Plan reference

BRICK: DETERIORATED MASONRY SILLS - MINOR

20

REPAIR

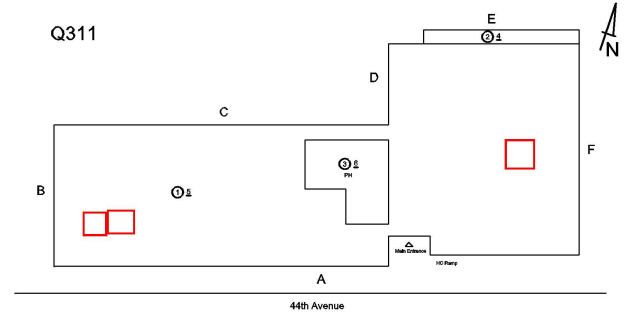
Roof Plan reference

IRMA: ROOFING: MAJOR ACTIVE ROOF LEAKS IN INSTRUCTIONAL SPACE

300

REPLACE ROOFING WITHOUT MAJOR EQUIPMENT REMOVAL

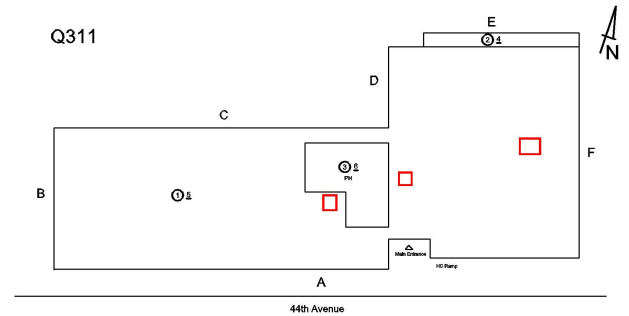
Roof Plan reference

IRMA: ROOFING: DETERIORATED PAVERS WITH INTEGRAL INSULATION

30

REPLACE

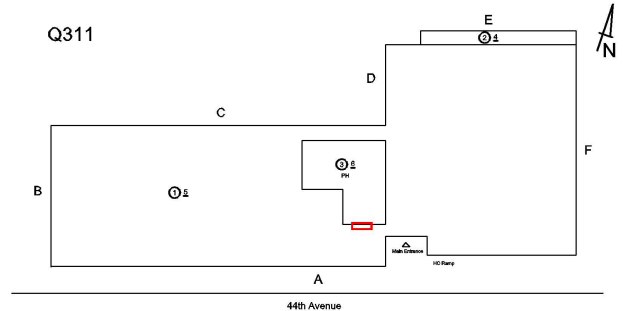
Violations	Roof 1 No violations recorded.
ROOFING DRAINS	Inspected
Condition	2 - Between Good and Fair
Deficiency	No deficiencies recorded
Specialties	Inspected
BULKHEAD/PENTHOUSE	Inspected
Condition	2 - Between Good and Fair
Deficiency	BULKHEAD/PENTHOUSE WALLS/EXTERIOR: EFFLORESCENCE
Roof Plan reference

Deficiency Quantity	10
Quantity Uom	S.F.
Potential Action	MAINTENANCE
Urgency of Action	PRIORITY 1
Purpose of Action	LEVEL 1
Deficiency Photo1	No photo recorded
Violations	No violations recorded.
CUPOLA/ SPIRES/ TOWERS	Does not Exist
DORMER	Does not Exist
DUNNAGE STEEL	Inspected
Condition	2 - Between Good and Fair
Deficiency	No deficiencies recorded
SKYLIGHT/ROOF VENT	Does not Exist
ROOF/GRAVITY TANK	Does not Exist
STAIRS/RAMPS: EXTERIOR	Inspected
BUILDING CHEEK/FLANK WALLS	Inspected
Condition	2 - Between Good and Fair
Deficiency	CAST IN PLACE CONCRETE: CRACKS/SPALLING - MINOR

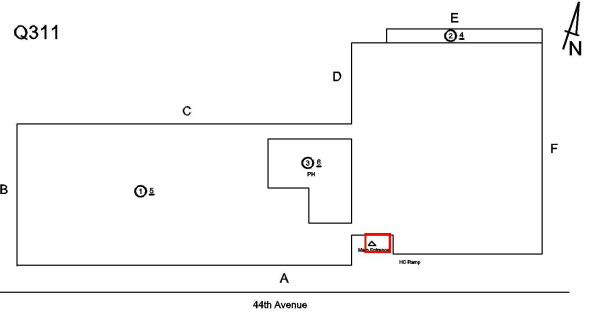
Roof Plan reference

BUILDING CHEEK/FLANK WALLS

10
S.F.
REPAIR
PRIORITY 3
LEVEL 2

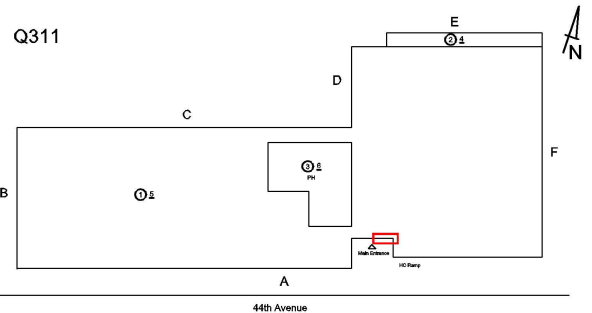
Roof Plan reference

CONCRETE: CRACKS/SPALLING - MINOR

20
S.F.
REPAIR
PRIORITY 3
LEVEL 2

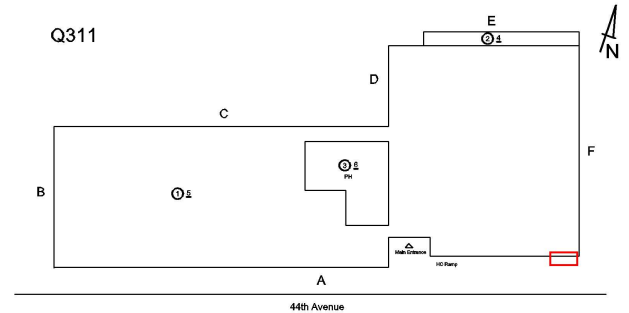
Roof Plan reference

ALUMINUM - OTHER: BROKEN PANE

Question	Response
EXTERIOR	
WINDOWS	
WINDOWS	
Elevation	 
Deficiency Quantity	20
Quantity Uom	S.F.
Potential Action	MAINTENANCE
Urgency of Action	PRIORITY 3
Purpose of Action	LEVEL 2
Deficiency Photo1	 
Violations	Facade A No violations recorded.
INTERIOR	Inspected
POOLS	Does not Exist
STRUCTURAL	Inspected
COLUMNS/BEAMS/BEARING WALLS	Inspected
Condition	2 - Between Good and Fair
Deficiency	No deficiencies recorded
FLOOR STRUCTURE	Inspected
Condition	3 - Fair
Deficiency	CONCRETE SLAB ON GRADE: THRU CRACKS
Deficiency Location/Instance	Basement - Electrical Panel Room, Rooms B02, B04
Deficiency Quantity	50
Quantity Uom	S.F.
Potential Action	REPAIR
Urgency of Action	PRIORITY 3
Purpose of Action	LEVEL 5
