NYC Department of Education
Building Condition Assessment Survey 2023 - 2024

Architectural Inspection

Asset: P.S./I.S. 78 - QUEENS, 46-08 5TH STREET, New York, 11101

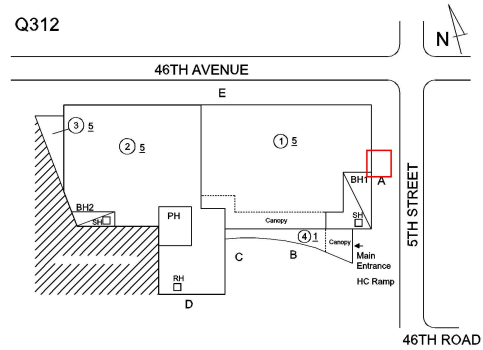
Elevation

BRICK: DETERIORATED MASONRY SILLS - MINOR

10
L.F.
REPAIR
PRIORITY 3
LEVEL 2

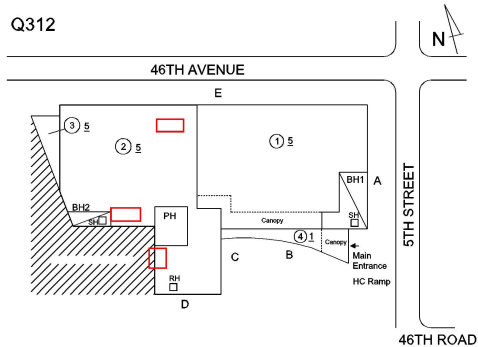
Roof 3
Instance Quantity	400
Instance Quantity Uom	S.F.
Does the roof have major mechanical equipment sitting on Dunnage Steel less than 18" above the Roofing?	No
Does this roof instance have a Sustainable Roof System?	No
Do solar panels exist on these roofs?	No
Is/Are the roof(s) suitable for Solar Panel installation?	No
Installation Year	2023
Source of Installation	Custodial Staff
Deficiency	No deficiencies recorded
ROOFING DRAINS	
Condition	Inspected
Deficiency	5 - Poor
Roof Plan reference	<p>Q312</p>

Deficiency Quantity	3
Quantity Uom	EACH
Potential Action	REPLACE
Urgency of Action	PRIORITY 4
Purpose of Action	LEVEL 2

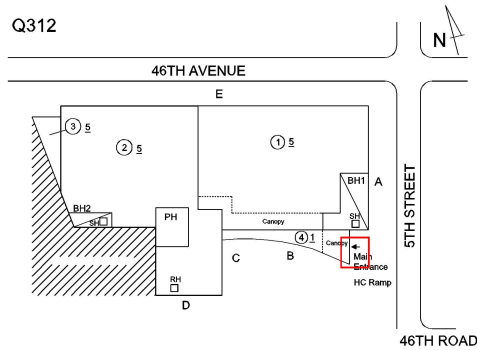
Roof 2
Violations	No violations recorded.
Specialties	Inspected
BULKHEAD/PENTHOUSE	Inspected
Condition	2 - Between Good and Fair
Deficiency	No deficiencies recorded
CUPOLA/ SPIRES/ TOWERS	Does not Exist
DORMER	Does not Exist
DUNNAGE STEEL	Inspected
Condition	2 - Between Good and Fair
Deficiency	No deficiencies recorded
SKYLIGHT/ROOF VENT	Does not Exist
ROOF/GRAVITY TANK	Does not Exist
STAIRS/RAMPS: EXTERIOR	Inspected
BUILDING CHEEK/FLANK WALLS	Inspected
Condition	3 - Fair
Deficiency	CAST IN PLACE CONCRETE: DETERIORATED JOINTS AT COPING STONES
Roof Plan reference	<p>Q312</p>

Deficiency Quantity	10
Quantity Uom	L.F.
Potential Action	MAINTENANCE
Urgency of Action	PRIORITY 3
Purpose of Action	LEVEL 2

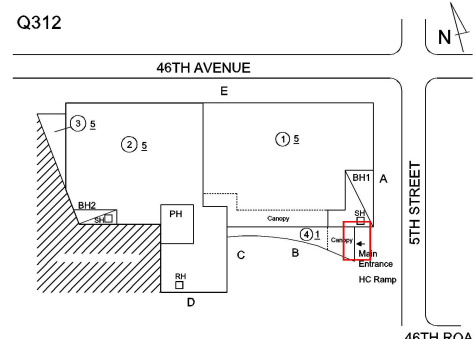
<p>Main Entrance</p> <p>No violations recorded.</p>
<p>Deficiency</p> <p>Roof Plan reference</p> <p>Deficiency Quantity</p> <p>Quantity Uom</p> <p>Potential Action</p> <p>Urgency of Action</p> <p>Purpose of Action</p> <p>Deficiency Photo1</p> <p>Violations</p>	<p>CAST IN PLACE CONCRETE: CRACKS/SPALLING - MINOR</p> <p>Q312</p>

<p>15</p> <p>S.F.</p> <p>REPAIR</p> <p>PRIORITY 3</p> <p>LEVEL 2</p>

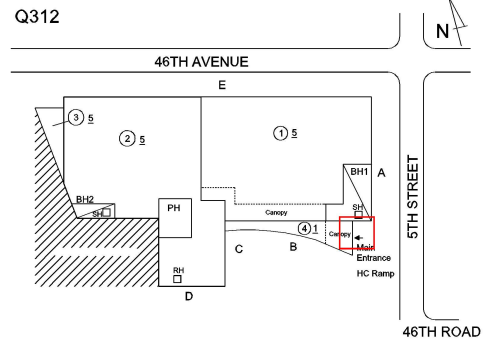
<p>Main Entrance</p> <p>No violations recorded.</p>
RAILINGS	
Condition	Inspected
Deficiency	2 - Between Good and Fair
STAIRS/RAMPS	
Condition	Inspected
Deficiency	3 - Fair
Deficiency	CONCRETE: CRACKS/SPALLING - MINOR

10
S.F.
REPAIR
PRIORITY 3
LEVEL 2

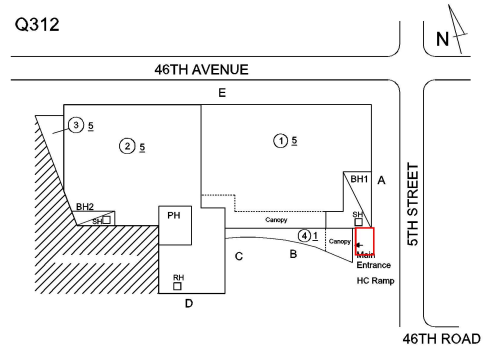
CONCRETE: CRACKS/SPALLING - MAJOR

10
S.F.
REPLACE
PRIORITY 4
LEVEL 2
