NYC Department of Education
Building Condition Assessment Survey 2023 - 2024

Architectural Inspection

Asset: THE WALTER MCCAFFREY CAMPUS - QUEENS, 45-45 42ND STREET, New York, 11104

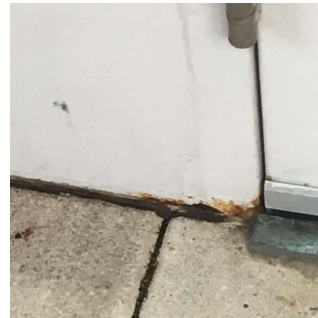
METAL: DENTED, MAJOR RUSTING

REPLACE

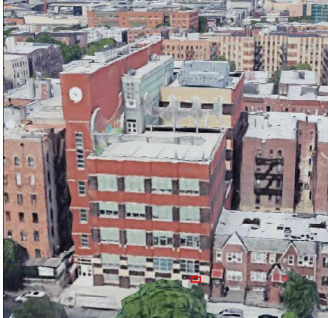
Question	Response
EXTERIOR	
DOORS	Inspected
TRANSOM/SIDE LIGHT	
Violations	Facade A No violations recorded.
EXTERIOR WALLS	Inspected
Material Type(s)	Masonry, Steel
Replacement Quantity	45,000
Replacement Uom	S.F.
Instance on All Facades except Facade G	Inspected
Instance Condition	2 - Between Good and Fair
Instance Quantity	42,000
Instance Quantity Uom	S.F.
Deficiency	BRICK: DETERIORATED MASONRY SILLS - MINOR
Roof Plan reference	<p align="center">Q313</p>

Deficiency Quantity	10
Quantity Uom	L.F.
Potential Action	REPAIR
Urgency of Action	PRIORITY 3
Purpose of Action	LEVEL 2
Deficiency Photo1

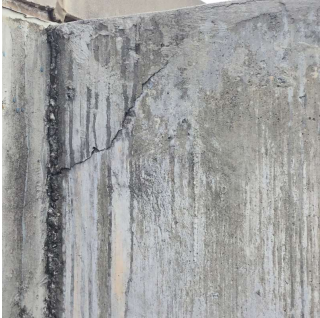
Question	Response
EXTERIOR	
WINDOWS	
WINDOWS	
Are these windows insulated	Yes
Installation Year	2014
Source of Installation	Custodial Staff
Deficiency	No deficiencies recorded
INTERIOR	Inspected
POOLS	Does not Exist
STRUCTURAL	Inspected
COLUMNS/BEAMS/BEARING WALLS	Inspected
Condition	2 - Between Good and Fair
Deficiency	CONCRETE COLUMNS/BEAMS: CRACKED/SPALLED/REINFORCEMENT EXPOSED
Deficiency Location/Instance	PH
Deficiency Quantity	15
Quantity Uom	S.F.
Potential Action	REPAIR
Urgency of Action	PRIORITY 3
Purpose of Action	LEVEL 5
Deficiency Photo1

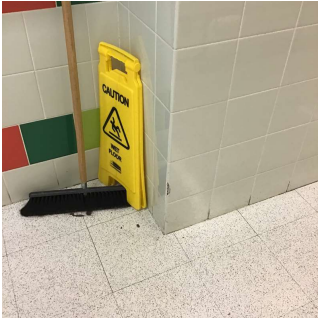
Question	Response
INTERIOR	
CAFETERIA	
Floor Finish	
Instance on 1st Floor	Inspected
Condition	2 - Between Good and Fair
Deficiency	No deficiencies recorded
Sliding-folding Partition	
Instance on 1st Floor	Does not Exist
Stage	
Instance on 1st Floor	Does not Exist
Walls	
Instance on 1st Floor	Inspected
Condition	2 - Between Good and Fair
Deficiency	CERAMIC TILE: BROKEN/ MISSING
Deficiency Location/Instance	Near Exit Stair B/1
Deficiency Quantity	10
Quantity Uom	S.F.
Potential Action	REPLACE
Urgency of Action	PRIORITY 3
Purpose of Action	LEVEL 2
Deficiency Photo1

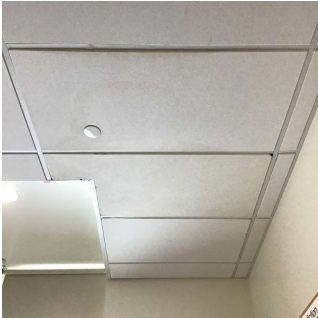
Violations	Near Sink No violations recorded.
LIBRARY	Inspected
Instance on Room 503	Inspected
Built-in Furnishing	
Instance on Room 503	Does not Exist
Ceiling	
Instance on Room 503	Inspected
Condition	3 - Fair
Deficiency	ACOUSTIC TILES: DAMAGED/MISSING - ACTIVE LEAK
Deficiency Location/Instance	Near Windows Right Side, Center
Deficiency Quantity	40
Quantity Uom	S.F.
Potential Action	REPLACE
Urgency of Action	PRIORITY 5
Purpose of Action	LEVEL 2
Deficiency Photo1

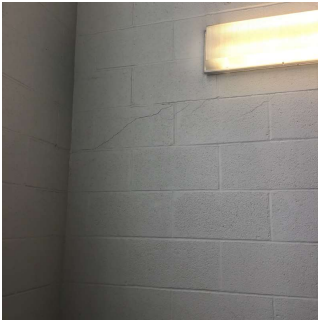
Question	Response
INTERIOR	
STAIRS/RAMPS: INTERIOR	
Walls	
Deficiency Photo1

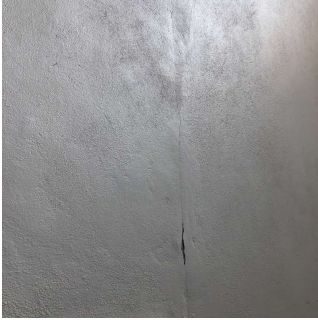
Violations	Stair B/5 No violations recorded.
Deficiency	PLASTER: CRACKS/SPALLING
Deficiency Location/Instance	Stair C/Basement , 1
Deficiency Quantity	30
Quantity Uom	S.F.
Potential Action	REPLACE
Urgency of Action	PRIORITY 3
Purpose of Action	LEVEL 2
Deficiency Photo1

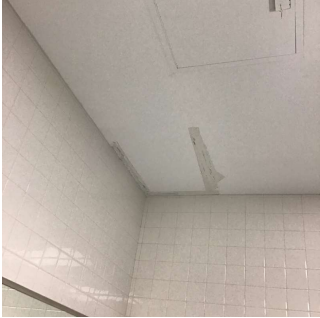
Violations	Stair C/Cellar No violations recorded.
TOILET ROOMS - STAFF	
	Inspected
Ceiling	Inspected
Condition	4 - Between Fair and Poor
Deficiency	GYPSUM BOARD: DAMAGED/DETERIORATED
Deficiency Location/Instance	Rooms C027, C028, 506
Deficiency Quantity	50
Quantity Uom	S.F.
Potential Action	REPLACE
Urgency of Action	PRIORITY 3
Purpose of Action	LEVEL 2

Question	Response
INTERIOR	
TOILET ROOMS - STUDENTS	
Ceiling	
Potential Action	REPLACE
Urgency of Action	PRIORITY 3
Purpose of Action	LEVEL 2
Deficiency Photo1
