**NYC Department of Education**  
**Building Condition Assessment Survey 2023 - 2024**

Architectural Inspection

Q315

**Asset: THE TIFFANY SCHOOL, 43-18 97TH PLACE, New York, 11368**

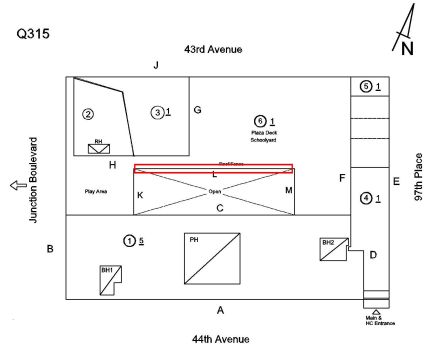
Roof Plan reference

Question	Response
<b>Architectural</b>	
<b>EXTERIOR</b>	Inspected
<b>AREAWAY</b>	Does not Exist
<b>AWNINGS AND CANOPIES</b>	Inspected
Condition	2 - Between Good and Fair
Deficiency	No deficiencies recorded
<b>CHIMNEY</b>	Inspected
Material Type(s)	Metal
Condition	2 - Between Good and Fair
Deficiency	No deficiencies recorded
<b>COPING</b>	Inspected
Condition	3 - Fair
Deficiency	CAST STONE: DETERIORATED BED JOINT

50  
L.F.  
REPOINT  
PRIORITY 3  
LEVEL 2

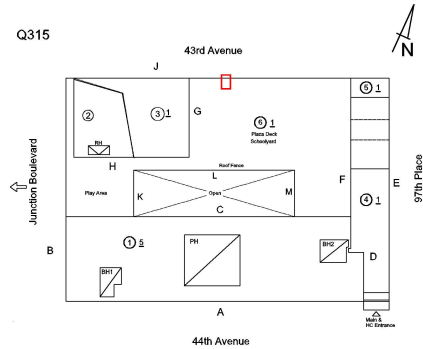
Roof Plan reference

**CAST STONE: DETERIORATED TRANSVERSE JOINTS**

10  
L.F.  
MAINTENANCE  
PRIORITY 3  
LEVEL 2

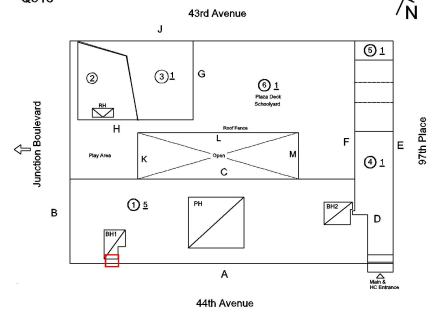
**CAST STONE: DETERIORATED FLASHING**

REPLACE

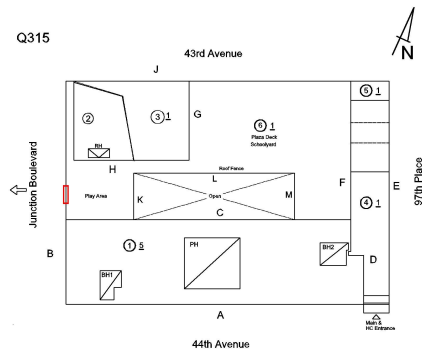
Roof Plan reference

**METAL: DETERIORATED DOOR AND FRAME - MINOR DETERIORATION**

2  
EACH  
MAINTENANCE  
PRIORITY 3  
LEVEL 2

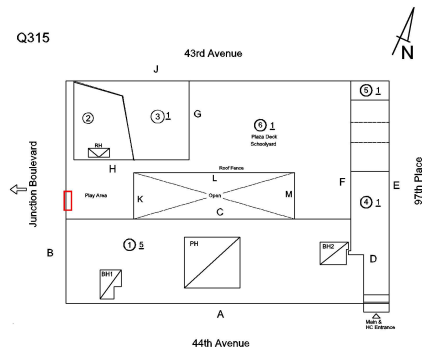
Roof Plan reference

METAL: DENTED, MAJOR RUSTING

10  
S.F.  
REPLACE

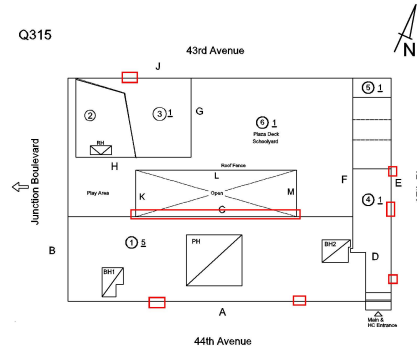
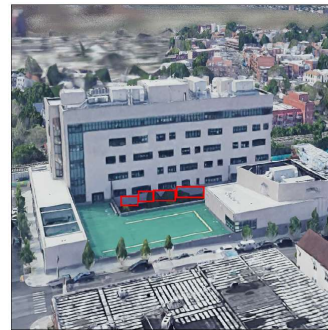
Roof Plan reference

**CAST IN PLACE / PRE-CAST CONCRETE: DETERIORATED JOINTS**

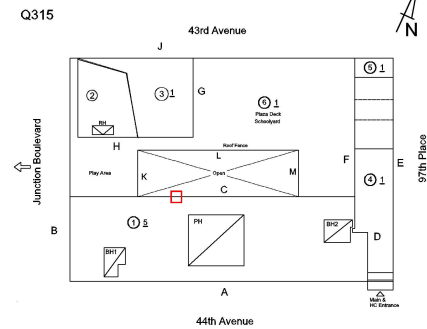
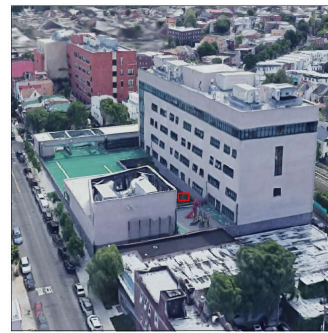
Roof Plan reference

**BRICK: MASONRY SILLS - DETERIORATED JOINTS**

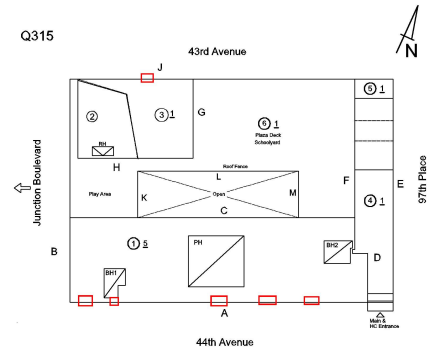
Roof Plan reference

**CAST IN PLACE / PRE-CAST CONCRETE: MINOR CRACKS/SPALLING**

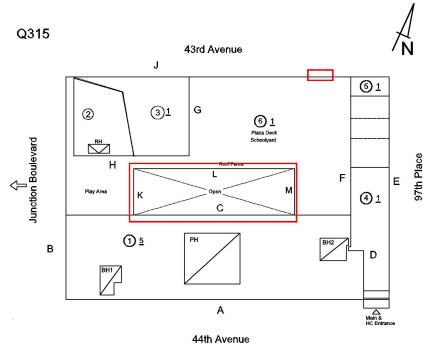
Roof Plan reference

**PARAPETS**

40  
S.F.  
REPOINT  
PRIORITY 3  
LEVEL 2

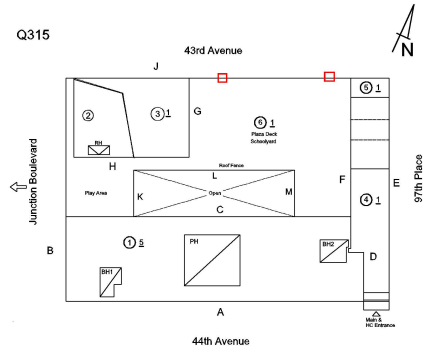
Roof Plan reference

**CONCRETE MASONRY UNITS: MINOR CRACKS, SPALLING**

20  
S.F.  
REPAIR  
PRIORITY 3  
LEVEL 2

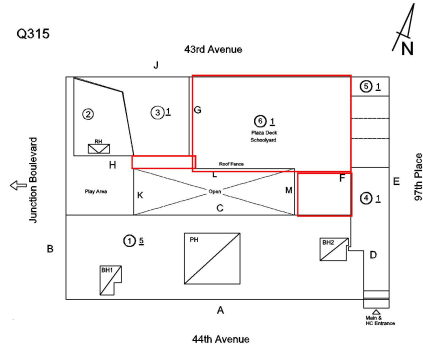
Question	Response
<b>EXTERIOR</b>	
<b>PARAPETS</b>	
Deficiency Photo1	 
Violations	Roof 6 No violations recorded.
<b>PLAZA DECK</b>	Inspected
Instance on Concrete: Roof 6	Inspected
Instance Condition	3 - Fair
Instance Quantity	17,000
Instance Quantity Uom	S.F.
Installation Year	2015
Source of Installation	Custodial Staff
Deficiency	<b>CONCRETE: MAJOR CRACKS</b>
Roof Plan reference	<p>Q315</p>  
Deficiency Quantity	30
Quantity Uom	S.F.
Potential Action	REPLACE
Urgency of Action	PRIORITY 4
Purpose of Action	LEVEL 2
Deficiency Photo1	 
Violations	Roof 6 No violations recorded.
Deficiency	<b>CONCRETE: MINOR CRACKS</b>

2,000  
S.F.  
REPAIR  
PRIORITY 3  
LEVEL 2

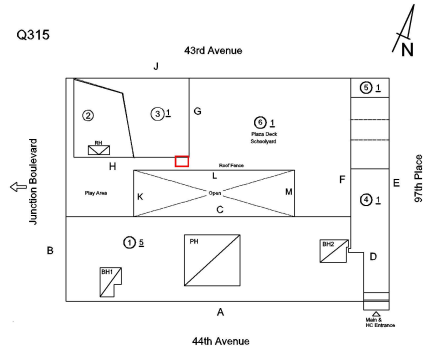
Roof Plan reference

Yes	Potential Falling Debris	Deteriorated concrete plaza deck is a potential tripping hazard.	EXTERIOR   PLAZA DECK	Walkway between playground and schoolyard	Demetrios Piatos	Fireman
-----	--------------------------	--	-----------------------	---	------------------	---------

**CONCRETE: MAJOR CRACKS**

10  
S.F.  
REPLACE  
PRIORITY 5  
LEVEL 6

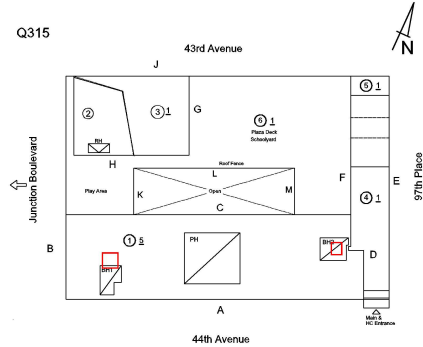
Roof Plan reference

Is/Are the roof(s) suitable for Solar Panel installation?	No
Installation Year	2015
Source of Installation	Custodial Staff
Deficiency	IRMA: ROOFING: DETERIORATED PAVERS WITH INTEGRAL INSULATION

20  
S.F.  
REPLACE  
PRIORITY 4  
LEVEL 2

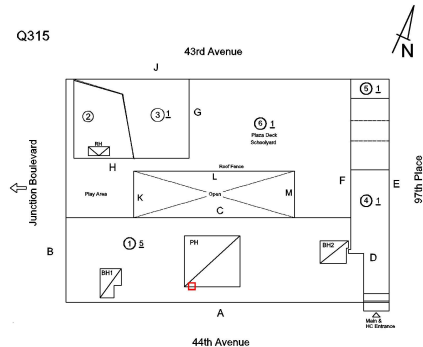
Roof Plan reference

BULKHEAD/PENTHOUSE WALLS/EXTERIOR:  
CRACKS/SPALLING - MINOR

10  
S.F.  
REPAIR

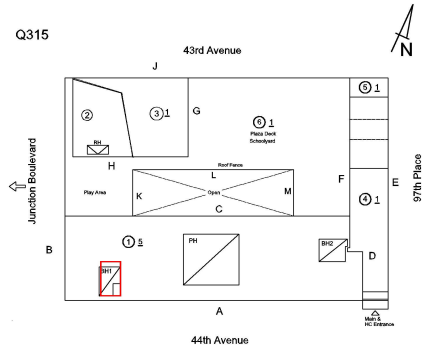
Question	Response
<b>EXTERIOR</b>	
<b>ROOF</b>	
<b>Specialties</b>	
<b>BULKHEAD/PENTHOUSE</b>	
Urgency of Action	PRIORITY 3
Purpose of Action	LEVEL 2
Deficiency Photo1	 
Violations	PH No violations recorded.
Deficiency	BULKHEAD/PENTHOUSE WALLS/INTERIOR: CMU CRACKS/SPALLING
Roof Plan reference	Q315

Deficiency Quantity	40
Quantity Uom	S.F.
Potential Action	REPLACE
Urgency of Action	PRIORITY 3
Purpose of Action	LEVEL 2
Deficiency Photo1

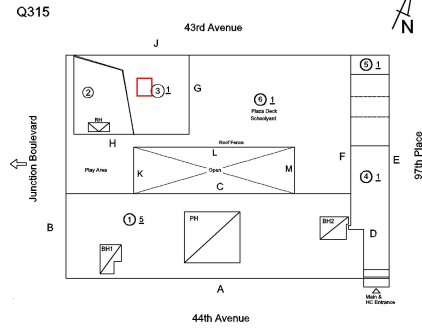
Roof Plan reference

Violations	BH1 No violations recorded.
<b>CUPOLA/ SPIRES/ TOWERS</b>	Does not Exist
<b>DORMER</b>	Does not Exist
<b>DUNNAGE STEEL</b>	Inspected
Condition	2 - Between Good and Fair
Deficiency	HEIGHT LESS THAN 18"

20  
L.F.  
REPLACE  
PRIORITY 3  
LEVEL 2

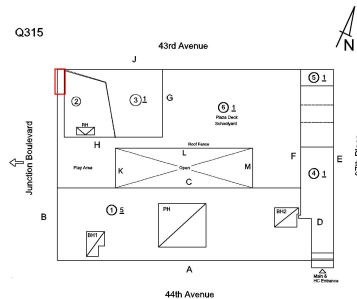
Roof Plan reference

MASONRY UNIT: CRACKS/SPALLING - MINOR

20  
S.F.  
REPAIR  
PRIORITY 3

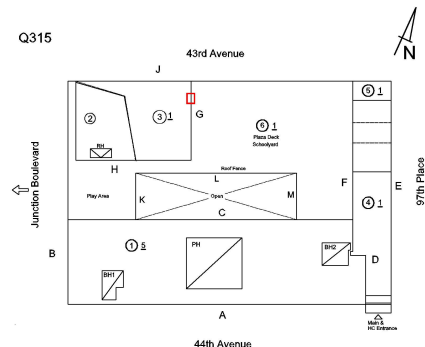
Roof Plan reference

ALUMINUM - OTHER: BROKEN PANE

Question	Response
<b>EXTERIOR</b>	
<b>WINDOWS</b>	
<b>WINDOWS</b>	
Elevation	 
Deficiency Quantity	20
Quantity Uom	S.F.
Potential Action	MAINTENANCE
Urgency of Action	PRIORITY 3
Purpose of Action	LEVEL 2
Deficiency Photo1	 
Violations	Facade G - 1st Floor No violations recorded.
<b>INTERIOR</b>	Inspected
<b>POOLS</b>	Does not Exist
<b>STRUCTURAL</b>	Inspected
<b>COLUMNS/BEAMS/BEARING WALLS</b>	Inspected
Condition	2 - Between Good and Fair
Deficiency	No deficiencies recorded
<b>FLOOR STRUCTURE</b>	Inspected
Condition	3 - Fair
Deficiency	CONCRETE: CRACKS/SPALLED/REINFORCEMENT EXPOSED
Deficiency Location/Instance	Roof 1 - EMR, Ground Floor - Corridor near Mechanical Rooms, Rooms G16A, G16C, G16F
Deficiency Quantity	60
Quantity Uom	S.F.
Potential Action	REPAIR
Urgency of Action	PRIORITY 3
Purpose of Action	LEVEL 5

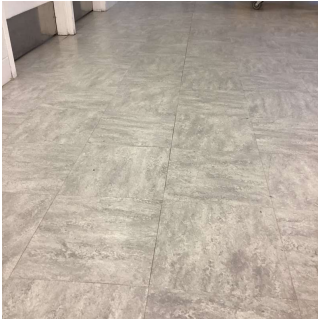
Question	Response
<b>INTERIOR</b>	
<b>CAFETERIA</b>	
<b>Door(s)</b>	
Deficiency	No deficiencies recorded
<b>Fixed Equipment</b>	
Instance on Ground Floor	Does not Exist
<b>Floor Finish</b>	
Instance on Ground Floor	Inspected
Condition	2 - Between Good and Fair
Deficiency	VINYL TILES: DETERIORATED SUBSTRATE
Deficiency Location/Instance	Near Entrance
Deficiency Quantity	20
Quantity Uom	S.F.
Potential Action	REPLACE
Urgency of Action	PRIORITY 3
Purpose of Action	LEVEL 2
Deficiency Photo1

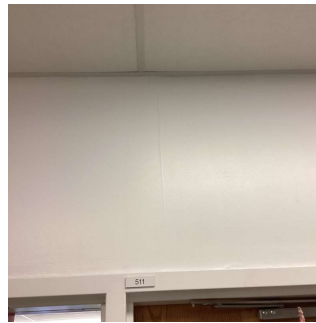
Corridor near Room 511

Question	Response
<b>INTERIOR</b>	
<b>CLASSROOMS/CORRIDORS/ADMIN SPACES</b>	
<b>Ceiling</b>	
Deficiency Photo1	 
	Corridor near Room 203
Violations	No violations recorded.
<b>Door(s)</b>	Inspected
Condition	2 - Between Good and Fair
Deficiency	No deficiencies recorded
<b>Floor Finish</b>	Inspected
Condition	2 - Between Good and Fair
Deficiency	CERAMIC TILE: BROKEN/MISSING TILES
Deficiency Location/Instance	Main Entrance Lobby
Deficiency Quantity	10
Quantity Uom	S.F.
Potential Action	REPLACE
Urgency of Action	PRIORITY 3
Purpose of Action	LEVEL 2
Deficiency Photo1	 
	Main Entrance Lobby
Violations	No violations recorded.
<b>Walls</b>	Inspected
Condition	2 - Between Good and Fair
Deficiency	GYPSUM BOARD: DETERIORATED
Deficiency Location/Instance	Corridor near Rooms 511, 506, 413, 410, 326 and others
Deficiency Quantity	150
Quantity Uom	S.F.
Potential Action	REPLACE
Urgency of Action	PRIORITY 3
Purpose of Action	LEVEL 2

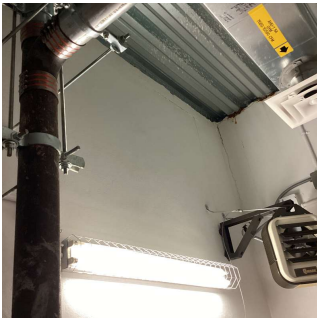
Question	Response
<b>INTERIOR</b>	
<b>GYMNASIUM</b>	
<b>Floor Finish</b>	
Violations	Near Room G20A No violations recorded.
<b>Seating</b>	
Instance on Ground Floor	Inspected
Condition	2 - Between Good and Fair
Deficiency	No deficiencies recorded
<b>Sliding-folding Partition</b>	
Instance on Ground Floor	Inspected
Condition	2 - Between Good and Fair
Deficiency	No deficiencies recorded
<b>Stage</b>	
Instance on Ground Floor	Does not Exist
<b>Walls</b>	
Instance on Ground Floor	Inspected
Condition	2 - Between Good and Fair
Deficiency	PLASTER: CRACKS/SPALLING
Deficiency Location/Instance	Room G20A
Deficiency Quantity	20
Quantity Uom	S.F.
Potential Action	REPLACE
Urgency of Action	PRIORITY 3
Purpose of Action	LEVEL 2
Deficiency Photo1

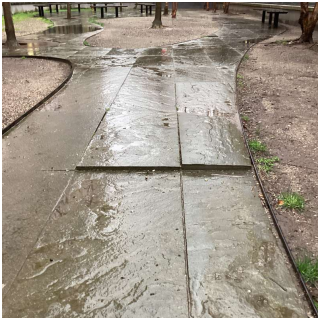
Question	Response
<b>SITE</b>	
<b>Drainage System for Soil</b>	Inspected
<b>Culverts - Soil Covering</b>	Does not Exist
<b>DRINKING FOUNTAINS</b>	Does not Exist
<b>FENCES</b>	Inspected
Condition	2 - Between Good and Fair
Deficiency	No deficiencies recorded
<b>IRRIGATION SYSTEM</b>	Does not Exist
<b>PAVING</b>	Inspected
<b>Student Non-Use</b>	Does not Exist
<b>Student Use</b>	Inspected
Gravel Exists?	Yes
<b>Asphalt</b>	Does not Exist
<b>Concrete</b>	Does not Exist
<b>Pavers</b>	Inspected
Condition	2 - Between Good and Fair
Deficiency	HEAVING
Deficiency Location/Instance	Courtyard
Deficiency Quantity	20
Quantity Uom	S.F.
Potential Action	REPLACE
Urgency of Action	PRIORITY 3
Purpose of Action	LEVEL 2
Deficiency Photo1
