NYC Department of Education
Building Condition Assessment Survey 2023 - 2024

Architectural Inspection

Asset: THE RIDGEWOOD SCHOOL, 360 SENECA AVENUE, New York, 11385

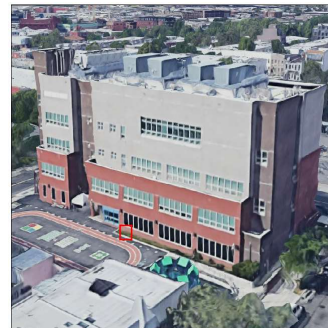
Question	Response
EXTERIOR	
DOORS	Inspected
LINTELS	Inspected
Deficiency	No deficiencies recorded
TRANSOM/SIDE LIGHT	Inspected
Condition	2 - Between Good and Fair
Deficiency	No deficiencies recorded
EXTERIOR WALLS	Inspected
Material Type(s)	Steel, Masonry
Replacement Quantity	29,000
Replacement Uom	S.F.
Instance on All Facades (Masonry)	Inspected
Instance Condition	2 - Between Good and Fair
Instance Quantity	25,000
Instance Quantity Uom	S.F.
Deficiency	BRICK: MINOR CRACKS AND SPALLING
Roof Plan reference	Q320

10
S.F.
RESTITCH
PRIORITY 3
LEVEL 2

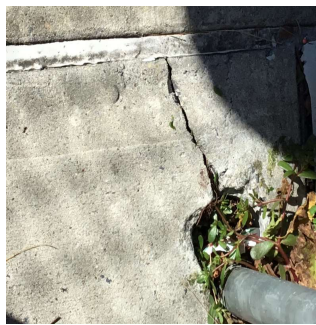
Facade B

Question	Response
EXTERIOR	
ROOF	
Specialties	
BULKHEAD/PENTHOUSE	
Roof Plan reference	<p align="center">Q320</p>
Deficiency Quantity	10
Quantity Uom	S.F.
Potential Action	MAINTENANCE
Urgency of Action	PRIORITY 1
Purpose of Action	LEVEL 1
Deficiency Photo1	
Violations	BH No violations recorded.
CUPOLA/ SPIRES/ TOWERS	Does not Exist
DORMER	Does not Exist
DUNNAGE STEEL	Inspected
Condition	2 - Between Good and Fair
Deficiency	No deficiencies recorded
SKYLIGHT/ROOF VENT	Does not Exist
ROOF/GRAVITY TANK	Does not Exist
STAIRS/RAMPS: EXTERIOR	Inspected
BUILDING CHEEK/FLANK WALLS	Inspected
Condition	2 - Between Good and Fair
Deficiency	No deficiencies recorded
RAILINGS	Inspected
Condition	2 - Between Good and Fair
Deficiency	No deficiencies recorded
STAIRS/RAMPS	Inspected
Condition	3 - Fair
Deficiency	CONCRETE: CRACKS/SPALLING - MINOR

20
S.F.
REPAIR
PRIORITY 3
LEVEL 2

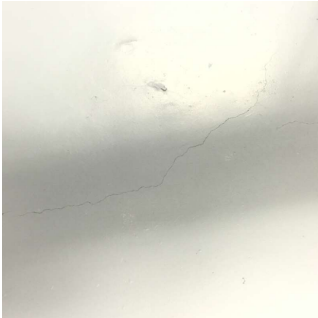
Question	Response
INTERIOR	
STRUCTURAL	Inspected
COLUMNS/BEAMS/BEARING WALLS	Inspected
Condition	2 - Between Good and Fair
Deficiency	No deficiencies recorded
FLOOR STRUCTURE	Inspected
Condition	3 - Fair
Deficiency	CONCRETE SLAB ON GRADE: THRU CRACKS
Deficiency Location/Instance	Basement
Deficiency Quantity	70
Quantity Uom	S.F.
Potential Action	REPAIR
Urgency of Action	PRIORITY 3
Purpose of Action	LEVEL 5
Deficiency Photo1

Violations	Room C27 (Electrical Panel Room similar) No violations recorded.
FOUNDATION WALLS	Inspected
Material Type(s)	Concrete
Condition	4 - Between Fair and Poor
Deficiency	CONCRETE: WATER INFILTRATION IN INSTRUCTIONAL SPACE
Deficiency Location/Instance	Basement - Kitchen
Deficiency Quantity	100
Quantity Uom	S.F.
Potential Action	INSTALL WATERPROOFING
Urgency of Action	PRIORITY 5
Purpose of Action	LEVEL 5
Deficiency Photo1

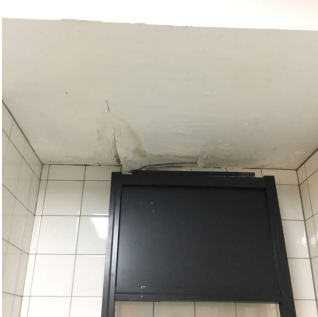
Violations	Room C10 No violations recorded.
ROOF STRUCTURE	Inspected

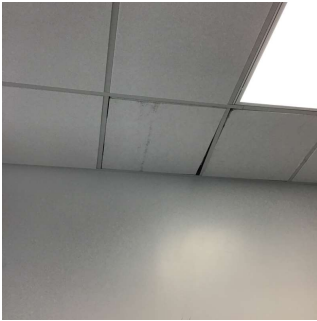
Near Entrance
Violations	No violations recorded.
Deficiency	ACOUSTIC TILES: DAMAGED/MISSING
Deficiency Location/Instance	Near Entrance , Corridor near Room 206

Corridor near Room 206
Violations	No violations recorded.
Deficiency	GYPSUM BOARD: DAMAGED/DETERIORATED - ACTIVE LEAK
Deficiency Location/Instance	Room 301
Deficiency Quantity	20
Quantity Uom	S.F.
Potential Action	REPLACE
Urgency of Action	PRIORITY 5
Purpose of Action	LEVEL 2
Deficiency Photo1

Deficiency Quantity	30
Quantity Uom	S.F.
Potential Action	REPLACE
Urgency of Action	PRIORITY 3
Purpose of Action	LEVEL 2

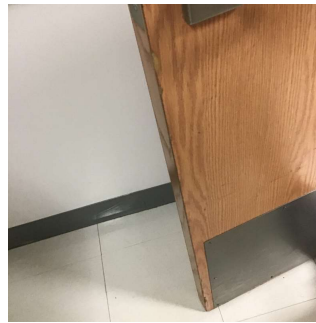
Room 101

Room 301
Violations	No violations recorded.
Door(s)	Inspected
Condition	5 - Poor
Deficiency	WOOD: DETERIORATED DOOR
Deficiency Location/Instance	Rooms 101, 109, 209, 312, 315.
Deficiency Quantity	5
Quantity Uom	EACH
Potential Action	MAINTENANCE
Urgency of Action	PRIORITY 3
Purpose of Action	LEVEL 2

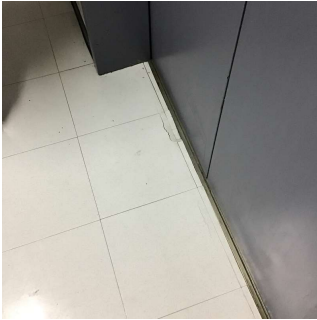
Question	Response
INTERIOR	
KITCHEN	
Door(s)	
Condition	2 - Between Good and Fair
Deficiency	No deficiencies recorded
Floor Finish	
Instance on Basement	Inspected
Condition	2 - Between Good and Fair
Deficiency	VINYL TILES: DETERIORATED SUBSTRATE
Deficiency Location/Instance	Room C10
Deficiency Quantity	10
Quantity Uom	S.F.
Potential Action	REPLACE
Urgency of Action	PRIORITY 3
Purpose of Action	LEVEL 2
Deficiency Photo1

Room C10
Violations	No violations recorded.
Walls	
Instance on Basement	Inspected
Condition	2 - Between Good and Fair
Deficiency	GYP SUM BOARD: DETERIORATED
Deficiency Location/Instance	Room C06E
Deficiency Quantity	10
Quantity Uom	S.F.
Potential Action	REPLACE
Urgency of Action	PRIORITY 3
Purpose of Action	LEVEL 2
Deficiency Photo1

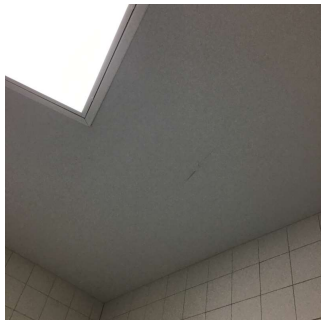
Violations	Room C04A No violations recorded.

Question	Response
INTERIOR	
STAIRS/RAMPS: INTERIOR	Inspected
Walls	Inspected
Violations	Stair A/2 No violations recorded.
TOILET ROOMS - STAFF	Inspected
Ceiling	Inspected
Condition	2 - Between Good and Fair
Deficiency	No deficiencies recorded
Door(s)	Inspected
Condition	2 - Between Good and Fair
Deficiency	No deficiencies recorded
Floor Finish	Inspected
Condition	2 - Between Good and Fair
Deficiency	No deficiencies recorded
Stalls	Inspected
Condition	2 - Between Good and Fair
Deficiency	No deficiencies recorded
Walls	Inspected
Condition	2 - Between Good and Fair
Deficiency	No deficiencies recorded
TOILET ROOMS - STUDENTS	Inspected
Ceiling	Inspected
Condition	2 - Between Good and Fair
Deficiency	GYPSON BOARD: DAMAGED/DETERIORATED
Deficiency Location/Instance	Room C04A
Deficiency Quantity	20
Quantity Uom	S.F.
Potential Action	REPLACE
Urgency of Action	PRIORITY 3
Purpose of Action	LEVEL 2
Deficiency Photo1

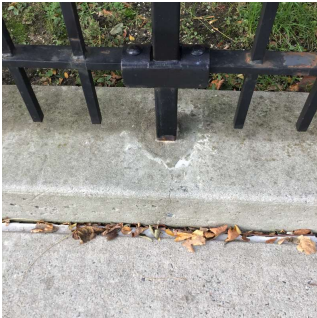
Violations	Seneca Avenue No violations recorded.
IRRIGATION SYSTEM	Does not Exist
PAVING	Inspected
Student Non-Use	Inspected
Gravel Exists?	No
Asphalt	Does not Exist

Question	Response
INTERIOR	
TOILET ROOMS - STUDENTS	
Stalls	Inspected
Deficiency	No deficiencies recorded
Walls	Inspected
Condition	2 - Between Good and Fair
Deficiency	No deficiencies recorded
LIFE SAFETY	Inspected
F.D. HOLDING AREA	Does not Exist
STEEL STAIRS	Does not Exist
SITE	Inspected
CONTAINERIZATION	Does not Exist
Drainage System for Asphalt	Inspected
Catch Basins/Manhole - Surrounded by asphalt	Inspected
Condition	2 - Between Good and Fair
Deficiency	No deficiencies recorded
Culverts - Asphalt Covering	Does not Exist
Drainage System for Concrete	Inspected
Catch Basins/Manhole - Surrounded by concrete	Inspected
Condition	2 - Between Good and Fair
Deficiency	No deficiencies recorded
Culverts - Concrete Covering	Does not Exist
Drainage System for Soil	Does not Exist
DRINKING FOUNTAINS	Does not Exist
FENCES	Inspected
Condition	2 - Between Good and Fair
Deficiency	CONCRETE CURB: DAMAGED/DETERIORATED
Deficiency Location/Instance	Seneca Avenue, schoolyard.

Deficiency Quantity	30
Quantity Uom	S.F.
Potential Action	REPLACE
Urgency of Action	PRIORITY 3
Purpose of Action	LEVEL 2
Deficiency Photo1

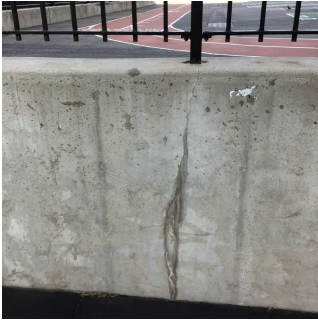
Violations	Stockholm Avenue No violations recorded.
Deficiency	CAST IN PLACE CONCRETE: CRACKS/SPALLING - MAJOR
Deficiency Location/Instance	Dekalb Avenue, Schoolyard, Playground Area.
Deficiency Quantity	40
Quantity Uom	S.F.
Potential Action	REPLACE
Urgency of Action	PRIORITY 3
Purpose of Action	LEVEL 2
