NYC Department of Education
Building Condition Assessment Survey 2023 - 2024

Architectural Inspection

Asset: EAST ELMHURST COMMUNITY SCHOOL - QUEENS, 26-25 97TH STREET, New York, 11369

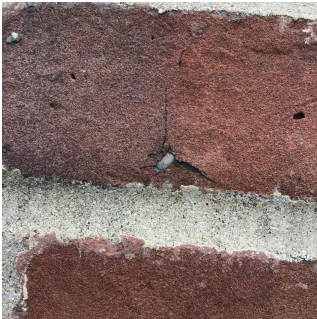
Violations	AW4 No violations recorded.
AWNINGS AND CANOPIES	Does not Exist
CHIMNEY	Inspected
Material Type(s)	Masonry
Condition	2 - Between Good and Fair
Deficiency	BRICK: MINOR CRACKS AND SPALLING
Roof Plan reference	Q329
Deficiency Quantity	20
Quantity Uom	S.F.
Potential Action	RESTITCH
Urgency of Action	PRIORITY 3
Purpose of Action	LEVEL 2
Deficiency Photo1

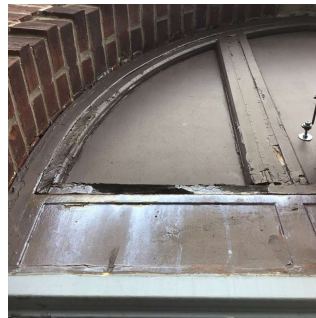
WOOD: EXCESSIVELY WEATHERED

REPLACE

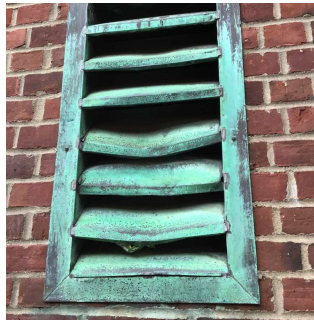
Facade C

Deficiency	BROKEN/ DENTED BLADES
------------	-----------------------

REPLACE

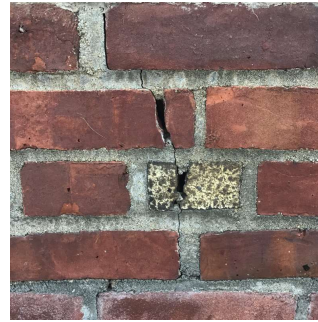
Roof 1

BRICK: MAJOR DETERIORATION/CRACKS

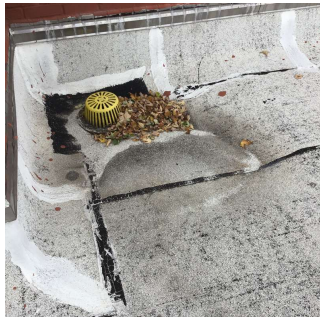
Roof 1 - Rooms 301, 306, 307, 310 (Shown), 313, Stair A/3, Corridor near Room 317
Violations	No violations recorded.
Deficiency	MODIFIED BITUMEN: ROOFING: DELAMINATION
Roof Plan reference

Deficiency Quantity	50
Quantity Uom	S.F.
Potential Action	REPLACE ROOFING WITHOUT MAJOR EQUIPMENT REMOVAL
Urgency of Action	PRIORITY 4
Purpose of Action	LEVEL 2
Deficiency Photo1

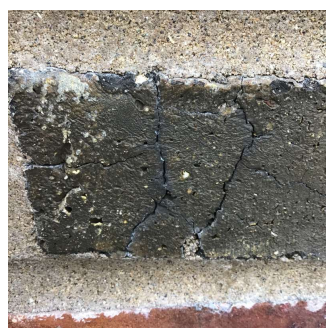
<p>BH</p> <p>No violations recorded.</p>
<p>Deficiency</p>	<p>BULKHEAD/PENTHOUSE WALLS/EXTERIOR: DETERIORATED JOINTS</p>

<p>Q329</p> <p>30</p> <p>S.F.</p> <p>MAINTENANCE</p> <p>PRIORITY 3</p> <p>LEVEL 2</p> <p>No photo recorded</p> <p>No violations recorded.</p>
<p>Deficiency</p> <p>Roof Plan reference</p> <p>Deficiency Quantity</p> <p>Quantity Uom</p> <p>Potential Action</p> <p>Urgency of Action</p> <p>Purpose of Action</p> <p>Deficiency Photo1</p> <p>Violations</p>	<p>BULKHEAD/PENTHOUSE WALLS/EXTERIOR: CRACKS/SPALLING - MINOR</p>

<p>Q329</p> <p>20</p> <p>S.F.</p> <p>REPAIR</p> <p>PRIORITY 3</p> <p>LEVEL 2</p>

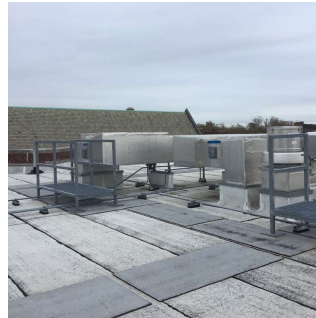
Roof 1

HEIGHT LESS THAN 18"

20
 L.F.
 REPLACE
 PRIORITY 3
 LEVEL 2

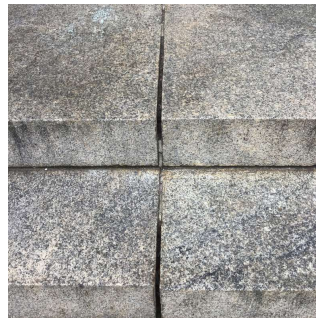
STONE: DETERIORATED JOINTS

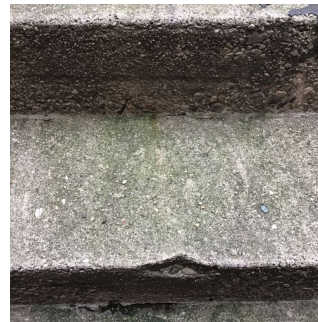
Facade A

CONCRETE: WORN-OUT TREAD/RISER/NOSING

REPLACE

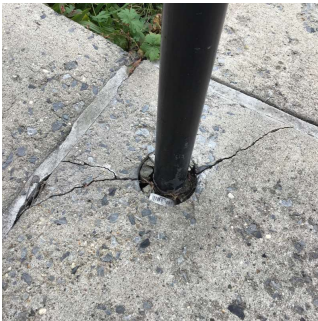
CONCRETE: CRACKS/SPALLING - MINOR

REPAIR

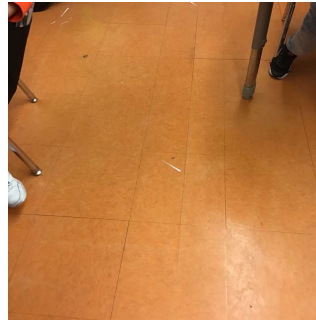
Room 103

Violations	Main Entrance No violations recorded.
Deficiency	VINYL TILES: DETERIORATED SUBSTRATE
Deficiency Location/Instance	Rooms 103, 104
Deficiency Quantity	80
Quantity Uom	S.F.
Potential Action	REPLACE
Urgency of Action	PRIORITY 3
Purpose of Action	LEVEL 2

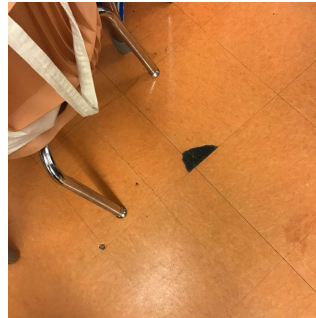
Room 103

VINYL TILES: BROKEN/DETERIORATED/MISSING TILES

REPLACE

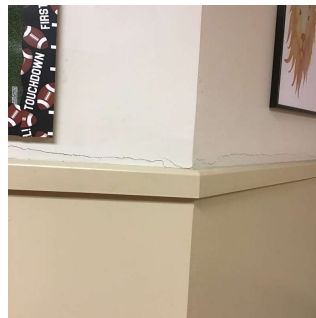
PLASTER: CRACKS/SPALLING

REPLACE

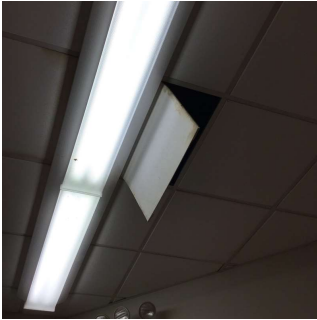
Violations	Stair A/Basement No violations recorded.

Violations	Near Serving Area No violations recorded.
LIBRARY	Does not Exist
LOCKER ROOM	Does not Exist
MULTI-PURPOSE ROOM	Does not Exist
SCIENCE DEMO ROOM	Does not Exist
SCIENCE LAB	Inspected
Instance on Room 301	Inspected
Alternative use	Yes
Fixed Equipment	
Instance on Room 301	Inspected
Condition	2 - Between Good and Fair
Deficiency	No deficiencies recorded
SCIENCE PREP ROOM	Does not Exist
SHOWER ROOM	Does not Exist
STAIRS/RAMPS: INTERIOR	Inspected
Do Letter Stair Signs Exist?	Yes
Ceiling	Inspected
Condition	2 - Between Good and Fair
Deficiency	ACOUSTIC TILES: DAMAGED/MISSING
Deficiency Location/Instance	Stair A/Basement
Deficiency Quantity	10
Quantity Uom	S.F.
Potential Action	REPLACE
Urgency of Action	PRIORITY 5
Purpose of Action	LEVEL 6
Deficiency Photo1

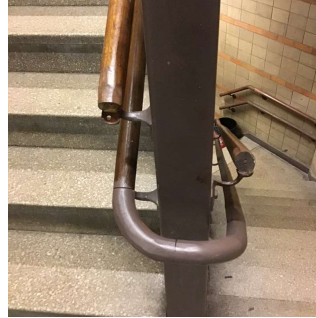
Stair C/Basement

Question	Response
INTERIOR	
STAIRS/RAMPS: INTERIOR	
Ceiling	
Deficiency	ACOUSTIC TILES: DAMAGED/MISSING
Deficiency Location/Instance	Stair A/Basement
Deficiency Quantity	10
Quantity Uom	S.F.
Potential Action	REPLACE
Urgency of Action	PRIORITY 3
Purpose of Action	LEVEL 2
Deficiency Photo1	 
Violations	Stair A/Basement No violations recorded.
Deficiency	PLASTER: CRACKS/SPALLING - ACTIVE LEAK
Deficiency Location/Instance	Stair A/3
Deficiency Quantity	30
Quantity Uom	S.F.
Potential Action	REPLACE
Urgency of Action	PRIORITY 5
Purpose of Action	LEVEL 2
Deficiency Photo1	 
Violations	Stair A/3 No violations recorded.
Door(s)	Inspected
Condition	2 - Between Good and Fair
Deficiency	No deficiencies recorded
Partition	Does not Exist
Railings	Inspected
Condition	4 - Between Fair and Poor
Deficiency	WOOD: DAMAGED
Deficiency Location/Instance	Stairs A/1, 2, B/1, C/Basement
Deficiency Quantity	20
Quantity Uom	L.F.
Potential Action	REPLACE

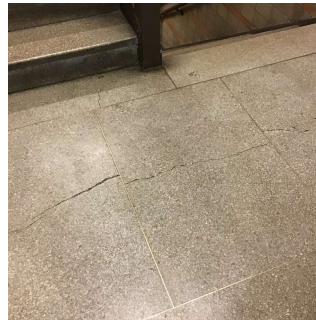
Stair C/Basement

TERRAZZO: CRACKS

REPLACE

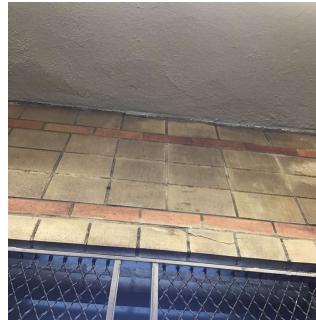
Stair B/2

GLAZED BLOCK: CRACKS/SPALLING

REPLACE

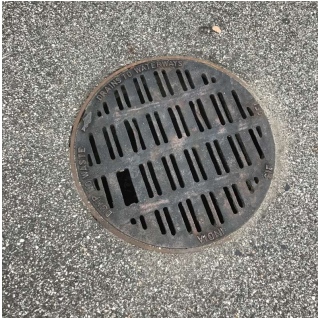
Question	Response
LIFE SAFETY	Inspected
F.D. HOLDING AREA	Does not Exist
STEEL STAIRS	Does not Exist
SITE	Inspected
CONTAINERIZATION	Does not Exist
Drainage System for Asphalt	Inspected
Catch Basins/Manhole - Surrounded by asphalt	Inspected
Condition	3 - Fair
Deficiency	DAMAGED COVER
Deficiency Location/Instance	Playground
Deficiency Quantity	1
Quantity Uom	EACH
Potential Action	REPLACE
Urgency of Action	PRIORITY 3
Purpose of Action	LEVEL 2
Deficiency Photo1

Violations	Playground No violations recorded.
Culverts - Asphalt Covering	Does not Exist
Drainage System for Concrete	Inspected
Catch Basins/Manhole - Surrounded by concrete	Inspected
Condition	3 - Fair
Deficiency	DAMAGED COVER
Deficiency Location/Instance	Near Exit 8
Deficiency Quantity	1
Quantity Uom	EACH
Potential Action	REPLACE
Urgency of Action	PRIORITY 5
Purpose of Action	LEVEL 6
Deficiency Photo1

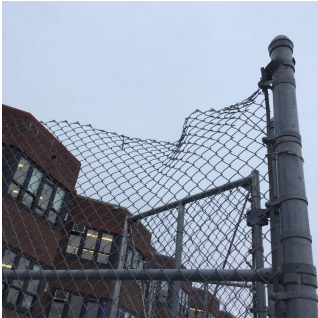
Question	Response
SITE	
Drainage System for Soil	Inspected
Catch Basins/Manhole - Surrounded by Soil	Inspected
Condition	2 - Between Good and Fair
Deficiency	No deficiencies recorded
Culverts - Soil Covering	Does not Exist
DRINKING FOUNTAINS	Does not Exist
FENCES	Inspected
Condition	3 - Fair
Deficiency	CHAIN LINK: DAMAGED/DETERIORATED
Deficiency Location/Instance	Near Exit 7
Deficiency Quantity	50
Quantity Uom	S.F.
Potential Action	REPLACE
Urgency of Action	PRIORITY 3
Purpose of Action	LEVEL 2
Deficiency Photo1

Violations	Near Exit 7 No violations recorded.
IRRIGATION SYSTEM	Does not Exist
PAVING	Inspected
Student Non-Use	Does not Exist
Student Use	Inspected
Gravel Exists?	No
Asphalt	Does not Exist
Concrete	Inspected
Condition	4 - Between Fair and Poor
Deficiency	HEAVING
Deficiency Location/Instance	Near Exit 8
Deficiency Quantity	50
Quantity Uom	S.F.
Potential Action	REPLACE
Urgency of Action	PRIORITY 5
Purpose of Action	LEVEL 6

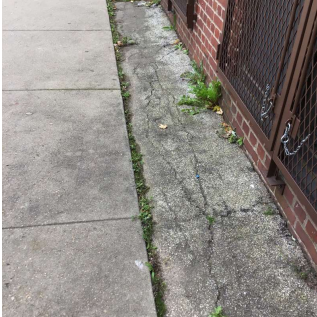
Question	Response
SITE	
PAVING	
Site Sidewalks & Walkways	
Asphalt	
Deficiency Photo1

Violations	Near Exit 6 No violations recorded.
Concrete	Inspected
Condition	4 - Between Fair and Poor
Deficiency	DAMAGED/DETERIORATED/MISSING SECTIONS
Deficiency Location/Instance	Between Gardens area, Near Exit 6.
Deficiency Quantity	775
Quantity Uom	S.F.
Potential Action	REPLACE
Urgency of Action	PRIORITY 3
Purpose of Action	LEVEL 2
Deficiency Photo1

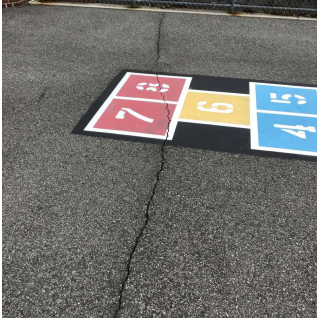
Question	Response
SITE	
PLAYGROUNDS	
Pavement	
Urgency of Action	PRIORITY 3
Purpose of Action	LEVEL 2
Deficiency Photo1

Violations	Near Garden No violations recorded.
Play Equipment	
Instance on 97th Street	Inspected
Condition	2 - Between Good and Fair
Deficiency	No deficiencies recorded
Safety Surfacing	
Instance on 97th Street	Inspected
Condition	2 - Between Good and Fair
Deficiency	No deficiencies recorded
Unpaved Area	
Instance on 97th Street	Does not Exist
PLAYING SURFACE	Does not Exist
RETAINING WALLS	Inspected
Are there any Retaining Walls 6' OR higher facing public street/sidewalk?	Yes
Condition	2 - Between Good and Fair
Deficiency	No deficiencies recorded
SEATING	Does not Exist
SITE WALLS (NOT RETAINING WALLS)	Does not Exist
STAIRS/RAMPS: EXTERIOR	Does not Exist
ARTWORK	Does not Exist
