NYC Department of Education
Building Condition Assessment Survey 2023 - 2024

Architectural Inspection

Asset: **CENTREVILLE EDUCATIONAL BUILDING - QUEENS, 150-15 RALEIGH STREET, 11417**

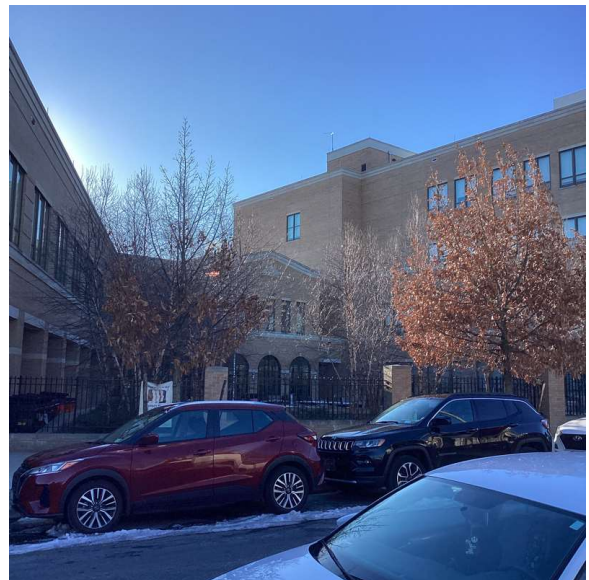
Facade Photo

Raleigh Street - Southeast view

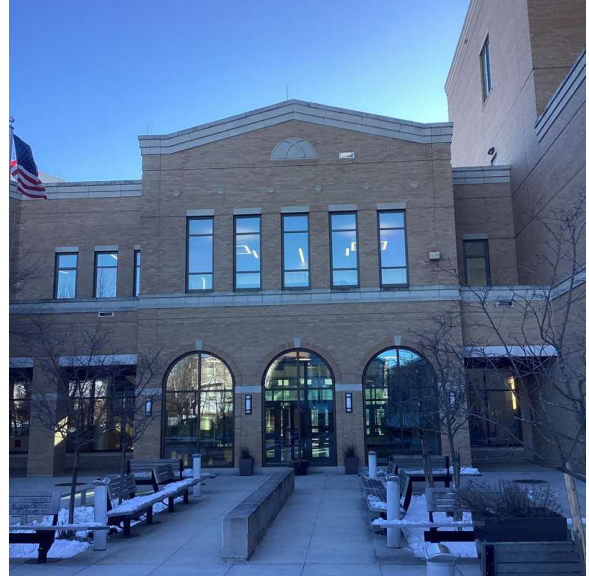
Main Entrance Photo

Facade A - Raleigh Street

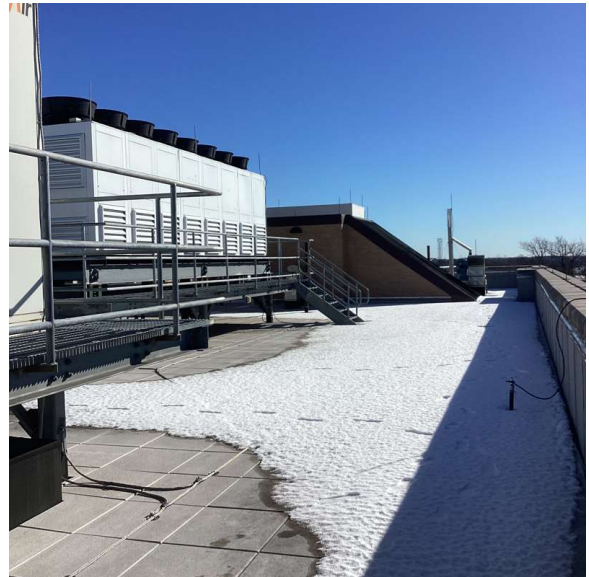
Roof Photo

Roof 1 - Northeast view

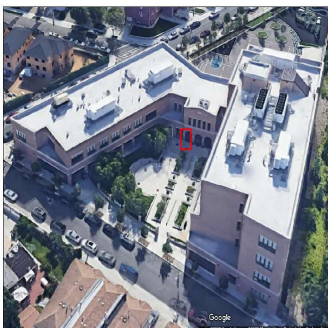
Question	Response
EXTERIOR	
EXTERIOR WALLS	
Instance Condition	2 - Between Good and Fair
Instance Quantity	46,000
Instance Quantity Uom	S.F.
Deficiency	BRICK: MINOR CRACKS AND SPALLING
Roof Plan reference	 
Elevation

Deficiency Quantity	10
Quantity Uom	S.F.
Potential Action	RESTITCH
Urgency of Action	PRIORITY 3
Purpose of Action	LEVEL 2
Deficiency Photo1

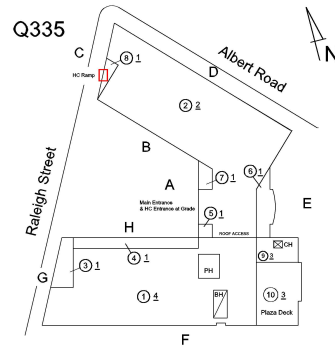
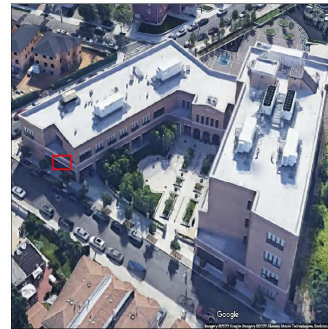
Violations	Facade A No violations recorded.
EXTERIOR SOFFITS	
Condition	Inspected
Deficiency	STUCCO/PLASTER: MINOR CRACKS/SPALLING

REPAIR

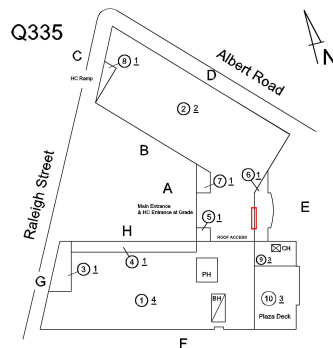
Instance Condition	2 - Between Good and Fair
Instance Quantity	4,800
Instance Quantity Uom	S.F.
Are these windows insulated	Yes
Installation Year	2017
Source of Installation	Custodial Staff
Deficiency	ALUMINUM - OTHER: AIR/WATER INFILTRATION, DETERIORATED JOINTS WITH DAMAGED CAULKING
Roof Plan reference

Question	Response
EXTERIOR	
WINDOWS	
WINDOWS	
Elevation	 
Deficiency Quantity	90
Quantity Uom	L.F.
Potential Action	MAINTENANCE
Urgency of Action	PRIORITY 3
Purpose of Action	LEVEL 2
Deficiency Photo1	 
Violations	Facade A - Room 230, Facade E - 2nd Floor Corridor No violations recorded.
INTERIOR	Inspected
POOLS	Does not Exist
STRUCTURAL	Inspected
COLUMNS/BEAMS/BEARING WALLS	Inspected
Condition	2 - Between Good and Fair
Deficiency	No deficiencies recorded
FLOOR STRUCTURE	Inspected
Condition	2 - Between Good and Fair
Deficiency	No deficiencies recorded
FOUNDATION WALLS	Inspected
Material Type(s)	Concrete
Condition	2 - Between Good and Fair
Deficiency	No deficiencies recorded
ROOF STRUCTURE	Inspected
Condition	2 - Between Good and Fair
Deficiency	No deficiencies recorded
VAULTS-BUNKERS	Does not Exist
AUDITORIUM	Does not Exist
CAFETERIA	Inspected
Instance on 1st Floor	Inspected
Ceiling
