**NYC Department of Education**  
**Building Condition Assessment Survey 2023 - 2024**

Architectural Inspection

**Asset:** P.S. 339 - QUEENS, 39-07 57TH STREET, New York, 11377

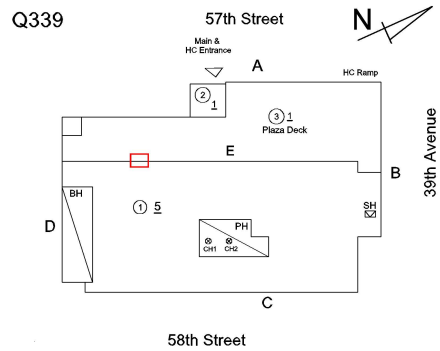
Question	Response
<b>Architectural</b>	
<b>EXTERIOR</b>	Inspected
<b>AREAWAY</b>	Does not Exist
<b>AWNINGS AND CANOPIES</b>	Does not Exist
<b>CHIMNEY</b>	Inspected
Material Type(s)	Metal
Condition	2 - Between Good and Fair
Deficiency	No deficiencies recorded
<b>COPING</b>	Inspected
Condition	3 - Fair
Deficiency	CAST STONE: DETERIORATED BED JOINT
Roof Plan reference	Q339

Deficiency Quantity	10
Quantity Uom	L.F.
Potential Action	REPOINT
Urgency of Action	PRIORITY 3
Purpose of Action	LEVEL 2

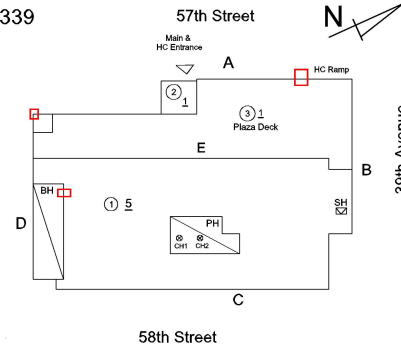
**CAST STONE: CRACKED/BROKEN PIECES**

**REPLACE-IN-KIND**

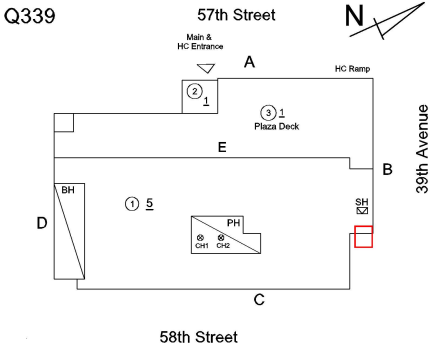
**METAL: DETERIORATED DOOR AND FRAME - MAJOR DETERIORATION**

Deficiency Quantity	2
Quantity Uom	EACH
Potential Action	REPLACE
Urgency of Action	PRIORITY 4
Purpose of Action	LEVEL 2
Deficiency Photo1

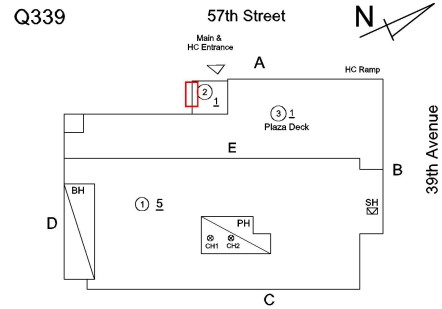
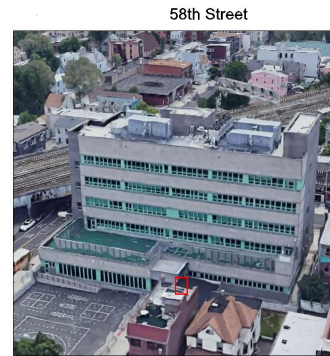
Violations	Facade B - Exit 2 No violations recorded.
<b>DOOR HARDWARE</b>	Inspected
Condition	2 - Between Good and Fair
Deficiency	No deficiencies recorded
<b>LINTELS</b>	Inspected
Condition	2 - Between Good and Fair
Deficiency	No deficiencies recorded
<b>TRANSOM/SIDE LIGHT</b>	Inspected
Condition	2 - Between Good and Fair
Deficiency	No deficiencies recorded
<b>EXTERIOR WALLS</b>	Inspected
Material Type(s)	Masonry
Replacement Quantity	26,000
Replacement Uom	S.F.
Instance on All Facades	Inspected
Instance Condition	3 - Fair
Instance Quantity	26,000
Instance Quantity Uom	S.F.
Deficiency	BRICK: EFFLORESCENCE

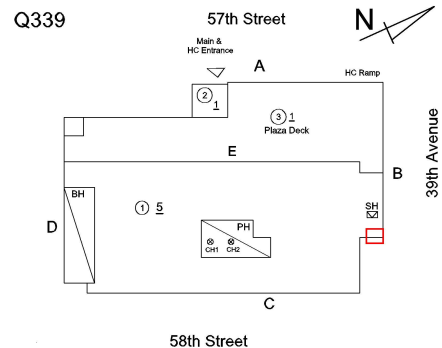
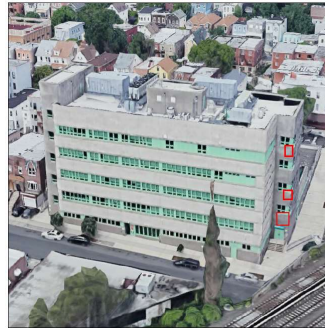
BRICK: EFFLORESCENCE

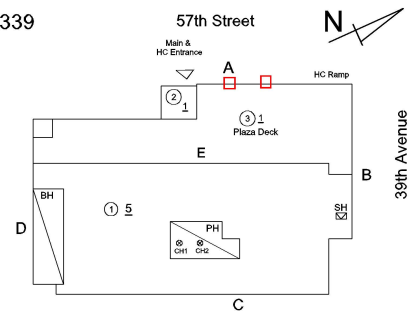
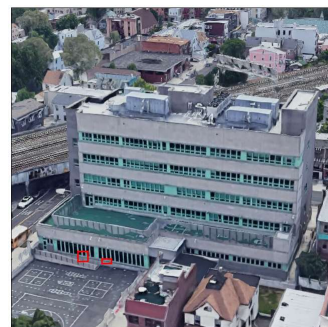
BRICK: DETERIORATED MASONRY SILLS - MINOR

REPAIR

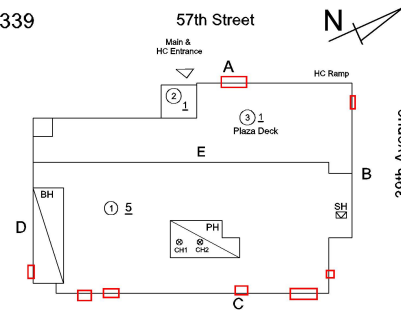
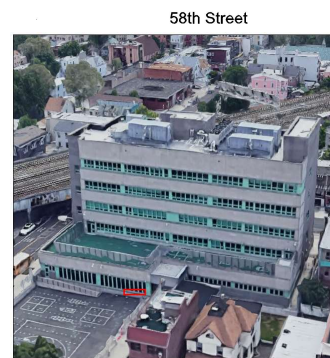
BRICK: MINOR CRACKS AND SPALLING

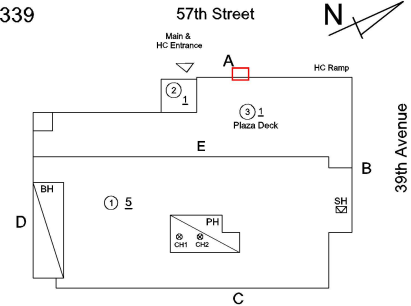
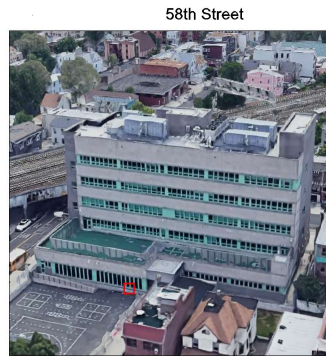
BRICK: MASONRY SILLS - DETERIORATED JOINTS

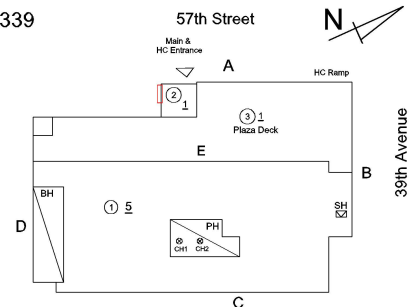
BRICK: WATER INFILTRATION IN INSTRUCTIONAL SPACE

Question	Response
<b>EXTERIOR</b>	
<b>EXTERIOR WALLS</b>	
Elevation	 
Deficiency Quantity	100
Quantity Uom	S.F.
Potential Action	REPAIR
Urgency of Action	PRIORITY 5
Purpose of Action	LEVEL 2
Deficiency Photo1	 
Violations	Facade A - Main Entrance Vestibule No violations recorded.
<b>EXTERIOR SOFFITS</b>	Inspected
Condition	2 - Between Good and Fair
Deficiency	No deficiencies recorded
<b>LOADING DOCK</b>	Does not Exist
<b>LOUVER</b>	Inspected
Condition	2 - Between Good and Fair
Deficiency	No deficiencies recorded
<b>PARAPETS</b>	Inspected
Material Type(s)	Masonry, Concrete
Replacement Quantity	2,500
Replacement Uom	C.F.
Instance on All Roofs	Inspected
Instance Condition	2 - Between Good and Fair
Instance Quantity	2,500
Instance Quantity Uom	C.F.
Deficiency	No deficiencies recorded
<b>PLAZA DECK</b>	Inspected
Instance on Concrete: Roof 3	Inspected
Instance Condition	3 - Fair
Instance Quantity	2,000
Instance Quantity Uom	S.F.

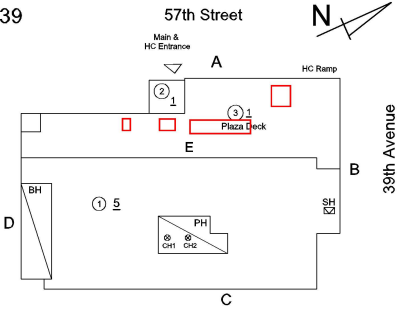
Question	Response
<b>EXTERIOR</b>	
<b>PLAZA DECK</b>	
Source of Installation	Documented
Deficiency	CONCRETE: MINOR CRACKS
Roof Plan reference	Q339

Deficiency Quantity	70
Quantity Uom	S.F.
Potential Action	REPAIR
Urgency of Action	PRIORITY 3
Purpose of Action	LEVEL 2
Deficiency Photo1

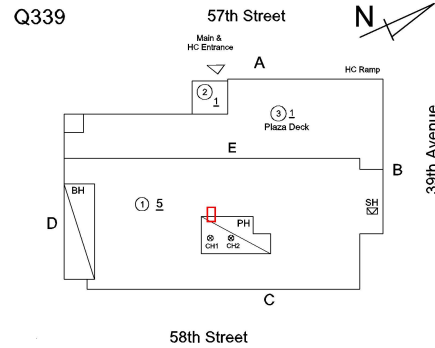
Deficiency IRMA: ROOFING: MAJOR ACTIVE ROOF LEAKS IN NON-INSTRUCTIONAL SPACE

Deficiency Quantity	100
Quantity Uom	S.F.
Potential Action	REPLACE ROOFING WITHOUT MAJOR EQUIPMENT REMOVAL
Urgency of Action	PRIORITY 5
Purpose of Action	LEVEL 2
Deficiency Photo1

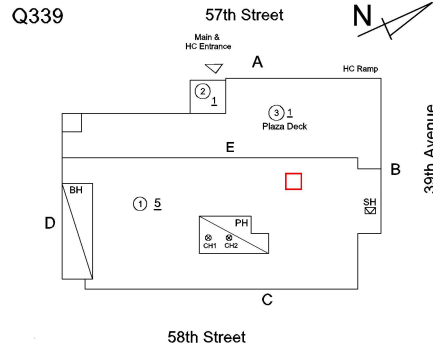
Roof 1 - Room 502  
 No violations recorded.

Violations	No violations recorded.
Deficiency	IRMA: ROOFING: MAJOR ACTIVE ROOF LEAKS IN INSTRUCTIONAL SPACE

Q339  
 100  
 S.F.  
 REPLACE ROOFING WITHOUT MAJOR EQUIPMENT  
 REMOVAL  
 PRIORITY 5  
 LEVEL 2

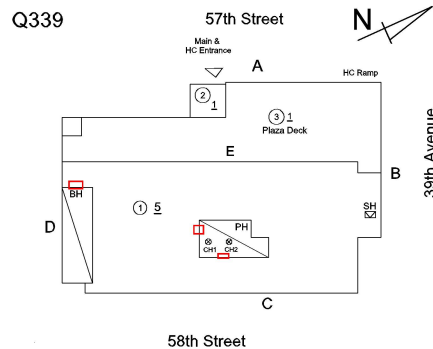
BULKHEAD/PENTHOUSE WALLS/EXTERIOR:  
 CRACKS/SPALLING - MINOR

Question	Response
<b>EXTERIOR</b>	
<b>ROOF</b>	
<b>Specialties</b>	
<b>BULKHEAD/PENTHOUSE</b>	
Potential Action	REPAIR
Urgency of Action	PRIORITY 3
Purpose of Action	LEVEL 2
Deficiency Photo1

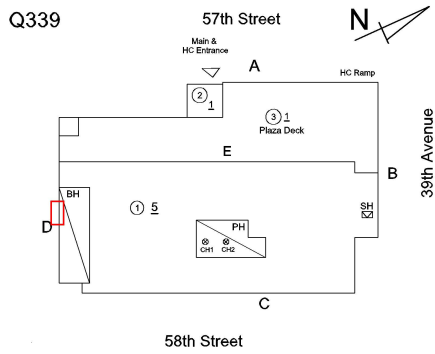
Violations	BH No violations recorded.
Deficiency	BULKHEAD/PENTHOUSE WALLS/INTERIOR: CMU CRACKS/SPALLING
Roof Plan reference	Q339

Deficiency Quantity	40
Quantity Uom	S.F.
Potential Action	REPLACE
Urgency of Action	PRIORITY 3
Purpose of Action	LEVEL 2
Deficiency Photo1

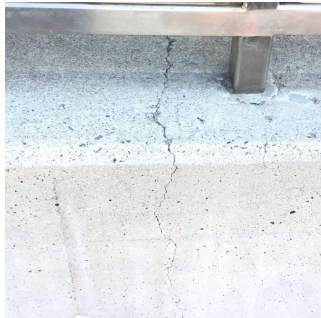
Question	Response
<b>EXTERIOR</b>	
<b>ROOF</b>	Inspected
<b>Specialties</b>	Inspected
<b>DUNNAGE STEEL</b>	Inspected
Deficiency	No deficiencies recorded
<b>SKYLIGHT/ROOF VENT</b>	Does not Exist
<b>ROOF/GRAVITY TANK</b>	Does not Exist
<b>STAIRS/RAMPS: EXTERIOR</b>	Inspected
<b>BUILDING CHEEK/FLANK WALLS</b>	Inspected
Condition	3 - Fair
Deficiency	CAST IN PLACE CONCRETE: CRACKS/SPALLING - MINOR
Roof Plan reference	Q339
Deficiency Quantity	40
Quantity Uom	S.F.
Potential Action	REPAIR
Urgency of Action	PRIORITY 3
Purpose of Action	LEVEL 2
Deficiency Photo1

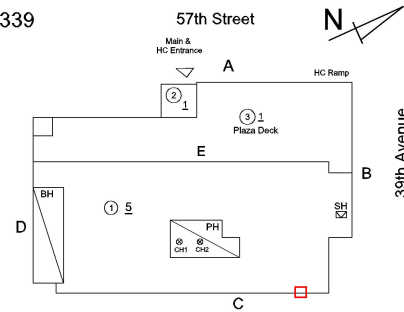
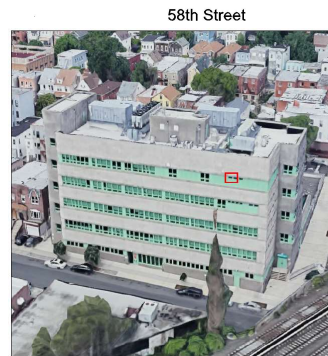
ALUMINUM - OTHER: BROKEN PANE

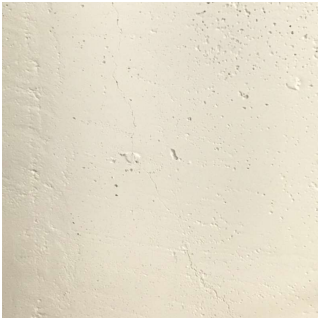
Question	Response
<b>INTERIOR</b>	Inspected
<b>POOLS</b>	Does not Exist
<b>STRUCTURAL</b>	Inspected
<b>COLUMNS/BEAMS/BEARING WALLS</b>	Inspected
Condition	2 - Between Good and Fair
Deficiency	No deficiencies recorded
<b>FLOOR STRUCTURE</b>	Inspected
Condition	2 - Between Good and Fair
Deficiency	No deficiencies recorded
<b>FOUNDATION WALLS</b>	Inspected
Material Type(s)	Concrete
Condition	3 - Fair
Deficiency	CONCRETE: CRACKED/SPALLED/REINFORCEMENT EXPOSED
Deficiency Location/Instance	Basement
Deficiency Quantity	30
Quantity Uom	S.F.
Potential Action	REPAIR
Urgency of Action	PRIORITY 3
Purpose of Action	LEVEL 5
Deficiency Photo1

Violations	Room C08J (Room C08H similar) No violations recorded.
<b>ROOF STRUCTURE</b>	Inspected
Condition	2 - Between Good and Fair
Deficiency	No deficiencies recorded
<b>VAULTS-BUNKERS</b>	Does not Exist
<b>AUDITORIUM</b>	Does not Exist
<b>CAFETERIA</b>	Inspected
Instance on 1st Floor	Inspected

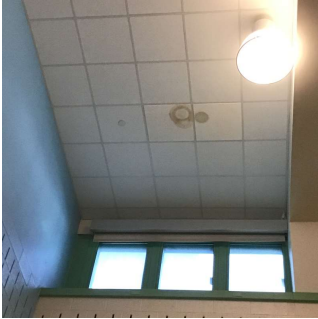
Question	Response
<b>INTERIOR</b>	
<b>CLASSROOMS/CORRIDORS/ADMIN SPACES</b>	Inspected
<b>Walls</b>	Inspected
Violations	Room 502 No violations recorded.
<b>Specialties</b>	Does not Exist
<b>GYMNASIUM</b>	Inspected
Instance on Basement	Inspected
<b>Ceiling</b>	
Instance on Basement	Inspected
Condition	2 - Between Good and Fair
Deficiency	ACOUSTIC TILES: DAMAGED/MISSING
Deficiency Location/Instance	Near the window
Deficiency Quantity	10
Quantity Uom	S.F.
Potential Action	REPLACE
Urgency of Action	PRIORITY 3
Purpose of Action	LEVEL 2
Deficiency Photo1

Violations	Near the window No violations recorded.
<b>Door(s)</b>	
Instance on Basement	Inspected
Condition	2 - Between Good and Fair
Deficiency	No deficiencies recorded
<b>Fixed Equipment</b>	
Instance on Basement	Inspected
Condition	2 - Between Good and Fair
Deficiency	No deficiencies recorded
<b>Floor Finish</b>	
Instance on Basement	Inspected
Condition	2 - Between Good and Fair

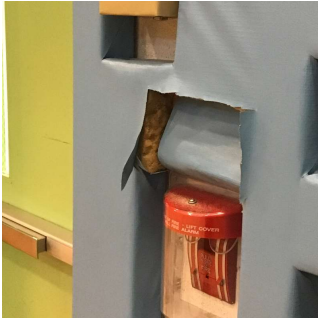
Question	Response
<b>INTERIOR</b>	
<b>GYMNASIUM</b>	
<b>Walls</b>	
Instance on Basement	Inspected
Condition	2 - Between Good and Fair
Deficiency	WOOD PANELING: DETERIORATED
Deficiency Location/Instance	Near Left Stage
Deficiency Quantity	50
Quantity Uom	S.F.
Potential Action	REPLACE
Urgency of Action	PRIORITY 3
Purpose of Action	LEVEL 2
Deficiency Photo1	 
Violations	Near Left Stage No violations recorded.
Deficiency	WALL PADDING: DETERIORATED
Deficiency Location/Instance	Near Entrance
Deficiency Quantity	20
Quantity Uom	S.F.
Potential Action	REPLACE
Urgency of Action	PRIORITY 3
Purpose of Action	LEVEL 2
Deficiency Photo1

Violations	Near Entrance No violations recorded.
<b>Window Curtains/Shades/Blinds</b>	
Instance on Basement	Does not Exist
<b>INTERIOR DOOR HARDWARE</b>	
Condition	Inspected
Deficiency	2 - Between Good and Fair
Deficiency	No deficiencies recorded
<b>INTERIOR GUARDS</b>	
Condition	Inspected
Deficiency	2 - Between Good and Fair

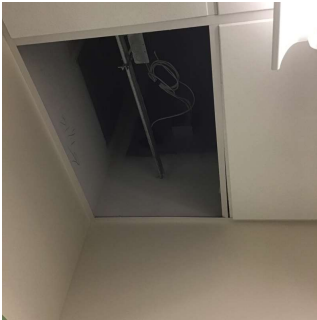
Question	Response
<b>INTERIOR</b>	
<b>KITCHEN</b>	Inspected
<b>Walls</b>	
Deficiency Photo1	 
Violations	Room 102D No violations recorded.
<b>LIBRARY</b>	Inspected
Instance on Room 512	Inspected
<b>Built-in Furnishing</b>	
Instance on Room 512	Does not Exist
<b>Ceiling</b>	
Instance on Room 512	Inspected
Condition	2 - Between Good and Fair
Deficiency	ACOUSTIC TILES: DAMAGED/MISSING
Deficiency Location/Instance	Main Ceiling, Room 512B
Deficiency Quantity	20
Quantity Uom	S.F.
Potential Action	REPLACE
Urgency of Action	PRIORITY 3
Purpose of Action	LEVEL 2
Deficiency Photo1

Violations	Room 512B No violations recorded.
<b>Door(s)</b>	
Instance on Room 512	Inspected
Condition	2 - Between Good and Fair
Deficiency	No deficiencies recorded
<b>Floor Finish</b>	
Instance on Room 512	Inspected
Condition	2 - Between Good and Fair
Deficiency	No deficiencies recorded
<b>Walls</b>	
Instance on Room 512	Inspected
Condition	2 - Between Good and Fair

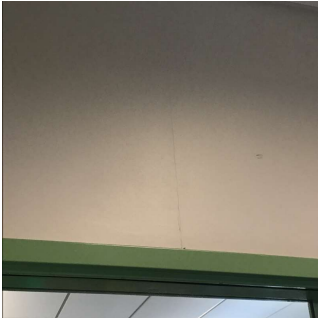
Question	Response
<b>INTERIOR</b>	
<b>LIBRARY</b>	Inspected
<b>Walls</b>	
Deficiency	GYP SUM BOARD: DETERIORATED
Deficiency Location/Instance	Room 512A
Deficiency Quantity	10
Quantity Uom	S.F.
Potential Action	REPLACE
Urgency of Action	PRIORITY 3
Purpose of Action	LEVEL 2
Deficiency Photo1

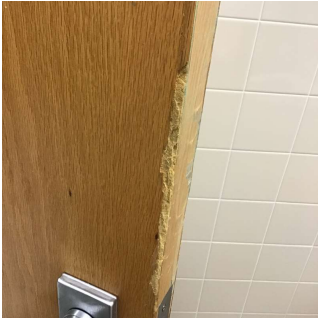
Question	Response
<b>INTERIOR</b>	
<b>STAIRS/RAMPS: INTERIOR</b>	Inspected
<b>Walls</b>	Inspected
Violations	Stair B/5 No violations recorded.
<b>TOILET ROOMS - STAFF</b>	Inspected
<b>Ceiling</b>	Inspected
Condition	2 - Between Good and Fair
Deficiency	No deficiencies recorded
<b>Door(s)</b>	Inspected
Condition	5 - Poor
Deficiency	WOOD: DETERIORATED DOOR
Deficiency Location/Instance	Room 204
Deficiency Quantity	1
Quantity Uom	EACH
Potential Action	MAINTENANCE
Urgency of Action	PRIORITY 3
Purpose of Action	LEVEL 2
Deficiency Photo1

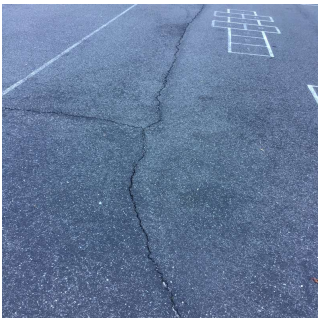
Main Entrance (gate)
Violations	No violations recorded.
<b>IRRIGATION SYSTEM</b>	Does not Exist
<b>PAVING</b>	Inspected
<b>Student Non-Use</b>	Does not Exist
<b>Student Use</b>	Inspected
Gravel Exists?	No
<b>Asphalt</b>	Inspected
Condition	3 - Fair
Deficiency	CRACKS - MAJOR
Deficiency Location/Instance	Schoolyard
Deficiency Quantity	400
Quantity Uom	S.F.
Potential Action	REPLACE
Urgency of Action	PRIORITY 3
Purpose of Action	LEVEL 2
Deficiency Photo1

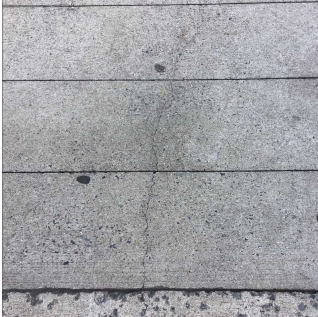
Schoolyard
Violations	No violations recorded.
<b>Concrete</b>	Does not Exist
<b>Pavers</b>	Does not Exist
<b>Site Sidewalks &amp; Walkways</b>	Inspected
<b>Asphalt</b>	Does not Exist
<b>Concrete</b>	Inspected
Condition	2 - Between Good and Fair
Deficiency	CRACKS - MAJOR
Deficiency Location/Instance	Main Entrance

Question	Response
<b>SITE</b>	
<b>PAVING</b>	
<b>Site Sidewalks &amp; Walkways</b>	
<b>Concrete</b>	
Deficiency Quantity	15
Quantity Uom	S.F.
Potential Action	REPLACE
Urgency of Action	PRIORITY 3
Purpose of Action	LEVEL 2
Deficiency Photo1

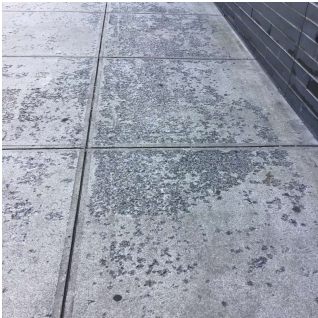
Main Entrance
Violations	No violations recorded.
<b>Pavers</b>	Does not Exist
<b>DOT Sidewalk</b>	Inspected
<b>Asphalt</b>	Does not Exist
<b>Concrete</b>	Inspected
Condition	4 - Between Fair and Poor
Deficiency	DAMAGED/DETERIORATED/MISSING SECTIONS
Deficiency Location/Instance	57th Street, 58th Street, 39th Avenue
Deficiency Quantity	2,000
Quantity Uom	S.F.
Potential Action	REPLACE
Urgency of Action	PRIORITY 3
Purpose of Action	LEVEL 2
Deficiency Photo1

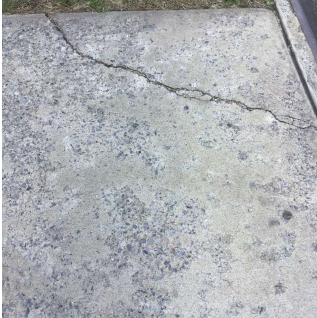
Question	Response
<b>SITE</b>	
<b>PAVING</b>	
<b>DOT Sidewalk</b>	
<b>Concrete</b>	Inspected

39th Avenue
Violations	No violations recorded.
<b>Pavers</b>	Inspected
Condition	2 - Between Good and Fair
Deficiency	DAMAGED/MISSING
Deficiency Location/Instance	58th Street
Deficiency Quantity	10
Quantity Uom	S.F.
Potential Action	REPLACE
Urgency of Action	PRIORITY 3
Purpose of Action	LEVEL 2
Deficiency Photo1
