**NYC Department of Education**  
**Building Condition Assessment Survey 2023 - 2024**

Architectural Inspection

**Asset:**        **PRE-K CENTER @ 56-01 61ST STREET - QUEENS, 56-01 61ST STREET, New York, 11378**

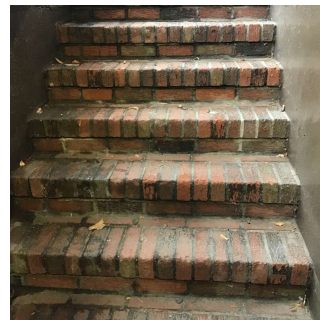
AW1

AREAWAY STAIRS: DETERIORATED  
TREADS/RISERS/NOSINGS

15  
S.F.  
REPLACE  
PRIORITY 4  
LEVEL 2

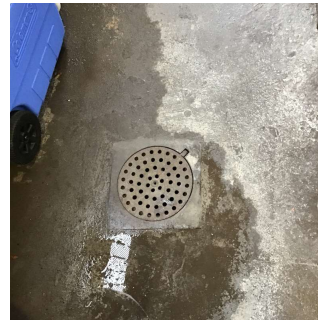
AW1  
No violations recorded.

**AREAWAY**

1  
EACH  
MAINTENANCE  
PRIORITY 5  
LEVEL 2

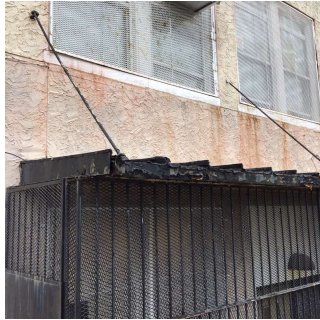
METAL: DETERIORATION/DAMAGED/MISSING PIECES

100  
S.F.  
REPLACE  
PRIORITY 4  
LEVEL 2

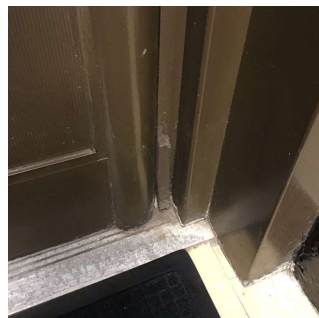
Question	Response
<b>EXTERIOR</b>	
<b>DOORS</b>	
<b>DOORS AND FRAMES</b>	
Deficiency	METAL: DETERIORATED DOOR - MINOR DETERIORATION
Roof Plan reference

Deficiency Quantity	2
Quantity Uom	EACH
Potential Action	MAINTENANCE
Urgency of Action	PRIORITY 3
Purpose of Action	LEVEL 2
Deficiency Photo1

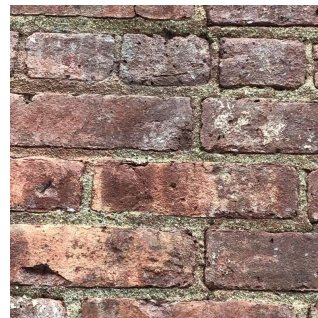
Facade C

BRICK: DETERIORATED JOINTS

300

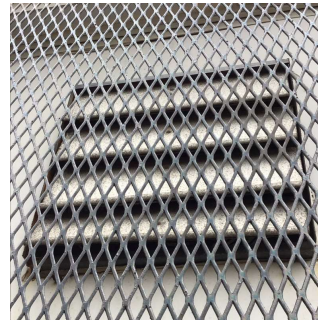
Facade B

BROKEN/ DENTED BLADES

10

REPLACE

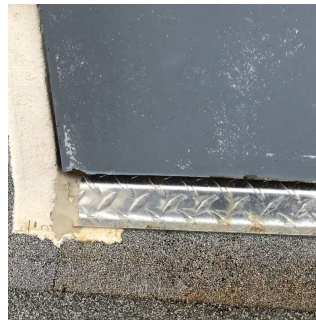
BH1  
No violations recorded.

BULKHEAD/PENTHOUSE DOORS: DETERIORATED DOOR

1  
EACH  
REPLACE DOOR  
PRIORITY 3  
LEVEL 2

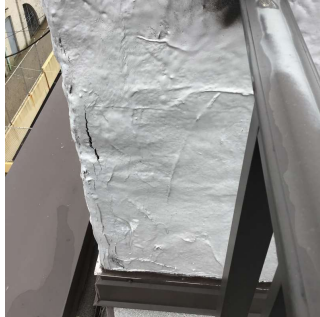
Deficiency **BULKHEAD/PENTHOUSE WALLS/EXTERIOR: CRACKS/SPALLING - MAJOR**

30  
S.F.  
REPLACE  
PRIORITY 4  
LEVEL 2

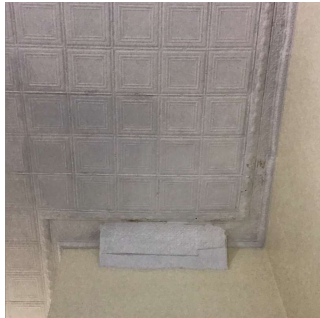
Violations	BH1 No violations recorded.
Deficiency	BULKHEAD/PENTHOUSE ROOF: MAJOR LEAKAGE
Roof Plan reference

Deficiency Quantity	100
Quantity Uom	S.F.
Potential Action	REPLACE
Urgency of Action	PRIORITY 5
Purpose of Action	LEVEL 2
Deficiency Photo1

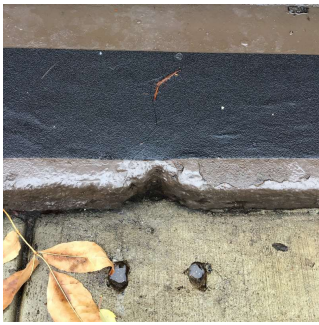
Inspected  
 3 - Fair  
 CONCRETE: WORN-OUT TREAD/RISER/NOSING

15  
 S.F.  
 REPLACE  
 PRIORITY 5  
 LEVEL 6

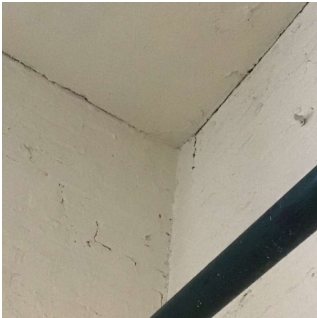
Question	Response
<b>INTERIOR</b>	
<b>STRUCTURAL</b>	
<b>FOUNDATION WALLS</b>	
Deficiency Quantity	20
Quantity Uom	S.F.
Potential Action	REPOINT
Urgency of Action	PRIORITY 4
Purpose of Action	LEVEL 5
Deficiency Photo1	 
Violations	Basement - Boiler Room No violations recorded.
Deficiency	<b>BRICK: CRACKED/SPALLED</b>
Deficiency Location/Instance	Basement - Boiler Room
Deficiency Quantity	20
Quantity Uom	S.F.
Potential Action	RESTITCH
Urgency of Action	PRIORITY 3
Purpose of Action	LEVEL 5
Deficiency Photo1

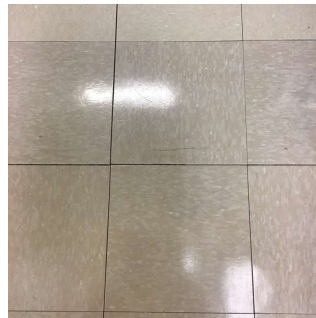
Corridor near Room 207A

VINYL TILES: BROKEN/DETERIORATED/MISSING TILES

REPLACE

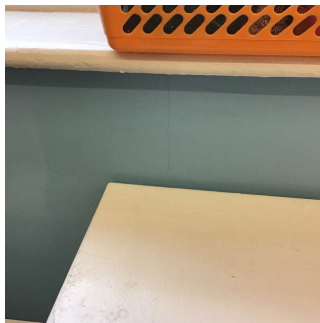
Room 109
Violations	No violations recorded.
Deficiency	PLASTER: CRACKS/SPALLING
Deficiency Location/Instance	Room 109
Deficiency Quantity	20
Quantity Uom	S.F.
Potential Action	REPLACE
Urgency of Action	PRIORITY 3
Purpose of Action	LEVEL 2

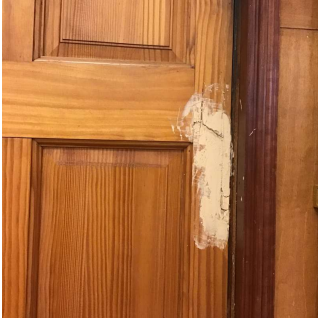
<b>LOCKER ROOM</b>	Does not Exist
<b>MULTI-PURPOSE ROOM</b>	Inspected
Instance on Basement	Inspected
<b>Ceiling</b>	
Instance on Basement	Inspected
Condition	2 - Between Good and Fair
Deficiency	No deficiencies recorded
<b>Door(s)</b>	
Instance on Basement	Inspected
Condition	3 - Fair
Deficiency	WOOD: DETERIORATED DOOR

Question	Response
<b>INTERIOR</b>	
<b>MULTI-PURPOSE ROOM</b>	
<b>Door(s)</b>	
Deficiency Location/Instance	Storage Room
Deficiency Quantity	1
Quantity Uom	EACH
Potential Action	MAINTENANCE
Urgency of Action	PRIORITY 3
Purpose of Action	LEVEL 2
Deficiency Photo1

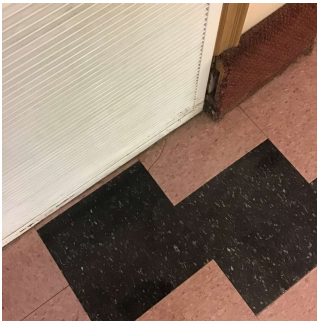
Violations	Near Stage No violations recorded.
Deficiency	VINYL TILES: BROKEN/DETERIORATED/MISSING TILES
Deficiency Location/Instance	Near Stage, steps right side, Center, Windows
Deficiency Quantity	20
Quantity Uom	S.F.

Potential Action	REPLACE
Urgency of Action	PRIORITY 3
Purpose of Action	LEVEL 2

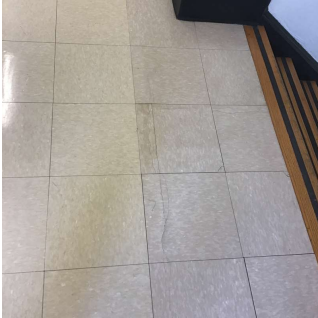
Deficiency	VINYL TILES: BROKEN/DETERIORATED/MISSING TILES

Question	Response
<b>INTERIOR</b>	
<b>STAIRS/RAMPS: INTERIOR</b>	
<b>Stairs and Landings</b>	
Deficiency Location/Instance	Stair A/Basement 1, 2, B/1, 2
Deficiency Quantity	50
Quantity Uom	S.F.
Potential Action	REPLACE
Urgency of Action	PRIORITY 3
Purpose of Action	LEVEL 2
Deficiency Photo1

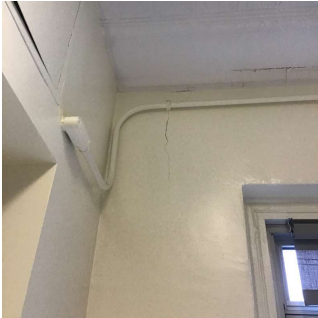
Violations	Stair A/2 No violations recorded.
<b>Walls</b>	Inspected
Condition	2 - Between Good and Fair
Deficiency	PLASTER: CRACKS/SPALLING
Deficiency Location/Instance	Stair A/1, B/Basement
Deficiency Quantity	40
Quantity Uom	S.F.
Potential Action	REPLACE
Urgency of Action	PRIORITY 3
Purpose of Action	LEVEL 2
Deficiency Photo1

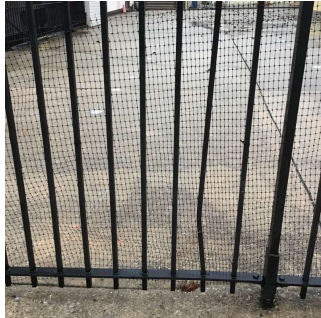
Violations	61st Street No violations recorded.
Deficiency	<b>WROUGHT IRON: DAMAGED/DETERIORATED</b>
Deficiency Location/Instance	61st Street
Deficiency Quantity	40
Quantity Uom	S.F.
Potential Action	REPLACE
Urgency of Action	PRIORITY 3
Purpose of Action	LEVEL 2
Deficiency Photo1

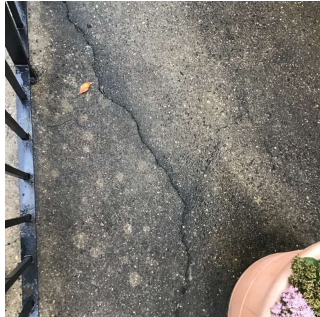
Violations	61st Street No violations recorded.
<b>IRRIGATION SYSTEM</b>	
	Does not Exist
<b>PAVING</b>	
	Inspected
<b>Student Non-Use</b>	
Gravel Exists?	Inspected No
<b>Asphalt</b>	
	Does not Exist
<b>Concrete</b>	
Condition	Inspected 3 - Fair
Deficiency	<b>DAMAGED/DETERIORATED/MISSING SECTIONS</b>
Deficiency Location/Instance	61st Street, AC Equipment area.
Deficiency Quantity	50
Quantity Uom	S.F.
Potential Action	REPLACE
Urgency of Action	PRIORITY 3
Purpose of Action	LEVEL 2

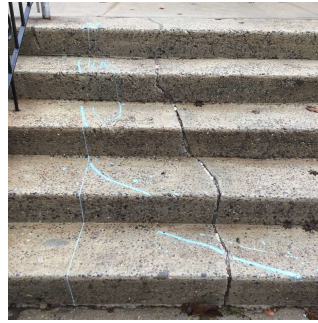
Question	Response
<b>SITE</b>	
<b>RETAINING WALLS</b>	Inspected
Deficiency Photo1	 
Violations	Schoolyard No violations recorded.
<b>SEATING</b>	Does not Exist
<b>SITE WALLS (NOT RETAINING WALLS)</b>	Does not Exist
<b>STAIRS/RAMPS: EXTERIOR</b>	Inspected
<b>Railings</b>	Inspected
Condition	3 - Fair
Deficiency	RUST - MAJOR
Deficiency Location/Instance	Near Playground
Deficiency Quantity	10
Quantity Uom	L.F.
Potential Action	REPLACE
Urgency of Action	PRIORITY 5
Purpose of Action	LEVEL 6
Deficiency Photo1	 
Violations	Near Playground No violations recorded.
<b>Site Cheek/flank Walls</b>	Inspected
Condition	2 - Between Good and Fair
Deficiency	No deficiencies recorded
<b>Stairs/ramps</b>	Inspected
Condition	3 - Fair
Deficiency	CAST IN PLACE CONCRETE: CRACKS/SPALLING - MAJOR
Deficiency Location/Instance	Near Playground
Deficiency Quantity	60
Quantity Uom	S.F.
Potential Action	REPLACE
Urgency of Action	PRIORITY 3
Purpose of Action	LEVEL 2
