**NYC Department of Education**  
**Building Condition Assessment Survey 2023 - 2024**

Architectural Inspection

**Asset:**        **PRE-K CENTER @ 46-16 76TH STREET - QUEENS, 46-16 76 STREET, New York, 11373**

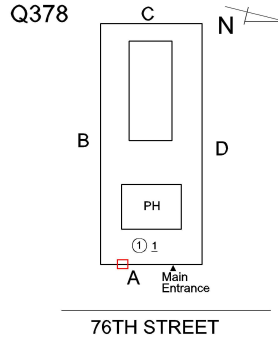
**PARAPETS**

Instance Condition	3 - Fair
Instance Quantity	800
Instance Quantity Uom	C.F.
Deficiency	CONCRETE: MINOR CRACKS, SPALLING
Roof Plan reference	Q378

Deficiency Quantity	20
Quantity Uom	S.F.
Potential Action	REPAIR
Urgency of Action	PRIORITY 3
Purpose of Action	LEVEL 2
Deficiency Photo1

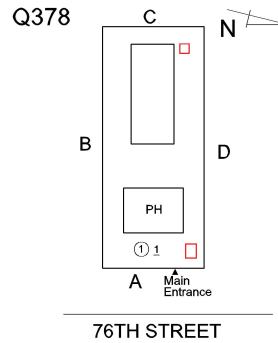
**ROOFING DRAINS**

Deficiency Quantity  
Quantity Uom  
Potential Action  
Urgency of Action  
Purpose of Action  
Deficiency Photo1

2  
EACH  
REPLACE  
PRIORITY 4  
LEVEL 2

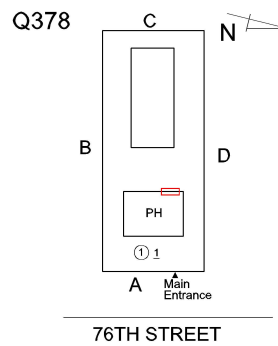
BULKHEAD/PENTHOUSE WALLS/INTERIOR: GYPSUM BOARD DAMAGED/DETERIORATED

Deficiency Quantity  
Quantity Uom  
Potential Action  
Urgency of Action  
Purpose of Action

10  
S.F.  
REPLACE  
PRIORITY 3  
LEVEL 2
