NYC Department of Education
Building Condition Assessment Survey 2023 - 2024

Architectural Inspection

Asset: **PRE-K CENTER @ 168-42 JAMAICA AVENUE - QUEENS, 168-42 JAMAICA AVENUE, New York, 11432**

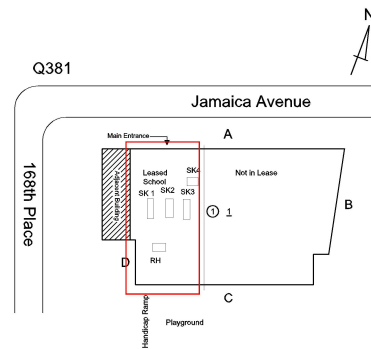
Question	Response
Architectural	
EXTERIOR	Inspected
AREAWAY	Does not Exist
AWNINGS AND CANOPIES	Does not Exist
CHIMNEY	Inspected
Material Type(s)	Metal
Condition	2 - Between Good and Fair
Deficiency	No deficiencies recorded
COPING	Inspected
Condition	2 - Between Good and Fair
Deficiency	METAL: DETERIORATED TRANSVERSE JOINTS
Roof Plan reference

30
L.F.
MAINTENANCE
PRIORITY 3
LEVEL 2

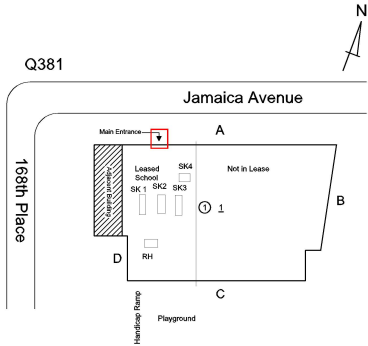
Violations	Roof 1 No violations recorded.
CORNICE	Inspected
Condition	2 - Between Good and Fair
Deficiency	No deficiencies recorded
DOORS	Inspected
DOORS AND FRAMES	Inspected
Condition	5 - Poor
Deficiency	METAL: DETERIORATED DOOR AND FRAME - MAJOR DETERIORATION
Roof Plan reference

Deficiency Quantity	2
Quantity Uom	EACH
Potential Action	REPLACE
Urgency of Action	PRIORITY 4
Purpose of Action	LEVEL 2
Deficiency Photo1

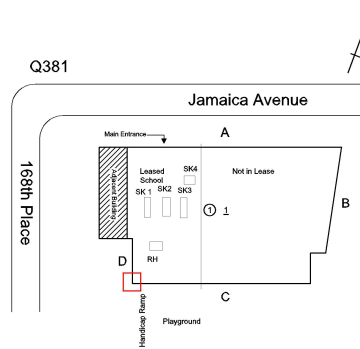
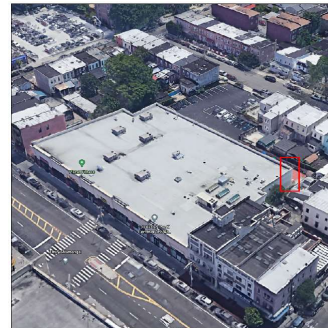
Question	Response
EXTERIOR	
DOORS	
LINTELS	Inspected
Condition	2 - Between Good and Fair
Deficiency	No deficiencies recorded
TRANSOM/SIDE LIGHT	Inspected
Condition	2 - Between Good and Fair
Deficiency	No deficiencies recorded
EXTERIOR WALLS	Inspected
Material Type(s)	Masonry, Concrete
Replacement Quantity	7,500
Replacement Uom	S.F.
Instance on All Facades	Inspected
Instance Condition	4 - Between Fair and Poor
Instance Quantity	7,500
Instance Quantity Uom	S.F.
Deficiency	CONCRETE MASONRY UNIT: MAJOR / THRU CRACKS
Roof Plan reference

100
S.F.
REMOVE AND REBUILD
PRIORITY 4
LEVEL 2

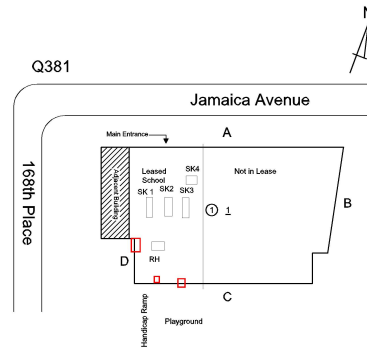
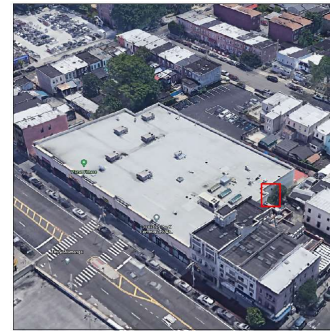
CONCRETE MASONRY UNIT: MINOR CRACKS AND SPALLING

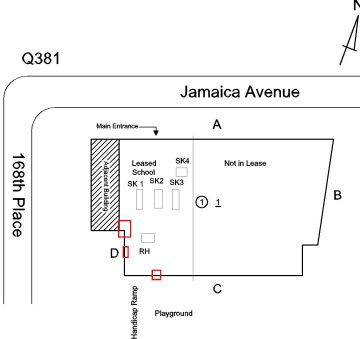
Question	Response
EXTERIOR	
PARAPETS	
Instance on All Facades	Inspected
Instance Condition	3 - Fair
Instance Quantity	1,850
Instance Quantity Uom	C.F.
Deficiency	CONCRETE MASONRY UNITS: MINOR CRACKS, SPALLING
Roof Plan reference

Deficiency Quantity	30
Quantity Uom	S.F.
Potential Action	REPAIR
Urgency of Action	PRIORITY 3
Purpose of Action	LEVEL 2
Deficiency Photo1

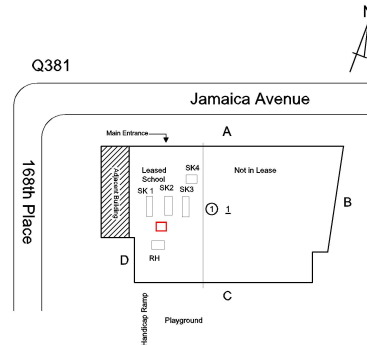
Question	Response
EXTERIOR	
ROOF	
Roofing	
ROOFING	
Instance Photo	 
	Roof 1
Instance Quantity	12,000
Instance Quantity Uom	S.F.
Does the roof have major mechanical equipment sitting on Dunnage Steel less than 18" above the Roofing?	No
Does this roof instance have a Sustainable Roof System?	Yes
Sustainable Roof Type	White Roof
Sustainable Roof Location (Roof Number)	Roof 1
Do solar panels exist on these roofs?	No
Is/Are the roof(s) suitable for Solar Panel installation?	No
Installation Year	2015
Source of Installation	Custodial Staff
Deficiency	MODIFIED BITUMEN: FLASHING: CAP FLASHING DAMAGED
Roof Plan reference	 
Deficiency Quantity	10
Quantity Uom	L.F.
Potential Action	REPLACE
Urgency of Action	PRIORITY 4
Purpose of Action	LEVEL 2
Deficiency Photo1	 
	Roof 1
Violations	No violations recorded.
Deficiency	MODIFIED BITUMEN: ROOFING: MAJOR ACTIVE ROOF LEAKS IN INSTRUCTIONAL SPACE

100
S.F.
REPLACE ROOFING WITHOUT MAJOR EQUIPMENT
REMOVAL
PRIORITY 5
LEVEL 2

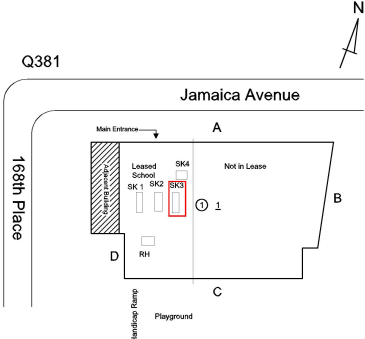
Question	Response
EXTERIOR	
ROOF	
Specialties	
SKYLIGHT/ROOF VENT	
Roof Plan reference

Deficiency Quantity	50
Quantity Uom	S.F.
Potential Action	MAINTENANCE
Urgency of Action	PRIORITY 3
Purpose of Action	LEVEL 2
Deficiency Photo1
