NYC Department of Education
Building Condition Assessment Survey 2023 - 2024

Architectural Inspection

Q387

Asset: **PRE-K CENTER @ 100-01 SPRINGFIELD BOULEVARD - QUEENS, 100-01**
SPRINGFIELD BOULEVARD, New York, 10429

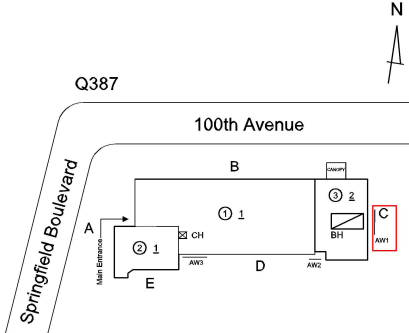
Question	Response
EXTERIOR	
AREAWAY	
Instance Quantity	3
Instance Quantity Uom	EACH
Deficiency	AREAWAY DRAINS: CLOGGED
Roof Plan reference

Deficiency Quantity	1
Quantity Uom	EACH
Potential Action	MAINTENANCE
Urgency of Action	PRIORITY 5
Purpose of Action	LEVEL 2
Deficiency Photo1

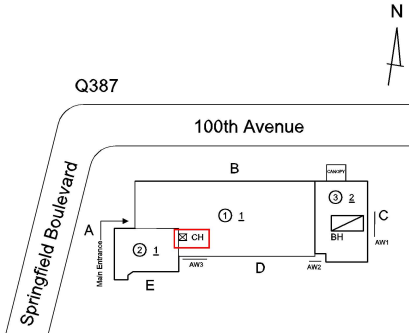
Violations	<p>Facade C - AW1</p> <p>No violations recorded.</p>
AWNINGS AND CANOPIES	
Condition	Inspected
Deficiency	2 - Between Good and Fair
Deficiency	No deficiencies recorded
CHIMNEY	
Material Type(s)	Inspected
Condition	Masonry
Condition	3 - Fair
Deficiency	BRICK: DETERIORATED JOINTS
Roof Plan reference

Deficiency Quantity	30
Quantity Uom	S.F.
Potential Action	REPOINT

Question	Response
EXTERIOR	
CHIMNEY	
Urgency of Action	PRIORITY 3
Purpose of Action	LEVEL 2
Deficiency Photo1

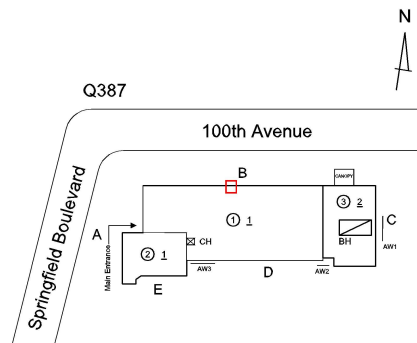
Roof 1
Violations	No violations recorded.
COPING	Does not Exist
CORNICE	Does not Exist
DOORS	Inspected
DOORS AND FRAMES	
Condition	2 - Between Good and Fair
Deficiency	No deficiencies recorded
DOOR HARDWARE	
Condition	3 - Fair
Deficiency	No deficiencies recorded
LINTELS	
Condition	2 - Between Good and Fair
Deficiency	No deficiencies recorded
TRANSOM/SIDE LIGHT	
Condition	2 - Between Good and Fair
Deficiency	No deficiencies recorded
EXTERIOR WALLS	
Material Type(s)	Masonry
Replacement Quantity	4,600
Replacement Uom	S.F.
Instance on All Facades	Inspected
Instance Condition	3 - Fair
Instance Quantity	4,600
Instance Quantity Uom	S.F.
Deficiency	BRICK: DETERIORATED CONTROL/EXPANSION JOINTS
Roof Plan reference

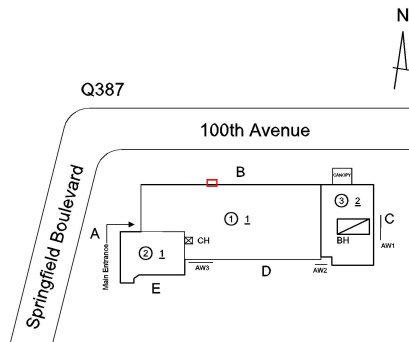
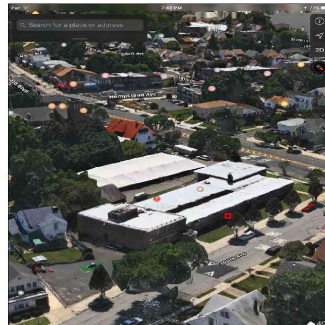
BRICK: DETERIORATED MASONRY SILLS - MINOR

REPAIR

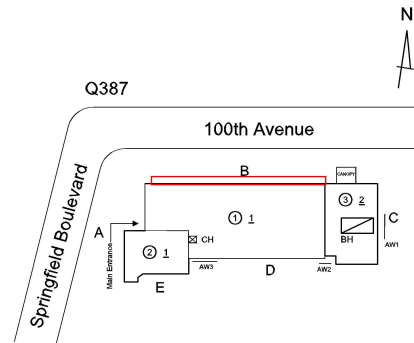
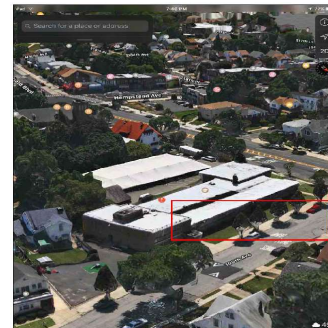
BRICK: MASONRY SILLS - DETERIORATED JOINTS

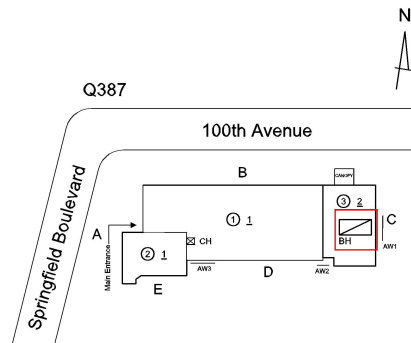
Deficiency	No deficiencies recorded
ROOFING DRAINS	Inspected
Condition	2 - Between Good and Fair
Deficiency	No deficiencies recorded
Specialties	Inspected
BULKHEAD/PENTHOUSE	Inspected
Condition	3 - Fair
Deficiency	BULKHEAD/PENTHOUSE WALLS/EXTERIOR: DETERIORATED JOINTS
Roof Plan reference

Question	Response
EXTERIOR	
ROOF	
Specialties	
BULKHEAD/PENTHOUSE	
Deficiency Quantity	100
Quantity Uom	S.F.
Potential Action	REPOINT
Urgency of Action	PRIORITY 3
Purpose of Action	LEVEL 2
Deficiency Photo1	 
Violations	Roof 1 - Bulkhead No violations recorded.
CUPOLA/ SPIRES/ TOWERS	Does not Exist
DORMER	Does not Exist
DUNNAGE STEEL	Does not Exist
SKYLIGHT/ROOF VENT	Does not Exist
ROOF/GRAVITY TANK	Does not Exist
STAIRS/RAMPS: EXTERIOR	Does not Exist
WINDOWS	Inspected
Replacement Quantity	3,000
Replacement Uom	S.F.
EXTERIOR GUARDS	Inspected
Condition	2 - Between Good and Fair
Deficiency	No deficiencies recorded
LINTELS	Inspected
Condition	2 - Between Good and Fair
Deficiency	No deficiencies recorded
WINDOWS	Inspected
Material Type(s)	Aluminum
Instance on Aluminum - Other: All Facades	Inspected
Instance Condition	1 - Good
Instance Quantity	3,000
Instance Quantity Uom	S.F.
Are these windows insulated	Yes
Installation Year	2020
