NYC Department of Education
Building Condition Assessment Survey 2023 - 2024

Architectural Inspection

Asset: **PRE-K CENTER @ 96-10 23RD AVENUE - QUEENS, 96-10 23 AVENUE, New York, 11369**

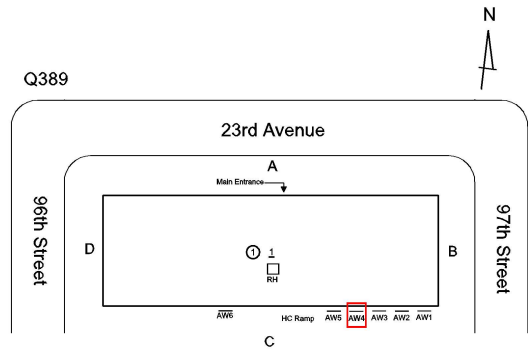
Roof Plan reference

Question	Response
Architectural	
EXTERIOR	Inspected
AREAWAY	Inspected
Instance on AW1 - AW6	Inspected
Instance Condition	3 - Fair
Instance Quantity	6
Instance Quantity Uom	EACH
Deficiency	AREAWAY WALLS: CRACKS AND SPALLING

AREAWAY

10
S.F.
REPLACE
PRIORITY 4
LEVEL 2

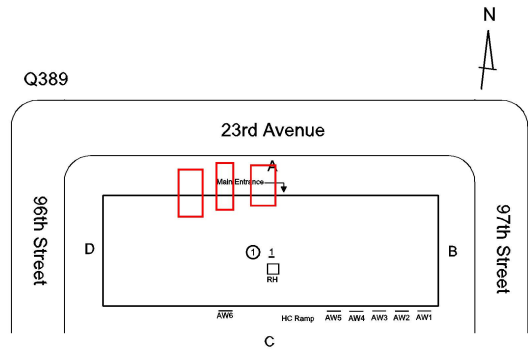
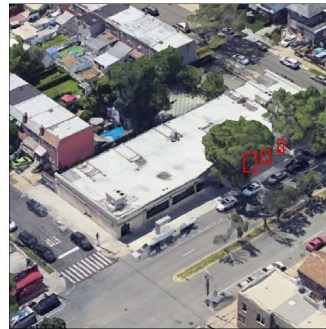
Question	Response
EXTERIOR	
EXTERIOR WALLS	
Replacement Uom	S.F.
Instance on All Facades	Inspected
Instance Condition	3 - Fair
Instance Quantity	6,000
Instance Quantity Uom	S.F.
Deficiency	CONCRETE MASONRY UNIT: MAJOR / THRU CRACKS
Roof Plan reference	 
Elevation	 
Deficiency Quantity	30
Quantity Uom	S.F.
Potential Action	REMOVE AND REBUILD
Urgency of Action	PRIORITY 4
Purpose of Action	LEVEL 2
Deficiency Photo1	 
Violations	Facade C No violations recorded.
Deficiency	STUCCO CEMENT SURFACE: CRACKS, SPALLING

EXTERIOR WALLS

30

REPLACE

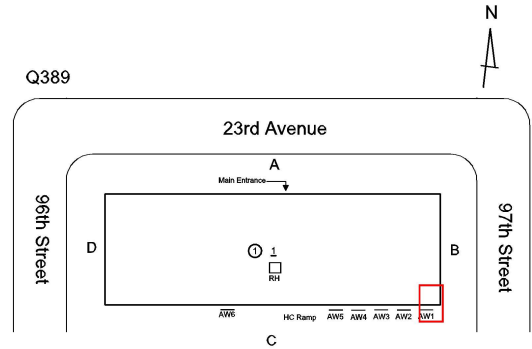
Question	Response
EXTERIOR	
PARAPETS	Inspected
Deficiency	No deficiencies recorded
PLAZA DECK	Does not Exist
ROOF	Inspected
Roofing	Inspected
Replacement Quantity	11,000
Replacement Uom	S.F.
ROOF HATCH/SMOKE HATCH	Inspected
Condition	2 - Between Good and Fair
Deficiency	No deficiencies recorded
LEADERS, GUTTERS, DOWNSPOUTS, SCUPPERS	Inspected
Condition	3 - Fair
Deficiency	DAMAGED/MISSING
Roof Plan reference

10
L.F.
REPLACE
PRIORITY 4
LEVEL 2

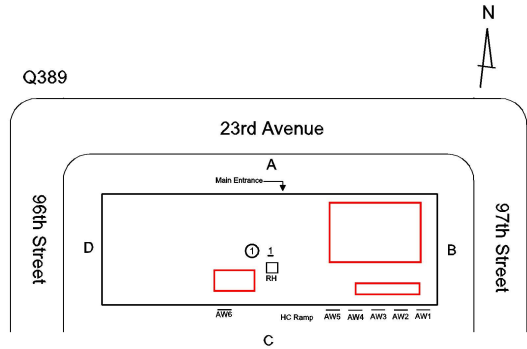
Roof 1
Instance Quantity	11,000
Instance Quantity Uom	S.F.
Does the roof have major mechanical equipment sitting on Dunnage Steel less than 18" above the Roofing?	Yes
Does this roof instance have a Sustainable Roof System?	Yes
Sustainable Roof Type	White Roof
Sustainable Roof Location (Roof Number)	Roof 1
Do solar panels exist on these roofs?	No
Is/Are the roof(s) suitable for Solar Panel installation?	Yes
Installation Year	2015
Source of Installation	Custodial Staff
Deficiency	MODIFIED BITUMEN: ROOFING: DELAMINATION
Roof Plan reference

Deficiency Quantity	300
Quantity Uom	S.F.
Potential Action	REPLACE ROOFING WITHOUT MAJOR EQUIPMENT REMOVAL
Urgency of Action	PRIORITY 4
Purpose of Action	LEVEL 2
Deficiency Photo1

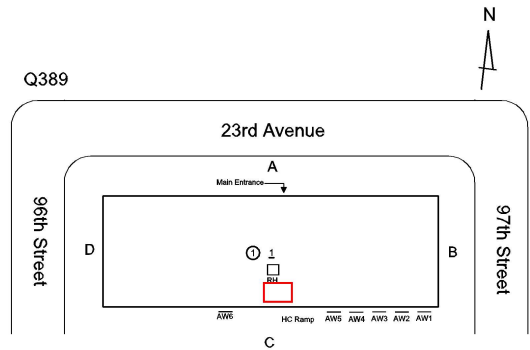
Roof Plan reference

Roof 1
Violations	No violations recorded.
Deficiency	MODIFIED BITUMEN: ROOFING: MAJOR ACTIVE ROOF LEAKS IN NON-INSTRUCTIONAL SPACE

ROOFING

100
S.F.
REPLACE ROOFING WITHOUT MAJOR EQUIPMENT
REMOVAL
PRIORITY 5
LEVEL 2

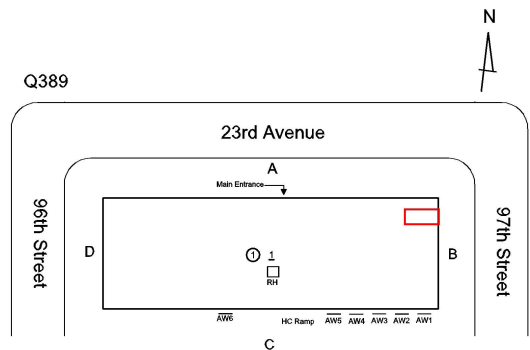
Roof Plan reference

MODIFIED BITUMEN: ROOFING: MAJOR ACTIVE ROOF
LEAKS IN INSTRUCTIONAL SPACE

100
S.F.
REPLACE ROOFING WITHOUT MAJOR EQUIPMENT
REMOVAL
PRIORITY 5
LEVEL 2

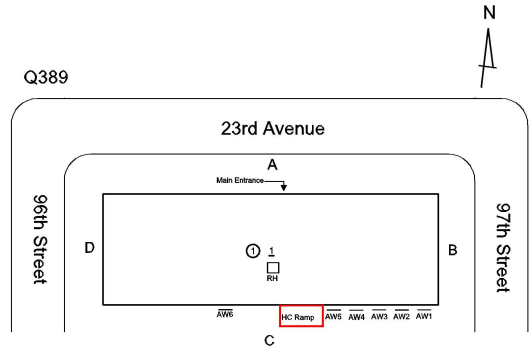
Question	Response
EXTERIOR	
ROOF	Inspected
Specialties	Inspected
ROOF/GRAVITY TANK	Does not Exist
STAIRS/RAMPS: EXTERIOR	Inspected
BUILDING CHEEK/FLANK WALLS	Inspected
Condition	3 - Fair
Deficiency	CAST IN PLACE CONCRETE: CRACKS/SPALLING - MAJOR
Roof Plan reference

15
S.F.
REPLACE
PRIORITY 4
LEVEL 2

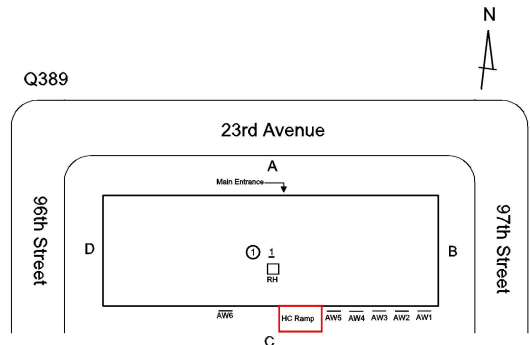
RAILINGS	Inspected
Condition	2 - Between Good and Fair
Deficiency	No deficiencies recorded
STAIRS/RAMPS	Inspected
Condition	4 - Between Fair and Poor
Deficiency	CONCRETE: CRACKS/SPALLING - MAJOR
Roof Plan reference

Question	Response
EXTERIOR	
STAIRS/RAMPS: EXTERIOR	Inspected
STAIRS/RAMPS	
Deficiency Quantity	20
Quantity Uom	S.F.
Potential Action	REPLACE
Urgency of Action	PRIORITY 4
Purpose of Action	LEVEL 2
Deficiency Photo1	 
Violations	Facade C No violations recorded.
WINDOWS	Inspected
Replacement Quantity	1,000
Replacement Uom	S.F.
EXTERIOR GUARDS	Inspected
Condition	2 - Between Good and Fair
Deficiency	No deficiencies recorded
LINTELS	Inspected
Condition	2 - Between Good and Fair
Deficiency	No deficiencies recorded
WINDOWS	Inspected
Material Type(s)	Aluminum
Instance on Aluminum - Other: Facades A, C, D	Inspected
Instance Condition	3 - Fair
Instance Quantity	1,000
Instance Quantity Uom	S.F.
Are these windows insulated	Yes
Installation Year	2015
Source of Installation	Custodial Staff
Deficiency	ALUMINUM - OTHER: AIR/WATER INFILTRATION
Roof Plan reference
