**NYC Department of Education**  
**Building Condition Assessment Survey 2023 - 2024**

Architectural Inspection

**Asset:** SAINT TERESA OF AVILA SCHOOL - QUEENS, 109-55 128 STREET, 11420

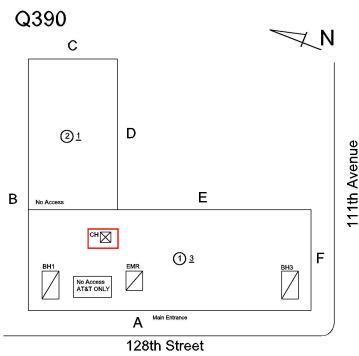
BRICK: DETERIORATED CAP

Violations	Roof 1 - open cap allows water leaks to below No violations recorded.
<b>COPING</b>	
Condition	Inspected
Deficiency	2 - Between Good and Fair
Deficiency	No deficiencies recorded
<b>CORNICE</b>	
Condition	Does not Exist
<b>DOORS</b>	
Condition	Inspected
<b>DOORS AND FRAMES</b>	
Condition	Inspected
Deficiency	4 - Between Fair and Poor
Deficiency	WOOD: DETERIORATED DOOR AND FRAME - MAJOR DETERIORATION
Roof Plan reference	<p>Q390</p>

REPLACE

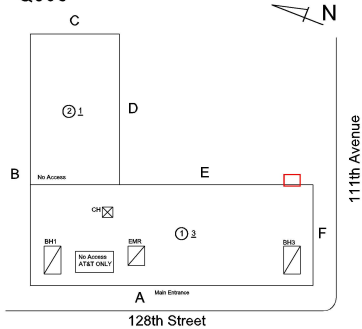
Deficiency Quantity	2
Quantity Uom	EACH
Potential Action	REPLACE
Urgency of Action	PRIORITY 4
Purpose of Action	LEVEL 2
Deficiency Photo1

Violations	Facade E No violations recorded.
<b>DOOR HARDWARE</b>	
Condition	Inspected
Condition	3 - Fair

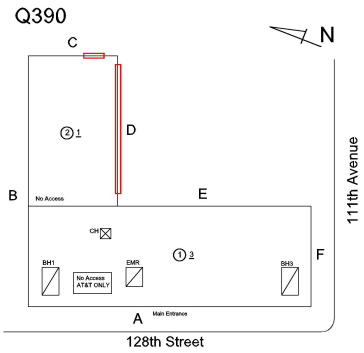
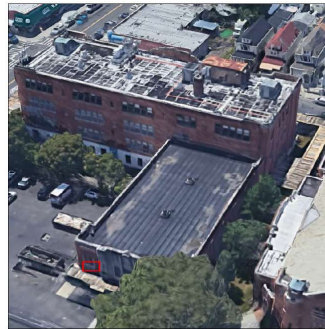
Roof Plan reference

BRICK: DETERIORATED MASONRY SILLS - MAJOR

REMOVE AND REPLACE

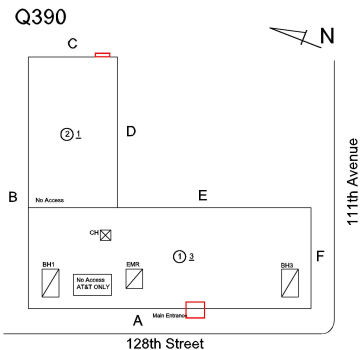
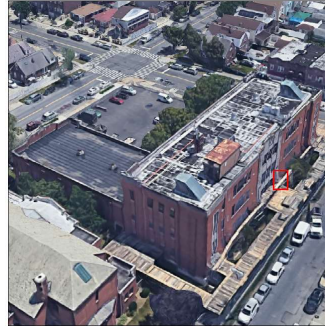
Roof Plan reference

STONE: CHIPPED/SPALLED/BROKEN PIECES - MINOR

REPAIR

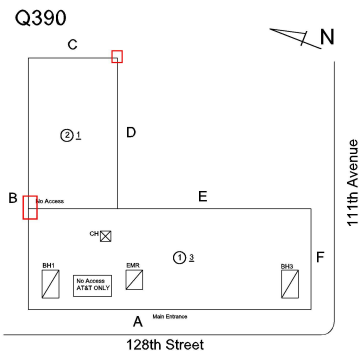
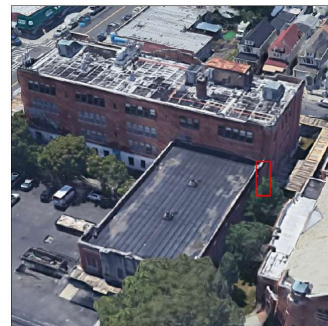
Roof Plan reference

BRICK: CRACKS/DISPLACED/SPALLED BRICK AT BUILDING CORNERS

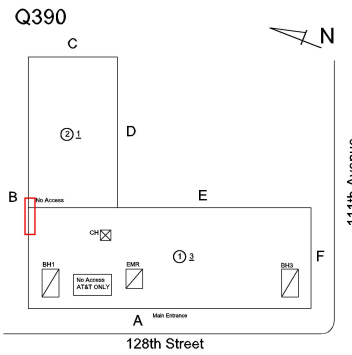
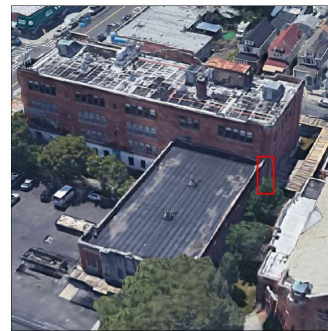
Roof Plan reference

**BRICK: DETERIORATED JOINTS**

2,000  
S.F.  
REPOINT  
PRIORITY 3  
LEVEL 2

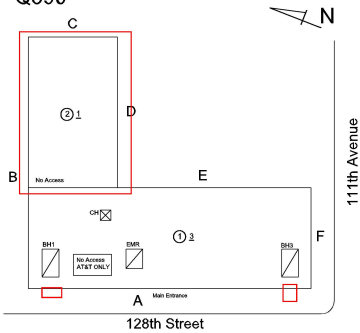
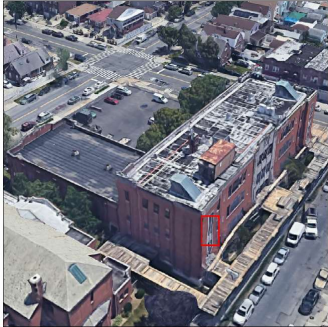
Question	Response
<b>EXTERIOR</b>	
<b>EXTERIOR WALLS</b>	
Violations	Facade B No violations recorded.
Deficiency	GLASS BLOCK: CHIPPED/ BROKEN PIECES
Roof Plan reference	Q390

Deficiency Quantity	100
Quantity Uom	S.F.
Potential Action	REPLACE-IN-KIND
Urgency of Action	PRIORITY 4
Purpose of Action	LEVEL 2
Deficiency Photo1

Violations	Facade A No violations recorded.
<b>EXTERIOR SOFFITS</b>	Does not Exist
<b>LOADING DOCK</b>	Does not Exist
<b>LOUVER</b>	Inspected
Condition	2 - Between Good and Fair
Deficiency	No deficiencies recorded
<b>PARAPETS</b>	Inspected
Material Type(s)	Masonry
Replacement Quantity	2,200
Replacement Uom	C.F.

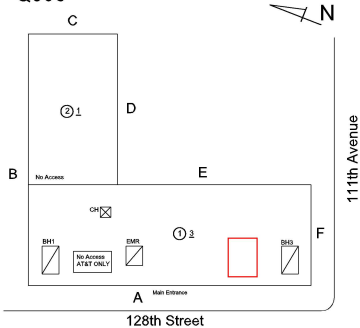
Question	Response
<b>EXTERIOR</b>	
<b>ROOF</b>	
<b>Specialties</b>	
<b>DUNNAGE STEEL</b>	Inspected
Condition	2 - Between Good and Fair
Deficiency	HEIGHT LESS THAN 18"
Roof Plan reference	<p>Q390</p>

Deficiency Quantity	40
Quantity Uom	L.F.
Potential Action	REPLACE
Urgency of Action	PRIORITY 3
Purpose of Action	LEVEL 2
Deficiency Photo1

Violations	Roof 1 No violations recorded.
<b>SKYLIGHT/ROOF VENT</b>	Does not Exist
<b>ROOF/GRAVITY TANK</b>	Does not Exist
<b>STAIRS/RAMPS: EXTERIOR</b>	Inspected
<b>BUILDING CHEEK/FLANK WALLS</b>	Does not Exist
<b>RAILINGS</b>	Inspected
Condition	2 - Between Good and Fair
Deficiency	No deficiencies recorded
<b>STAIRS/RAMPS</b>	Inspected
Condition	2 - Between Good and Fair
Deficiency	No deficiencies recorded
<b>WINDOWS</b>	Inspected
Replacement Quantity	2,500
Replacement Uom	S.F.
<b>EXTERIOR GUARDS</b>	Inspected
Condition	3 - Fair
Deficiency	DETERIORATED/TORN-OUT/MISSING

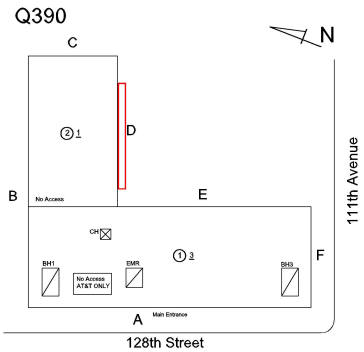
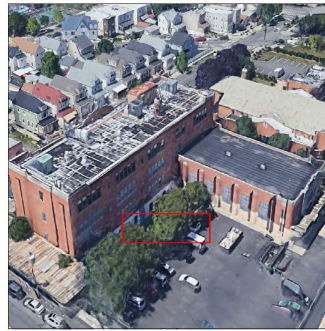
Roof Plan reference

**EXTERIOR GUARDS**

100  
S.F.  
REPLACE  
PRIORITY 4  
LEVEL 2

Facade D  
No violations recorded.

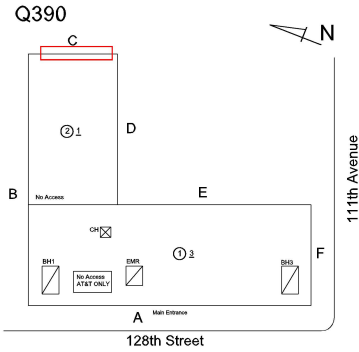
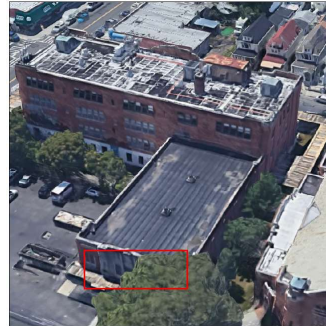
Roof Plan reference

Deficiency	No deficiencies recorded
Instance on Wood: Facade C	Inspected
Instance Condition	5 - Poor
Instance Quantity	100
Instance Quantity Uom	S.F.
Are these windows insulated	No
Installation Year	1953
Source of Installation	Custodial Staff

Deficiency **WOOD: DETERIORATED**

100  
S.F.  
REPLACE WINDOW  
PRIORITY 4  
LEVEL 2

Facade C  
No violations recorded.
