**NYC Department of Education**  
**Building Condition Assessment Survey 2023 - 2024**

Architectural Inspection

**Q404**

**Asset: HUNTERS POINT CAMPUS - QUEENS, 1-50 51ST AVENUE, New York, 11101**

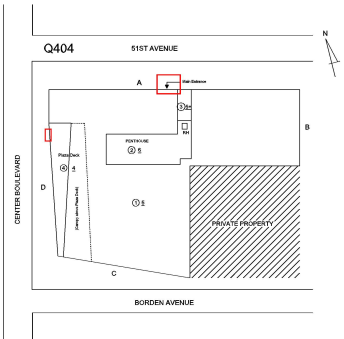
Question	Response
<b>EXTERIOR</b>	
<b>COPING</b>	
Deficiency	No deficiencies recorded
<b>CORNICE</b>	Does not Exist
<b>DOORS</b>	Inspected
<b>DOORS AND FRAMES</b>	Inspected
Condition	3 - Fair
Deficiency	METAL: DETERIORATED DOOR AND FRAME - MINOR DETERIORATION
Roof Plan reference

Deficiency Quantity	6
Quantity Uom	EACH
Potential Action	MAINTENANCE
Urgency of Action	PRIORITY 3
Purpose of Action	LEVEL 2
Deficiency Photo1	No photo recorded
Violations	No violations recorded.
<b>DOOR HARDWARE</b>	Inspected
Condition	3 - Fair
Deficiency	No deficiencies recorded
<b>LINTELS</b>	Inspected
Condition	2 - Between Good and Fair
Deficiency	No deficiencies recorded
<b>TRANSOM/SIDE LIGHT</b>	Inspected
Condition	2 - Between Good and Fair
Deficiency	No deficiencies recorded
<b>EXTERIOR WALLS</b>	Inspected
Material Type(s)	Masonry, Steel
Replacement Quantity	25,000
Replacement Uom	S.F.
Instance on All Facades	Inspected
Instance Condition	3 - Fair

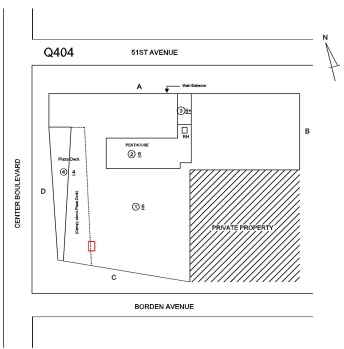
Question	Response
<b>EXTERIOR</b>	
<b>PARAPETS</b>	Inspected
Instance Quantity	9,000
Instance Quantity Uom	C.F.
Deficiency	No deficiencies recorded
<b>PLAZA DECK</b>	Inspected
Instance on Pavers: Roof 4	Inspected
Instance Condition	2 - Between Good and Fair
Instance Quantity	5,000
Instance Quantity Uom	S.F.
Installation Year	2013
Source of Installation	Custodial Staff
Deficiency	No deficiencies recorded
<b>ROOF</b>	Inspected
<b>Roofing</b>	Inspected
Replacement Quantity	35,400
Replacement Uom	S.F.
<b>ROOF HATCH/SMOKE HATCH</b>	Inspected
Condition	2 - Between Good and Fair
Deficiency	No deficiencies recorded
<b>LEADERS, GUTTERS, DOWNSPOUTS, SCUPPERS</b>	Inspected
Condition	3 - Fair
Deficiency	DAMAGED/MISSING
Roof Plan reference

Deficiency Quantity	10
Quantity Uom	L.F.
Potential Action	REPLACE
Urgency of Action	PRIORITY 4
Purpose of Action	LEVEL 2
Deficiency Photo1

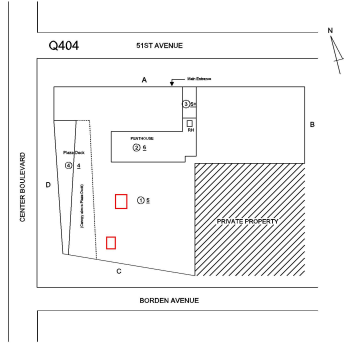
Roof 1
Instance Quantity	35,000
Instance Quantity Uom	S.F.
Does the roof have major mechanical equipment sitting on Dunnage Steel less than 18" above the Roofing?	No
Does this roof instance have a Sustainable Roof System?	No
Do solar panels exist on these roofs?	No
Is/Are the roof(s) suitable for Solar Panel installation?	No
Installation Year	2013
Source of Installation	Custodial Staff
Deficiency	<b>IRMA: ROOFING: MAJOR ACTIVE ROOF LEAKS IN INSTRUCTIONAL SPACE</b>
Roof Plan reference

Deficiency Quantity	300
Quantity Uom	S.F.
Potential Action	<b>REPLACE ROOFING WITHOUT MAJOR EQUIPMENT REMOVAL</b>
Urgency of Action	<b>PRIORITY 5</b>

Purpose of Action	<b>LEVEL 4</b>

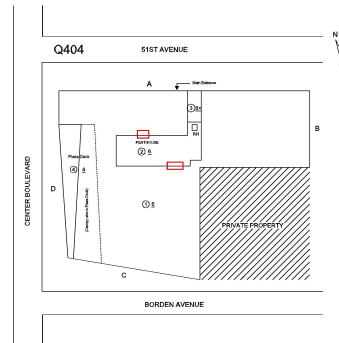
Violations	Roof 1 - Penthouse No violations recorded.
Deficiency	BULKHEAD/PENTHOUSE WALLS/EXTERIOR: EFFLORESCENCE

Deficiency Quantity	50
Quantity Uom	S.F.
Potential Action	MAINTENANCE
Urgency of Action	PRIORITY 1
Purpose of Action	LEVEL 1
Deficiency Photo1	No photo recorded
Violations	No violations recorded.

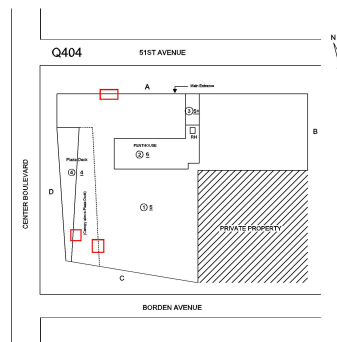
ALUMINUM - OTHER: BROKEN PANE

Question	Response
<b>EXTERIOR</b>	
<b>WINDOWS</b>	
<b>WINDOWS</b>	
Elevation	 
Deficiency Quantity	90
Quantity Uom	S.F.
Potential Action	MAINTENANCE
Urgency of Action	PRIORITY 3
Purpose of Action	LEVEL 2
Deficiency Photo1

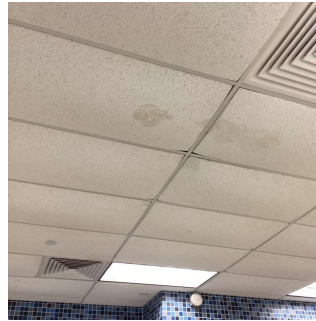
Near Windows

Near Serving Area
Violations	No violations recorded.
Instance on 5th Floor - Room 505	Inspected
Condition	2 - Between Good and Fair
Deficiency	ACOUSTIC TILES: DAMAGED/MISSING
Deficiency Location/Instance	Near center, Windows, Hall
Deficiency Quantity	70
Quantity Uom	S.F.
Potential Action	REPLACE
Urgency of Action	PRIORITY 3
Purpose of Action	LEVEL 2

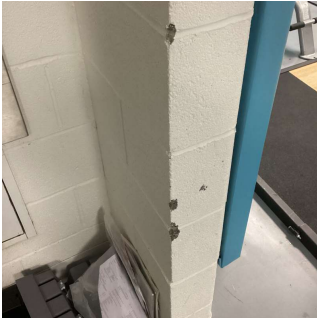
Question	Response
<b>INTERIOR</b>	
<b>MULTI-PURPOSE ROOM</b>	
<b>Stage</b>	
Instance on 2nd Floor - Room 230/240	Does not Exist
<b>Walls</b>	
Instance on 2nd Floor - Room 230/240	Inspected
Condition	2 - Between Good and Fair
Deficiency	MASONRY: CRACKS/SPALLING
Deficiency Location/Instance	Near Drinking Fountain
Deficiency Quantity	10
Quantity Uom	S.F.
Potential Action	REPLACE
Urgency of Action	PRIORITY 3
Purpose of Action	LEVEL 2
Deficiency Photo1

Near Drinking Fountain
Violations	No violations recorded.
<b>Window Curtains/Shades/Blinds</b>	
Instance on 2nd Floor - Room 230/240	Does not Exist
<b>SCIENCE DEMO ROOM</b>	
	Does not Exist
<b>SCIENCE LAB</b>	
Instance on Room 519	Inspected
Alternative use	No
Instance on Rooms 319, 323, 523, 525	Inspected
Alternative use	No
<b>Fixed Equipment</b>	
Instance on Room 519	Inspected
Condition	3 - Fair
Deficiency	CABINETS: MISSING/DAMAGED
Deficiency Location/Instance	Room 519

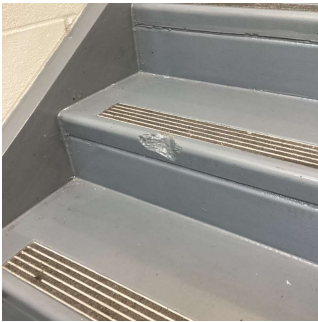
Question	Response
<b>INTERIOR</b>	
<b>STAIRS/RAMPS: INTERIOR</b>	
<b>Partition</b>	Does not Exist
<b>Railings</b>	Inspected
Condition	2 - Between Good and Fair
Deficiency	No deficiencies recorded
<b>Stairs and Landings</b>	Inspected
Condition	2 - Between Good and Fair
Deficiency	CONCRETE: CRACKS/SPALLING - MAJOR
Deficiency Location/Instance	Stair B/1
Deficiency Quantity	10
Quantity Uom	S.F.
Potential Action	REPLACE
Urgency of Action	PRIORITY 3
Purpose of Action	LEVEL 2
Deficiency Photo1

Violations	Stair B/1 No violations recorded.
Deficiency	CERAMIC TILE: BROKEN/MISSING
Deficiency Location/Instance	Stair C/5
Deficiency Quantity	10
Quantity Uom	S.F.
Potential Action	REPLACE
Urgency of Action	PRIORITY 3
Purpose of Action	LEVEL 2
Deficiency Photo1

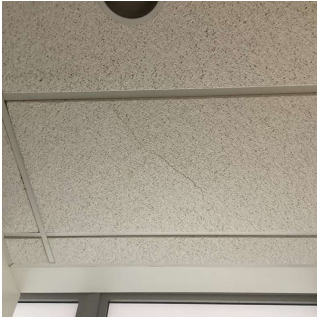
Question	Response
<b>INTERIOR</b>	
<b>STAIRS/RAMPS: INTERIOR</b>	
<b>Walls</b>	
Potential Action	REPLACE
Urgency of Action	PRIORITY 3
Purpose of Action	LEVEL 2
Deficiency Photo1	 
	Stair A/4
Violations	No violations recorded.
<b>TOILET ROOMS - STAFF</b>	Inspected
<b>Ceiling</b>	Inspected
Condition	2 - Between Good and Fair
Deficiency	ACOUSTIC TILES: DAMAGED/MISSING
Deficiency Location/Instance	Room 246F
Deficiency Quantity	10
Quantity Uom	S.F.
Potential Action	REPLACE
Urgency of Action	PRIORITY 3
Purpose of Action	LEVEL 2
Deficiency Photo1

Room 246F
Violations	No violations recorded.
<b>Door(s)</b>	Inspected
Condition	2 - Between Good and Fair
Deficiency	No deficiencies recorded
<b>Floor Finish</b>	Inspected
Condition	2 - Between Good and Fair
Deficiency	No deficiencies recorded
<b>Stalls</b>	Does not Exist
<b>Walls</b>	Inspected
Condition	2 - Between Good and Fair
Deficiency	No deficiencies recorded
<b>TOILET ROOMS - STUDENTS</b>	Inspected

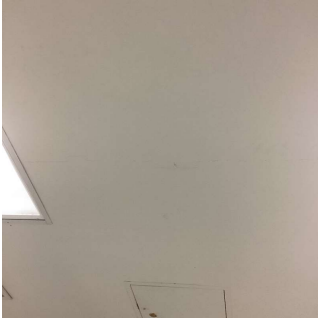
Question	Response
<b>INTERIOR</b>	
<b>TOILET ROOMS - STUDENTS</b>	
<b>Ceiling</b>	
Condition	2 - Between Good and Fair
Deficiency	GYPSUM BOARD: DAMAGED/DETERIORATED
Deficiency Location/Instance	Rooms 131, 337
Deficiency Quantity	20
Quantity Uom	S.F.
Potential Action	REPLACE
Urgency of Action	PRIORITY 3
Purpose of Action	LEVEL 2
Deficiency Photo1

Violations	Room 131 No violations recorded.
<b>Door(s)</b>	
Condition	Inspected
Condition	2 - Between Good and Fair
Deficiency	WOOD: DETERIORATED DOOR
Deficiency Location/Instance	Room 335
Deficiency Quantity	1
Quantity Uom	EACH
Potential Action	MAINTENANCE
Urgency of Action	PRIORITY 3
Purpose of Action	LEVEL 2
Deficiency Photo1

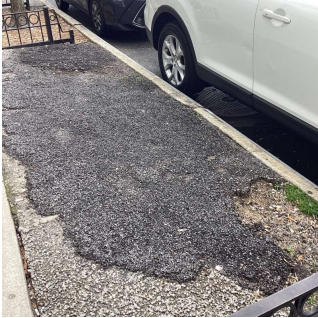
Condition	2 - Between Good and Fair
Deficiency	No deficiencies recorded
<b>Pavers</b>	Inspected
Condition	2 - Between Good and Fair
Deficiency	No deficiencies recorded
<b>DOT Sidewalk</b>	Inspected
<b>Asphalt</b>	Inspected
Condition	3 - Fair
Deficiency	CRACKS - MAJOR
Deficiency Location/Instance	Center Boulevard
Deficiency Quantity	120
Quantity Uom	S.F.
Potential Action	REPLACE
Urgency of Action	PRIORITY 3
Purpose of Action	LEVEL 2
Deficiency Photo1

Question	Response
<b>SITE</b>	
<b>PAVING</b>	
<b>DOT Sidewalk</b>	
<b>Asphalt</b>	Inspected
	Center Boulevard
Violations	No violations recorded.
<b>Concrete</b>	Inspected
Condition	4 - Between Fair and Poor
Deficiency	DAMAGED CURBS
Deficiency Location/Instance	51st Avenue, Borden Avenue, Center Boulevard
Deficiency Quantity	105
Quantity Uom	L.F.
Potential Action	REPLACE
Urgency of Action	PRIORITY 3
Purpose of Action	LEVEL 2
Deficiency Photo1

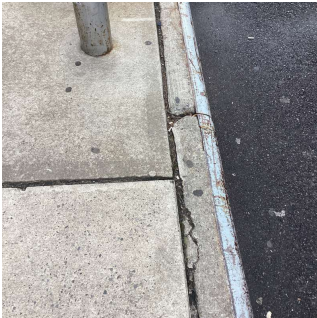
51st Avenue
Violations	No violations recorded.
Deficiency	DAMAGED/DETERIORATED/MISSING SECTIONS
Deficiency Location/Instance	51st Avenue, Borden Avenue, Center Boulevard
Deficiency Quantity	450
Quantity Uom	S.F.
Potential Action	REPLACE
Urgency of Action	PRIORITY 3
Purpose of Action	LEVEL 2
Deficiency Photo1
