**NYC Department of Education**  
**Building Condition Assessment Survey 2023 - 2024**

Architectural Inspection

Asset: **PRE-K CENTER @ 14-45 143RD STREET - QUEENS, 14-45 143RD STREET, New York, 11357**

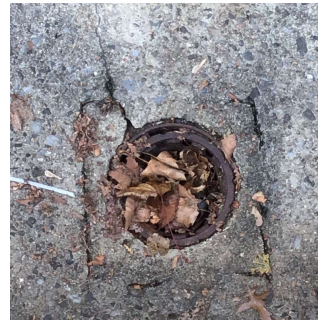
AW3

**AREAWAY DRAINS: DETERIORATED**

REPLACE

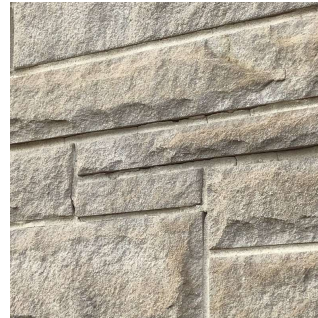
Facade C

STONE: DETERIORATED JOINTS

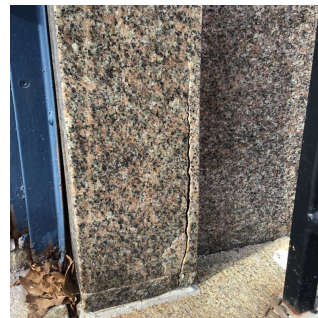
Facade C

STONE: CHIPPED/SPALLED/BROKEN PIECES - MAJOR

10  
S.F.  
REPLACE  
PRIORITY 4  
LEVEL 2

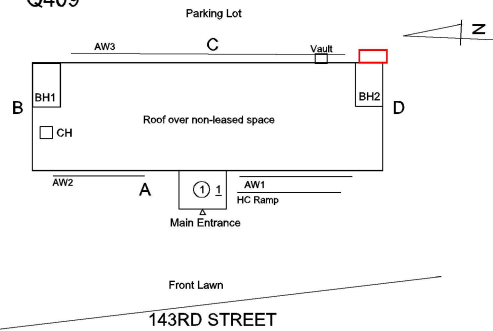
**CONCRETE: CRACKS/SPALLING - MAJOR**

10  
S.F.  
REPLACE  
PRIORITY 4  
LEVEL 2

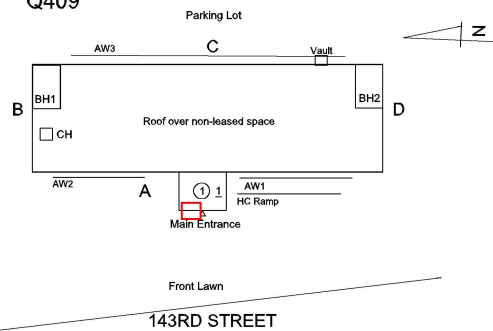
STONE: CRACKS/SPALLING - MINOR

10  
S.F.  
REPAIR  
PRIORITY 3  
LEVEL 2

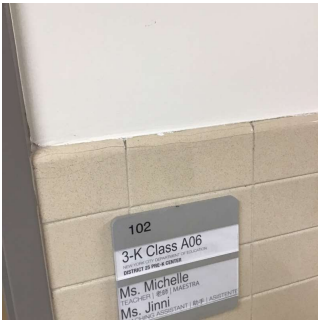
<b>Question</b>	<b>Response</b>
<b>INTERIOR</b>	
<b>CLASSROOMS/CORRIDORS/ADMIN SPACES</b>	Inspected
<b>Floor Finish</b>	Inspected
Violations	No violations recorded.
<b>Walls</b>	Inspected
Condition	2 - Between Good and Fair
Deficiency	GLAZED BLOCK: CRACKS/SPALLING
Deficiency Location/Instance	Corridor near Rooms 107, 104A, 102, Corridor near Stair B/1, Basement and others
Deficiency Quantity	80
Quantity Uom	S.F.
Potential Action	REPLACE
Urgency of Action	PRIORITY 3
Purpose of Action	LEVEL 2
Deficiency Photo1

Violations	Corridor near Room 102 No violations recorded.
<b>Specialties</b>	Does not Exist
<b>GYMNASIUM</b>	Does not Exist
<b>INTERIOR DOOR HARDWARE</b>	Inspected
Condition	2 - Between Good and Fair
Deficiency	No deficiencies recorded
<b>INTERIOR GUARDS</b>	Does not Exist
<b>KITCHEN</b>	Inspected
Instance on 1st Floor	Inspected
Instance on 2nd Floor	Inspected
<b>Ceiling</b>	
Instance on 1st Floor	Inspected

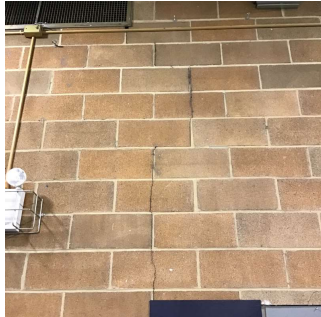
Question	Response
<b>INTERIOR</b>	
<b>MULTI-PURPOSE ROOM</b>	
<b>Door(s)</b>	
Deficiency Photo1	 
	Main Entrance
Violations	No violations recorded.
<b>Fixed Equipment</b>	
Instance on Basement	Does not Exist
<b>Floor Finish</b>	
Instance on Basement	Inspected
Condition	2 - Between Good and Fair
Deficiency	CONCRETE: CRACKS
Deficiency Location/Instance	Room B02 Storage Room
Deficiency Quantity	50
Quantity Uom	S.F.
Potential Action	REPLACE
Urgency of Action	PRIORITY 3
Purpose of Action	LEVEL 2
Deficiency Photo1	 
	Room B02 Storage Room
Violations	No violations recorded.
<b>Sliding-folding Partition</b>	
Instance on Basement	Does not Exist
<b>Stage</b>	
Instance on Basement	Does not Exist
<b>Walls</b>	
Instance on Basement	Inspected
Condition	2 - Between Good and Fair
Deficiency	MASONRY: CRACKS/SPALLING
Deficiency Location/Instance	Near Entrance, Near Stair C
Deficiency Quantity	40
Quantity Uom	S.F.
Potential Action	REPLACE
Urgency of Action	PRIORITY 3

Question	Response
<b>INTERIOR</b>	
<b>MULTI-PURPOSE ROOM</b>	
<b>Walls</b>	
Purpose of Action	LEVEL 2
Deficiency Photo1

Near Entrance
Violations	No violations recorded.
<b>Window Curtains/Shades/Blinds</b>	
Instance on Basement	Does not Exist
<b>SCIENCE DEMO ROOM</b>	Does not Exist
<b>SCIENCE LAB</b>	Does not Exist
<b>SCIENCE PREP ROOM</b>	Does not Exist
<b>SHOWER ROOM</b>	Does not Exist
<b>STAIRS/RAMPS: INTERIOR</b>	Inspected
Do Letter Stair Signs Exist?	Yes
<b>Ceiling</b>	Inspected
Condition	2 - Between Good and Fair
Deficiency	No deficiencies recorded
<b>Door(s)</b>	Inspected
Condition	2 - Between Good and Fair
Deficiency	No deficiencies recorded
<b>Partition</b>	Does not Exist
<b>Railings</b>	Inspected
Condition	2 - Between Good and Fair
Deficiency	No deficiencies recorded
<b>Stairs and Landings</b>	Inspected
Condition	2 - Between Good and Fair
Deficiency	TERRAZZO: CRACKS
Deficiency Location/Instance	Stairs A/Basement, C/Basement

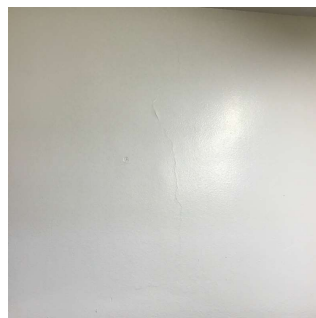
PLASTER: CRACKS/SPALLING

REPLACE

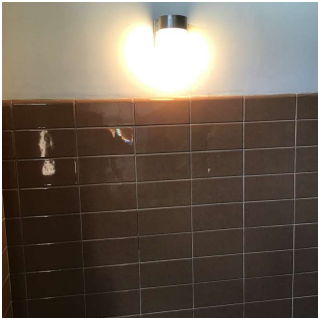
Question	Response
<b>INTERIOR</b>	
<b>STAIRS/RAMPS: INTERIOR</b>	
<b>Walls</b>	
Violations	Stair C/Basement No violations recorded.
Deficiency	CERAMIC TILE: BROKEN/ MISSING
Deficiency Location/Instance	Stairs A/Basement, B/1
Deficiency Quantity	20
Quantity Uom	S.F.
Potential Action	REPLACE
Urgency of Action	PRIORITY 3
Purpose of Action	LEVEL 2
Deficiency Photo1

Violations	Stair B/1 No violations recorded.
Deficiency	PLASTER: CRACKS/SPALLING - ACTIVE LEAK
Deficiency Location/Instance	Stair C/2
Deficiency Quantity	20
Quantity Uom	S.F.
Potential Action	REPLACE
Urgency of Action	PRIORITY 5
Purpose of Action	LEVEL 2
Deficiency Photo1

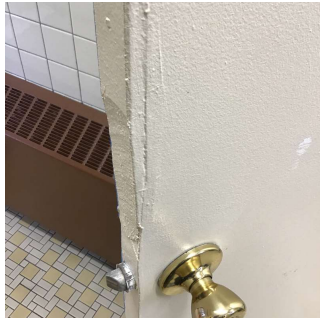
Violations	Stair C/2 No violations recorded.
<b>TOILET ROOMS - STAFF</b>	Inspected
<b>Ceiling</b>	Inspected
Condition	2 - Between Good and Fair
Deficiency	No deficiencies recorded
<b>Door(s)</b>	Inspected
Condition	5 - Poor
Deficiency	WOOD: DETERIORATED DOOR
Deficiency Location/Instance	Room 215A

Question	Response
<b>INTERIOR</b>	
<b>TOILET ROOMS - STAFF</b>	
<b>Door(s)</b>	
Deficiency Quantity	1
Quantity Uom	EACH
Potential Action	MAINTENANCE
Urgency of Action	PRIORITY 3
Purpose of Action	LEVEL 2
Deficiency Photo1

Room 215A
Violations	No violations recorded.
<b>Floor Finish</b>	Inspected
Condition	2 - Between Good and Fair
Deficiency	No deficiencies recorded
<b>Stalls</b>	Does not Exist
<b>Walls</b>	Inspected
Condition	2 - Between Good and Fair
Deficiency	No deficiencies recorded
<b>TOILET ROOMS - STUDENTS</b>	Inspected
<b>Ceiling</b>	Inspected
Condition	2 - Between Good and Fair
Deficiency	PLASTER: CRACKS/SPALLING
Deficiency Location/Instance	Rooms 100J, B09
Deficiency Quantity	20
Quantity Uom	S.F.
Potential Action	REPLACE
Urgency of Action	PRIORITY 3
Purpose of Action	LEVEL 2
Deficiency Photo1	 
	Room 100J
Violations	No violations recorded.
<b>Door(s)</b>	Inspected
Condition	5 - Poor
Deficiency	METAL: DETERIORATED DOOR

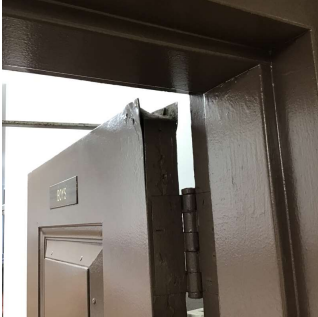
Question	Response
<b>INTERIOR</b>	
<b>TOILET ROOMS - STUDENTS</b>	
<b>Door(s)</b>	
Deficiency Location/Instance	Rooms B09, B08
Deficiency Quantity	2
Quantity Uom	EACH
Potential Action	MAINTENANCE
Urgency of Action	PRIORITY 3
Purpose of Action	LEVEL 2
Deficiency Photo1

Violations	Room B09 No violations recorded.
<b>Deficiency</b>	<b>WOOD: DETERIORATED DOOR</b>
Deficiency Location/Instance	Rooms 100J, 100 L
Deficiency Quantity	2
Quantity Uom	EACH
Potential Action	MAINTENANCE
Urgency of Action	PRIORITY 3
Purpose of Action	LEVEL 2
Deficiency Photo1

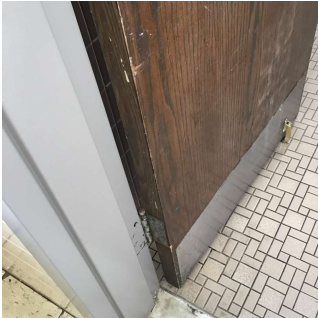
Violations	Room 100J No violations recorded.
<b>Floor Finish</b>	Inspected
Condition	3 - Fair
<b>Deficiency</b>	<b>CERAMIC TILE: DETERIORATED SUBSTRATE</b>
Deficiency Location/Instance	Rooms 201, 100L, B09, B08
Deficiency Quantity	40
Quantity Uom	S.F.
Potential Action	REPLACE
Urgency of Action	PRIORITY 3
Purpose of Action	LEVEL 2
