NYC Department of Education
Building Condition Assessment Survey 2023 - 2024

Architectural Inspection

Q411

Asset: BEACH CHANNEL AF - QUEENS, 100-00 BEACH CHANNEL DRIVE, New York, 11694

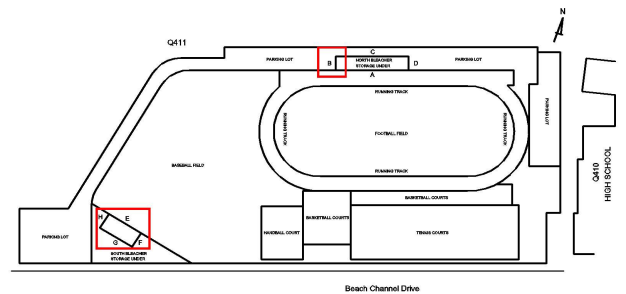
Roof Plan reference

Deficiency METAL: DETERIORATED DOOR AND FRAME - MAJOR DETERIORATION

REPLACE

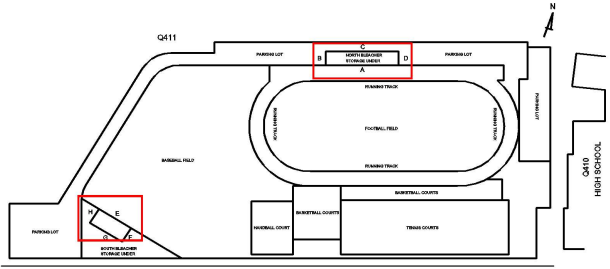
Violations	Facade B No violations recorded.
DOOR HARDWARE	Inspected
Condition	2 - Between Good and Fair
Deficiency	No deficiencies recorded
LINTELS	Inspected
Condition	2 - Between Good and Fair
Deficiency	No deficiencies recorded
TRANSOM/SIDE LIGHT	Does not Exist
EXTERIOR WALLS	Inspected
Material Type(s)	Concrete
Replacement Quantity	7,000
Replacement Uom	S.F.
Instance on All Facades	Inspected
Instance Condition	5 - Poor
Instance Quantity	7,000
Instance Quantity Uom	S.F.
Deficiency	CAST IN PLACE / PRE-CAST CONCRETE: MAJOR CRACKS/SPALLING
Roof Plan reference

Question	Response
EXTERIOR	
EXTERIOR WALLS	
Quantity Uom	S.F.
Potential Action	REPLACE
Urgency of Action	PRIORITY 4
Purpose of Action	LEVEL 2
Deficiency Photo1	 
	Facade B
Violations	No violations recorded.
EXTERIOR SOFFITS	Does not Exist
LOUVER	Does not Exist
PARAPETS	Inspected
Material Type(s)	Concrete
Replacement Quantity	1,000
Replacement Uom	C.F.
Instance on North and South Bleachers	Inspected
Instance Condition	4 - Between Fair and Poor
Instance Quantity	1,000
Instance Quantity Uom	C.F.
Deficiency	CONCRETE: MINOR CRACKS, SPALLING
Roof Plan reference	 
Deficiency Quantity	100
Quantity Uom	S.F.
Potential Action	REPAIR
Urgency of Action	PRIORITY 3
Purpose of Action	LEVEL 2

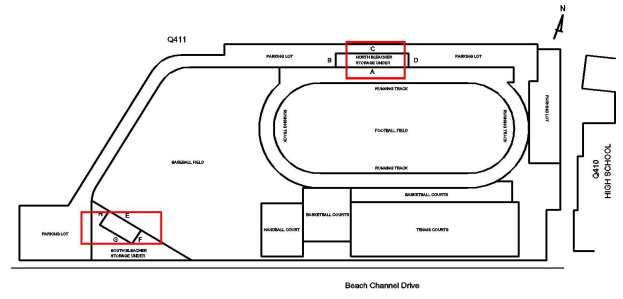
Roof Plan reference

Violations	North Bleachers No violations recorded.
PLAZA DECK	Inspected
Instance on Concrete: North and South Bleachers	Inspected
Instance Condition	5 - Poor
Instance Quantity	2,100
Instance Quantity Uom	S.F.
Installation Year	1973
Source of Installation	Custodial Staff
Deficiency	CONCRETE: MAJOR ACTIVE PLAZA DECK LEAKS IN NON-INSTRUCTIONAL SPACE

300
S.F.
REPLACE
PRIORITY 5
LEVEL 2

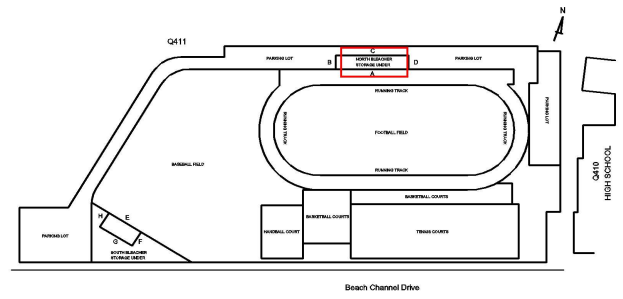
Roof Plan reference

CONCRETE: MINOR CRACKS

100
S.F.
REPAIR
PRIORITY 3
LEVEL 2

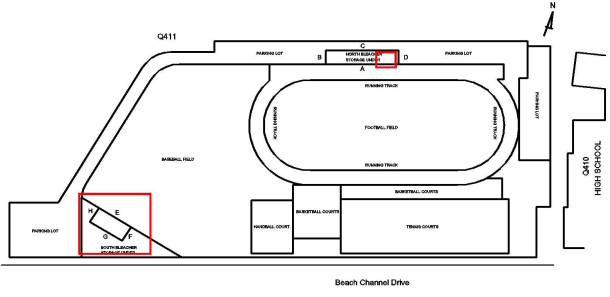
Question	Response
EXTERIOR	
PLAZA DECK	
Violations	North Bleachers No violations recorded.
Deficiency	CONCRETE: MAJOR CRACKS
Roof Plan reference

Deficiency Quantity	30
Quantity Uom	S.F.
Potential Action	REPLACE
Urgency of Action	PRIORITY 4
Purpose of Action	LEVEL 2
Deficiency Photo1

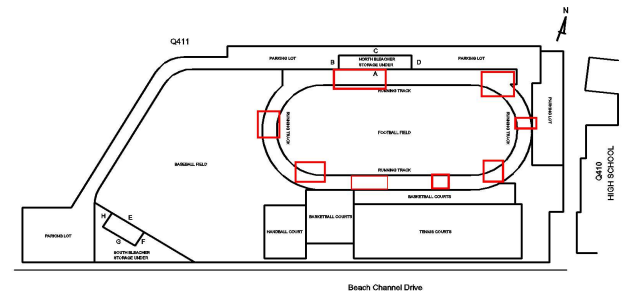
Roof Plan reference

Running Track
