NYC Department of Education
Building Condition Assessment Survey 2023 - 2024

Architectural Inspection

Asset: BENJAMIN N. CARDOZO HS - Q, 57-00 223 STREET, New York, 11364

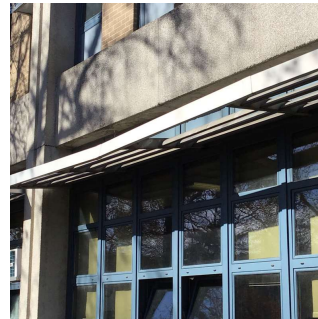
Facade B

METAL: DETERIORATION/DAMAGED/MISSING PIECES

REPLACE

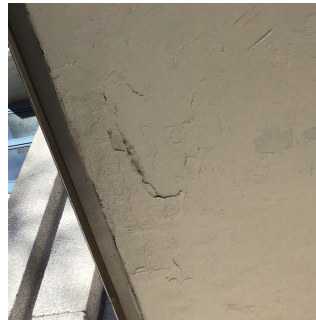
Facade B
No violations recorded.

CONCRETE: MAJOR CRACKS/SPALLING

10
S.F.
REPAIR
PRIORITY 4
LEVEL 2

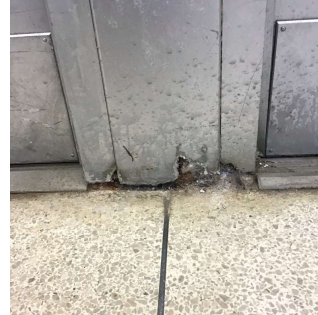
Facade C - Exit 14

METAL: DETERIORATED DOOR AND FRAME - MAJOR DETERIORATION

12
EACH
REPLACE

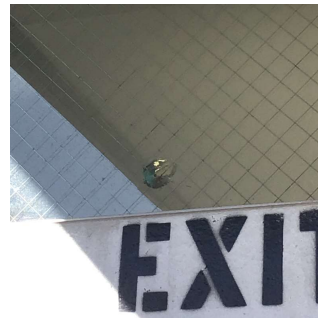
Facade B - Exit 3

METAL: BROKEN GLASS

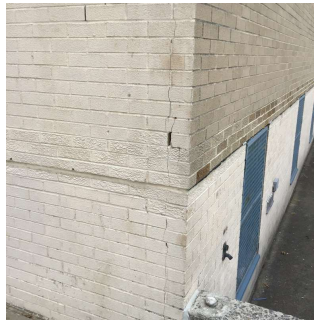
Facade G

BRICK: CRACKS/DISPLACED/SPALLED BRICK AT BUILDING CORNERS

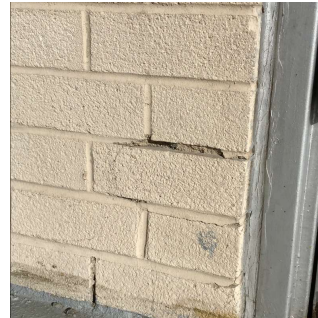
Facade C

BRICK: DETERIORATED JOINTS

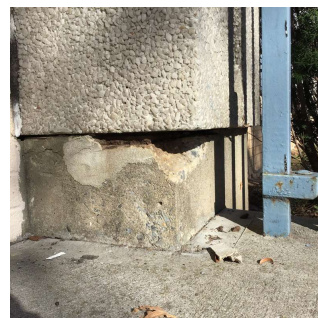
**CAST IN PLACE / PRE-CAST CONCRETE: MAJOR
CRACKS/SPALLING**

30
S.F.
REPLACE
PRIORITY 4
LEVEL 2

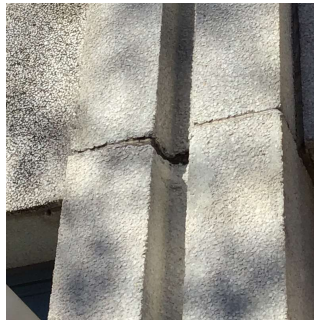
Facade B

CAST IN PLACE / PRE-CAST CONCRETE: DETERIORATED CONTROL/EXPANSION JOINTS

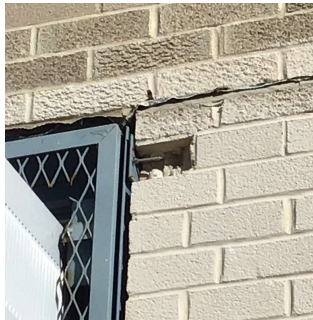
Facade E

BRICK: MAJOR / THRU CRACKS

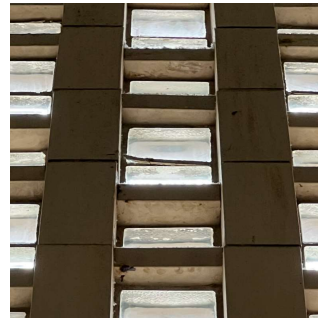
Facade B - Stair A/2

GLASS BLOCK: DETERIORATED JOINTS

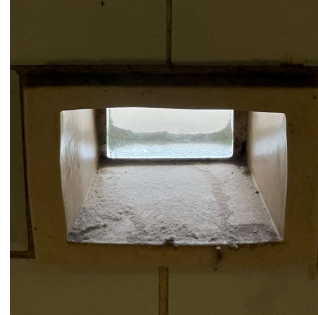
Facade B - Stair C/2

GLASS BLOCK: WATER INFILTRATION IN INSTRUCTIONAL SPACE

REPAIR
PRIORITY 5
LEVEL 2

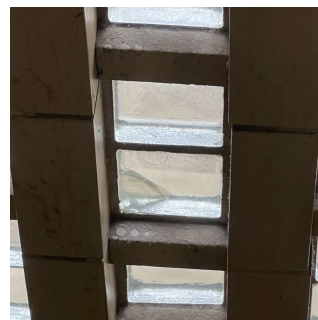
GLASS BLOCK: CHIPPED/ BROKEN PIECES

40
S.F.
REPLACE-IN-KIND
PRIORITY 4
LEVEL 2

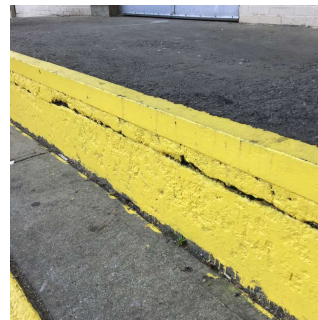
Facade E

CHEEK WALL/CRACKS, SPALLING - MAJOR

REPLACE

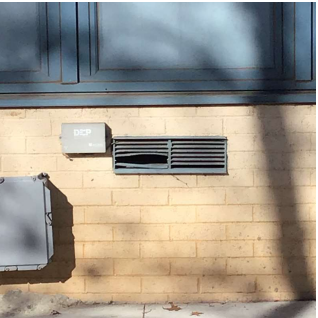
BROKEN/ DENTED BLADES

Deficiency Quantity	40
Quantity Uom	S.F.
Potential Action	REPLACE
Urgency of Action	PRIORITY 4
Purpose of Action	LEVEL 2
Deficiency Photo1

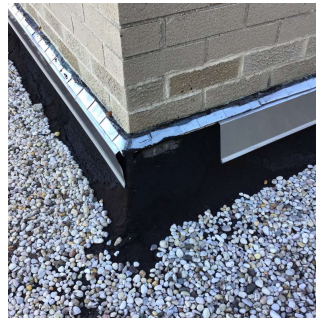
Roof 7

Installation Year	2004
Source of Installation	Custodial Staff
Deficiency	BUILT-UP: FLASHING: CAP FLASHING MISSING
Roof Plan reference

Deficiency Quantity	10
Quantity Uom	L.F.
Potential Action	INSTALL NEW
Urgency of Action	PRIORITY 4
Purpose of Action	LEVEL 2
Deficiency Photo1

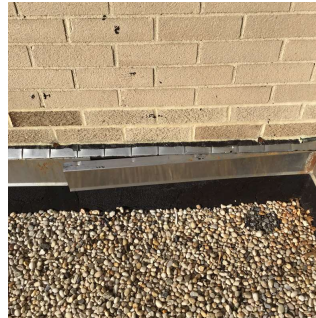
Roof 7

Deficiency	BUILT-UP: FLASHING: CAP FLASHING DAMAGED
Roof Plan reference

Deficiency Quantity	10
Quantity Uom	L.F.
Potential Action	REPLACE
Urgency of Action	PRIORITY 4
Purpose of Action	LEVEL 2

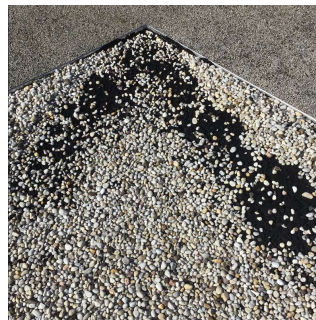
BH1

BUILT-UP: ROOFING: LOSS OF GRAVEL

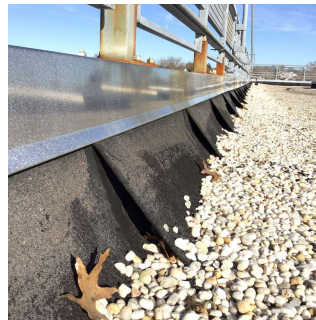
Roof 8
No violations recorded.

BUILT-UP: FLASHING: BASE FLASHING DETERIORATED

80
S.F.
REMOVE AND REPLACE
PRIORITY 4
LEVEL 2

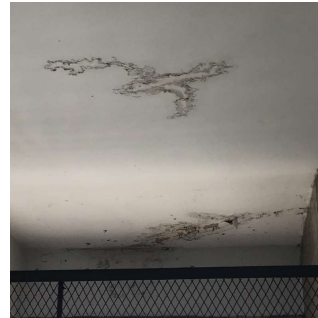
BH1

Deficiency **BULKHEAD/PENTHOUSE CEILING: PLASTER DAMAGED/DETERIORATED**

50
S.F.
REPLACE
PRIORITY 3
LEVEL 2

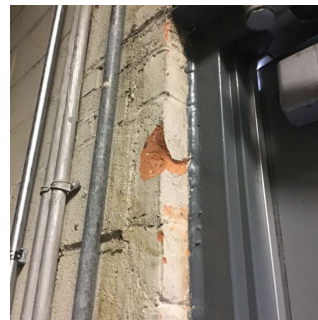
PH2

**BULKHEAD/PENTHOUSE WALLS/INTERIOR: BRICK
CRACKS/SPALLING**

REPLACE

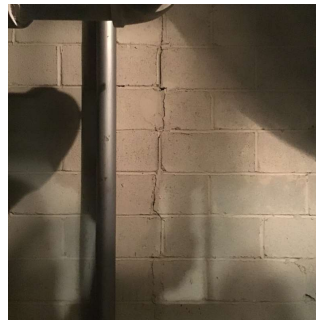
PH2
No violations recorded.

**BULKHEAD/PENTHOUSE WALLS/INTERIOR: CMU
CRACKS/SPALLING**

20
S.F.
REPLACE
PRIORITY 4
LEVEL 2

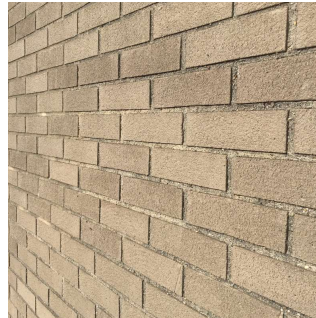
BH3

BULKHEAD/PENTHOUSE WALLS/EXTERIOR: DETERIORATED JOINTS

800
S.F.
REPOINT
PRIORITY 3
LEVEL 2

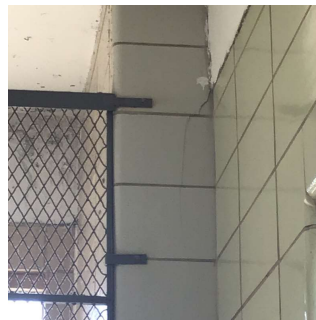
BH2

BULKHEAD/PENTHOUSE WALLS/INTERIOR: SALT GLAZED BRICK CRACKS/SPALLING

REPLACE

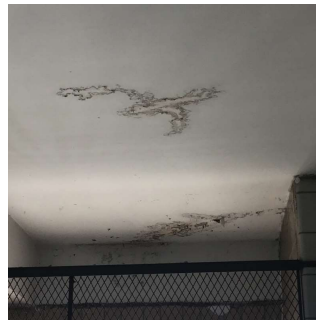
BH1
No violations recorded.

BULKHEAD/PENTHOUSE ROOF: MAJOR LEAKAGE

200
S.F.
REPLACE
PRIORITY 5
LEVEL 2

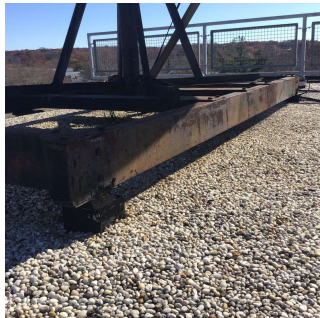
Question	Response
EXTERIOR	
ROOF	
Specialties	
BULKHEAD/PENTHOUSE	
Deficiency Photo1	 
Violations	PH2 - doors cannot be shut No violations recorded.
CUPOLA/ SPIRES/ TOWERS	Does not Exist
DORMER	Does not Exist
DUNNAGE STEEL	Inspected
Condition	2 - Between Good and Fair
Deficiency	HEIGHT LESS THAN 18"
Roof Plan reference

Deficiency Quantity	30
Quantity Uom	L.F.
Potential Action	REPLACE
Urgency of Action	PRIORITY 3
Purpose of Action	LEVEL 2
Deficiency Photo1

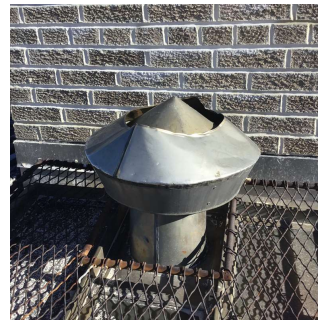
SK1
No violations recorded.

Violations	BH1 No violations recorded.
SKYLIGHT/ROOF VENT	Inspected
Material Type(s)	Glass, Plastic
Condition	3 - Fair
Deficiency	SHAFT VENTS DAMAGED

1
EACH
MAINTENANCE
PRIORITY 3
LEVEL 2

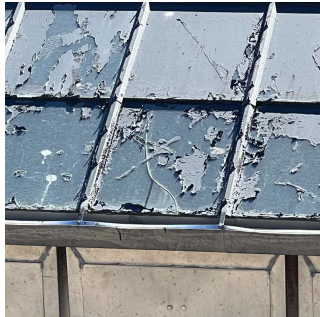
BROKEN GLASS

20
S.F.
MAINTENANCE
PRIORITY 3
LEVEL 2

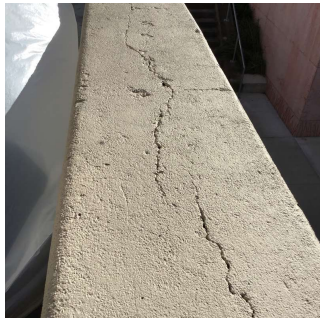
Deficiency Quantity	10
Quantity Uom	S.F.
Potential Action	REPAIR
Urgency of Action	PRIORITY 3
Purpose of Action	LEVEL 2
Deficiency Photo1

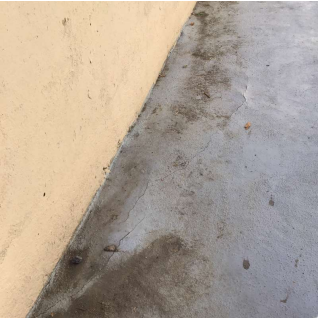
Question	Response
EXTERIOR	
STAIRS/RAMPS: EXTERIOR	
STAIRS/RAMPS	
Condition	2 - Between Good and Fair
Deficiency	CONCRETE: CRACKS/SPALLING - MINOR
Roof Plan reference

Deficiency Quantity	10
Quantity Uom	S.F.
Potential Action	REPAIR
Urgency of Action	PRIORITY 3
Purpose of Action	LEVEL 2
Deficiency Photo1

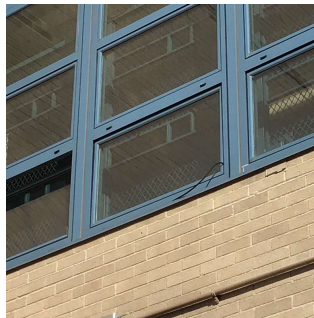
Facade E (All Facades similar)

Violations	Facade C No violations recorded.
WINDOWS	Inspected
Replacement Quantity	19,000
Replacement Uom	S.F.
EXTERIOR GUARDS	Inspected
Condition	2 - Between Good and Fair
Deficiency	No deficiencies recorded
LINTELS	Inspected
Condition	2 - Between Good and Fair
Deficiency	No deficiencies recorded
WINDOWS	Inspected
Material Type(s)	Aluminum
Instance on Aluminum - Other: All Facades	Inspected
Instance Condition	3 - Fair
Instance Quantity	19,000
Instance Quantity Uom	S.F.
Are these windows insulated	Yes
Installation Year	2007
Source of Installation	Custodial Staff
Deficiency	ALUMINUM - OTHER: DETERIORATED

REPLACE WINDOW

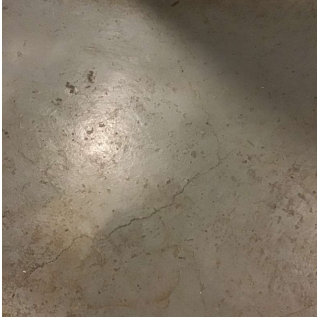
PH2
Violations	No violations recorded.
Deficiency	CONCRETE SLAB ON GRADE: THRU CRACKS
Deficiency Location/Instance	Boiler Room, Oil Tank Room
Deficiency Quantity	40
Quantity Uom	S.F.
Potential Action	REPAIR
Urgency of Action	PRIORITY 3
Purpose of Action	LEVEL 5
Deficiency Photo1

Question	Response
INTERIOR	
STRUCTURAL	
FLOOR STRUCTURE	
Potential Action	REPAIR
Urgency of Action	PRIORITY 3
Purpose of Action	LEVEL 5
Deficiency Photo1

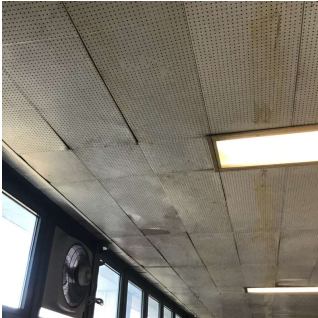
Question	Response
INTERIOR	
AUDITORIUM	Inspected
Instance on 1st Floor (897 Seats)	Inaccessible
CAFETERIA	Inspected
Instance on 1st Floor	Inspected
Ceiling	
Instance on 1st Floor	Inspected
Condition	3 - Fair
Deficiency	METAL PAN: DAMAGED/MISSING
Deficiency Location/Instance	Near Windows, rear Near Left Side Exit, Center, Near Servery, near Partitions and others
Deficiency Quantity	250
Quantity Uom	S.F.
Potential Action	REPLACE
Urgency of Action	PRIORITY 3
Purpose of Action	LEVEL 2
Deficiency Photo1

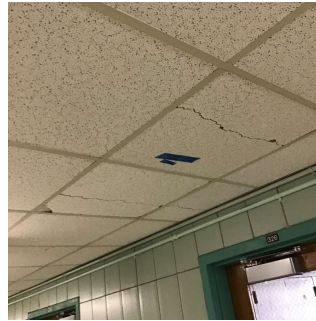
Corridor near Room 326

Violations	Room 167 No violations recorded.
Deficiency	ACOUSTIC TILES: DAMAGED/MISSING
Deficiency Location/Instance	Corridor near Rooms 328, 326, 323, 314, 307 and others
Deficiency Quantity	600
Quantity Uom	S.F.
Potential Action	REPLACE
Urgency of Action	PRIORITY 3
Purpose of Action	LEVEL 2

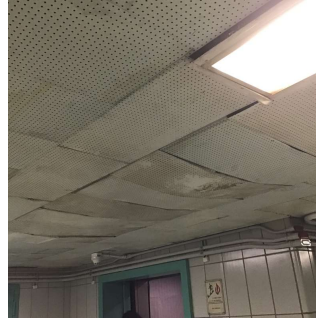
Corridor near Room B03

METAL PAN: DAMAGED/MISSING

REPLACE

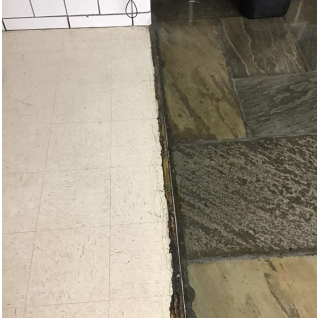
Question	Response
INTERIOR	
CLASSROOMS/CORRIDORS/ADMIN SPACES	
Door(s)	Inspected
	Room 315
Violations	No violations recorded.
Floor Finish	Inspected
Condition	2 - Between Good and Fair
Deficiency	VINYL TILES: BROKEN/DETERIORATED/MISSING TILES
Deficiency Location/Instance	Near Main Entrance, Corridor near Rooms 332, 308, 305, 241 and others
Deficiency Quantity	230
Quantity Uom	S.F.
Potential Action	REPLACE
Urgency of Action	PRIORITY 3
Purpose of Action	LEVEL 2
Deficiency Photo1

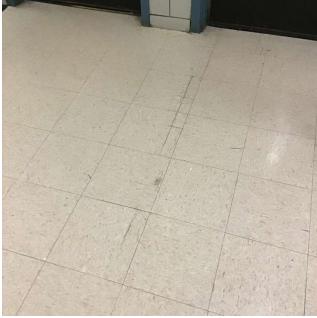
Main Entrance
Violations	No violations recorded.
Deficiency	VINYL TILES: DETERIORATED SUBSTRATE
Deficiency Location/Instance	Corridor near Room 117, near Main Entrance
Deficiency Quantity	40
Quantity Uom	S.F.
Potential Action	REPLACE
Urgency of Action	PRIORITY 3
Purpose of Action	LEVEL 2
Deficiency Photo1

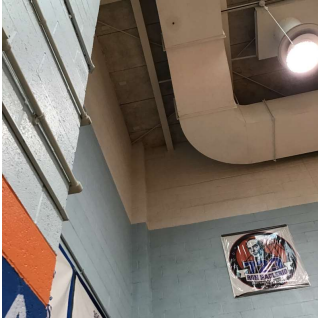
Question	Response
INTERIOR	
CLASSROOMS/CORRIDORS/ADMIN SPACES	
Walls	Inspected
Deficiency Photo1	 
	Corridor near Room 326
Violations	No violations recorded.
Specialties	Inspected
Classroom Locker(s)	Inspected
Condition	2 - Between Good and Fair
Deficiency	No deficiencies recorded
Fixed Seating	Does not Exist
GYMNASIUM	Inspected
Instance on 1st Floor - Boys	Inspected
Instance on 1st Floor - Girls (3500 SF)	Inspected
Ceiling	Inspected
Instance on 1st Floor - Girls (3500 SF)	Inspected
Condition	2 - Between Good and Fair
Deficiency	TECTUM: DAMAGED/MISSING
Deficiency Location/Instance	Near Storage Room
Deficiency Quantity	10
Quantity Uom	S.F.
Potential Action	REPLACE
Urgency of Action	PRIORITY 3
Purpose of Action	LEVEL 2
Deficiency Photo1	 
	Near Storage Room
Violations	No violations recorded.
Instance on 1st Floor - Boys	Inspected
Condition	2 - Between Good and Fair
Deficiency	TECTUM: DAMAGED/MISSING
Deficiency Location/Instance	Left Side Near Entrance

Deficiency Quantity	10
Quantity Uom	S.F.
Potential Action	REPLACE

Question	Response
INTERIOR	
GYMNASIUM	
Ceiling	
Urgency of Action	PRIORITY 3
Purpose of Action	LEVEL 2
Deficiency Photo1

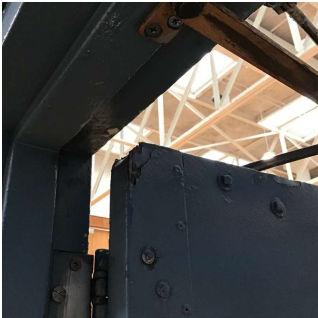
Left Side Near Entrance
Violations	No violations recorded.
Door(s)	
Instance on 1st Floor - Girls (3500 SF)	Inspected
Condition	5 - Poor
Deficiency	METAL: DETERIORATED DOOR
Deficiency Location/Instance	Lateral Doors to Boys Gymnasium, Main Entrance
Deficiency Quantity	3
Quantity Uom	EACH
Potential Action	MAINTENANCE
Urgency of Action	PRIORITY 3
Purpose of Action	LEVEL 2
Deficiency Photo1

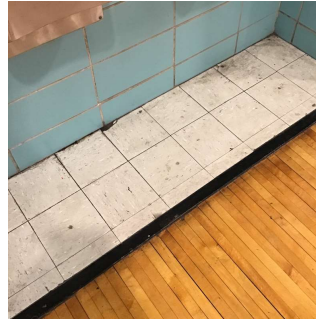
Lateral Doors to Boys Gymnasium
Violations	No violations recorded.
Fixed Equipment	
Instance on 1st Floor - Girls (3500 SF)	Inspected
Condition	2 - Between Good and Fair
Deficiency	No deficiencies recorded
Instance on 1st Floor - Boys	Inspected
Condition	2 - Between Good and Fair
Deficiency	No deficiencies recorded
Floor Finish	
Instance on 1st Floor - Boys	Inspected
Condition	2 - Between Good and Fair
Deficiency	VINYL TILES: BROKEN/DETERIORATED/MISSING TILES

Deficiency Location/Instance	Near Stair H
Deficiency Quantity	10

Quantity Uom	S.F.
Potential Action	REPLACE
Urgency of Action	PRIORITY 3
Purpose of Action	LEVEL 2
Deficiency Photo1

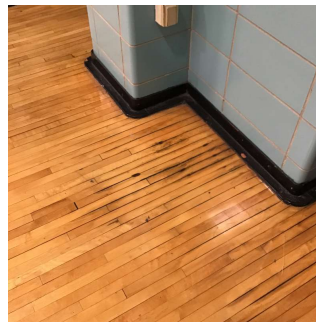
Near Storage Room

Deficiency	WOOD: DAMAGED/DETERIORATED
Deficiency Location/Instance	Near Storage Room, Near Stair H
Deficiency Quantity	40
Quantity Uom	S.F.
Potential Action	REPLACE
Urgency of Action	PRIORITY 3
Purpose of Action	LEVEL 2
Deficiency Photo1

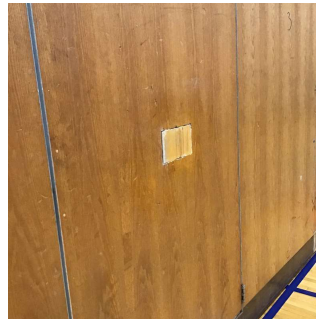
Instance on 1st Floor - Girls (3500 SF)	Inspected
Condition	3 - Fair
Deficiency	MOVABLE PANELS: DAMAGED
Deficiency Location/Instance	Center
Deficiency Quantity	40
Quantity Uom	S.F.
Potential Action	REPLACE
Urgency of Action	PRIORITY 3
Purpose of Action	LEVEL 2
Deficiency Photo1

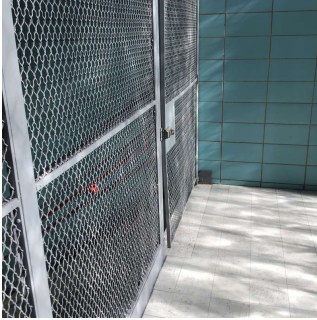
Question	Response
INTERIOR	
GYMNASIUM	
Walls	
Deficiency Photo1	 
Violations	Right Side No violations recorded.
Instance on 1st Floor - Boys	Inspected
Condition	2 - Between Good and Fair
Deficiency	GLAZED BLOCK: CRACKS/SPALLING
Deficiency Location/Instance	Near Entrance, Rear near Stairs
Deficiency Quantity	20
Quantity Uom	S.F.
Potential Action	REPLACE
Urgency of Action	PRIORITY 3
Purpose of Action	LEVEL 2
Deficiency Photo1	 
Violations	Near Entrance No violations recorded.
Window Curtains/Shades/Blinds	
Instance on 1st Floor - Boys	Does not Exist
Instance on 1st Floor - Girls (3500 SF)	Does not Exist
INTERIOR DOOR HARDWARE	
Condition	Inspected
Deficiency	3 - Fair
Deficiency	No deficiencies recorded
INTERIOR GUARDS	
Condition	Inspected
Deficiency	2 - Between Good and Fair
Deficiency	DETERIORATED/TORN-OUT/MISSING
Deficiency Location/Instance	Stair A/Bulkhead
Deficiency Quantity	20
Quantity Uom	S.F.
Potential Action	REPLACE

Question	Response
INTERIOR	
INTERIOR GUARDS	
Deficiency Photo1

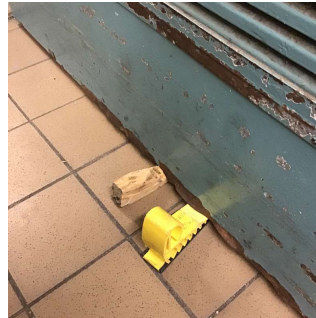
Storage Room Near Lockers

METAL: DETERIORATED DOOR

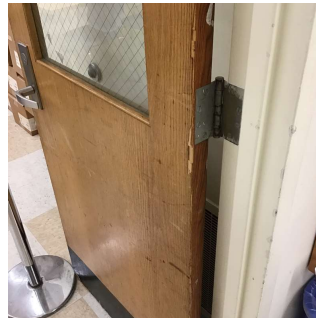
Conference Room
No violations recorded.

WOOD: DETERIORATED DOOR

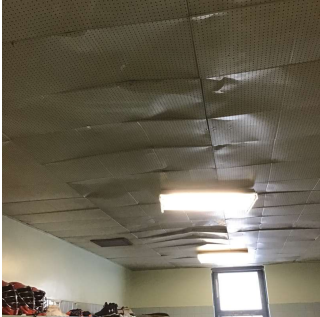
Question	Response
INTERIOR	
LOCKER ROOM	
Alternative use	No
Ceiling	
Instance on Room B59 (49 Lockers, 300 SF)	Inspected
Condition	5 - Poor
Deficiency	METAL PAN: DAMAGED/MISSING
Deficiency Location/Instance	Near Window, Center, Near Entrance
Deficiency Quantity	150
Quantity Uom	S.F.
Potential Action	REPLACE
Urgency of Action	PRIORITY 3
Purpose of Action	LEVEL 2
Deficiency Photo1

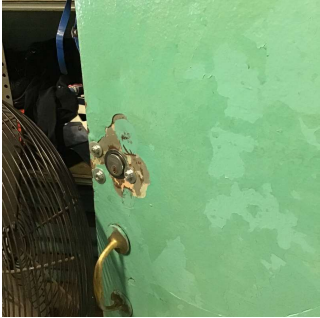
Near Window
Violations	No violations recorded.
Door(s)	
Instance on Room B59 (49 Lockers, 300 SF)	Inspected
Condition	3 - Fair
Deficiency	METAL: DETERIORATED DOOR
Deficiency Location/Instance	Main Entrance
Deficiency Quantity	1
Quantity Uom	EACH
Potential Action	MAINTENANCE
Urgency of Action	PRIORITY 3
Purpose of Action	LEVEL 2
Deficiency Photo1

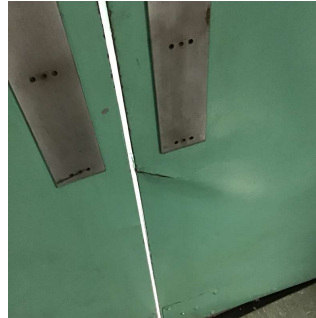
Main Entrance
Violations	No violations recorded.
Instance on Room B67 - Boys (2,539 Lockers)	Inspected
Condition	5 - Poor
Deficiency	METAL: DETERIORATED DOOR
Deficiency Location/Instance	Entrance B67

Deficiency Quantity	1

Quantity Uom	EACH
Potential Action	MAINTENANCE
Urgency of Action	PRIORITY 3
Purpose of Action	LEVEL 2
Deficiency Photo1

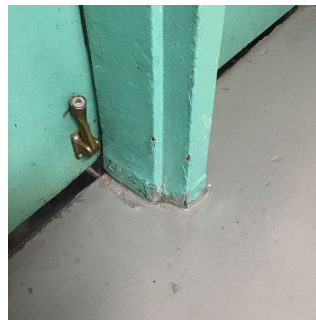
Deficiency	METAL: DETERIORATED DOOR AND FRAME
Deficiency Location/Instance	Main Entrance
Deficiency Quantity	2
Quantity Uom	EACH
Potential Action	MAINTENANCE
Urgency of Action	PRIORITY 3
Purpose of Action	LEVEL 2
Deficiency Photo1

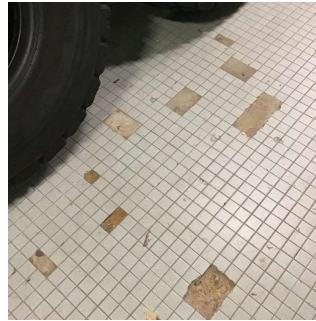
Instance on Room B59 (49 Lockers, 300 SF)	Inspected
Condition	5 - Poor
Deficiency	CERAMIC TILE: BROKEN/MISSING TILES
Deficiency Location/Instance	Near Entrance
Deficiency Quantity	140
Quantity Uom	S.F.
Potential Action	REPLACE
Urgency of Action	PRIORITY 3
Purpose of Action	LEVEL 2

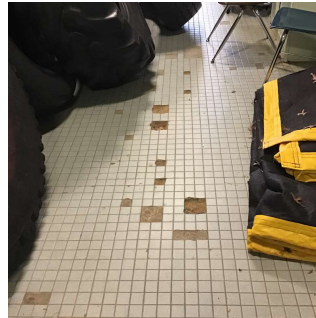
Center

CERAMIC TILE: BROKEN/MISSING TILES

REPLACE

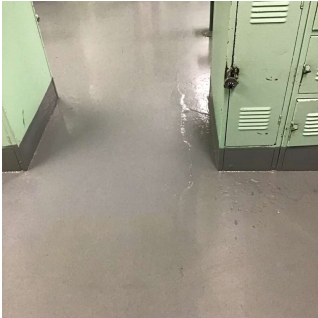
Question	Response
INTERIOR	
LOCKER ROOM	
Floor Finish	
	Near Locker/510
Violations	No violations recorded.
Instance on Room B66 - Girls (2000 Lockers)	Inspected
Condition	2 - Between Good and Fair
Deficiency	CONCRETE: CRACKS
Deficiency Location/Instance	Near Locker/670
Deficiency Quantity	25
Quantity Uom	S.F.
Potential Action	REPLACE
Urgency of Action	PRIORITY 3
Purpose of Action	LEVEL 2
Deficiency Photo1

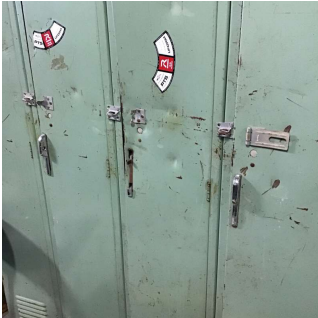
Near Locker/670
Violations	No violations recorded.
Locker Room Lockers	
Instance on Room B59 (49 Lockers, 300 SF)	Inspected
Condition	3 - Fair
Deficiency	DAMAGED UNITS
Deficiency Location/Instance	Locker/84, 64
Deficiency Quantity	2
Quantity Uom	EACH
Potential Action	REPLACE
Urgency of Action	PRIORITY 3
Purpose of Action	LEVEL 2
Deficiency Photo1

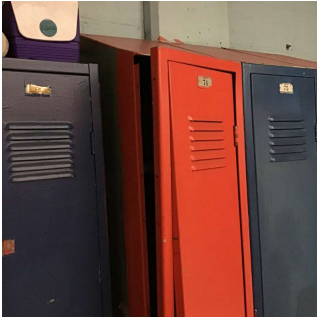
Locker/84
Violations	No violations recorded.
Instance on Room B55 (23 Lockers, 200 SF)	Inspected
Condition	3 - Fair
Deficiency	DAMAGED UNITS
Deficiency Location/Instance	Locker/74

Question	Response
INTERIOR	
LOCKER ROOM	
Locker Room Lockers	
Deficiency Quantity	1
Quantity Uom	EACH
Potential Action	REPLACE
Urgency of Action	PRIORITY 3
Purpose of Action	LEVEL 2
Deficiency Photo1

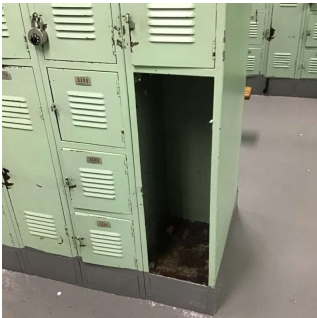
Locker/74	Locker/74
Violations	No violations recorded.
Instance on Room B66 - Girls (2000 Lockers)	Inspected
Condition	2 - Between Good and Fair
Deficiency	DAMAGED UNITS
Deficiency Location/Instance	Lockers/124, 146, 1190, 1198, 1236 and others
Deficiency Quantity	20
Quantity Uom	EACH
Potential Action	REPLACE
Urgency of Action	PRIORITY 3
Purpose of Action	LEVEL 2
Deficiency Photo1

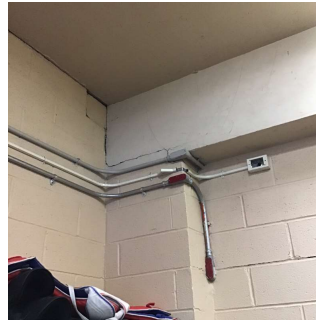
Locker/1190	Locker/1190
Violations	No violations recorded.
Walls	
Instance on Room B57 (37 Lockers, 300 SF)	Inspected
Condition	5 - Poor
Deficiency	PLASTER: CRACKS/SPALLING
Deficiency Location/Instance	Near Entrance
Deficiency Quantity	20
Quantity Uom	S.F.
Potential Action	REPLACE
Urgency of Action	PRIORITY 3
Purpose of Action	LEVEL 2

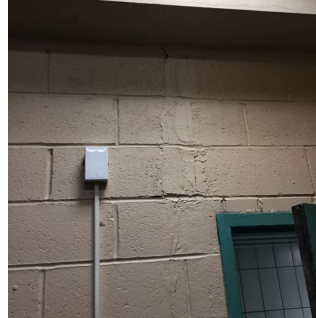
Near Entrance

MASONRY: CRACKS/SPALLING

REPLACE

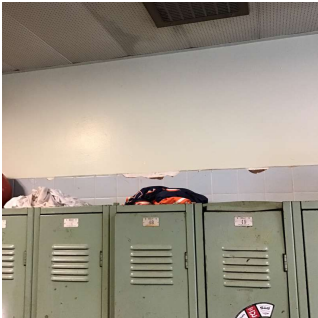
Question	Response
INTERIOR	
LOCKER ROOM	
Walls	
Violations	Left Side No violations recorded.
Deficiency	CERAMIC TILE: BROKEN/ MISSING
Deficiency Location/Instance	Left Side
Deficiency Quantity	10
Quantity Uom	S.F.
Potential Action	REPLACE
Urgency of Action	PRIORITY 3
Purpose of Action	LEVEL 2
Deficiency Photo1

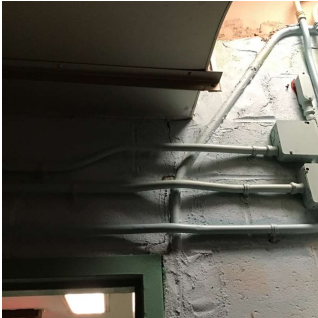
Violations	Left Side No violations recorded.
Instance on Room B55 (23 Lockers, 200 SF)	Inspected
Condition	4 - Between Fair and Poor
Deficiency	MASONRY: CRACKS/SPALLING
Deficiency Location/Instance	Near Entrance, Right Side
Deficiency Quantity	20
Quantity Uom	S.F.
Potential Action	REPLACE
Urgency of Action	PRIORITY 3
Purpose of Action	LEVEL 2
Deficiency Photo1

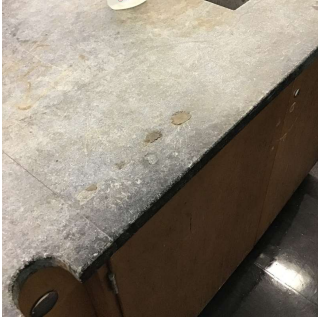
Question	Response
INTERIOR	
SCIENCE LAB	
Fixed Equipment	
Deficiency Location/Instance	Room 257
Deficiency Quantity	1
Quantity Uom	EACH
Potential Action	REPLACE
Urgency of Action	PRIORITY 3
Purpose of Action	LEVEL 2
Deficiency Photo1

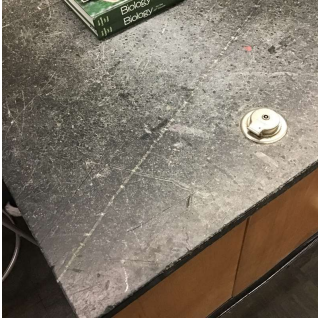
Violations	Room 257 No violations recorded.
Instance on Rooms 251, 253, 255, 257	Inspected
Condition	5 - Poor
Deficiency	TRI-FACIAL TABLE: DAMAGED
Deficiency Location/Instance	Rooms 251, 253, 255, 257
Deficiency Quantity	11
Quantity Uom	EACH
Potential Action	REPLACE
Urgency of Action	PRIORITY 3
Purpose of Action	LEVEL 2
Deficiency Photo1

Violations	Room 251 No violations recorded.
Deficiency	CABINETRY: MISSING/DAMAGED
Deficiency Location/Instance	Rooms 251, 253, 255, 257
Deficiency Quantity	40
Quantity Uom	L.F.
Potential Action	REPLACE
Urgency of Action	PRIORITY 3
Purpose of Action	LEVEL 2

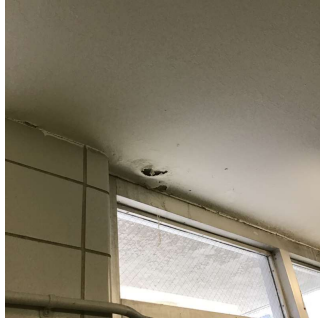
Question	Response
INTERIOR	
STAIRS/RAMPS: INTERIOR	
Ceiling	
Urgency of Action	PRIORITY 3
Purpose of Action	LEVEL 2
Deficiency Photo1

Violations	Stair D/Basement Vestibule No violations recorded.
Door(s)	Inspected
Condition	5 - Poor
Deficiency	METAL: DETERIORATED DOOR AND FRAME
Deficiency Location/Instance	Stair D/Basement Vestibule
Deficiency Quantity	4
Quantity Uom	EACH
Potential Action	MAINTENANCE
Urgency of Action	PRIORITY 3
Purpose of Action	LEVEL 2
Deficiency Photo1

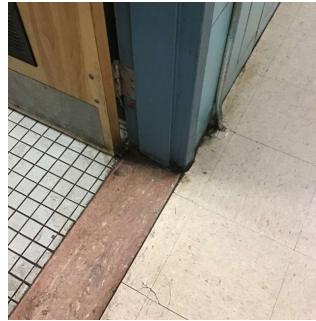
Room 163

WOOD: DETERIORATED DOOR

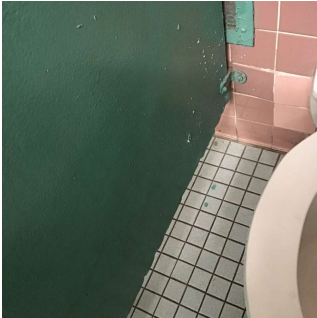
Question	Response
INTERIOR	
TOILET ROOMS - STUDENTS	
Floor Finish	Inspected
	Room 230
Violations	No violations recorded.
Stalls	Inspected
Condition	5 - Poor
Deficiency	RUST - MAJOR
Deficiency Location/Instance	Room 161
Deficiency Quantity	4
Quantity Uom	EACH
Potential Action	REPLACE
Urgency of Action	PRIORITY 3
Purpose of Action	LEVEL 2
Deficiency Photo1

Room 161
Violations	No violations recorded.
Walls	Inspected
Condition	2 - Between Good and Fair
Deficiency	CERAMIC TILE: BROKEN/ MISSING
Deficiency Location/Instance	Rooms 230, 338
Deficiency Quantity	20
Quantity Uom	S.F.
Potential Action	REPLACE
Urgency of Action	PRIORITY 3
Purpose of Action	LEVEL 2
Deficiency Photo1

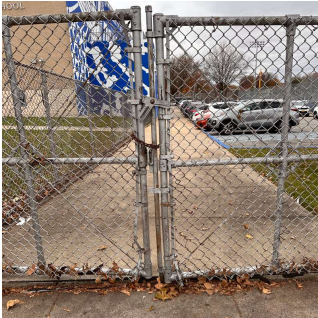
Question	Response
SITE	
Drainage System for Asphalt	Inspected
Catch Basins/Manhole - Surrounded by asphalt	Inspected
Condition	2 - Between Good and Fair
Deficiency	No deficiencies recorded
Culverts - Asphalt Covering	Does not Exist
Drainage System for Concrete	Inspected
Catch Basins/Manhole - Surrounded by concrete	Inspected
Condition	2 - Between Good and Fair
Deficiency	No deficiencies recorded
Culverts - Concrete Covering	Does not Exist
Drainage System for Soil	Inspected
Catch Basins/Manhole - Surrounded by Soil	Inspected
Condition	2 - Between Good and Fair
Deficiency	No deficiencies recorded
Culverts - Soil Covering	Does not Exist
DRINKING FOUNTAINS	Does not Exist
FENCES	Inspected
Condition	4 - Between Fair and Poor
Deficiency	CHAIN LINK: DAMAGED/DETERIORATED
Deficiency Location/Instance	223th Street
Deficiency Quantity	200
Quantity Uom	S.F.
Potential Action	REPLACE
Urgency of Action	PRIORITY 3
Purpose of Action	LEVEL 2

Violations	223th Street No violations recorded.
Deficiency	CHAIN LINK: DAMAGED POST/RAIL
Deficiency Location/Instance	223th Street
Deficiency Quantity	10
Quantity Uom	L.F.
Potential Action	REPLACE
Urgency of Action	PRIORITY 3
Purpose of Action	LEVEL 2

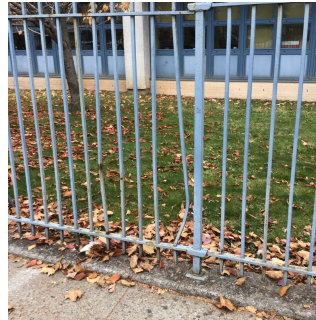
58th Street

CONCRETE CURB: DAMAGED/DETERIORATED

REPLACE

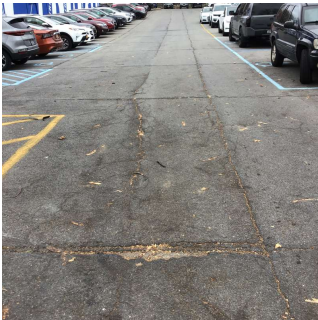
Question	Response
SITE	
IRRIGATION SYSTEM	Does not Exist
PAVING	Inspected
Student Non-Use	Inspected
Gravel Exists?	No
Asphalt	Inspected
Condition	4 - Between Fair and Poor
Deficiency	CRACKS - MAJOR
Deficiency Location/Instance	Parking Lot
Deficiency Quantity	1,200
Quantity Uom	S.F.
Potential Action	REPLACE
Urgency of Action	PRIORITY 3
Purpose of Action	LEVEL 2
Deficiency Photo1

Violations	Parking Lot No violations recorded.
Concrete	Inspected
Condition	2 - Between Good and Fair
Deficiency	No deficiencies recorded
Pavers	Does not Exist
Student Use	Does not Exist
Site Sidewalks & Walkways	Inspected
Asphalt	Does not Exist
Concrete	Inspected
Condition	4 - Between Fair and Poor
Deficiency	DAMAGED/DETERIORATED/MISSING SECTIONS
Deficiency Location/Instance	Near TCU, Exits 3, 4, 15, Main Entrance and others
Deficiency Quantity	525
Quantity Uom	S.F.
Potential Action	REPLACE
Urgency of Action	PRIORITY 3
Purpose of Action	LEVEL 2

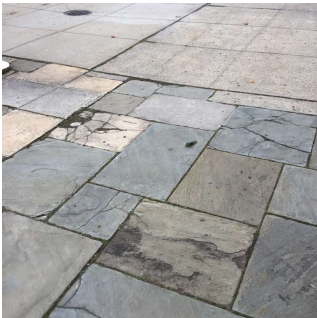
Question	Response
SITE	
PAVING	Inspected
Site Sidewalks & Walkways	
Concrete	Inspected
	Main Entrance
Violations	No violations recorded.
Pavers	Inspected
Condition	3 - Fair
Deficiency	DAMAGED/MISSING
Deficiency Location/Instance	Main Entrance
Deficiency Quantity	350
Quantity Uom	S.F.
Potential Action	REPLACE
Urgency of Action	PRIORITY 3
Purpose of Action	LEVEL 2
Deficiency Photo1

Main Entrance
Violations	No violations recorded.
DOT Sidewalk	Inspected
Asphalt	Does not Exist
Concrete	Inspected
Condition	3 - Fair
Deficiency	DAMAGED CURBS
Deficiency Location/Instance	58th Street, 223th Street
Deficiency Quantity	80
Quantity Uom	L.F.
Potential Action	REPLACE
Urgency of Action	PRIORITY 3
Purpose of Action	LEVEL 2
Deficiency Photo1

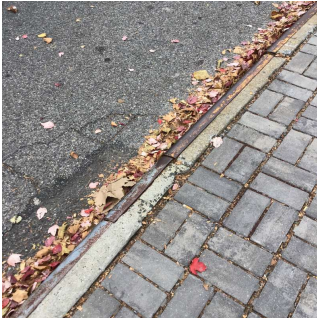
58th Street
Violations	No violations recorded.
Deficiency	DAMAGED/DETERIORATED/MISSING SECTIONS

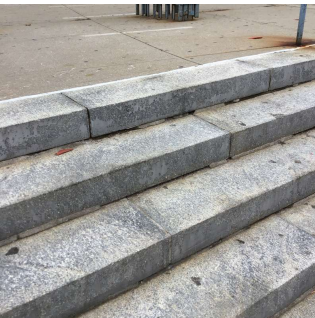
Deficiency	No deficiencies recorded
Stairs/ramps	Inspected
Condition	3 - Fair
Deficiency	STONE: DETERIORATED JOINTS
Deficiency Location/Instance	223rd Street
Deficiency Quantity	30
Quantity Uom	L.F.
Potential Action	REPOINT
Urgency of Action	PRIORITY 3

Violations	223rd Street No violations recorded.
Deficiency	STONE: CRACKS/SPALLING
Deficiency Location/Instance	223rd Street
Deficiency Quantity	20
Quantity Uom	S.F.
Potential Action	REPLACE
Urgency of Action	PRIORITY 3
Purpose of Action	LEVEL 2
Deficiency Photo1
