NYC Department of Education
Building Condition Assessment Survey 2023 - 2024

Architectural Inspection

Asset: SPRINGFIELD GDNS AF - QUEENS, 143-10 SPRINGFIELD BLVD, New York, 11413

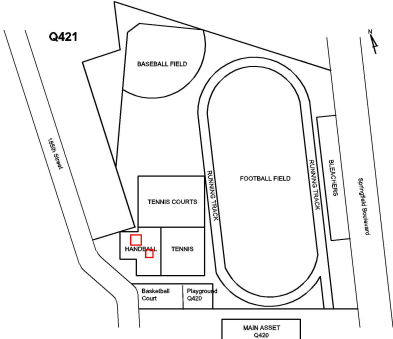
Question	Response
ATHLETIC FIELDS	
PLAYING SURFACE	
Deficiency	No deficiencies recorded
Instance on Football/Soccer Field	Inspected
Instance Condition	2 - Between Good and Fair
Instance Quantity	140,000
Instance Quantity Uom	S.F.
Deficiency	No deficiencies recorded
Instance on Handball Courts	Inspected
Instance Condition	2 - Between Good and Fair
Instance Quantity	4,000
Instance Quantity Uom	S.F.
Deficiency	POURED-IN-PLACE CONCRETE: DAMAGED/WORN OUT
Deficiency Location/Instance	Handball Courts
Roof Plan reference

Deficiency Quantity	30
Quantity Uom	S.F.
Potential Action	REPAIR
Urgency of Action	PRIORITY 3
Purpose of Action	LEVEL 2
Deficiency Photo1

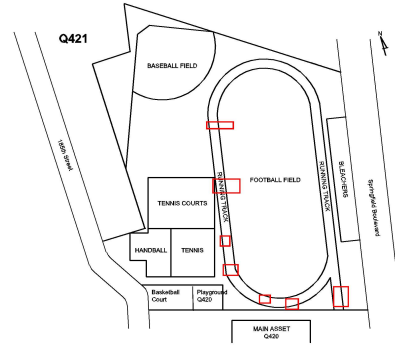
Handball Courts
Violations	No violations recorded.
Instance on Running Track	Inspected
Instance Condition	3 - Fair
Instance Quantity	42,000
Instance Quantity Uom	S.F.
Deficiency	ATHLETIC WEARING SURFACE: DAMAGED/DETERIORATED
Deficiency Location/Instance	Running Track

170

REPLACE

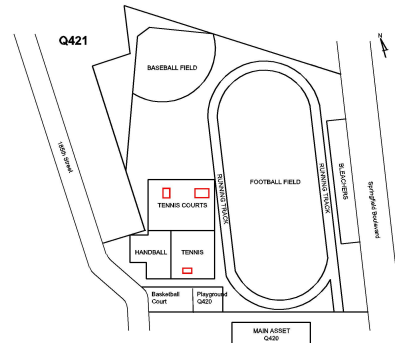
Tennis Courts

ASPHALT: DAMAGED/DETERIORATED

10

REPAIR

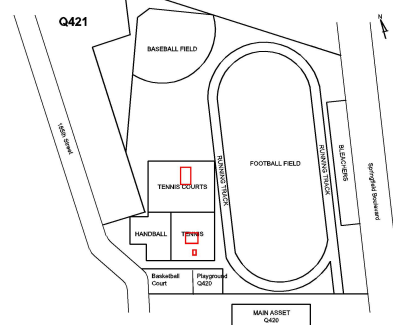
Tennis Courts

ASPHALT: DAMAGED/DETERIORATED

30

REPLACE
