**NYC Department of Education**  
**Building Condition Assessment Survey 2023 - 2024**

Architectural Inspection

Q443

**Asset:**           **3K CENTER @ 18-31 131ST STREET - QUEENS, 18-31 131ST STREET, 11356**

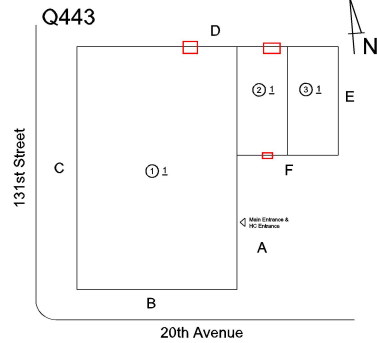
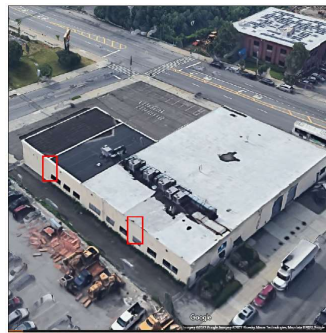
STONE: DETERIORATED CONTROL/EXPANSION JOINTS

30

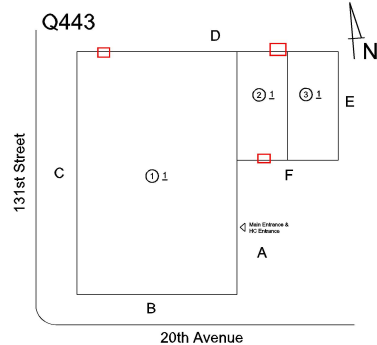
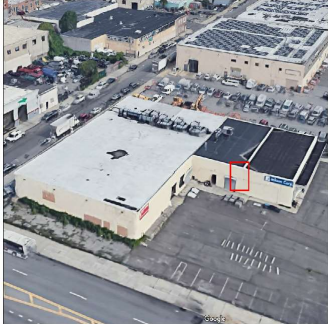
STONE: CHIPPED/SPALLED/BROKEN PIECES - MINOR

Deficiency Quantity	40
Quantity Uom	S.F.
Potential Action	REPAIR
Urgency of Action	PRIORITY 3
Purpose of Action	LEVEL 2
Deficiency Photo1
