NYC Department of Education
Building Condition Assessment Survey 2023 - 2024

Architectural Inspection

Asset: NEWCOMERS HIGH SCHOOL (OLD LIC)-Q, 28-01 41ST AVENUE, New York, 11101

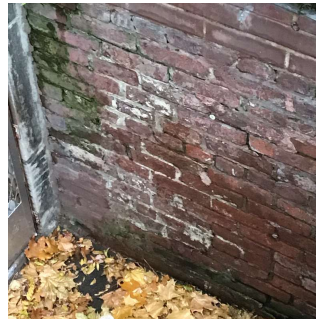
AW1

AREAWAY WALLS: DETERIORATED JOINTS

REPAIR

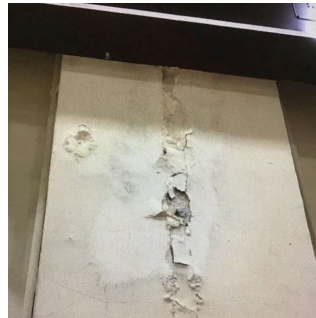
BRICK: WATER INFILTRATION IN INSTRUCTIONAL SPACE

Facade B - Stair H/1 - Vestibule Exit 8,
Facade G - Gymnasium 2nd Floor,
Facade H - Corridor near entrance Gymnasium 2nd Floor
(Shown), Gymnasium 4th Floor

REPAIR

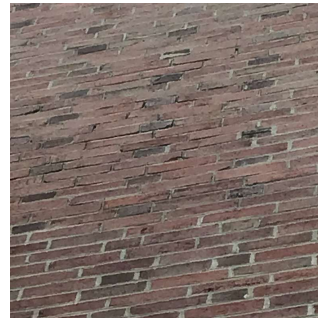
Facade B

BRICK: DETERIORATED JOINTS

50

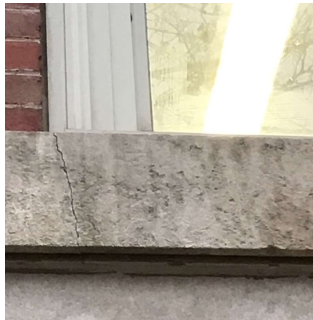
Facade A

STONE: DETERIORATED MASONRY SILLS - MAJOR

10

REMOVE AND REPLACE

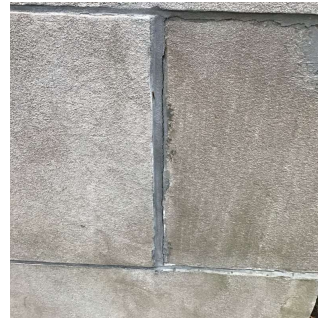
Facade A

STONE: CHIPPED/SPALLED/BROKEN PIECES - MINOR

20

REPAIR

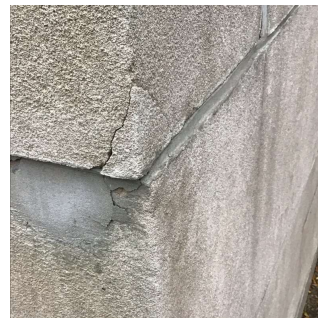
Facade A

STONE: CHIPPED/SPALLED/BROKEN PIECES - MAJOR

15

REPLACE

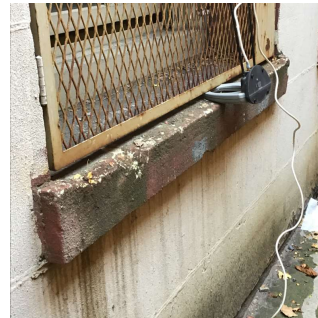
F

BRICK: DETERIORATED MASONRY SILLS - MINOR

10

REPAIR

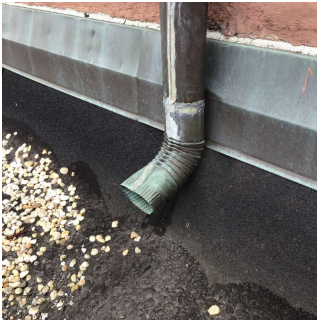
Violations	Roof 2 No violations recorded.
PLAZA DECK	Does not Exist
ROOF	Inspected
Roofing	Inspected
Replacement Quantity	38,000
Replacement Uom	S.F.
ROOF HATCH/SMOKE HATCH	Does not Exist
LEADERS, GUTTERS, DOWNSPOUTS, SCUPPERS	Inspected
Condition	3 - Fair
Deficiency	DAMAGED/MISSING
Roof Plan reference

Deficiency Quantity	40
Quantity Uom	L.F.
Potential Action	REPLACE
Urgency of Action	PRIORITY 4
Purpose of Action	LEVEL 2
Deficiency Photo1

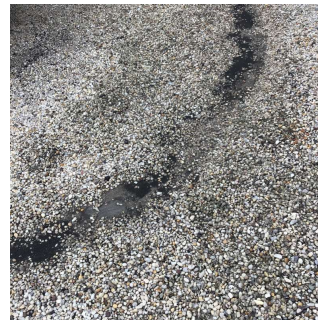
Roof 2
No violations recorded.

70
S.F.
INSTALL NEW GRAVEL
PRIORITY 3
LEVEL 2

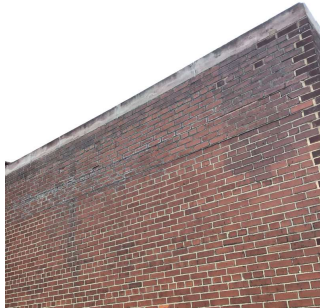
Violations	Roof 1 No violations recorded.
Specialties	Inspected
BULKHEAD/PENTHOUSE	Inspected
Condition	4 - Between Fair and Poor
Deficiency	BULKHEAD/PENTHOUSE WALLS/EXTERIOR: DETERIORATED JOINTS
Roof Plan reference

Deficiency Quantity	30
Quantity Uom	S.F.
Potential Action	REPOINT
Urgency of Action	PRIORITY 4
Purpose of Action	LEVEL 2
Deficiency Photo1

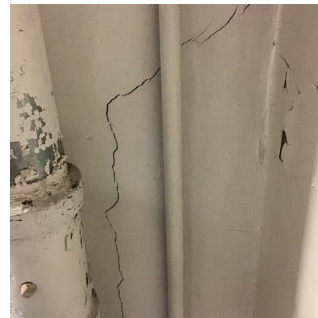
BH1
No violations recorded.

Violations	BH3 No violations recorded.
Deficiency	BULKHEAD/PENTHOUSE WALLS/INTERIOR: PLASTER CRACKS/SPALLING

10
S.F.
REPLACE
PRIORITY 4
LEVEL 2

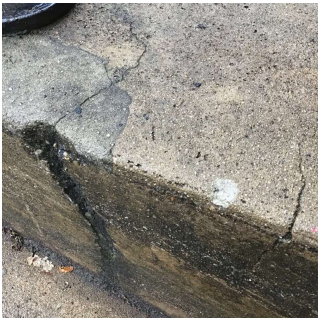
Violations	Roof 2 No violations recorded.
ROOF/GRAVITY TANK	Does not Exist
STAIRS/RAMPS: EXTERIOR	Inspected
BUILDING CHEEK/FLANK WALLS	Inspected
Condition	3 - Fair
Deficiency	CAST IN PLACE CONCRETE: CRACKS/SPALLING - MAJOR
Roof Plan reference

Deficiency Quantity	10
Quantity Uom	S.F.
Potential Action	REPLACE
Urgency of Action	PRIORITY 4
Purpose of Action	LEVEL 2
Deficiency Photo1

Violations	Facade H No violations recorded.
RAILINGS	Inspected

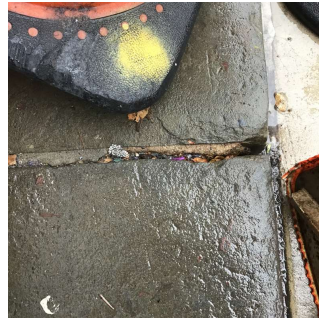
Question	Response
EXTERIOR	
STAIRS/RAMPS: EXTERIOR	
RAILINGS	Inspected
Condition	2 - Between Good and Fair
Deficiency	No deficiencies recorded
STAIRS/RAMPS	Inspected
Condition	5 - Poor
Deficiency	STONE: DETERIORATED JOINTS
Roof Plan reference

Deficiency Quantity	10
Quantity Uom	L.F.
Potential Action	REPOINT
Urgency of Action	PRIORITY 4
Purpose of Action	LEVEL 2
Deficiency Photo1

Violations	Facade B No violations recorded.
Deficiency	STONE: CRACKS/SPALLING - MAJOR
Roof Plan reference

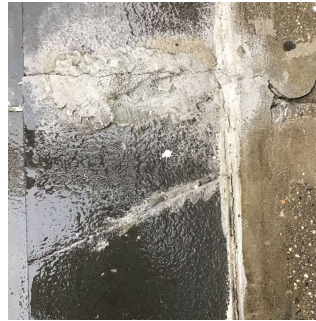
Facade A

Deficiency Quantity	30
Quantity Uom	S.F.
Potential Action	REPLACE
Urgency of Action	PRIORITY 4
Purpose of Action	LEVEL 2

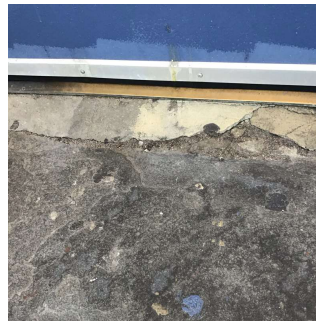
Facade B

STONE: CRACKS/SPALLING - MINOR

REPAIR

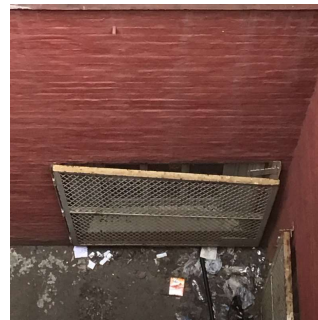
Facade F
No violations recorded.

DETERIORATED/TORN-OUT/MISSING

30
S.F.
REPLACE
PRIORITY 4
LEVEL 2

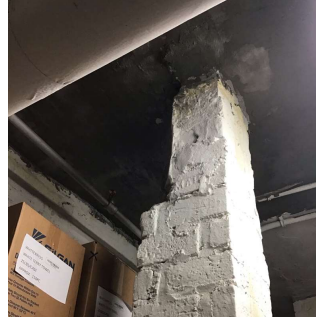
Basement - SB4
Violations	No violations recorded.
Deficiency	STEEL COLUMNS/BEAMS: DETERIORATED MASONRY FIREPROOFING
Deficiency Location/Instance	Basement - SB4
Deficiency Quantity	20
Quantity Uom	S.F.
Potential Action	REPLACE

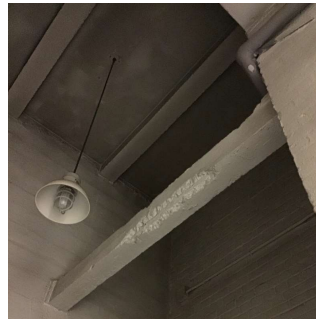
Basement - Boiler Room

STEEL COLUMNS/BEAMS: DETERIORATED CONCRETE FIREPROOFING

REPLACE

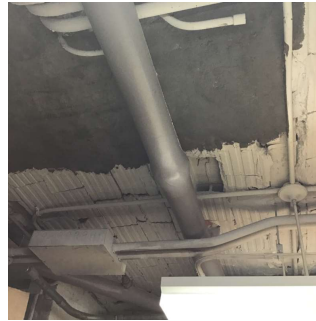
Basement -SB1

CINDER CONCRETE FLAT SLAB:
CRACKED/SPALLED/REINFORCEMENT EXPOSED

REPAIR

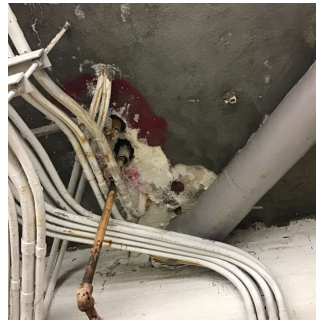
Basement -SB1

CINDER CONCRETE ARCH: METAL PAN DETERIORATED, SPALLED

REPAIR

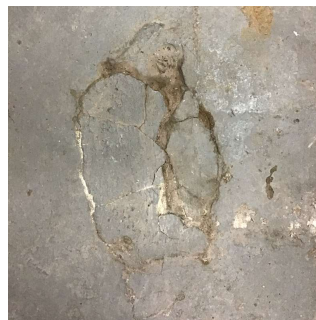
Basement - SB1

CONCRETE SLAB ON GRADE: THRU CRACKS

REPLACE

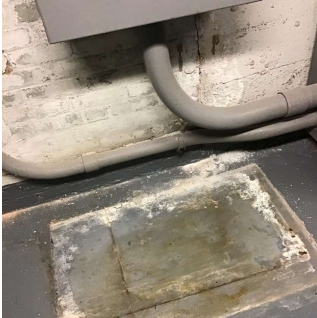
Question	Response
INTERIOR	
STRUCTURAL	
FLOOR STRUCTURE	Inspected
Violations	No violations recorded.
FOUNDATION WALLS	Inspected
Material Type(s)	Concrete
Condition	5 - Poor
Deficiency	CONCRETE: WATER INFILTRATION IN NON- INSTRUCTIONAL SPACE
Deficiency Location/Instance	Basement - Room SB4, General Area
Deficiency Quantity	500
Quantity Uom	S.F.
Potential Action	INSTALL WATERPROOFING
Urgency of Action	PRIORITY 5
Purpose of Action	LEVEL 5
Deficiency Photo1	 
Violations	Basement - Room SB4 No violations recorded.
Deficiency	CONCRETE: WATER INFILTRATION IN ELECTRICAL PANEL ROOM
Deficiency Location/Instance	Basement - Electrical Room
Deficiency Quantity	100
Quantity Uom	S.F.
Potential Action	INSTALL WATERPROOFING
Urgency of Action	PRIORITY 5
Purpose of Action	LEVEL 6
Deficiency Photo1

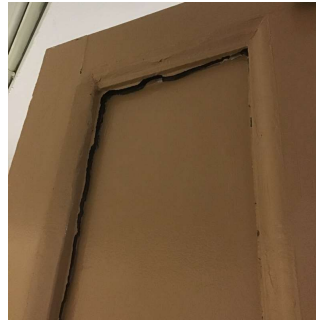
Stage Left Side Door

Violations	Basement - Vault No violations recorded.
AUDITORIUM	
Instance on 1st Floor (916 Seats)	Inspected
Ceiling	Inspected
Instance on 1st Floor (916 Seats)	Inspected
Condition	2 - Between Good and Fair
Deficiency	No deficiencies recorded
Door(s)	
Instance on 1st Floor (916 Seats)	Inspected
Condition	3 - Fair
Deficiency	METAL CLAD WOOD: DETERIORATED DOOR
Deficiency Location/Instance	Left Side Door

Deficiency Quantity	1
Quantity Uom	EACH
Potential Action	MAINTENANCE
Urgency of Action	PRIORITY 3
Purpose of Action	LEVEL 2

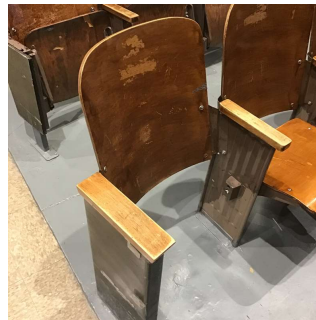
Seat C/1

DAMAGED/BROKEN/INOPERABLE

REPLACE

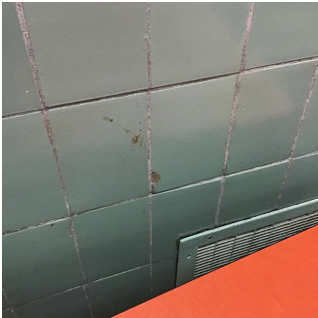
Near Stair F
Violations	No violations recorded.
Deficiency	GLAZED BLOCK: CRACKS/SPALLING
Deficiency Location/Instance	Near Entrance, Center
Deficiency Quantity	10
Quantity Uom	S.F.
Potential Action	REPLACE
Urgency of Action	PRIORITY 3
Purpose of Action	LEVEL 2
Deficiency Photo1

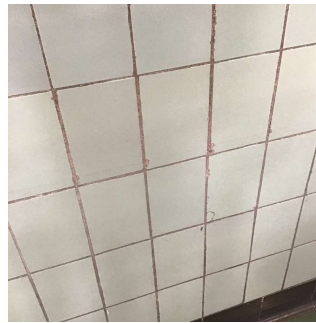
Near center
Violations	No violations recorded.
Instance on Basement - East	Inspected
Condition	2 - Between Good and Fair
Deficiency	GLAZED BLOCK: CRACKS/SPALLING
Deficiency Location/Instance	Near Serving Area
Deficiency Quantity	10
Quantity Uom	S.F.
Potential Action	REPLACE
Urgency of Action	PRIORITY 3
Purpose of Action	LEVEL 2

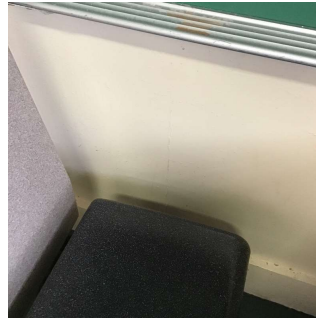
Near Windows

PLASTER: CRACKS/SPALLING

REPLACE

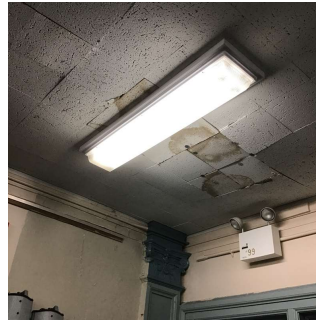
Corridor near Exit 9 - Vestibule

ACOUSTIC TILES ON PLASTER: DAMAGED/MISSING - ACTIVE LEAK

REPLACE

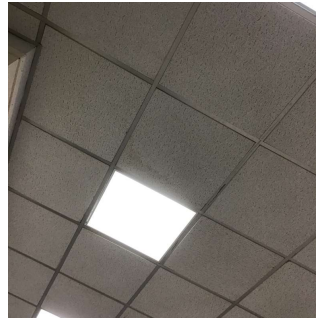
Room 202

ACOUSTIC TILES: DAMAGED/MISSING

REPLACE

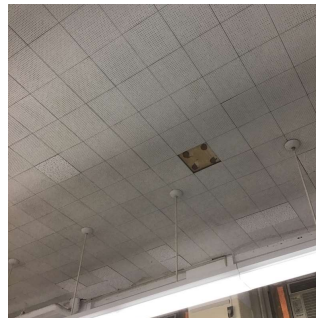
Room 014

ACOUSTIC TILES ON PLASTER: DAMAGED/MISSING

REPLACE

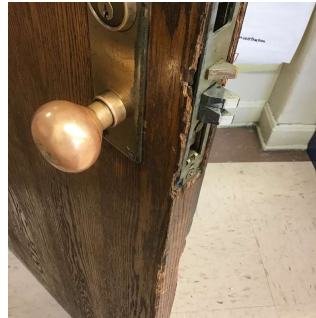
Room 402

WOOD: DETERIORATED DOOR

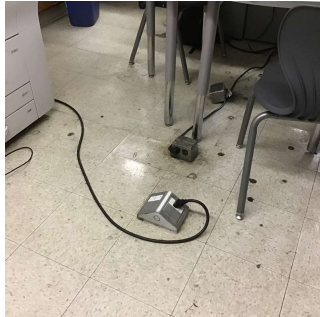
Question	Response
INTERIOR	
CLASSROOMS/CORRIDORS/ADMIN SPACES	
Floor Finish	
Violations	Room 319B No violations recorded.
Deficiency	VINYL TILES: TRIPPING HAZARD - ELECTRICAL OUTLET
Deficiency Location/Instance	Room 304
Deficiency Quantity	10
Quantity Uom	S.F.
Potential Action	REMOVE
Urgency of Action	PRIORITY 5
Purpose of Action	LEVEL 6
Deficiency Photo1

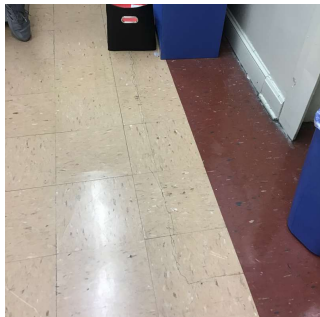
Violations	Room 304 No violations recorded.
Deficiency	VINYL TILES: DETERIORATED SUBSTRATE
Deficiency Location/Instance	Rooms 313, 317A, 412, 414, Corridor near Room 411, and others.
Deficiency Quantity	1,500
Quantity Uom	S.F.
Potential Action	REPLACE
Urgency of Action	PRIORITY 3
Purpose of Action	LEVEL 2
Deficiency Photo1

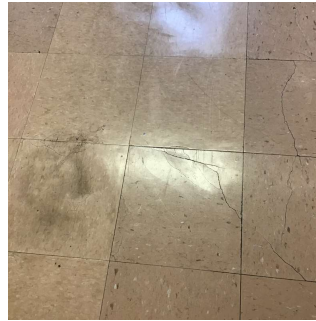
Corridor near Elevator A/4

Violations	Room 414 No violations recorded.
Deficiency	VINYL TILES: BROKEN/DETERIORATED/MISSING TILES
Deficiency Location/Instance	Rooms 109, 219, 409, 413, Corridor near Elevator A/4, and others.
Deficiency Quantity	3,000
Quantity Uom	S.F.

Potential Action	REPLACE
Urgency of Action	PRIORITY 3
Purpose of Action	LEVEL 2

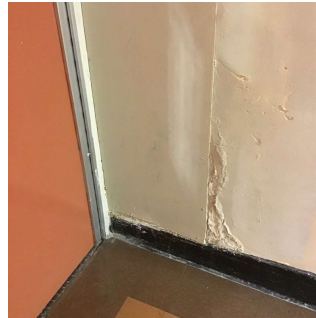
Corridor near Gymnasium 2nd Floor Entrance

PLASTER: CRACKS/SPALLING - ACTIVE LEAK

REPLACE

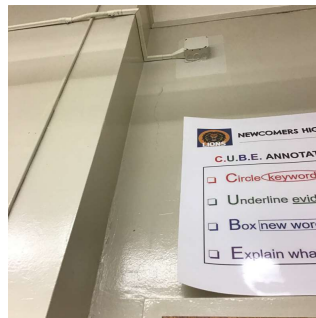
PLASTER: CRACKS/SPALLING

REPLACE

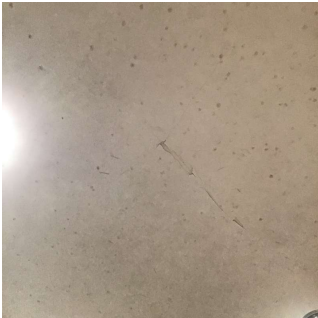
Question	Response
INTERIOR	
CLASSROOMS/CORRIDORS/ADMIN SPACES	Inspected
Walls	Inspected
	Room 414
Violations	No violations recorded.
Specialties	Does not Exist
GYMNASIUM	Inspected
Instance on 2nd Floor	Inspected
Instance on 4th Floor	Inspected
Ceiling	
Instance on 4th Floor	Inspected
Condition	2 - Between Good and Fair
Deficiency	PLASTER: CRACKS/SPALLING
Deficiency Location/Instance	Near center
Deficiency Quantity	20
Quantity Uom	S.F.
Potential Action	REPLACE
Urgency of Action	PRIORITY 4
Purpose of Action	LEVEL 4
Deficiency Photo1

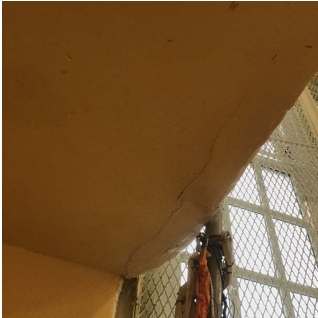
Near center
Violations	35467686K, 35548339K, 35636305M
Instance on 2nd Floor	Inspected
Condition	2 - Between Good and Fair
Deficiency	PLASTER: CRACKS/SPALLING
Deficiency Location/Instance	Near Windows
Deficiency Quantity	20
Quantity Uom	S.F.
Potential Action	REPLACE
Urgency of Action	PRIORITY 4
Purpose of Action	LEVEL 4
Deficiency Photo1

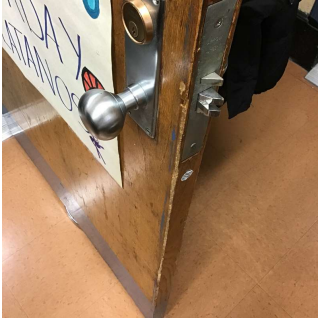
Question	Response
INTERIOR	
GYMNASIUM	Inspected
Door(s)	
Instance on 4th Floor	Inspected
Condition	3 - Fair
Deficiency	METAL CLAD WOOD: DETERIORATED DOOR
Deficiency Location/Instance	Room 419
Deficiency Quantity	1
Quantity Uom	EACH
Potential Action	MAINTENANCE
Urgency of Action	PRIORITY 3
Purpose of Action	LEVEL 2
Deficiency Photo1	 
	Room 419
Violations	No violations recorded.
Instance on 2nd Floor	Inspected
Condition	4 - Between Fair and Poor
Deficiency	WOOD: DETERIORATED DOOR
Deficiency Location/Instance	Office
Deficiency Quantity	2
Quantity Uom	EACH
Potential Action	MAINTENANCE
Urgency of Action	PRIORITY 3
Purpose of Action	LEVEL 2
Deficiency Photo1

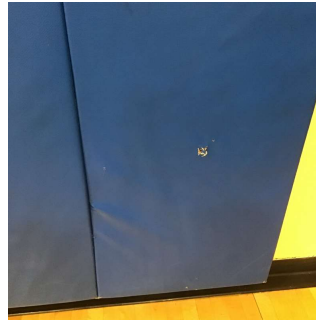
Near Stair H

Near Windows
Violations	No violations recorded.
Deficiency	WALL PADDING: DETERIORATED
Deficiency Location/Instance	Near Stair H, Windows
Deficiency Quantity	100
Quantity Uom	S.F.
Potential Action	REPLACE
Urgency of Action	PRIORITY 3
Purpose of Action	LEVEL 2

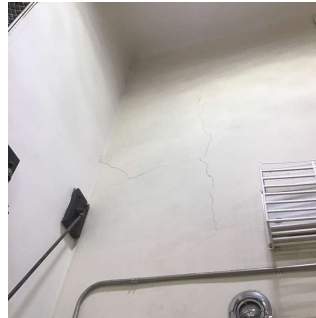
Near Entrance

PLASTER: CRACKS/SPALLING

REPLACE

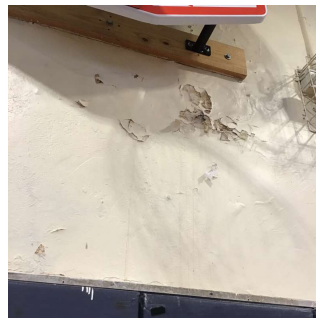
PLASTER: CRACKS/SPALLING - ACTIVE LEAK

REPLACE

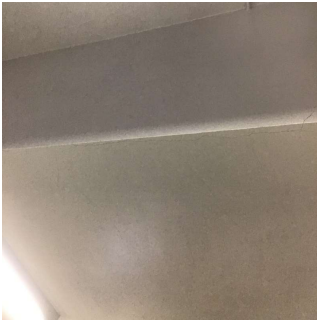
Violations	Stair BC/1 No violations recorded.
KITCHEN	
Instance on Basement	Inspected
Ceiling	
Instance on Basement	Inspected
Condition	2 - Between Good and Fair
Deficiency	PLASTER: CRACKS/SPALLING
Deficiency Location/Instance	Near Oven Area
Deficiency Quantity	20
Quantity Uom	S.F.
Potential Action	REPLACE
Urgency of Action	PRIORITY 3
Purpose of Action	LEVEL 2

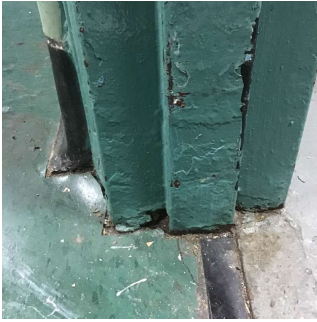
Violations	Near Oven Area No violations recorded.
Door(s)	
Instance on Basement	Inspected
Condition	4 - Between Fair and Poor
Deficiency	METAL: DETERIORATED DOOR AND FRAME
Deficiency Location/Instance	Storage Inside Cafeteria
Deficiency Quantity	1
Quantity Uom	EACH
Potential Action	MAINTENANCE
Urgency of Action	PRIORITY 3
Purpose of Action	LEVEL 2
Deficiency Photo1

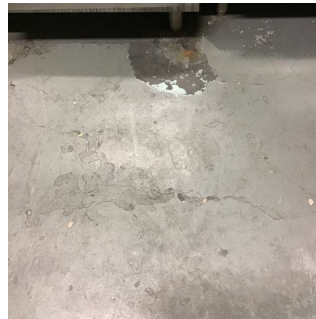
Instance on Basement	Inspected
Condition	2 - Between Good and Fair
Deficiency	CONCRETE: CRACKS
Deficiency Location/Instance	Storage Inside Cafeteria
Deficiency Quantity	10
Quantity Uom	S.F.
Potential Action	REPLACE
Urgency of Action	PRIORITY 3
Purpose of Action	LEVEL 2
Deficiency Photo1

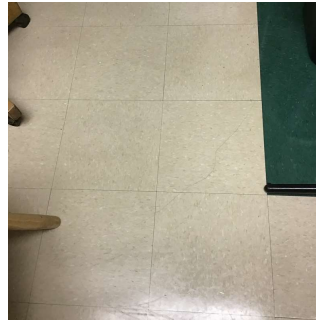
Deficiency	VINYL TILES: BROKEN/DETERIORATED/MISSING TILES
Deficiency Location/Instance	Office outside Serving Area
Deficiency Quantity	10
Quantity Uom	S.F.
Potential Action	REPLACE
Urgency of Action	PRIORITY 3
Purpose of Action	LEVEL 2

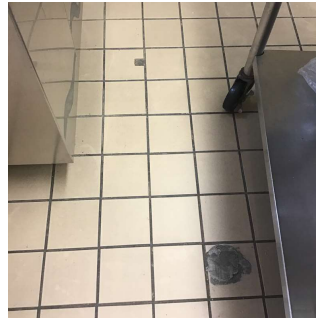
Serving Area

QUARRY TILE: BROKEN/MISSING TILES

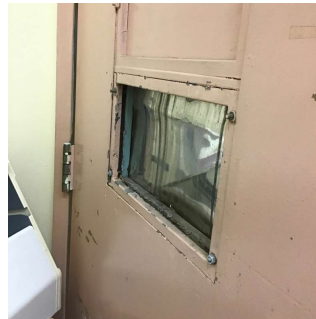
Instance on Room 213	Inspected
Condition	3 - Fair
Deficiency	METAL: DETERIORATED DOOR
Deficiency Location/Instance	Room 213A
Deficiency Quantity	1
Quantity Uom	EACH
Potential Action	MAINTENANCE
Urgency of Action	PRIORITY 3
Purpose of Action	LEVEL 2
Deficiency Photo1

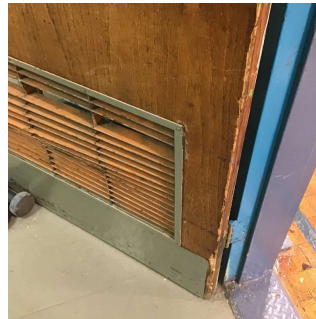
Entrance

Instance on 4th Floor - Boys (294 Lockers)	Inspected
Condition	5 - Poor
Deficiency	WOOD: DETERIORATED DOOR
Deficiency Location/Instance	Entrances
Deficiency Quantity	4
Quantity Uom	EACH
Potential Action	MAINTENANCE
Urgency of Action	PRIORITY 3
Purpose of Action	LEVEL 2
Deficiency Photo1

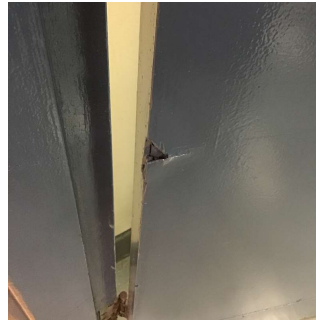
Entrance

Instance on 2nd Floor (495 Lockers)	Inspected
Condition	5 - Poor
Deficiency	WOOD: DETERIORATED DOOR
Deficiency Location/Instance	Entrance, Exits
Deficiency Quantity	3
Quantity Uom	EACH
Potential Action	MAINTENANCE
Urgency of Action	PRIORITY 3
Purpose of Action	LEVEL 2

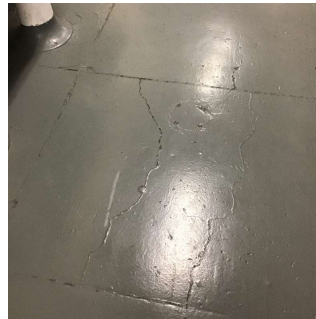
Near Drinking Fountain

CONCRETE: CRACKS

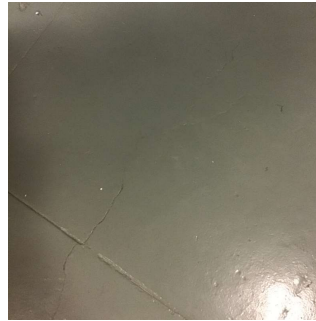
Near Entrance

CONCRETE: CRACKS

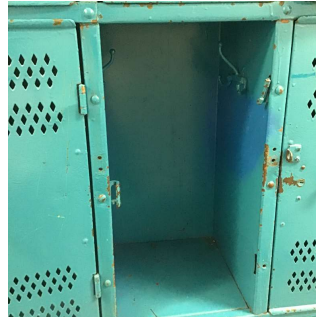
Locker 113

Instance on 4th Floor - Boys (294 Lockers)	Inspected
Condition	2 - Between Good and Fair
Deficiency	DAMAGED UNITS
Deficiency Location/Instance	Lockers 113, 144, 147, 395, 396, and others.
Deficiency Quantity	8
Quantity Uom	EACH
Potential Action	REPLACE
Urgency of Action	PRIORITY 3
Purpose of Action	LEVEL 2
Deficiency Photo1

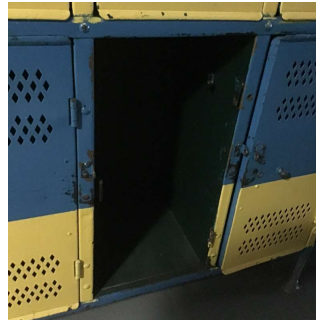
Instance on 4th Floor - Girls (900 Lockers)	Inspected
Condition	2 - Between Good and Fair
Deficiency	DAMAGED UNITS
Deficiency Location/Instance	Locker 44
Deficiency Quantity	1
Quantity Uom	EACH
Potential Action	REPLACE
Urgency of Action	PRIORITY 3
Purpose of Action	LEVEL 2

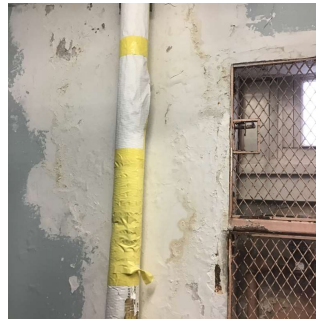
Near Windows

Instance on 4th Floor - Boys (294 Lockers)	Inspected
Condition	2 - Between Good and Fair
Deficiency	PLASTER: CRACKS/SPALLING
Deficiency Location/Instance	Near Windows, Entrances
Deficiency Quantity	50
Quantity Uom	S.F.
Potential Action	REPLACE
Urgency of Action	PRIORITY 3
Purpose of Action	LEVEL 2
Deficiency Photo1

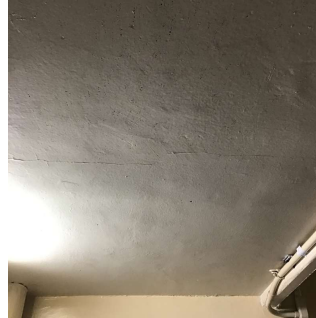
Stair DE/3

PLASTER: CRACKS/SPALLING

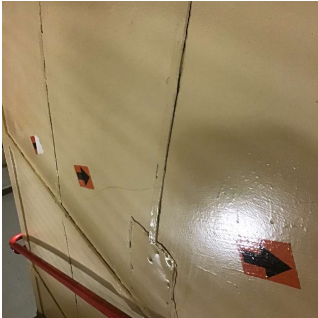
Question	Response
INTERIOR	
STAIRS/RAMPS: INTERIOR	
Door(s)	Inspected
	Stair DE/3
Violations	No violations recorded.
Partition	Inspected
Condition	3 - Fair
Deficiency	METAL FRAME: DAMAGED/DETERIORATED
Deficiency Location/Instance	Stair JK/Basement, 1, 3
Deficiency Quantity	40
Quantity Uom	L.F.
Potential Action	REPLACE
Urgency of Action	PRIORITY 3
Purpose of Action	LEVEL 2
Deficiency Photo1

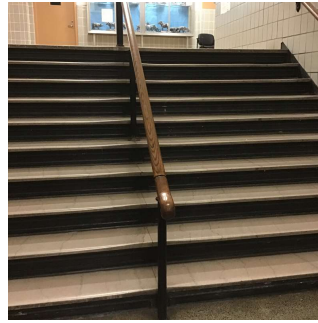
Violations	Stair JK/Basement No violations recorded.
Stairs and Landings	
Condition	Inspected 5 - Poor
Deficiency	STONE: BROKEN/MISSING
Deficiency Location/Instance	Vestibule Exit 9
Deficiency Quantity	10
Quantity Uom	S.F.
Potential Action	REPLACE
Urgency of Action	PRIORITY 5
Purpose of Action	LEVEL 6
Deficiency Photo1	 
Violations	Vestibule Exit 9 No violations recorded.
Deficiency	STONE: WORN-OUT TREAD/NOSINGS
Deficiency Location/Instance	Near Room 106
Deficiency Quantity	100
Quantity Uom	S.F.
Potential Action	REPLACE
Urgency of Action	PRIORITY 3
Purpose of Action	LEVEL 2

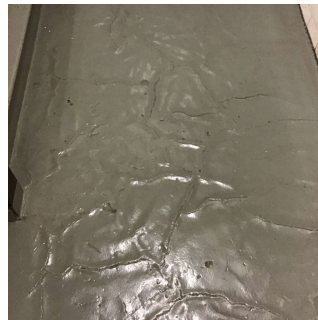
Stair H/1

ROLLED ASPHALT: DETERIORATED SUBSTRATE

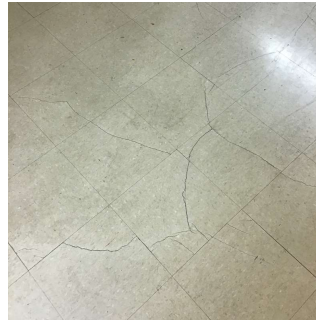
Question	Response
INTERIOR	
STAIRS/RAMPS: INTERIOR	
Stairs and Landings	
Deficiency	TERRAZZO: CRACKS
Deficiency Location/Instance	Stairs BC/Basement, FG/Basement - Vestibule, Vestibule near Auditorium.
Deficiency Quantity	150
Quantity Uom	S.F.
Potential Action	REPLACE
Urgency of Action	PRIORITY 3
Purpose of Action	LEVEL 2
Deficiency Photo1	 
	Stair FG/Basement - Vestibule
Violations	No violations recorded.
Deficiency	VINYL TILES: DETERIORATED SUBSTRATE
Deficiency Location/Instance	Stairs DE/4, FG/Basement, 3
Deficiency Quantity	300
Quantity Uom	S.F.
Potential Action	REPLACE
Urgency of Action	PRIORITY 3
Purpose of Action	LEVEL 2
Deficiency Photo1	 
	Stair FG/Basement
Violations	No violations recorded.
Deficiency	VINYL TILES: BROKEN/DETERIORATED/MISSING TILES
Deficiency Location/Instance	Stairs DE/3, FG/Basement, 1, 3
Deficiency Quantity	300
Quantity Uom	S.F.
Potential Action	REPLACE
Urgency of Action	PRIORITY 3
Purpose of Action	LEVEL 2

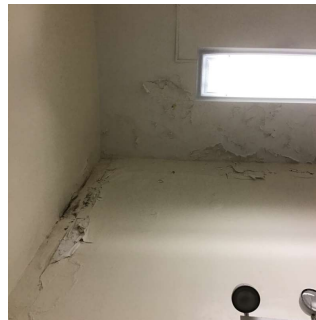
Auditorium- Vestibule Exit 8

PLASTER: CRACKS/SPALLING - ACTIVE LEAK

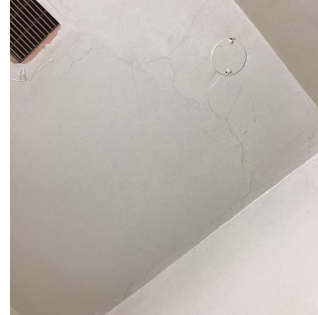
Room 321

Question	Response
INTERIOR	
STAIRS/RAMPS: INTERIOR	
Walls	
Violations	Stair BC/3 No violations recorded.
Deficiency	CERAMIC TILE: BROKEN/ MISSING
Deficiency Location/Instance	Stair DE/1, 2, 4, FG/2, JK/1, and others.
Deficiency Quantity	200
Quantity Uom	S.F.
Potential Action	REPLACE
Urgency of Action	PRIORITY 3
Purpose of Action	LEVEL 2
Deficiency Photo1	 
Violations	Stair D/4 No violations recorded.
Deficiency	PLASTER: CRACKS/SPALLING
Deficiency Location/Instance	Stairs BC/Basement , DE/2, FG/Basement
Deficiency Quantity	40
Quantity Uom	S.F.
Potential Action	REPLACE
Urgency of Action	PRIORITY 3
Purpose of Action	LEVEL 2
Deficiency Photo1	 
Violations	Stair FG/Basement No violations recorded.
TOILET ROOMS - STAFF	
Ceiling	Inspected
Condition	3 - Fair
Deficiency	PLASTER: CRACKS/SPALLING
Deficiency Location/Instance	Rooms 111, 321
Deficiency Quantity	20
Quantity Uom	S.F.
Potential Action	REPLACE

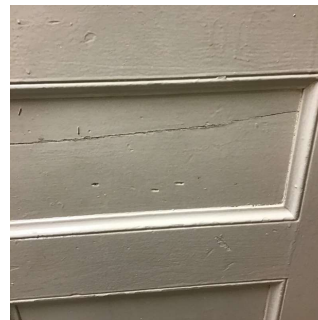
Gymnasium - Office

WOOD: DETERIORATED DOOR

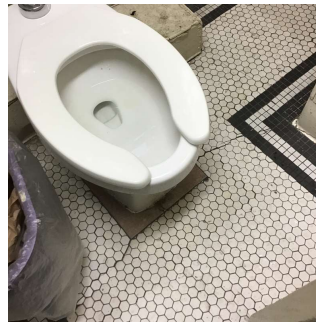
Gymnasium - Office

CERAMIC TILE: BROKEN/MISSING TILES

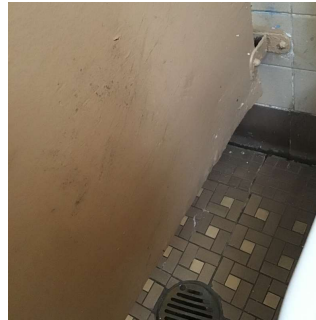
Room 323

RUST - MAJOR

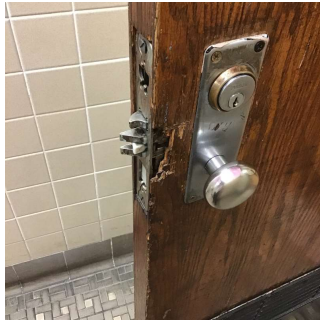
Question	Response
INTERIOR	
TOILET ROOMS - STUDENTS	
Ceiling	Inspected
Deficiency Photo1	 
Violations	Room 411 No violations recorded.
Door(s)	Inspected
Condition	5 - Poor
Deficiency	WOOD: DETERIORATED DOOR
Deficiency Location/Instance	Rooms 211, 311, 405
Deficiency Quantity	3
Quantity Uom	EACH
Potential Action	MAINTENANCE
Urgency of Action	PRIORITY 3
Purpose of Action	LEVEL 2
Deficiency Photo1

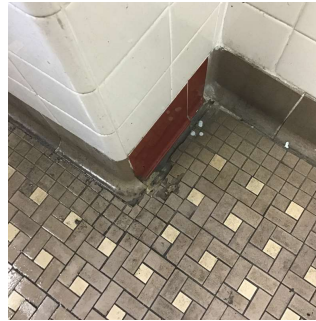
Room 405

Violations	Room 211 No violations recorded.
Floor Finish	Inspected
Condition	2 - Between Good and Fair
Deficiency	CERAMIC TILE: BROKEN/MISSING TILES
Deficiency Location/Instance	Rooms 311, 405, Locker 2nd Floor
Deficiency Quantity	20
Quantity Uom	S.F.
Potential Action	REPLACE
Urgency of Action	PRIORITY 3
Purpose of Action	LEVEL 2

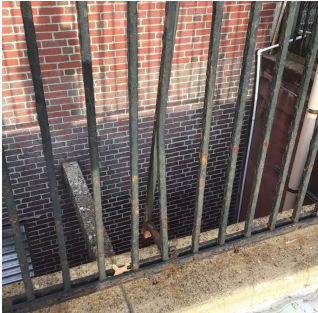
Violations	No violations recorded.
Deficiency	WROUGHT IRON: DAMAGED/DETERIORATED
Deficiency Location/Instance	28th Street, 29th Street
Deficiency Quantity	280
Quantity Uom	S.F.

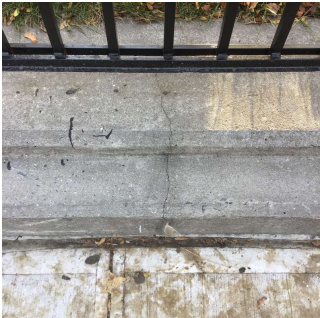
Question	Response
SITE	
FENCES	
Violations	29th Street No violations recorded.
Deficiency	CONCRETE CURB: DAMAGED/DETERIORATED
Deficiency Location/Instance	28th Street, 29th Street, 41st Street
Deficiency Quantity	130
Quantity Uom	S.F.
Potential Action	REPLACE
Urgency of Action	PRIORITY 3
Purpose of Action	LEVEL 2
Deficiency Photo1

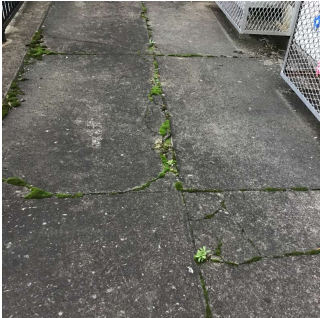
Violations	28th Street No violations recorded.
IRRIGATION SYSTEM	Does not Exist
PAVING	Inspected
Student Non-Use	Inspected
Gravel Exists?	No
Asphalt	Does not Exist
Concrete	Inspected
Condition	3 - Fair
Deficiency	CRACKS - MAJOR
Deficiency Location/Instance	Near Exits 2/3, 4/5, 6, 10/11
Deficiency Quantity	275
Quantity Uom	S.F.
Potential Action	REPLACE
Urgency of Action	PRIORITY 3
Purpose of Action	LEVEL 2
Deficiency Photo1

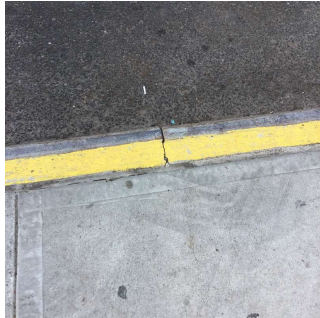
Question	Response
SITE	
PAVING	
DOT Sidewalk	
Concrete	
Deficiency Location/Instance	28th Street, 29th Street, 41st Avenue
Deficiency Quantity	250
Quantity Uom	L.F.
Potential Action	REPLACE
Urgency of Action	PRIORITY 3
Purpose of Action	LEVEL 2
Deficiency Photo1

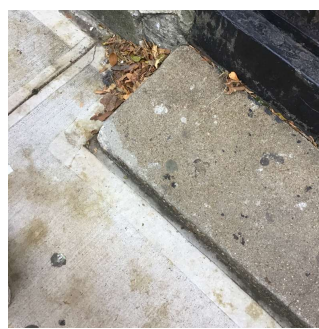
Violations	28th Street No violations recorded.
Pavers	Does not Exist
PLAYGROUNDS	Does not Exist
PLAYING SURFACE	Does not Exist
RETAINING WALLS	Inspected
Are there any Retaining Walls 6' OR higher facing public street/sidewalk?	No
Condition	2 - Between Good and Fair
Deficiency	No deficiencies recorded
SEATING	Does not Exist
SITE WALLS (NOT RETAINING WALLS)	Does not Exist
STAIRS/RAMPS: EXTERIOR	Inspected
Railings	Does not Exist
Site Cheek/flank Walls	Does not Exist
Stairs/ramps	Inspected
Condition	2 - Between Good and Fair
Deficiency	CAST IN PLACE CONCRETE: CRACKS/SPALLING - MAJOR
Deficiency Location/Instance	Near Exit 10/11
Deficiency Quantity	10
Quantity Uom	S.F.
